## Sunset Valley Elementary School Site Summary

<b>Address</b>	3000 Jones Road Austin, TX 78745
<b>Number of Permanent Campus Facilities</b>	2
<b>Original Year of Construction</b>	1971, 1996
<b>Total Campus Building Area (combined)</b>	64,766 SF

## Main School Building – BLDG-158A

## CRAWL SPACE – Sunset Valley ES – Main School Building (BLDG-158A)

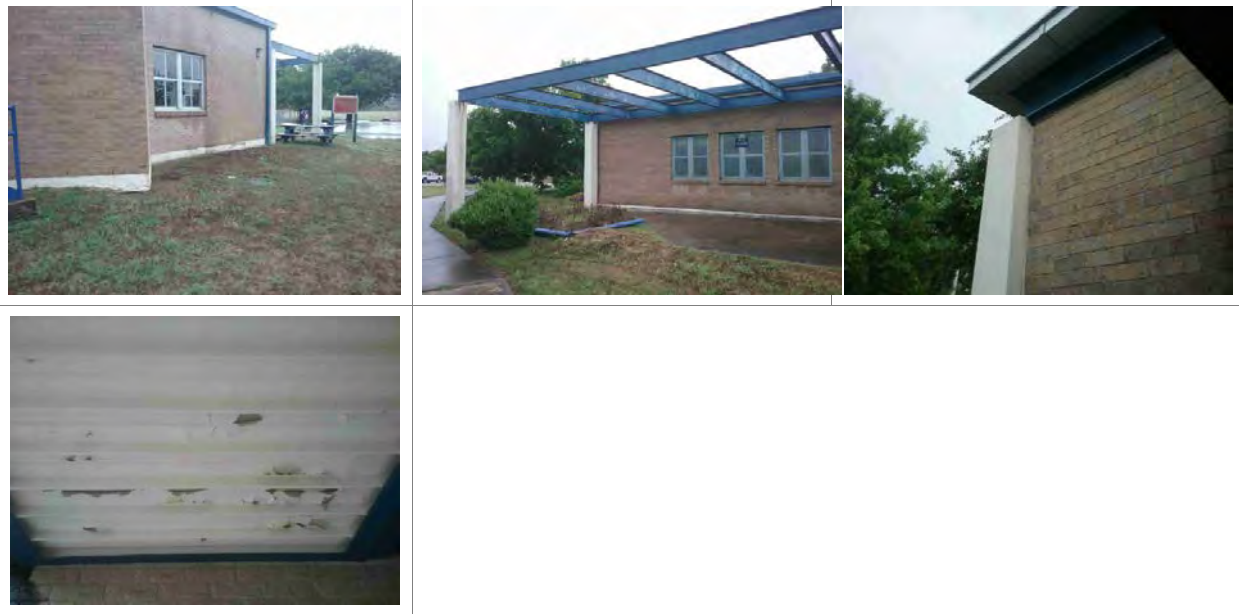
### Exterior Walls

System	Subsystem	Condition and Deficiency Overview	System Condition Rating
Exterior	Exterior Walls	<p>Exterior walls for the original building are brick facade with exposed concrete and steel structure. Some portions of the 300-wing appear newer and do not have the exposed beam at grade. The beam at grade appears to have a cementitious coating over the top of the structural concrete or the grade beam.</p> <p>The brickwork appeared to be in good condition, consistent with the age of the building or addition, while the exposed concrete columns and steel structure had more substantive issues that were observed to be in average condition. In some areas, the parging was cracked or spalling off the structure. Some of the exposed concrete columns at the exterior corners appeared to be rusting at the connection with the structural beam. This was particularly true on all of the steel trellises around the 300-wing. On the main building, there were a limited number of columns (less than six) that had a similar issue. Paint on the exposed steel beams and metal decking was observed to be in poor condition at the building and the exterior trellises along with portions of the drip edge at the roof. Sealants at exterior brick joints appeared to be failing.</p>	Average

1. Repaint steel structural elements.
2. Investigate rusting at concrete columns.
3. Remove old sealant at brickwork and install new.
4. Remove damaged parging and reparse concrete.
5. Replace the window system with one that has better thermal performance or replace finishes adjacent to windows with materials that can be exposed to moisture.
6. Replace existing sealant at windows.
7. Install thresholds at exterior doors that direct water outside.
8. Review existing door hardware.

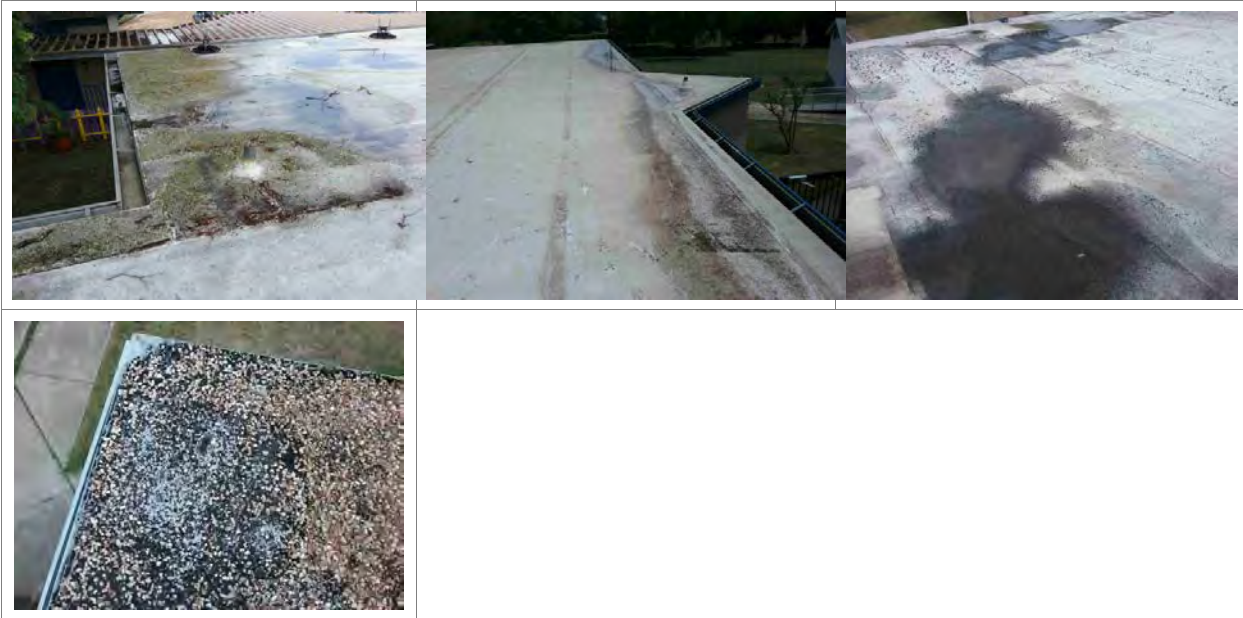
### **Roofing Deficiency Examples**

Roofing	<p>The various roof planes are covered with a variety of materials: built up, modified bitumen, and PVC (polyvinyl chloride) were noted while on the roof.</p> <p>A large number of downspouts appeared to be clogged and ejecting water through the joint at the cast iron boot or other joints in the downspout. All gutters held some amount of water, and in many locations, at the joints between the gutter sections; the joint sealant had failed and was leaking. This caused wetting of the brick and had the potential to introduce water into the exterior envelope.</p> <p>The fully adhered PVC was newer and showed the least number of issues, although leaks were reported and noted under these roof sections. (See ceiling finish deficiencies for documentation of items that were seen.) The PVC roof sections showed ponding at the edges of the roof, though it was not significant. Many of the PVC roof sections had adhesion issues at the transition between the tapered insulation and the roof edge blocking. This manifested itself in the form of wrinkles. None of these appeared to be inflated.</p>		Average

System	Subsystem	Condition and Deficiency Overview	System Condition Rating
		The modified bitumen and built up sections were keeping the water out but had significant issues that need to be addressed. The built up sections had been patched and were aged out. The modified bitumen sections had significant ponding. Though the largest area (A01) appeared to be in average condition, this area of the roof had significant ponding and a significant number of soft spots. Section A09 appeared to be in condition that suggested heavy rain could cause substantive damage inside the building.	
Interior Construction	Interior Walls	<p>The interior wall systems are a combination of exposed brick, CMU (concrete masonry unit), studs with a panelized vinyl-wrapped drywall system, and wood paneling.</p> <p>Given the types of systems covering the walls, minor movements in the foundation would not appear on the exterior surfaces of these interior walls. The walls were observed to be in average condition as a result of the number of surface issues in the vinyl wall covering and the potential for moisture issues as a result of wetting from the outside or the window systems.</p> <p>Accordion doors in the building were typically not as long as shown on the drawings. There had been an amount of infill and the door limited to about 9 feet in length. It was reported that the operable partition in the cafeteria was old and damaged. This unit appeared to be older, but the functioning of the system was not assessed, and material stored on either side limited the review.</p> <p>Many of the classrooms have interior windows looking in on the common areas. In addition, these units contained acrylic window panes. Acrylic is not a durable material.</p>	Average

1. Immediately replace the roofing on section A09.
2. Review condition of PVC material with installer.
3. Clean out all gutters and downspouts.
4. Review fall of gutters to ensure positive flow of water.

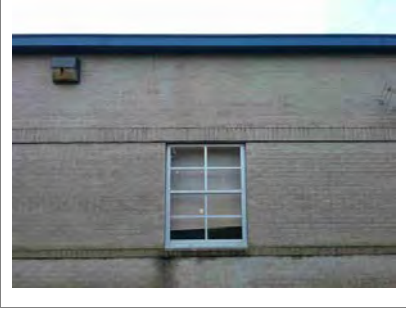
System	Subsystem	Condition and Deficiency Overview	System Condition Rating
Exterior	Exterior Walls	This building has brick exterior walls with windows inset over brick sills.  On the east side of the building, there a was vertical crack observed in the masonry through the brick.	Average
	Exterior Windows	The exterior window system is comprised of aluminum frames with single-pane glazing similar to the main building.  As a result of moisture, likely the result of condensation, the sills of the exterior windows showed water damage. The sealant around the windows was in a state of failure and needed to be replaced. Acrylic was present in a number of the operable sashes of the windows and should be replaced.	Average
	Exterior Doors	Exterior doors are hollow metal door panels with windows set in hollow metal frames.  One pair of doors appeared to have sagged and was repaired with a pivot hinge at the top of the doors. These types of hinges are not durable, and the doors will continue to sag inward.	Average

1. Investigate the crack in brick work.
2. Replace the sealant at windows.
3. Replace pivot and knuckle hinges with continuous gear hinges.

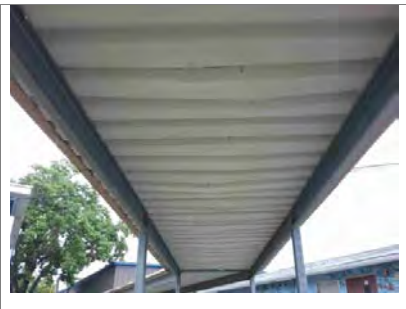
Roofing	The roof system is comprised of a fully adhered single-ply PVC system on the main building. Covered walkways utilize a metal panel system.  Like BLDG-158A, there appeared to be some ponding at the roof edge. At the covered walkway, there was physical damage that allowed water to come through.		Average

1. Review ponding at roof edge with installation contractor and warranty provider.

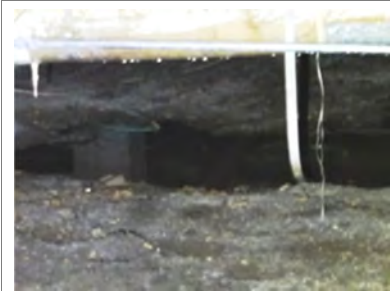
Standing water

1. Improve grading outside of building to promote drainage away from building
2. Re-grade in crawl space so lower grades existing around perimeter and prevent water from flowing elsewhere and ponding
3. Replace or reposition rotated retainers
4. Investigate need for improved ventilation

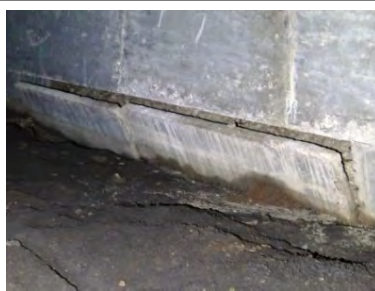
Overturned concrete soil retainers

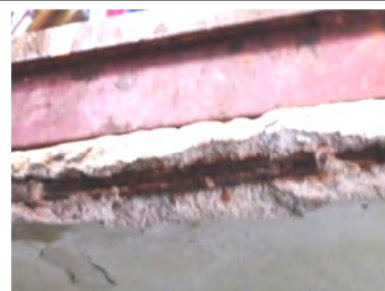
Exposed slab reinforcement below hatch

1. Clean & protect exposed, rusted reinforcement
2. Use epoxy injection to repair longitudinal cracks in pan joist webs
3. Patch larger spalls under slab or on pan joist webs

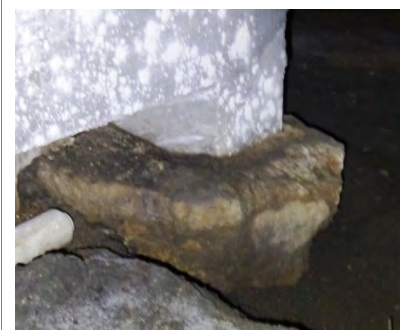
Mushrooming at drill shaft

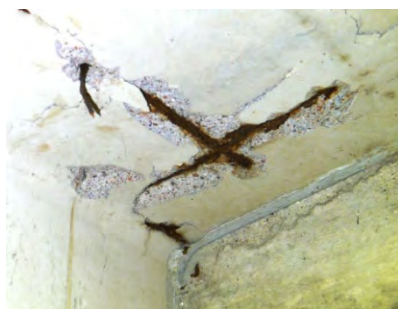
Exposed reinforcing underside of slab

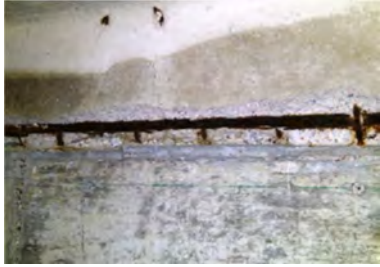
Exposed reinforcement in precast joist

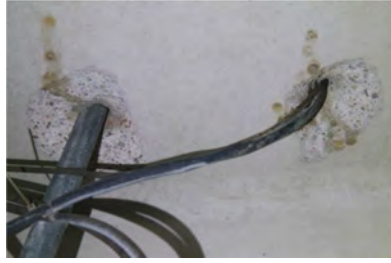
Spalling under deck

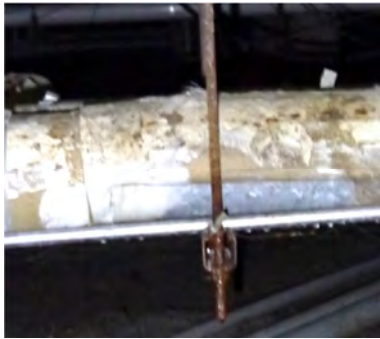
Rusted pipe hangers, degraded pipe insulation

1. Replace severely rusted hangers
2. Replace missing & degraded pipe insulation

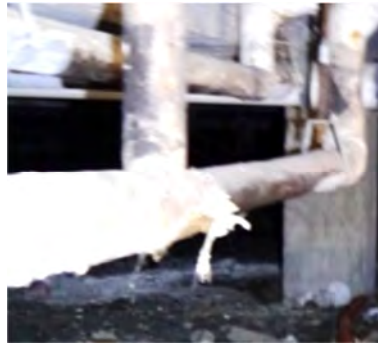
Stripped pipe insulation

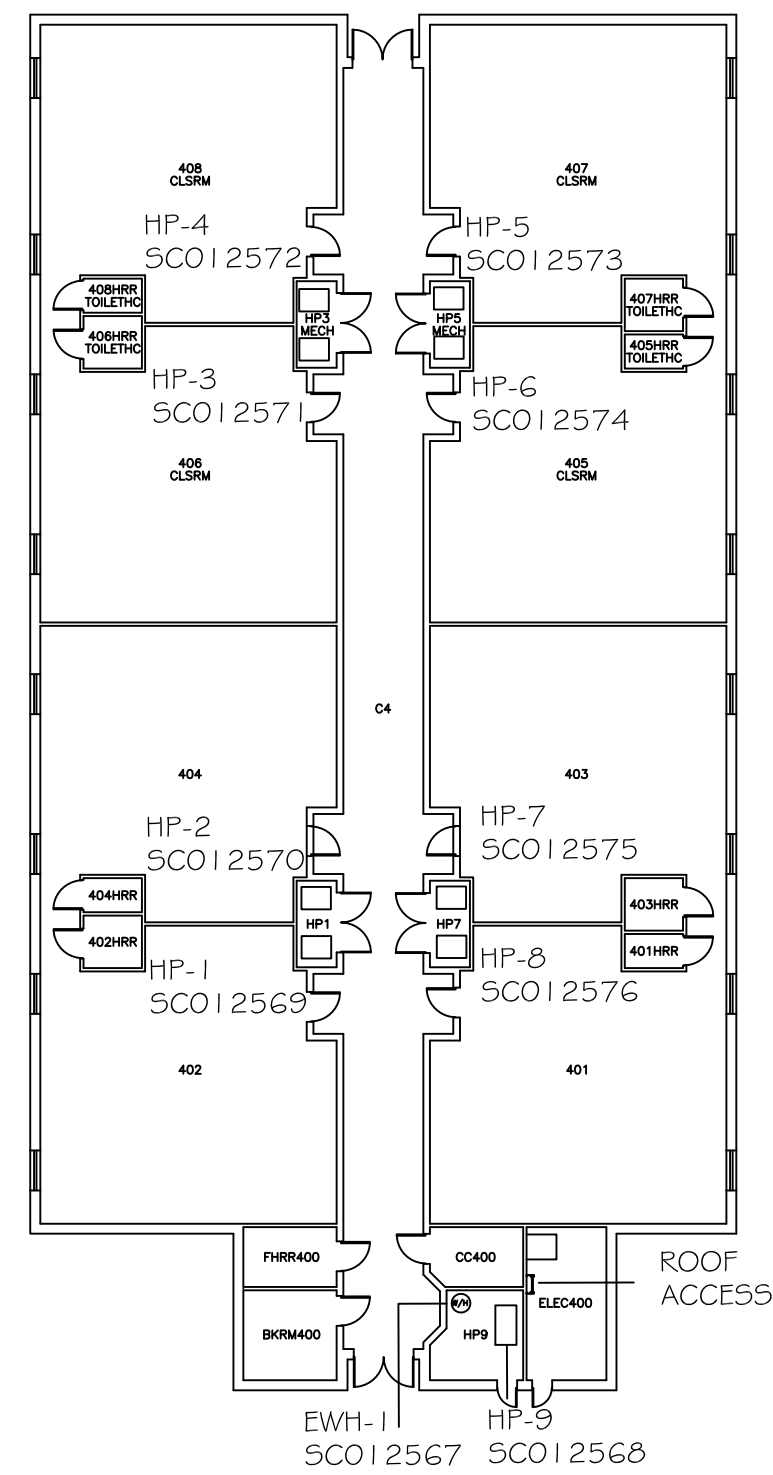
FLR-158B-01

- 1) DAMP SOIL
- 2) SIGNS OF PONDING WATER PREVIOUSLY
- 3) INADEQUATE VENTILATION
- 4) EXPOSED REINFORCEMENT IN BEAMS
- 5) LONGITUDINAL CRACKING IN PRECAST PAN JOIST WEBS
- 6) EXPOSED/RUSTED REINFORCEMENT IN PAN JOISTS
- 7) EXPOSED/RUSTED REINFORCEMENT UNDER SLAB
- 8) MISSING/DEGRADED PIPE INSULATION
- 9) RUSTED PIPE HANGERS

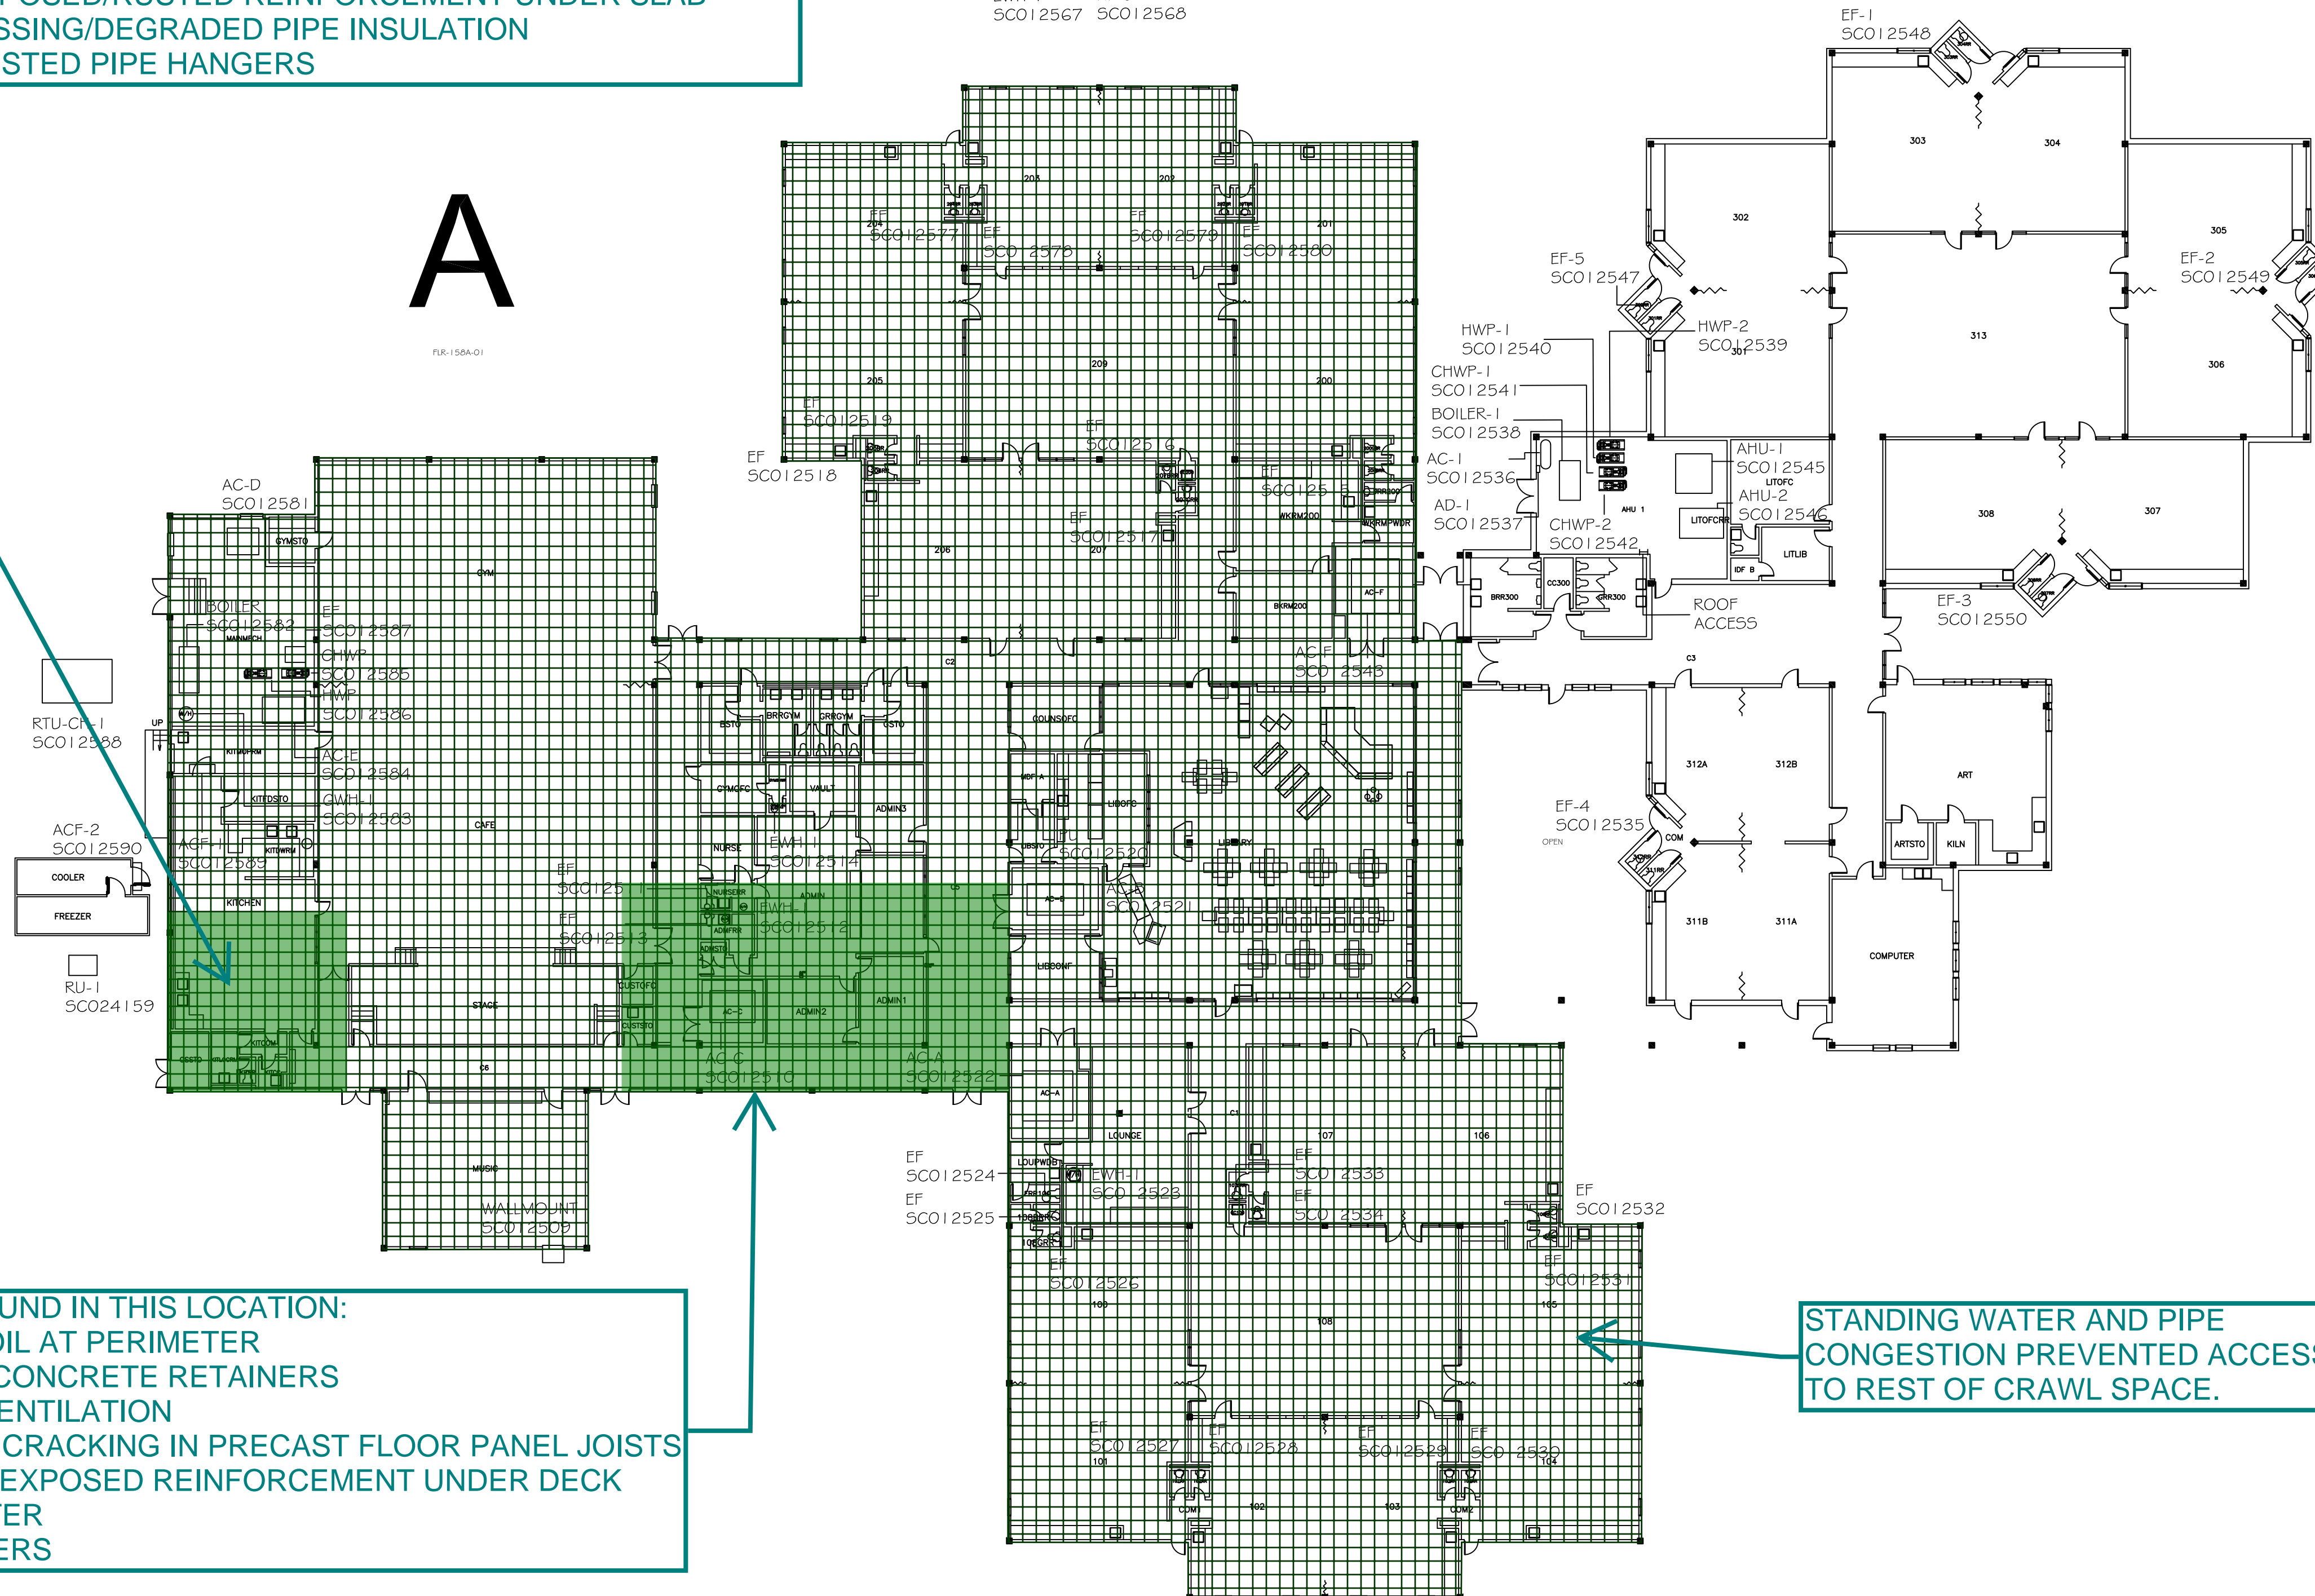
FLR-158A-01

- 1) SATURATED SOIL AT PERIMETER
- 2) OVERTURNED CONCRETE RETAINERS
- 3) INADEQUATE VENTILATION
- 4) LONGITUDINAL CRACKING IN PRECAST FLOOR PANEL JOISTS
- 5) SPALLING AND EXPOSED REINFORCEMENT UNDER DECK
- 6) STANDING WATER
- 7) RUSTED HANGERS

STANDING WATER AND PIPE CONGESTION PREVENTED ACCESS TO REST OF CRAWL SPACE.
