Travis Heights Elementary School Site Summary

Main School Building – BLDG-140A

Building Purpose	Administrative, Classrooms
Inspection Date	August 26, 2016, (Afternoon)
Inspection Conditions	92° - Sunny & Dry

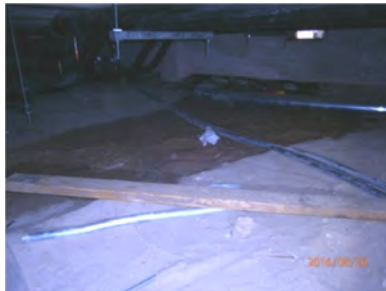
<p>Damp soil near Access Point 1</p>

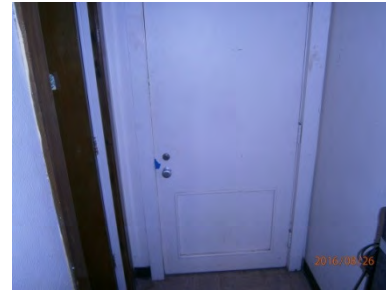
<p>Access Point 3 - Door to crawl space in Computer Lab was not locked & may be a safety hazard for children</p>

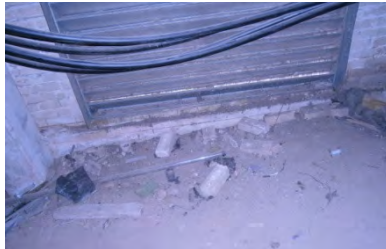
<p>Vent at Access Point 3 clogged with dirt</p>

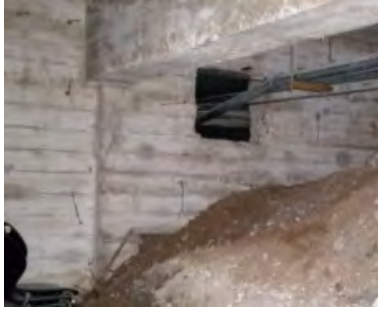
Some cracking around holes cut in perimeter walls, patching near boiler room

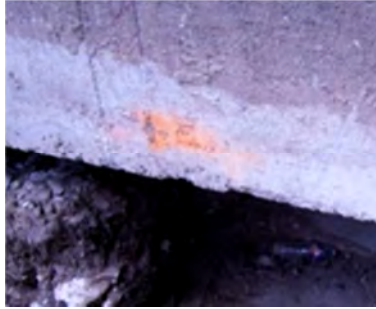
Minor honeycombing on perimeter beam

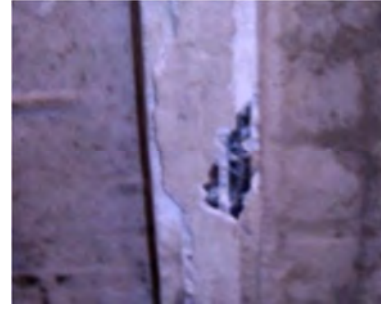
Exposed and rusted reinforcement in webs of pan form slab near Boiler Room

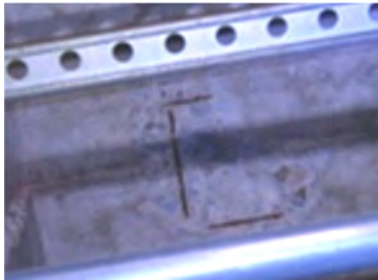
Exposed reinforcement in underside of slab of pan form slab near Boiler Room

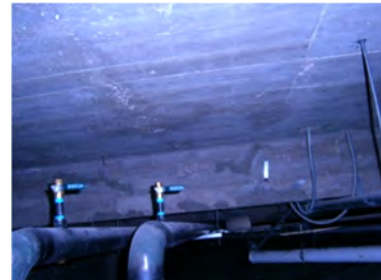
Minor spalls under slab at Access Point 3

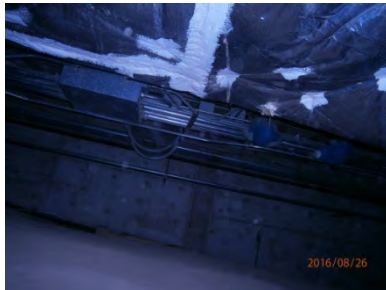
Damage to and patching of duct insulation

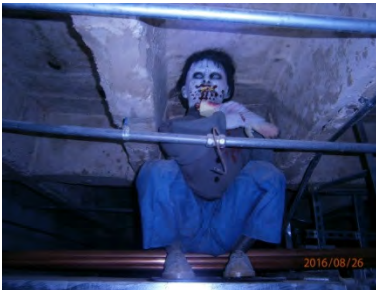
Scary items stored on ductwork near boiler room - **inappropriate for children**

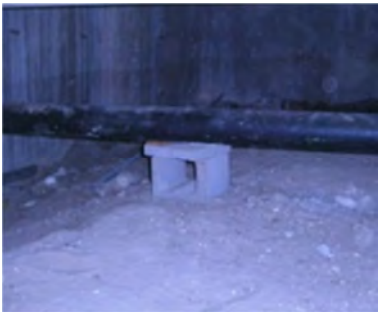
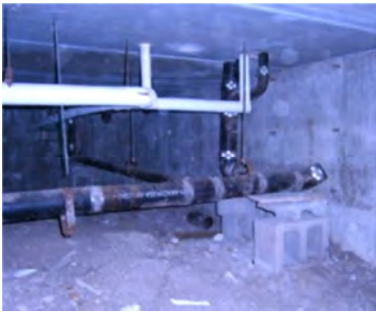
Pipe improperly supported	Rust on pipe, broken pipe hanger, Pipe improperly supported

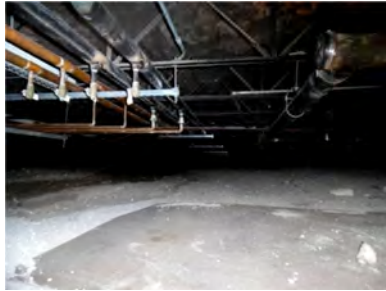
Damp soil in areas

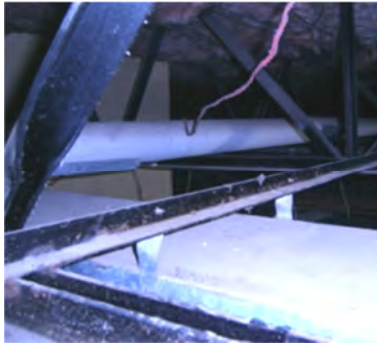
Minor rust on joists

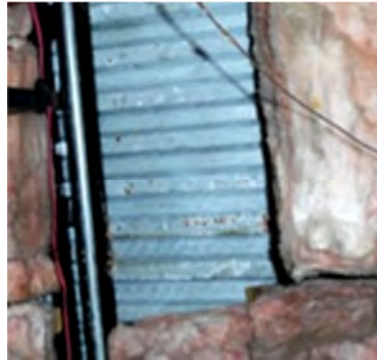
Minor rust on underside of metal floor deck

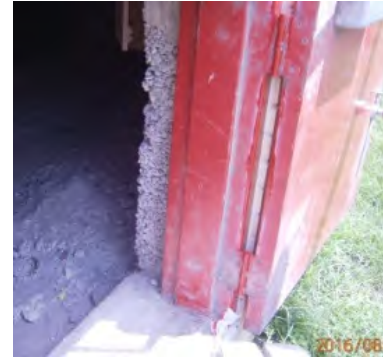
Honeycombing at perimeter wall at access door

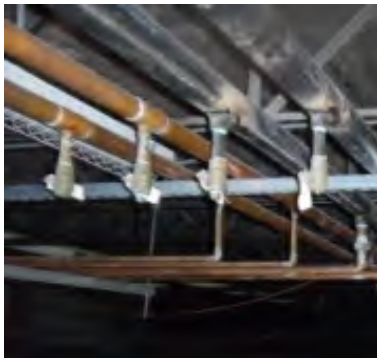
Rust on pipes

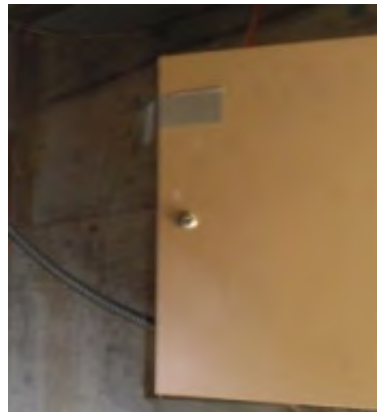
Electrical box appears to be unlocked and closed with duct tape

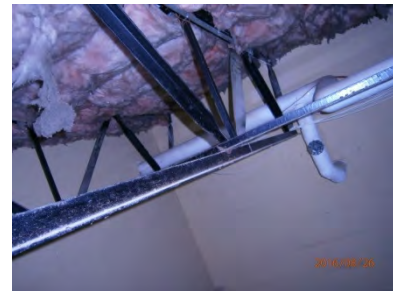
Batt insulation deteriorating

2. Replace degraded and fallen batt insulation.

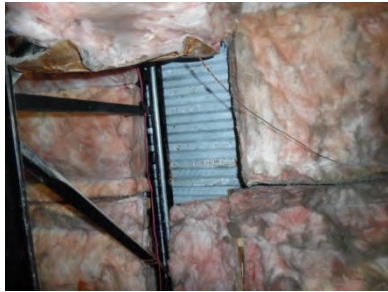
<p data-bbox="256 499 511 527">Batt insulation falling down</p>		
---	--	--
