Walnut Creek Elementary School Site Summary

Address	401 West Braker Lane Austin, TX
Number of Permanent Campus Facilities	2
Original Year of Construction	1961, 1999
Total Campus Building Area (combined)	79,223 SF

Introduction

Main School Building – BLDG-141A

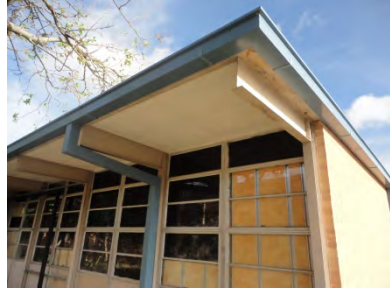
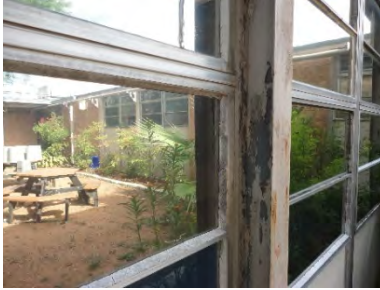
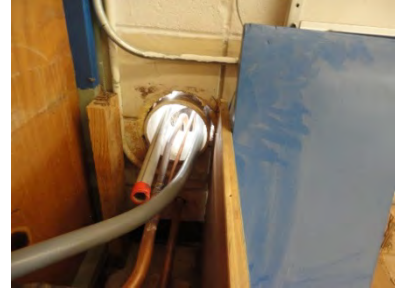
System	Subsystem	Condition and Deficiency Overview	System Condition Rating
Exterior	Exterior Walls	<p>The exterior walls are brick façade on CMU (concrete masonry unit). There is painted steel structure framing window openings, as a majority are full height window systems. There are painted structural steel roof beams that support the overhangs and a painted roof panel soffit. The main entrance has painted columns and beams supporting a metal roof structure.</p> <p>The exterior brick was in good condition. The steel structure at windows and overhangs had peeling paint throughout the perimeter. There was a conduit penetration in classroom 202 that was open to the exterior with no insulation.</p>	Good
	Exterior Windows	<p>The exterior windows are single pane aluminum framed windows. The windows on the front of the 100-wing were replaced in 2015 during repairs after a fire. The windows in the cafeteria have been replaced with double pane glazing presumably also in 2015. The new windows are double pane. The remaining windows appear to be original. These older windows are a full height window system with opaque metal panels approximately three feet off the floor and above seven feet with painted structural members for support.</p> <p>The original windows were in poor condition with failing seals, cracked window panes, and dented opaque panels. The windows in the art room were stuck open and a majority of these original windows were</p>	Poor

1. Repaint exposed steel framing.
2. Insulate conduit penetration to exterior in classroom 202.
3. Replace exterior full height window systems.
4. Repaint exterior doors.

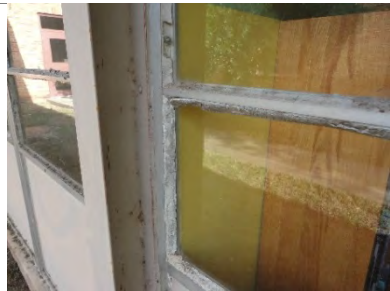
Exterior Windows

System	Subsystem	Condition and Deficiency Overview	System Condition Rating
		inoperable. A number of windows in the library wing were blocked off with black paper, studs, and insulation visible from the exterior due to renovations in 2015. The windows system in corridor C4 had a tinted reflective film on the glass that was damaged in various spots.	
	Exterior Doors	<p>The exterior doors are painted metal in painted hollow metal frames with clear vision panels on the top and bottom portion of the doors.</p> <p>The exterior doors were in average condition. The paint was peeling and facility staff reported they are at the end of their typical design service life.</p>	Average
Roofing	<p>The roof has a modified bitumen roof covering with painted metal gutters and downspouts. The roof covering over the cafeteria, A-02, appears to have been replaced during the renovation in 2015. There are eight 4'x4' fiberglass skylights on the gymnasium roof. The front entrance has a pre-finished standing seam roof canopy.</p> <p>The roof covering was in average condition with several areas that were in poor condition. There were numerous repairs previously to area A-10 with significant bubbling and cracking. The cafeteria (A-02) had evidence of roof leaks on the interior ceiling finish but not specifically visible on the roof. Facility staff reported roof leaks on the east end of area A-13 as well. The skylights over the gymnasium were in average condition. There were two skylights that had visible cracks that appeared to have been repaired previously.</p>		Average

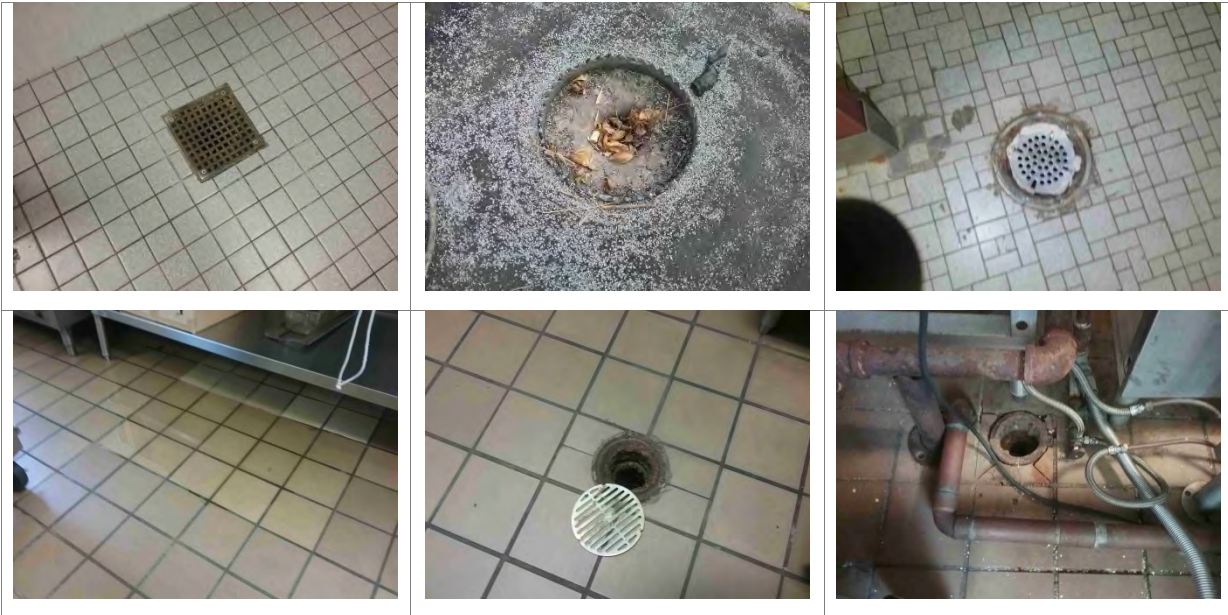
Other Plumbing	<p>Other plumbing consists of floor drains and roof drains. Associated other plumbing was observed to be in average condition. The male restroom outside the cafeteria emitted a foul odor potentially coming from the drain. One of the roof drains was observed to be missing its grate and had debris covering the opening. The grate over the floor drain in the female restroom outside the gymnasium was observed to be damaged. It was reported that this drain has been filled with cement.</p>	Average

1. Inspect, clean, and repair plumbing in multiple restrooms that are emitting an unpleasant odor.
2. Clean and flush all plumbing fixtures to remove and prevent odors.
3. Replace plumbing fixtures that are beyond their typical design service life before failure occurs.
4. Repair or replace drain grates that are missing, damaged, or not secured properly.

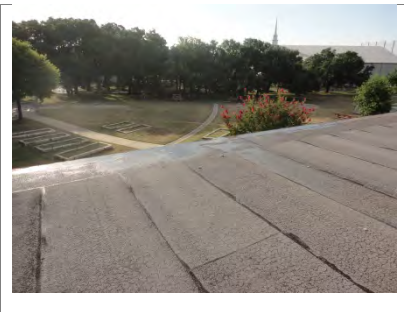
System	Subsystem	Condition and Deficiency Overview	System Condition Rating
Exterior	Exterior Walls	The exterior walls are brick façade on metal stud framed walls. The exterior walls were in good condition.	Good
	Exterior Windows	The exterior windows are single pane aluminum framed windows. The exterior windows were in good condition.	Good
	Exterior Doors	The exterior doors are painted metal with clear vision glass panels on the upper and lower portion of the windows. The exterior doors were in average condition. The paint was peeling on the exterior door from the 400- and 500-wing.	Average
Roofing	The roof covering is modified bitumen with pre-finished gutters and downspouts. The roof covering was in average condition. There was an area of ponding water on the southeast side of the 400-wing due to a condensate drain leaking on the roof and insufficient slope to drain. There were several other areas where ponding water has occurred in the past along the roof edges.		Average

1. Repair condensate drain leak.
2. Monitor roof drainage at perimeter.

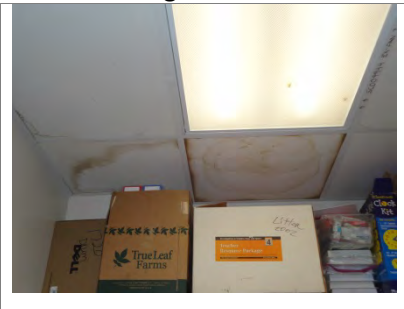
System	Subsystem	Condition and Deficiency Overview	System Condition Rating
	Interior Specialties	System not present.	N/A
Stairs	Exterior Stairs	System not present.	N/A
	Interior Stairs	System not present.	N/A
Interior Finishes	Interior Wall Finishes	The interior wall finishes include paint in the classrooms with ceramic tile up to six feet in the restrooms. The corridors have plastic laminate panels up to eight feet and painted gypsum board above. The interior wall finishes were in good condition.	Good
	Interior Floor Finishes	The interior floor finish is vinyl composition tile throughout the corridors and classrooms. The classroom restrooms have ceramic tile flooring. The interior floor finishes were in good condition.	Good
	Interior Ceiling Finishes	The interior ceiling finish is an acoustic ceiling tile and grid system in the classrooms and corridors. The restrooms have vinyl ceiling tile and grid. The interior ceiling finishes were in good condition with several discolored ceiling tiles in classroom 404 storage room, possibly due to a roof leak.	Good

1. Replace ceiling tile in storage room of classroom 404 and investigate possibility of a roof leak.

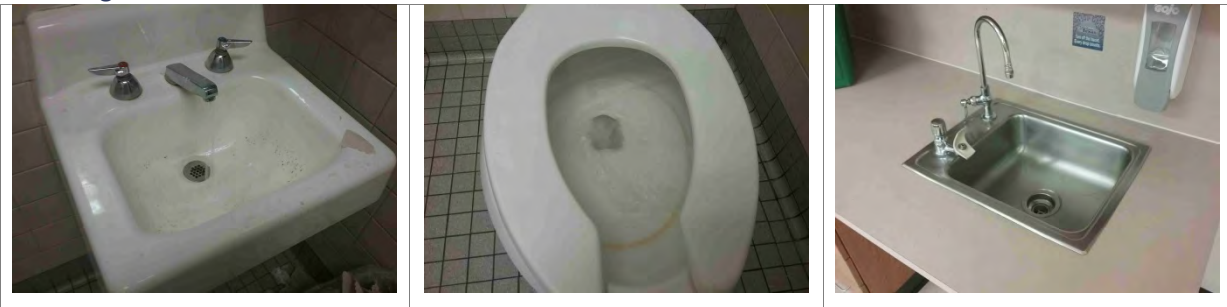
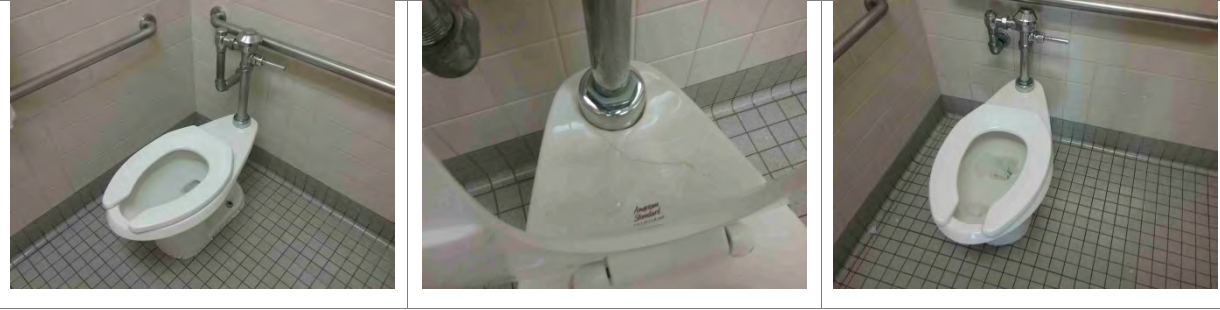
Conveying	System not present.		N/A
Plumbing	Plumbing Fixtures	Building BLDG-141B contains single use restrooms in each classroom and faculty restrooms in corridor 8. The restrooms contain floor-mounted vitreous china water closets with manual flush valves. Stainless steel drinking fountains were observed in corridor. Each classroom had a combination stainless steel sink and drinking fountain. A janitorial service sink was located in CC500. Majority of plumbing fixtures are in average working condition. The sink in the male faculty restroom MFRR400 was observed to have low flow. The fixtures in the female faculty restroom WFRR400 were observed to have the water shut off due to ongoing construction. The drinking fountain in classroom 503 was observed to have no flow. The water closet in classroom 503 was observed to not flush. The water closets in room 302 and MFRR400 were observed to be continuously flushing. The water closet off of room 303 was observed to have a cracked fixture. The water closet in room 401 was observed to be clogged.	Average

1. Repair or replace drinking fountains that were observed to be not functioning properly.
2. Repair or replace water closets that were broken or not functioning properly.
3. Repair or replace sinks and connected distribution plumbing that was observed to be leaking or not functioning properly.
4. Address any rust or corrosion observed to the equipment, its associated piping, or any other sub-asset by cleaning, re-painting, and/or repairing by any other means to prevent further deterioration.
5. Replace water heaters that are showing signs of deterioration and beyond their typical design service life before failure occurs.
6. Repair or replace any damaged or missing piping insulation as needed.

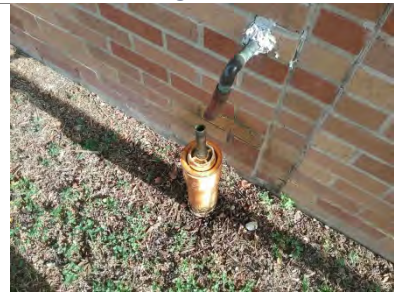
System	Subsystem	Condition and Deficiency Overview	System Condition Rating
		was observed to be in average condition with minor signs of deterioration associated with age. Some of the roof top distribution plumbing was observed to be missing its insulation.	
	Other Plumbing	There were roof drains that had lines coming from the exterior walls of the building. Some of these lines were observed to be cut and have signs of corrosion and rust.	Average
Mechanical/ HVAC	<p>The HVAC system is composed of water source heat pumps, roof top makeup air units, and RTUs. During the assessment a new RTU was in the process of being installed to feed the MDF room. Water source heat pump units are in the corridor and in each classroom. Various exhaust fans feed the building.</p> <p>Make-up air units and water source heat pump units were original to the building and showed signs of age. Make-up air units had signs of corrosion and rust on the exterior. MUC-1B was had wires protruding out of the top of the grate. Multiple heat pump units were observed to be making a buzzing sound during operation or a churning noise at shutdown. The heat pump unit in classroom 507 (AC-A1) was observed to not be functioning properly; when the on/off switch was toggled, the unit did not respond. The heat pump unit in room 400 (AC-2A) was observed to have evidence of leakage on the ground.</p> <p>The new unit for the MDF was not fully installed and functional yet but assumed to be in excellent condition when complete. Additionally, the unit's corresponding ductwork was observed to be partially installed and hanging hanging down from the ceiling. Two of the RTUs were original to the building and two were installed in 2005. Multiple RTUs had a condensate leak dripping from the back of the unit and had signs of rust on the outside of the units. Multiple HVAC units for the building were using R-22 refrigerant, which is an outdated refrigerant that is being phased out of use.</p>		Average

1. Repair drains on the exterior of the building that were observed to be cut and not allowing proper drainage.
