Widen Elementary School Site Summary

Introduction

Main School Building – BLDG-175A

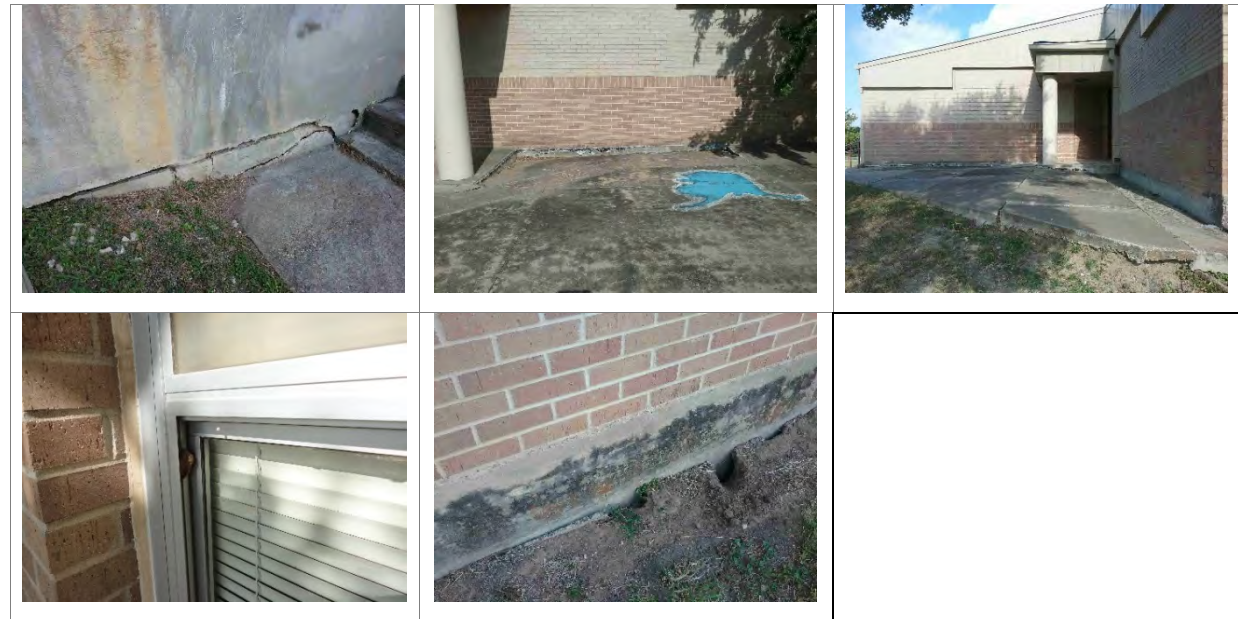
System	Subsystem	Condition and Deficiency Overview	System Condition Rating
Exterior	Exterior Walls	<p>The exterior walls are brick facade on CMU (concrete masonry unit) backing. There is pre-finished metal panel above eight feet to cover the attic space up to the sloped roofline.</p> <p>The building's brick and metal panels appeared to be in good condition. There was an area near the loading dock where the foundation was cracking. The sidewalks on the east and southeast end of the building have shifted and cracked due to soil erosion and settlement. There were multiple trip hazards. Pest control at windows and eaves was an issue in all areas around the school. Facility staff reported pests outside and inside the building.</p>	Good
	Exterior Windows	<p>The exterior windows are anodized aluminum frames with single-pane glazing in the classrooms. The exterior windows that occur in corridors are painted metal frames with single pane glazing.</p> <p>The exterior windows appeared to be in good condition.</p>	Good

1. Further investigate for settlement and drainage issues at sidewalks on the east side.
2. Further investigate for foundation cracks near the kitchen loading dock stair.

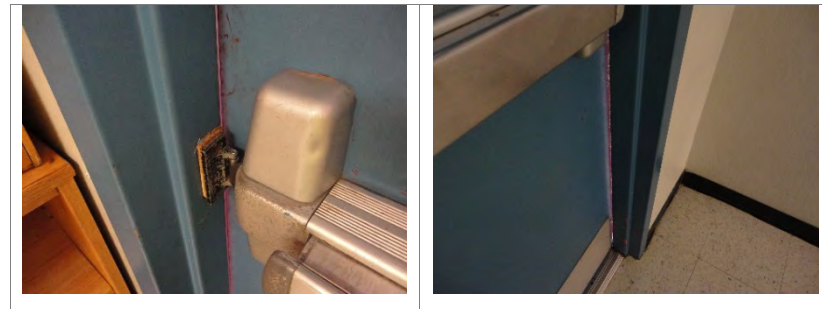
Exterior Doors	<p>The exterior doors are painted metal with painted metal frames. The doors have half glass lites and panic bar hardware. There are vestibule doors at the main two front entry doors. There is a call box and card reader on the west front entry doors.</p> <p>The exterior doors appeared to be in average condition, as there were no weather seals present. Light from outside and unconditioned air could be felt at the frame.</p>	Average

System	Subsystem	Condition and Deficiency Overview	System Condition Rating
		Facility staff reported the doors were not hung correctly and did not have bottom sweeps.	
Roofing	<p>The roofing material is modified bitumen over the administration area that holds three large HVAC (heating, ventilating, and air conditioning) units. It is also modified bitumen over a portion of the kitchen where numerous EFs (exhaust fans) are located. There is a roof hatch accessed internally from the book room and the cafeteria. The majority of the roof is sloped pre-finished standing seam metal. There are flat portions of metal standing seam roofing on the covered walkways.</p> <p>The roof appeared to be in good condition with a few areas on the flat roof with minor issues. There was evidence of previous standing water on the northwest corner of the flat roof over the admin area, and the seams have been patched west of the mechanical units and on the east portion of the modified bituminous roof covering. The southwest corner of the flat roof over the kitchen also appeared to have had standing water previously. Facility staff reported possible roof leaks occurring in the kitchen, and in and around the library. The covered walkways appeared to have had standing water at one time as well. Facility staff reported leaks on both the front and west walkway covers. The roof downspouts and underground storm sewer drains on the east side of the school appeared to be contributing to the soil erosion and settlement issues at the sidewalks. There were additional downspouts that were not draining to the storm drain system properly.</p>		Good

1. Provide regularly scheduled pest control and management around the property.
2. Provide security fencing to prevent access to the roof.
3. Provide weather stripping and door sweeps at all exterior doors.

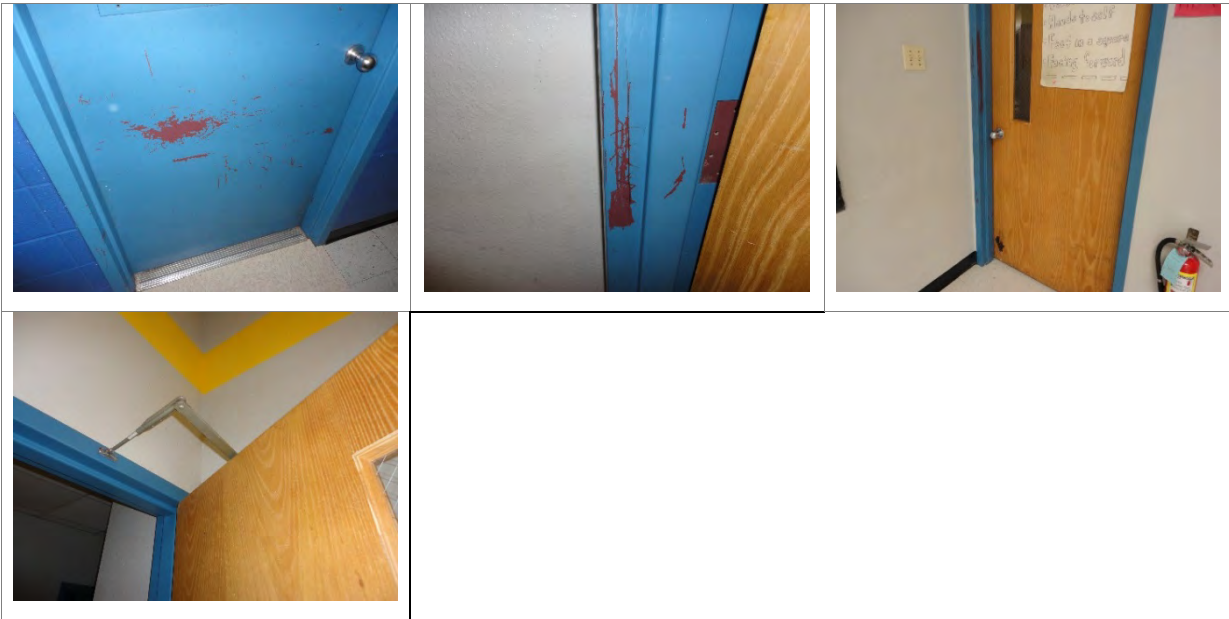
Interior Construction	Interior Walls	<p>The majority of the interior walls are gypsum board on studs. The cafeteria and gymnasium are CMU with a manual movable partition separating the two spaces.</p> <p>The interior walls appeared to be in good condition. Facility staff reported the movable partition between the café and gymnasium is not functional.</p>	Good
	Interior Doors	<p>The interior doors are wood veneer with wire glass vision lites and painted metal frames.</p> <p>The interior doors appeared to be in good condition with issues on the frames and hardware. The painted doors and frames in the A-wing rooms have peeling paint. The doors stops and hold-open hardware at the bottom of the doors appeared to be in poor condition throughout the school. They function appropriately, but were loosely attached to the doors.</p>	Good
	Interior Specialties	System not present.	N/A
Stairs	Exterior Stairs	<p>There are exterior stairs for access to the loading dock at the kitchen. There is a painted metal railing.</p> <p>The exterior concrete stairs appeared to be in average condition. There are cracks and wear due to high use, but they were still fully functional.</p>	Average

1. Repaint interior doors (if existing is painted) and repaint frames in the A-wing.

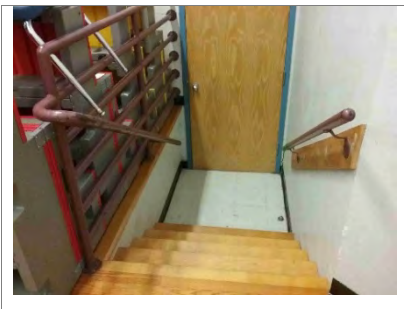
System	Subsystem	Condition and Deficiency Overview	System Condition Rating
	Interior Stairs	Stairs to the stage are fully carpeted on the cafeteria side. The stairs on either side from the back of the stage are wood. There are painted metal railings. The stairs appeared to be in good condition. The metal railings had peeling paint.	Good
Interior Finishes	Interior Wall Finishes	The interior wall finishes are paint throughout the classrooms with areas of acoustic panels attached to the walls. The corridors have wood veneer paneling up to seven feet and paint above. The walls in the A-wing classrooms had peeling paint and cracked gypsum board, specifically at the outside corners inside the classrooms. Clear plastic corner guards were installed, but the walls need repair. There were areas of peeling paint on the outside walls. The rubber cove base was missing in some of the A-wing classrooms.	Average

1. Repaint stair railings at stage stairs.
2. Patch and paint wall damage throughout the A-wing.
3. Replace rubber cover base where missing in A-wing.
4. Replace carpeting in the library.
5. Replace ceiling tiles in the gymnasium surrounding supply air vents. Provide regular filter replacement to HVAC units.

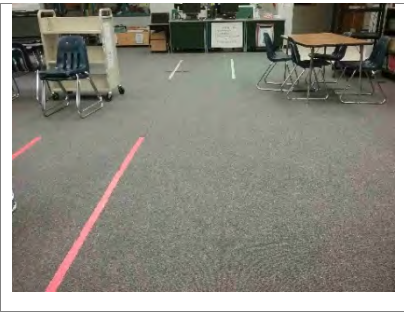
Interior Floor Finishes	The interior floor finishes include VCT (vinyl composition tile) in the classrooms, corridors, cafeteria, and gymnasium. The restrooms and kitchen have ceramic tile. A portion of the freezer tile was being replaced during the assessment. The stage has hardwood and carpeting on the steps into the cafeteria. The gymnasium has a vinyl sheet flooring with a wood appearance and solid color at the perimeter. The library has carpet throughout with VCT at the main entrance and the library workroom. The VCT has been well maintained with various areas that have been replaced with mismatched tiles. The carpeting in the library was worn and damaged.	Average
	Interior Ceiling Finishes	The majority of the ceiling finish is ACT (acoustic ceiling tile) and grid. The restrooms have painted gypsum board. The gymnasium has a high ACT and grid system. The interior ceiling finishes appeared to be in good condition. The tile was discolored around the air supply vents in the gymnasium.	Good

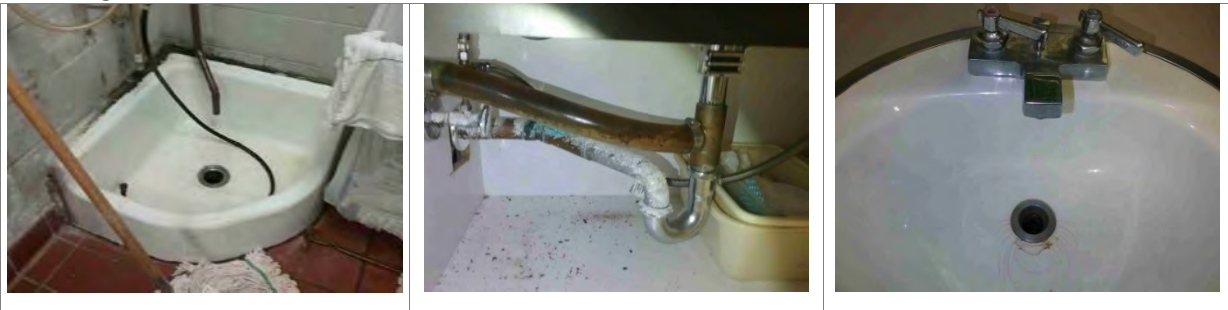
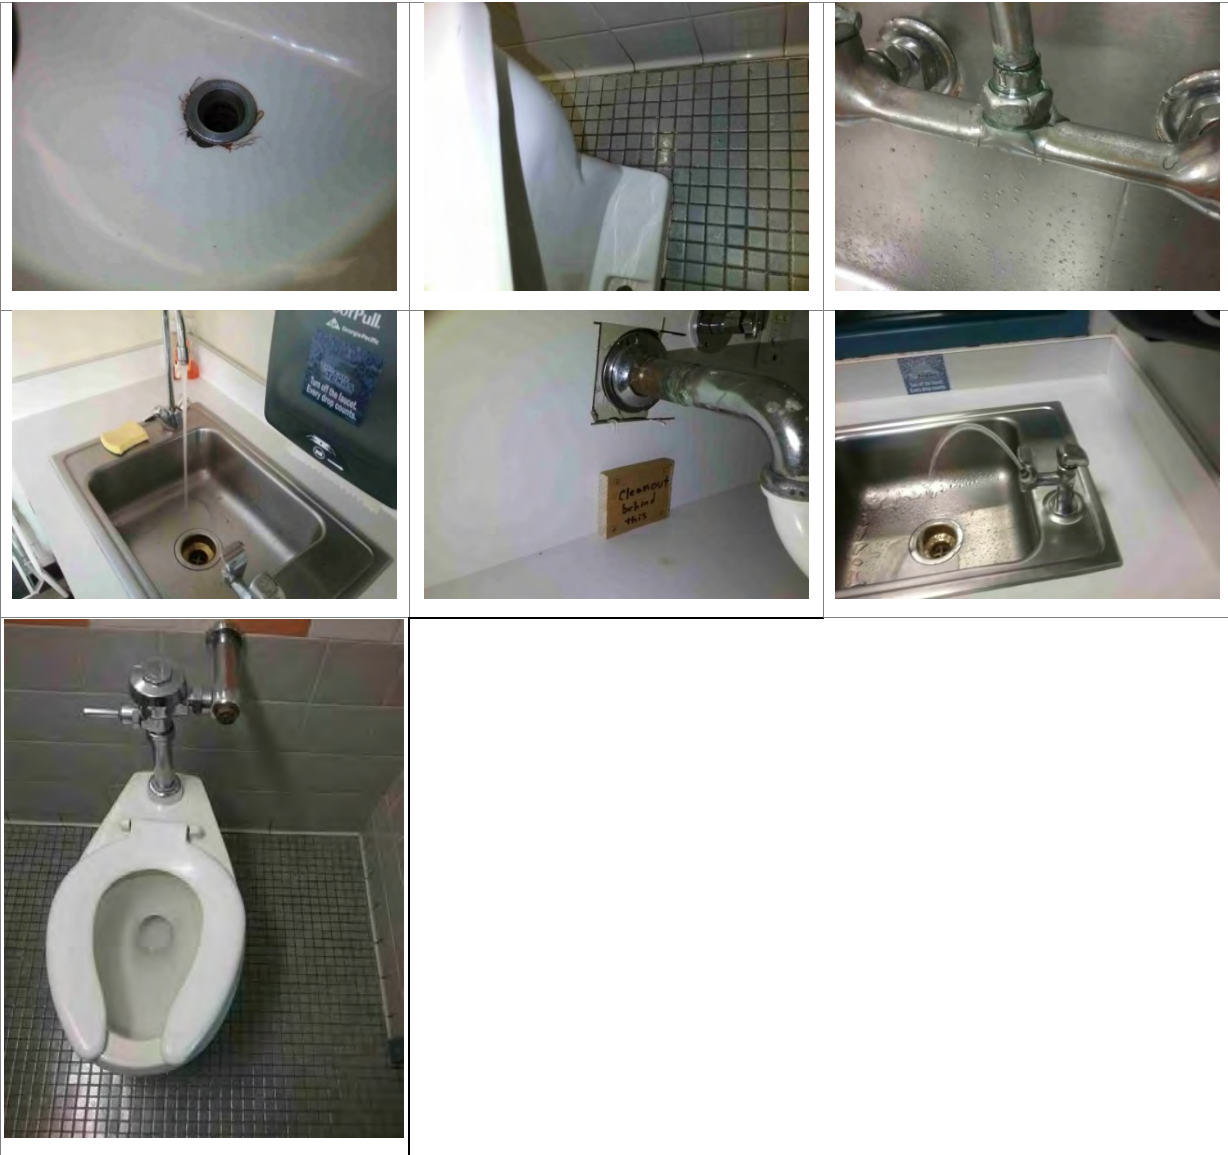
Conveying	System not present.		N/A
Plumbing	Plumbing Fixtures	The building contains predominantly single-use restrooms throughout the facility, with multi-use restrooms found outside of the gymnasium. Typical restrooms have floor-mounted vitreous china water closets with manual flush valves. Additionally, wall-hung vitreous china urinals with manual flush valves are	Average

System	Subsystem	Condition and Deficiency Overview	System Condition Rating
		<p>located in the dedicated male restrooms. Typical classrooms contain a single-basin stainless steel sink with a drinking fountain attached. Stainless steel drinking fountains and a water bottle fill-up station can be found in the corridors of the building.</p> <p>A commercial kitchen is located in the school's cafeteria. The kitchen contains stainless steel kitchen equipment, including a single-basin prep sink and a three-basin prep sink. It also has various wall-mounted vitreous china sinks for personal use. A triple-faucet stainless steel handwashing sink is located outside the cafeteria. The building also has service sinks located in various janitorial closets. Room D5 is an art room that contains one vitreous wash sink and three stainless steel basin sinks, one as a drinking fountain combo.</p> <p>The majority of the plumbing fixtures appeared to be in average working condition, but are aged and show minor signs of deterioration. The restrooms in the corridor between the A- and B-wings (MFHRR and WFHRR) and the lounge restroom (LOUWFRR) had cracked sinks. The cafeteria hand-washing sink had no hot water to the hot water knob. All three faucets to the hand-washing sinks leaked. It was reported in the facility interview that the water temperature in the hand-washing sink is too hot. One of the personal sinks in the kitchen was leaking from the faucet. The female restroom in the lounge had no hot water to the hot water knob. Room D5 had no hot water to the vitreous china sink. The hot water knob on the sink in room D4 was difficult to turn. The sink in room D2 had a note underneath it to clean out behind the wall; the visual assessment did not show any deficiencies.</p> <p>The shower in the gymnasium office had no hot water. The drinking fountains in rooms A4 and B8 would stick in the on position. The water closet in room A5 had a musty smell and evidence of a leak. The water closet in room B6 did not fully flush. The janitorial mops' sinks were in average to poor condition, some showing signs of leaks and corrosion around the base.</p>

1. Replace sinks that were observed to be cracked.
2. Investigate the sink in room D2 that had a note to clean out behind it, and repair as necessary.
3. Repair water closets that were observed to not be functioning properly.
4. Repair faucets that were observed to be leaking on the cafeteria hand washing sink.
5. Replace water heaters that are showing signs of deterioration and are beyond their expected design life before failure occurs.
6. Repair faucets on sinks that are not functioning properly.
7. Repair or replace any damaged or missing piping insulation as needed.
8. Repair piping in the kitchen that is leaking onto the floor.
9. Clean and flush out all floor drains to ensure adequate drainage; it was reported these are not draining properly.

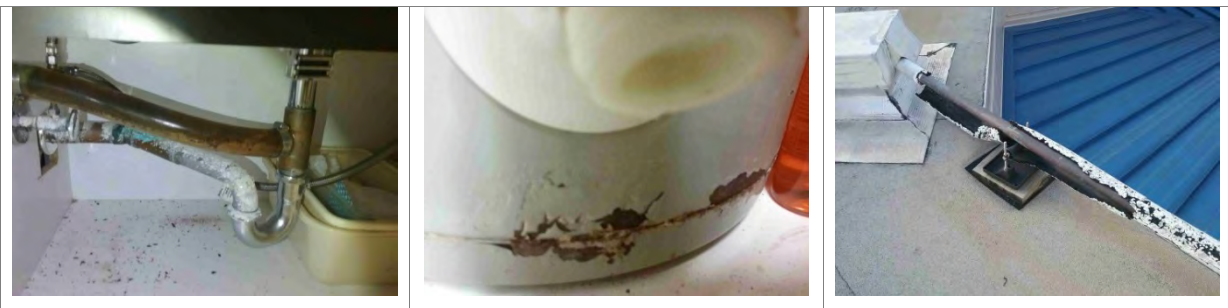
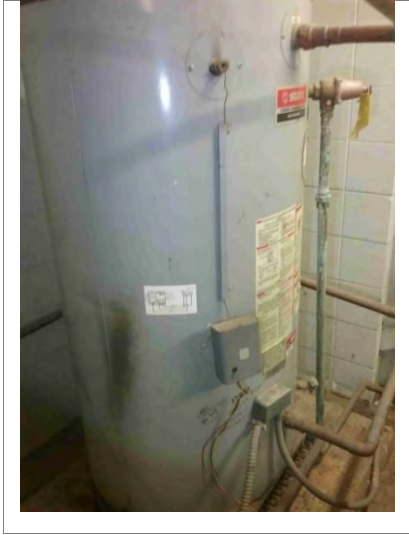
Domestic Water Distribution	Domestic hot water to the kitchen is provided by a 99-gallon, 0.399 MBH GWH (gas water heater) stored in the mechanical room (MAINMECH) located off the kitchen and cafeteria. Various smaller electric hot water heaters are located throughout the building to provide heated domestic water to specific locations in the school	Average

System	Subsystem	Condition and Deficiency Overview	System Condition Rating
		<p>(i.e., nurse's office and administration area). Domestic hot water is not supplied to the classroom plumbing fixtures.</p> <p>The GWH feeding the cafeteria was aged and out of date. It also had corrosion and rust and was in poor condition. The smaller units installed for specific hot water use were in good to average condition. Some were showing signs of age deterioration and rust.</p> <p>The plumbing distribution equipment was in average condition with damaged insulation and corrosion and rust piping throughout the building. Several sinks had corrosion and rust in the piping connecting to the sink.</p>	
	Other Plumbing	<p>Associated other plumbing was in average condition. The kitchen drain pipes had corrosion and rust. A floor drain in the kitchen was emitting a rotten smell. Leakage was seen in the MAINMECH room; floor drains had corrosion and rust on them. There was a pipe in the kitchen that was leaking. The restrooms in rooms A4, K2, and K4 were emitting a foul odor. It was reported by a maintenance worker that the building is known to have plumbing issues underneath the floor.</p>	Average

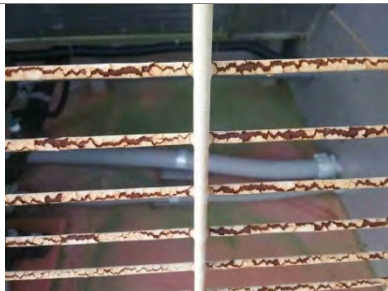
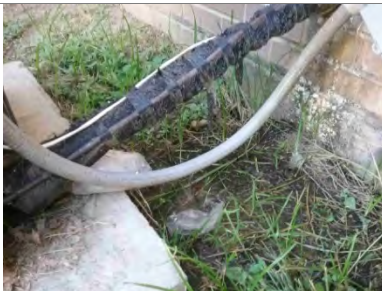
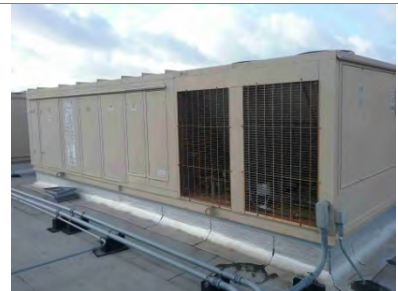
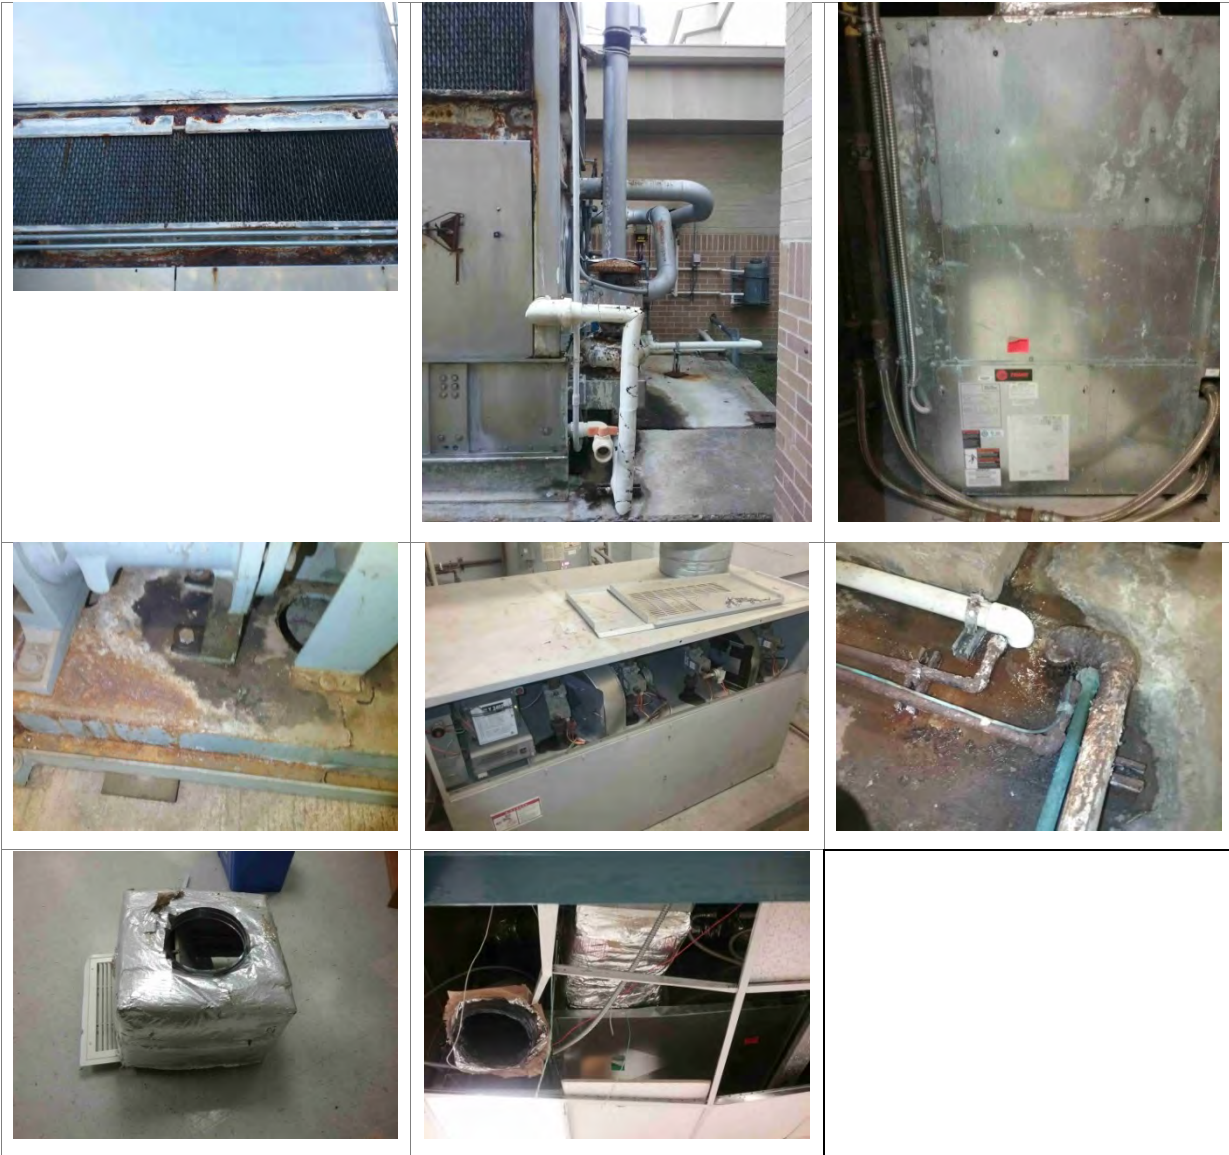
Mechanical/HVAC System Deficiency Examples

Mechanical/ HVAC	<p>The building's HVAC system is primarily composed of roof top AHUs (air handling units), heat pump systems, package units, and a cooling tower and boiler system. The MAINMECH room stored the boilers, chilled water pumps, and hot water pump. The heat pump systems are primarily stored inside of the ceiling and were not able to be assessed. Additionally there were mechanical closets that housed heat pump systems for the cafeteria and gymnasium. A single packaged AC condenser unit was found outside in the courtyard by room C8. Various sized exhaust fans fed the building.</p> <p>Roof top AHUs were in average condition, showing signs of corrosion and rust. AHU MUA-2 was making an excessively noisy whirring sound. This sound could be heard inside the classrooms below it. The cooling tower had no visible nameplate, but appeared to be aged. The unit has signs of corrosion and rust and evidence of leaks. One of the two boilers (B-2) was aged and had the back vent cover removed. The floor surrounding this unit had water puddled on it, indicating possible leakage from the unit. The other boiler (B-1) was newer and in good condition. Of the two chilled water pumps, CWP-1 was newer and in good condition, CWP-2 was aged and had signs of corrosion or rust. Additionally, there was evidence of leakage underneath the pump. The hot water pump (HWP-1) was aged and showed signs of corrosion and rust.</p> <p>The heat pump outside the cafeteria and gymnasium area, HP-46 was making a grinding and bubbling noise when operating. One of the in-ceiling heat pump systems was visible in room A8. The ceiling tiles were removed, and a piece of the connecting duct was on the ground inside the classroom. The heat pump in room</p>		Average

System	Subsystem	Condition and Deficiency Overview	System Condition Rating
		<p>D5 did not appear to be working properly. The thermostat was set to 74°F but read 84°F. It was very warm. A similar observation was made for the gymnasium office. The thermostat read 78°F but was set at 60°F. The associated units were in the ceiling and not visible.</p> <p>The condenser AC unit outside of room C8 is newer, but a condensation drip was observed off the back. The item is not documented on the floorplan. Multiple HVAC units were using R-22 refrigerant, which is an outdated refrigerant that is being phased out of use.</p>	
Fire Protection	Fire Alarm	<p>The building has a fire alarm system that consists of alarm and signaling devices such as horns/annunciators, strobes, horn/strobe combos, pull stations, and detectors. The fire alarm system is controlled by the Silent Knight control panel.</p> <p>The fire alarm system was in average condition due to the fire alarm end devices being aged or worn from outdoor exposure. Some end devices have been replaced, but the majority of the devices appeared to be near their end of life.</p>	Average

1. Replace HVAC equipment that is beyond its expected design life before failure occurs.
2. Assess condition of in-ceiling heat pump units. Repair or replace as necessary.

3. Repair heat pump units that feed room D5 and the gymnasium office that were not working properly.
4. Repair boiler (B-2) that was observed to have back vent cover removed.

5. Repair any equipment that was noted with excessive noise/vibration.
6. Repair HVAC equipment noted to have evidence of leaks.
7. Repair the in-ceiling heat pump unit and surrounding ductwork in room A8 that was observed to have pieces on the floor and be exposed through the ceiling.

8. Replace HVAC units that use R-22 refrigerant, which is an outdated refrigerant that is being phased out of use. These systems may need to be replaced before they meet their design life due to refrigeration restrictions.

9. Address any rust or corrosion observed on the equipment, its associated piping, or any other sub-asset by cleaning, repainting, or repairing to prevent further deterioration.

10. Provide regular filter replacement to HVAC units to reduce staining on the ceiling tile.

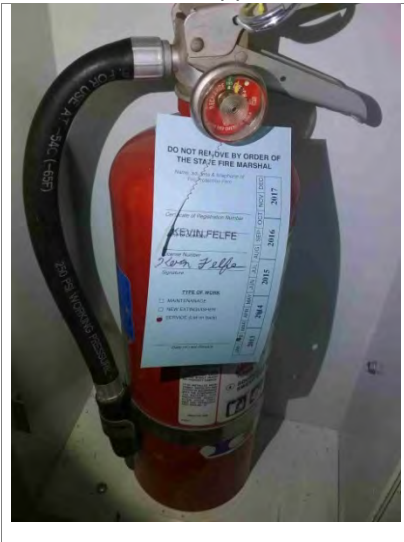
Fire Protection/Suppression	<p>A fire suppression system is present for the range hood in the kitchen with a tank mounted to the wall at the ceiling. The remaining fire suppression method consists of fire extinguishers throughout the building. Visual inspection showed these appeared to be in average condition. The majority of the extinguishers were up-to-date with their inspections. The extinguisher in the A-wing atrium was out of date with its inspection.</p>	Average
Electrical	Electrical Distribution	<p>The electrical service enters the building at the 277/480-volt 1600-amp main switchboard located in the main electrical room on the west side of the building near the kitchen area. The service feeds transformers and high-voltage panelboards, which are located in various electrical rooms throughout the building. There are ten distribution transformers rated at 480-volt primary that step-down to 120/208-volt secondary, which feeds power to 120/208-volt panelboards. The building does not have a lightning protection system.</p> <p>The electrical distribution equipment was in average condition. The majority of the assets are original to the building construction. One panel had screws missing from the housing enclosure that should be replaced. Three panelboards were missing breaker covers, and the bussing was exposed behind the breaker board. This condition could be considered a life safety hazard, and breaker covers should be installed immediately.</p>	Average

1. Inspect fire extinguishers that are out of date on annual inspections; replace if necessary.

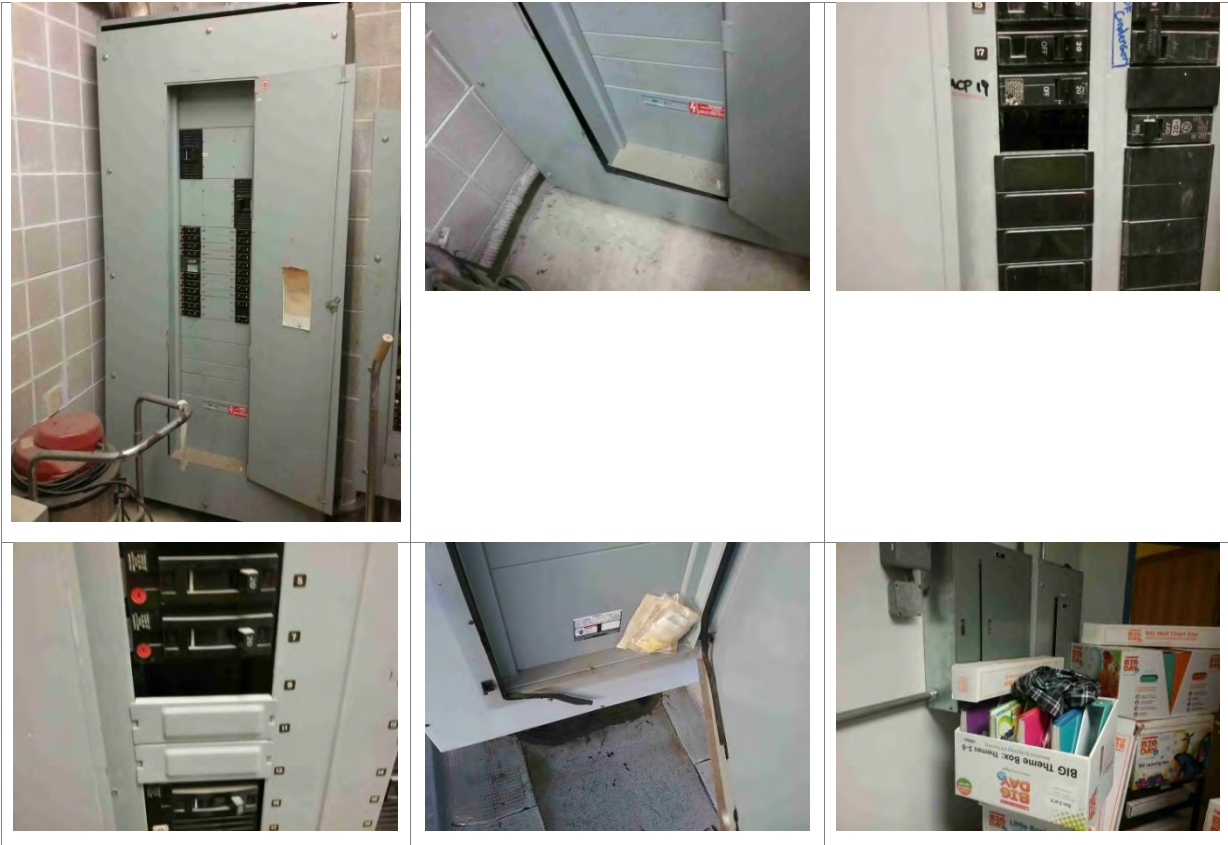
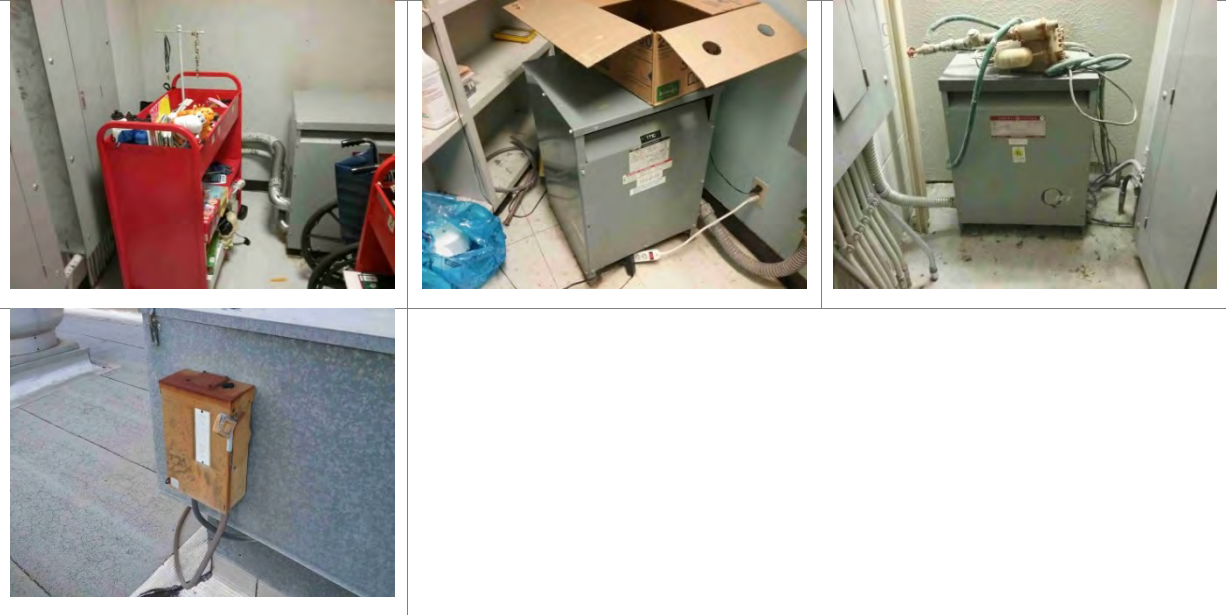
Electrical Distribution

System	Subsystem	Condition and Deficiency Overview	System Condition Rating
		<p>One roof top panel was found to have a damaged seal, which could allow for water infiltration. There are several storage rooms where items are blocking proper access to the panels and should be moved due to safety concerns. There are also several storage rooms where items are being stored on top of transformers, which could create a fire. Items should never be stored on top of or against any transformers. There are several safety switches for HVAC equipment on the roof that are heavily corroded or have holes that will allow for water infiltration into electrical conduit.</p> <p>The facility staff reported that there are not enough circuits throughout the cafeteria and kitchen area. Faculty has also reported that several facility circuits trip due to corroded conduit within the foundation.</p>	
	Lighting	<p>The building's exterior lighting consists of metal-halide and LED (light-emitting diode) luminaires that are located near parking lots, playground, covered/non-covered walkways, and building egresses. The interior lighting primarily consists of T8 fluorescent luminaires.</p> <p>The lighting for the building was in average condition. Many interior and exterior luminaires appeared to be aged past their design life. Observed deficiencies included broken lenses, inconsistent color temperatures, and non-functional fixtures. There are exit signs and emergency lighting present in the building that appeared to be in good working order. There are two original emergency lighting luminaires that are original to the building in the cafeteria and the gymnasium.</p> <p>There were several issues in the branch wiring, including damaged or loose conduit and missing junction box covers. Several exterior receptacles were found with broken covers. Some classroom light switches were beginning to arc. Faculty has requested additional lighting at building exits and around the exterior, along with additional emergency lighting luminaires for the corridors. Faculty also reported that water infiltrates the kitchen lights during rain.</p>	Average

1. Immediately provide missing breaker cover plates for all panels with open slots, as these instances should be considered life safety hazards.
2. Install fasteners in the large GE panelboard located in MAINELEC to properly secure the front cover.
3. Replace the door seal for the large roof top Siemens panelboard.
4. Relocate storage items that interfere with the access of panelboards, specifically in rooms BKRM and CAFELEC.
5. Remove items that are stored on top of building transformers. This should be considered a life safety hazard due to fire potential.
6. Replace corroded electrical safety switches for roof top HVAC units.
7. Replace light switches that are arcing.
8. Replace and properly route damaged roof top flexible conduit for HVAC and ventilation equipment.

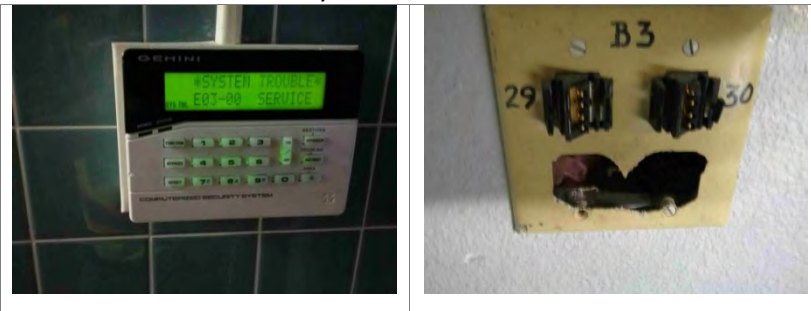
Communications & Security	<p>The building is equipped with telecommunications/cable systems, with the main backbone equipment located in MDF-A and IDF-B. Networking Wi-Fi access points are installed throughout the building. VOIP (voice over internet protocol) telephones are used for voice</p>	Average

System	Subsystem	Condition and Deficiency Overview	System Condition Rating
		<p>communications. Remnants of 1980s Token Ring LAN networking are still present in some of the classrooms.</p> <p>The building security is made up of surveillance cameras, motion detectors, and a proximity card access system. According to facility staff, the security system needs frequent maintenance. During the assessment, the system displayed several zone faults for the building. Faculty staff have also requested security system improvements, such as a forced-entry alarm code, new alarm codes, and the old alarm codes removed.</p> <p>Faculty report that the timekeeping and intercom systems work well.</p>

9. Remove abandoned Token Ring receptacles that remain within the building.
10. Investigate and repair security system faults and consider faculty improvement requests noted within this report.
11. Install additional circuits for the cafeteria and kitchen area, as noted by faculty.
12. Install additional lighting for building exits and emergency luminaires within the corridors.
13. Investigate the water infiltration issue with the kitchen lighting.
14. Troubleshoot and repair circuit trips associated with corroded conduit in the foundation.

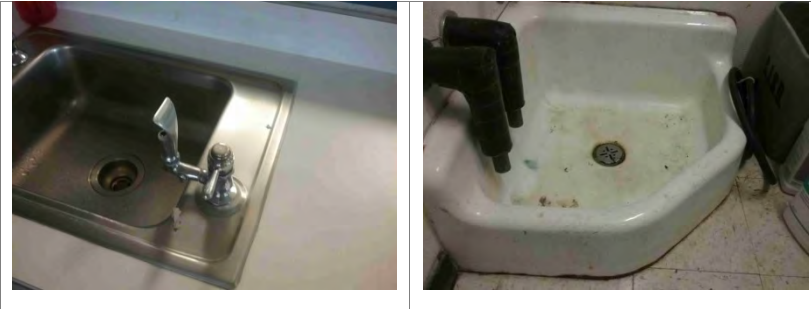
Conveying	System not present.		N/A
Plumbing	Plumbing Fixtures	Typical classrooms contain a single-basin stainless steel sink with a drinking fountain attached. Each pair of classrooms has two single-use restrooms containing floor-mounted vitreous china water closets in the connection between the two classrooms. The restrooms associated with rooms E5 and E6 are dedicated ADA accessible restrooms and may be accessed from the corridor. These restrooms (E5HRR and E6HRR) have a vitreous china sink. A single stainless steel drinking fountain is located in the corridor. A janitorial mop drain was located in ESTO. The majority of the plumbing fixtures appeared to be in good working condition. Poor flow was observed for the drinking fountain in room E5. The mop drain in ESTO was in average working condition with signs of deterioration. An odor was observed coming from the restroom in room E6 (E6HRR).	Average

1. Repair the drinking fountain in room E5.

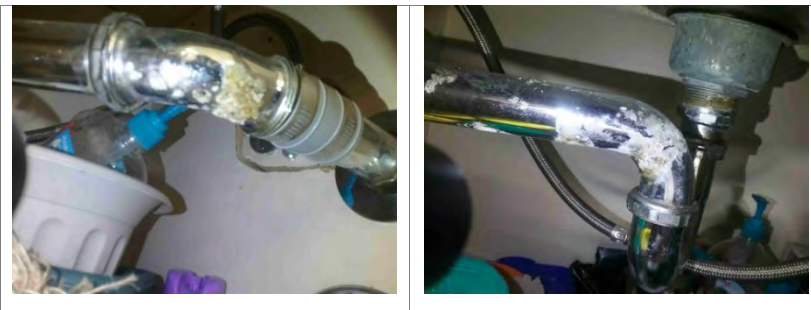
Domestic Water Distribution	A small electric water heater was found underneath the sink in room E1. The unit is newer and in good condition. The plumbing distribution equipment was in average	Average

System	Subsystem	Condition and Deficiency Overview	System Condition Rating
		condition with minor corrosion and rust on piping connecting to some of the sinks throughout the building. The domestic water system was in average condition with typical wear and tear associated with the system's age and general daily use.	
	Other Plumbing	System not present.	N/A
Mechanical/ HVAC	<p>The HVAC system is composed of geothermal heat pump systems, a make-up air unit, and air conditioning condensing units. The heat pump systems and AHU are listed on the floorplan in classrooms and in the E central corridor (COR E). These units are suspected to be stored in the ceiling and not accessible. It was reported in the facility interview that the geothermal units require excessive maintenance and that units in rooms E6 and E7 have functionality issues.</p> <p>The HVAC system was in average condition. Some units showed signs of degradation, rust, and corrosion. Multiple HVAC units were using R-22 refrigerant, which is an outdated refrigerant that is being phased out of use.</p>		Average

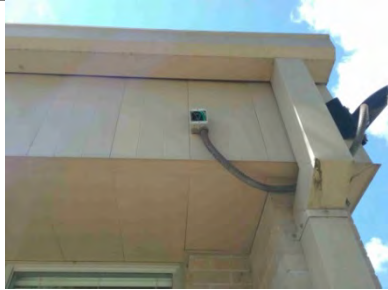
System	Subsystem	Condition and Deficiency Overview	System Condition Rating
	Lighting	<p>The building's exterior lighting consists of metal-halide luminaires at the main entrance, the rear egress, and the exterior HVAC equipment on the southwest side of the building. The interior lighting primarily consists of T8 fluorescent luminaires.</p> <p>The lighting for the building was in good condition. Observed minor deficiencies included missing bulbs in storage areas and an exterior metal-halide bulb past its typical design service life. One exterior outlet was found to have a melted and damaged cover. An uncovered junction box was found in the main electrical room. Exit signs were found to be in good condition.</p>	Good
	Communications & Security	<p>The building is equipped with telecommunications systems with the main equipment found in EELEC and CUSTOFC. Networking Wi-Fi access points are installed throughout the building. VOIP telephones are used for voice communications.</p> <p>The building security is made up of surveillance cameras, motion detectors, and a proximity card access system. There is a single exterior surveillance camera overlooking the campus playground. The playground camera was found to have an open junction box for the device wiring.</p>	Good

1. Install a conduit junction box cover for exterior surveillance camera overlooking the playground.
