## Winn Elementary School Site Summary

## Main School Building – BLDG-157A

## Stand-Alone Classroom Building – BLDG-157B

## CRAWL SPACE – Winn ES – Main Building (BLDG No. 157A)

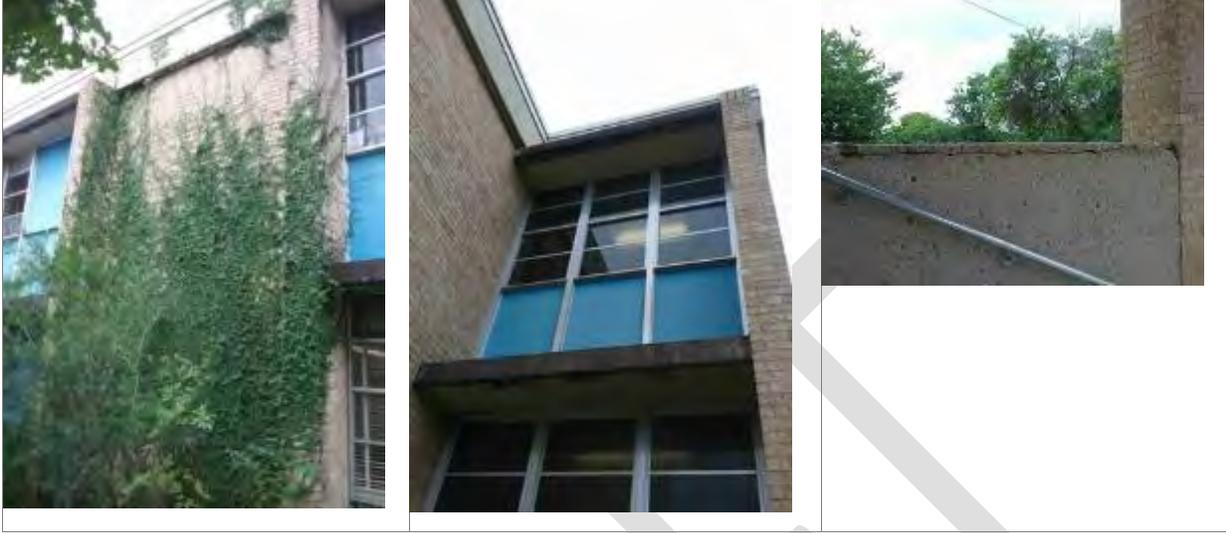
#### Exterior Walls

System	Subsystem	Condition and Deficiency Overview	System Condition Rating
<b>Exterior</b>	Exterior Walls	<p>The exterior consists of brick masonry walls. There is an aluminum canopy structure located along the southeast elevation of the building. The mechanical penthouses located on the roof level are clad with metal panel.</p> <p>The exterior façade walls appeared to be original construction and in good condition with a few deficiencies noted. Vine and plant growth was observed growing up the brick facade along the east elevation. The concrete slab edges exposed to the exterior of the building are blackened with dirt. The concrete wall at south egress doors is aged and cracked with exposed rebar.</p>	Good
	Exterior Windows	<p>The exterior windows are aluminum frames with single pane glazing. The windows appear to be original construction and in average condition as they are aged beyond useful life. The glazing seals appeared to be cracked and failing at several windows, and small holes from BB gun damage were observed at various locations.</p>	Average

1. Remove vine and plant growth from exterior façade wall and monitor area for continued growth. Remove as required.
2. Power wash the exposed concrete slab edges to remove dirt build-up.
3. Patch and repair the exterior concrete wall so that the rebar is not exposed and replace all loose and missing mortar joints around the wall.
4. Replace the aged exterior window system complete with new window units.
5. Replace the deteriorated exterior doors at the penthouse with new steel doors, frame, and hardware.

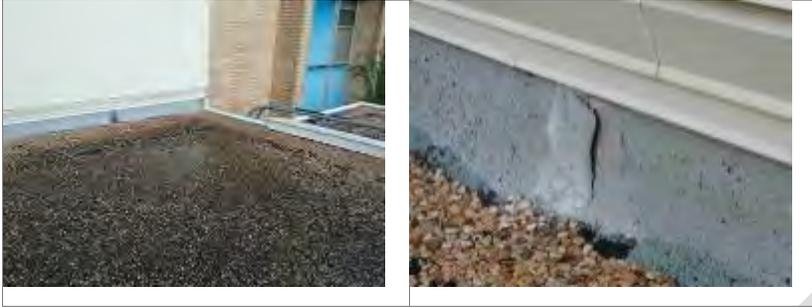
**Roofing Deficiency Examples**

Exterior Doors	<p>There is a secure main entry located along the west elevation of the building. The remaining exterior doors around the facility are metal. The exterior doors were observed to be in average condition showing signs of wear and use. The metal doors at the rooftop penthouse are corroded and the hardware is bent and damaged.</p>	Average
<b>Roofing</b>	<p>The roof is constructed of built-up asphalt with a granular topping. The roof was estimated to be original construction.</p> <p>The roof was observed to be in average condition. Areas of ponding water were observed. The gravel topping appeared thin or missing in areas leaving the</p>		Average

asphalt membrane exposed. The membrane and flashing appeared dried and cracked in various areas.	
<b>Interior Construction</b>	Interior Walls	<p>The interior partitions vary throughout the building and consist of stud construction finished with GWB, brick walls, or CMU walls. The classrooms are separated from one another by a series of accordion style or folding panel partition walls. There is a full height folding panel partition separating the gym area from the cafeteria area.</p> <p>The folding panel partitions dividing the classrooms were observed to be aged, deteriorated and in poor condition. The full-height folding partition in the gym appeared to be in good condition showing typical signs of wear.</p> <p>AISD staff indicated that the main building will undergo a partial renovation in the summer of 2016. The funded project includes the complete renovation of the administrative office suite and the library area. A new building will be constructed on the campus housing a counseling center. Another reported and funded project that will occur in the summer of 2016 is the removal of the existing folding panel partitions dividing the classrooms. The folding panel partitions will be replaced with permanent GWB partitions.</p>	Average

1. Replace the existing aged roofing system complete with a new roof system.

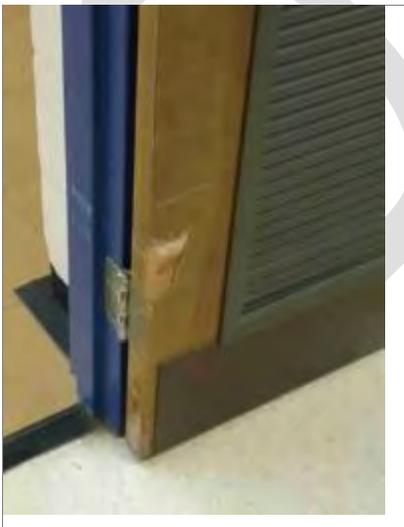
Interior Doors	The majority of the interior doors are wood with metal frames. The interior windows are constructed of hollow metal frames and single pane glazing. The wood interior doors appeared to be in average condition showing signs of wear. Some of the doors were chipped and damaged exposing sharp edges.	Average
	Interior Specialties	System not present.	N/A
<b>Stairs</b>	Exterior Stairs	The exterior stairs located around the exterior of the building are concrete with metal handrails. The stairs were observed to be in good condition.	Good
	Interior Stairs	The interior stairs are concrete with abrasive nosing and wood handrails. The interior stairs were observed to be in good condition.	Good
<b>Interior Finishes</b>	Interior Wall Finishes	<p>The interior wall finishes in the corridor and classroom areas include painted GWB walls finished with wood paneling in some areas. The kitchen is finished with wall tile while the gym is finished with acoustical wall panels over CMU. The restrooms are finished with wall tile.</p> <p>The interior wall finishes were observed to be in average condition. The wall tile in the restrooms appeared aged and chipped in several areas.</p>	Average

1. Replace damaged and chipped wood doors with new wood doors and associated hardware.
2. Replace all folding panel partitions in classrooms with permanent GWB construction complete with electrical and data systems. This project is funded and will occur in the summer of 2016.

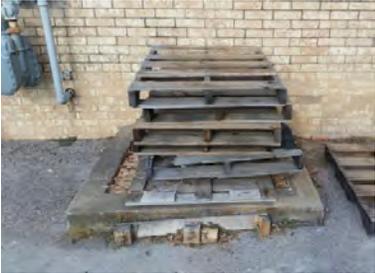
<p>Areaway covered by pallets</p>

1. Investigate need to provide proper ventilation in crawl space.
2. Investigate need for positive drainage away from building.
3. Remove stacked wooden pallets to provide crawl space ventilation.

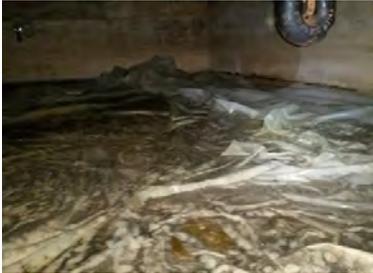
<p>Puddles on top of vapor barrier</p>	
---	--	--

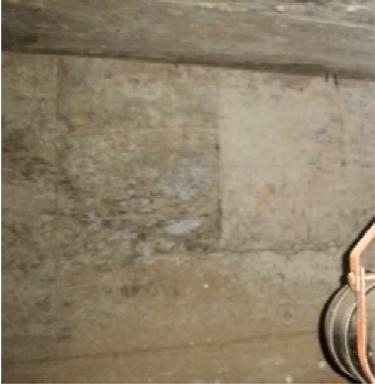
<p>Honeycombing at grade-supported beam</p>

1. Where reinforcing is exposed, remove rust and patch slab and wall concrete.

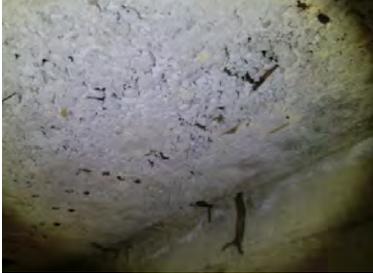
<p>Honeycombing and rusted slab reinf</p>

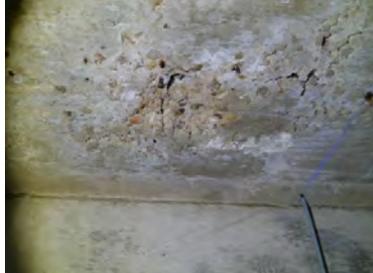
<p>Slab spalling and rusted reinf</p>

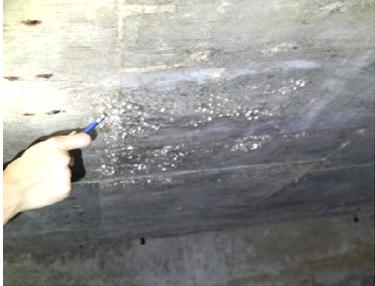
<p>Condensation under slab</p>

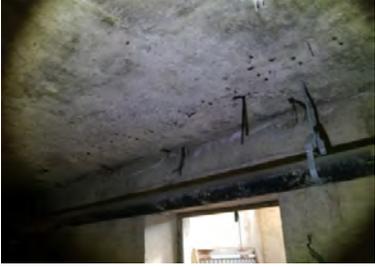
<p>Spalling at old pipe hanger connections</p>

1. Replace corroded pipe and/or hangers.

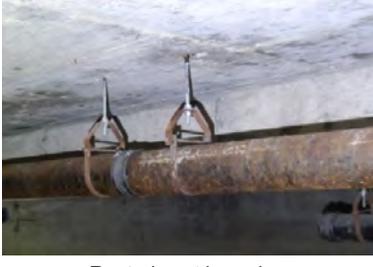
<p>Rusted cast iron pipe</p>	
--	--	--

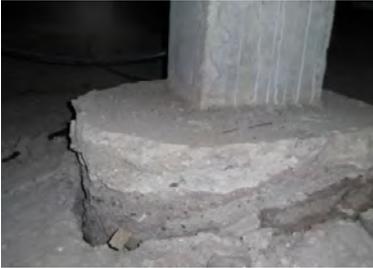
<p>Soil settlement evident at interior pier</p>

1. Investigate need for additional vents in crawlspace for improved ventilation.
2. Add and compact soil around exterior of building where large settlements have occurred. At a minimum, re-grade areas so that daylight is not visible under building.
3. Replace damaged and/or missing soil retaining panels.

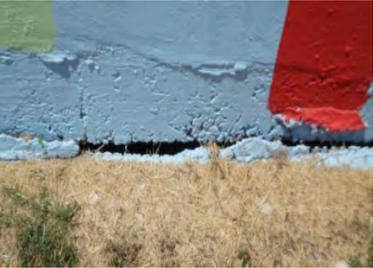
<p>Retainer panel no longer bears against perimeter beam due to settlement of soils.</p>

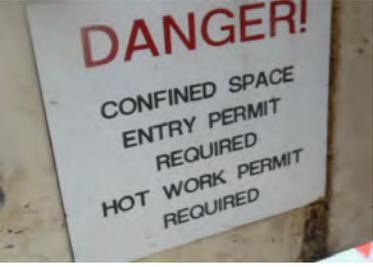
<p>DANGER! CONFINED SPACE ENTRY PERMIT REQUIRED HOT WORK PERMIT REQUIRED</p> <p>Confined space warning sign</p>

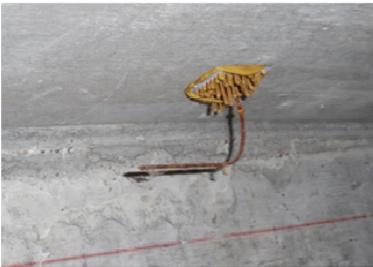
<p>Formwork nail left in slab</p>		
---	--	--

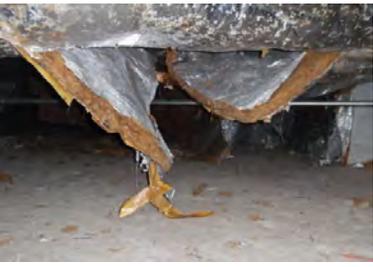
<p>Fallen insulation</p>	
--	--	--

1. Replace badly corroded hangers.
2. Replace fallen insulation.

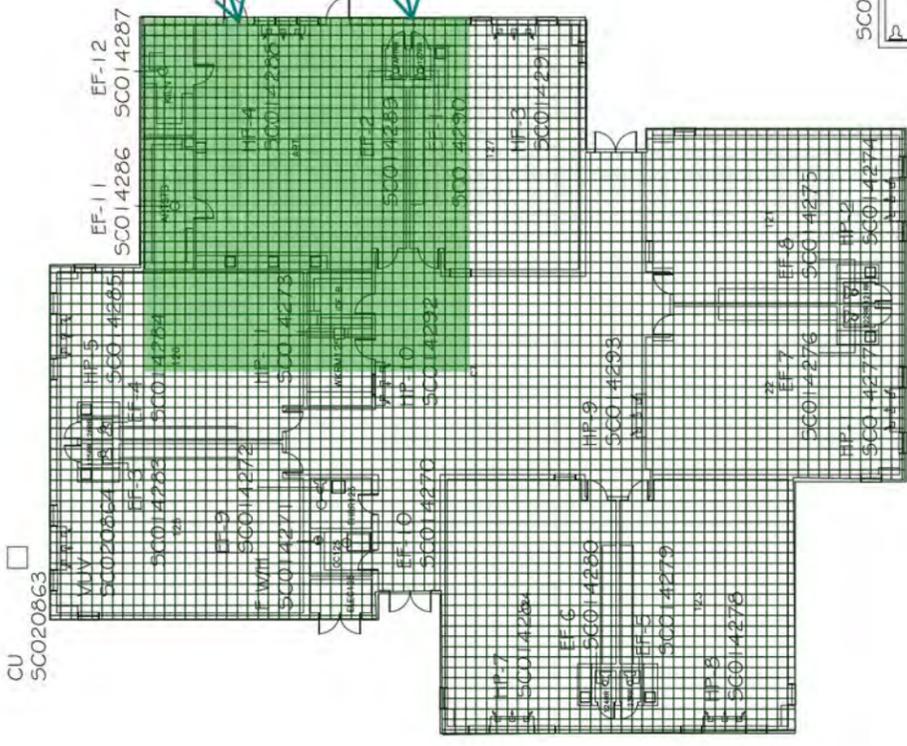
Deficiencies found in this location:

- 1) Large settlement of soil
- 2) Daylight visible under soil retainers
- 3) One missing soil retention panel observed
- 4) One overturned soil retention panel observed
- 5) Little to no ventilation.
- 6) Where slab was visible, formwork nails were seen still in place.
- 7) Minor pipe rusting
- 8) Large areas of crawlspace had detached insulation

- 1) Puddles on top of vapor barrier
- 2) No noticable drainage
- 3) Arealway was covered by wooden pallets
- 4) Limited honeycombing in exterior grade beams
- 5) Spalls, honeycombing, exposed reinforcement, and condensation were found on the underside of above slabs
- 6) Heavily rusted pipes
- 7) Spalling at hanger connections to slabs
