Wooldridge Elementary School Site Summary

Introduction

Main School Building – BLDG-152A

Stand-Alone Classroom Building – BLDG-152B

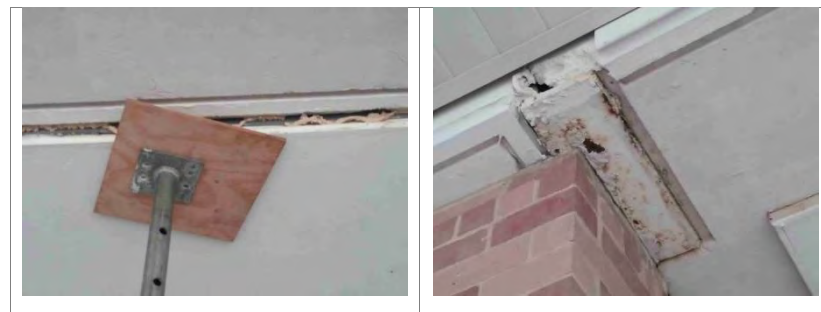
System	Subsystem	Condition and Deficiency Overview	System Condition Rating
Exterior	Exterior Walls	<p>The exterior of the building consists of 80% brick and 20% split-faced CMU (concrete masonry unit). The building is a split-level design, has three levels, and was built in 1969.</p> <p>The exterior of the building appeared to be in good condition. The soffit at the right of the entry doors was sagging. Maintenance had secured this sag with floor jacks temporarily, but it should be repaired more permanently. There was also a rusted metal column support piece at the entry that needed repair.</p>	Good
	Exterior Windows	<p>The windows are aluminum metal-framed inset into the brick façade and appeared to be in good condition.</p> <p>The windows had missing and degraded caulk at the top where the window meets the lintel. Windows adjoining the exit doors to BLDG-152B were damaged/cracked.</p>	Good

1. Repair the soffit in the front entryway where it is currently shored up.
2. Exterior windows need caulk on the top where they meet the brick.
3. Re-glaze exterior windows adjacent to exit doors that are scratched and cracked.
4. Exterior windows need caulk on the top where they meet the brick.

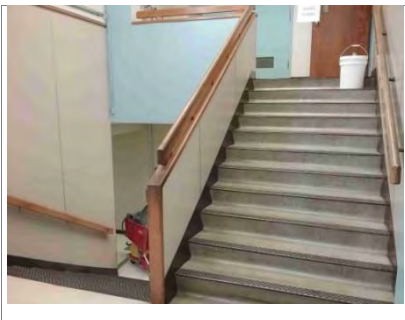
Interior Specialties	System not present.	N/A
Stairs	Exterior Stairs	System not present.	N/A
	Interior Stairs	The interior stairs are concrete with metal non-slip edges on the treads. The stairs were observed to be in good condition. The stair railings were worn.	Good
Interior Finishes	Interior Wall Finishes	About 5% of the interior walls are brick in the corridors; 5% are concrete walls and corridors; 25% are painted gypsum board in office areas and classrooms; 20% are wood paneling in classroom and corridors; 20% are CMU in the gymnasium, exterior classroom walls and halls; 10% are tile in the restrooms and kitchen areas; and 15% are laminated paneling in the staircases. The wall finishes were observed to be in average condition. The paint on many of the walls and columns was chipped or scraped. The ceramic tile around the corridor sink outside the cafeteria appeared to be in poor condition with chips and holes.	Average

1. Replace stained, yellowed perforated ceiling tile in the cafeteria as needed.
2. Replace rusted ceiling grid.
3. Repaint walls and columns.
4. Refinish wood railings at staircases.
5. Replace the ceramic tile surrounding the sink at the cafeteria entrance.
6. Repair tectum panels where they meet the brick wall above ramps at the east end of the building.
7. Replace all carpet in administration offices and room 100.

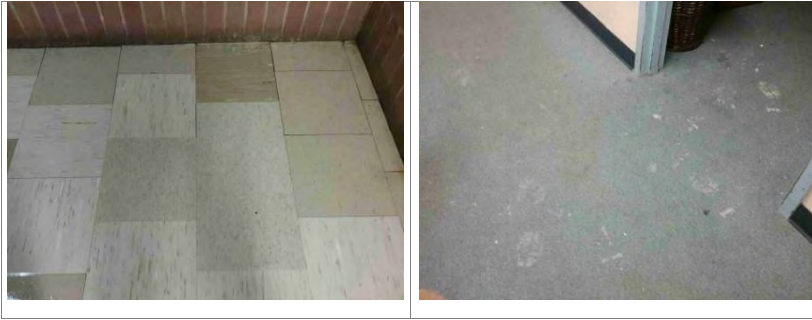
Interior Floor Finishes	About 75% of the interior floor finishes are VCT (vinyl composition tile) in the administration offices, cafeteria, corridors, and classrooms; 5% are ceramic tile in the restrooms and kitchen; 15% are wood flooring in the gymnasium and on the stage; 10% are carpet in the library, room 100 and administration offices. The carpet in the administration offices and room 100 was in very poor condition; it was dirty, stained, worn,	Average

System	Subsystem	Condition and Deficiency Overview	System Condition Rating
		and needed replacement. The vinyl tile in many areas was mismatched, and some tiles were cracked.	
	Interior Ceiling Finishes	<p>About 20% of the interior ceilings are tectum acoustical panels in the gymnasium and a small amount in the east end corridor; 60% are acoustical tiles in metal grid in the administration areas, corridors, library, cafeteria and classrooms; 15% are gypsum board ceilings in the restrooms, administration areas, cafeteria and classrooms; 3% are 12x12 perforated glue on tiles in the cafeteria kitchen; 1% is particle board in the mechanical rooms; and 1% is open corrugated decking with bar joists on the stage ceiling.</p> <p>The perforated tiles were worn, yellowed and outdated. There was ripped gypsum board in the corridor over the administration door. Ceiling tiles were stained in room 107 and in the admin office area. The grid was rusty and tiles were sagging in much of the building. The tectum panels in the corridor did not meet the brick wall. A folding partition was removed in rooms 109 and 110, and the ceiling had not been repaired. It was open to the deck above.</p>	Poor

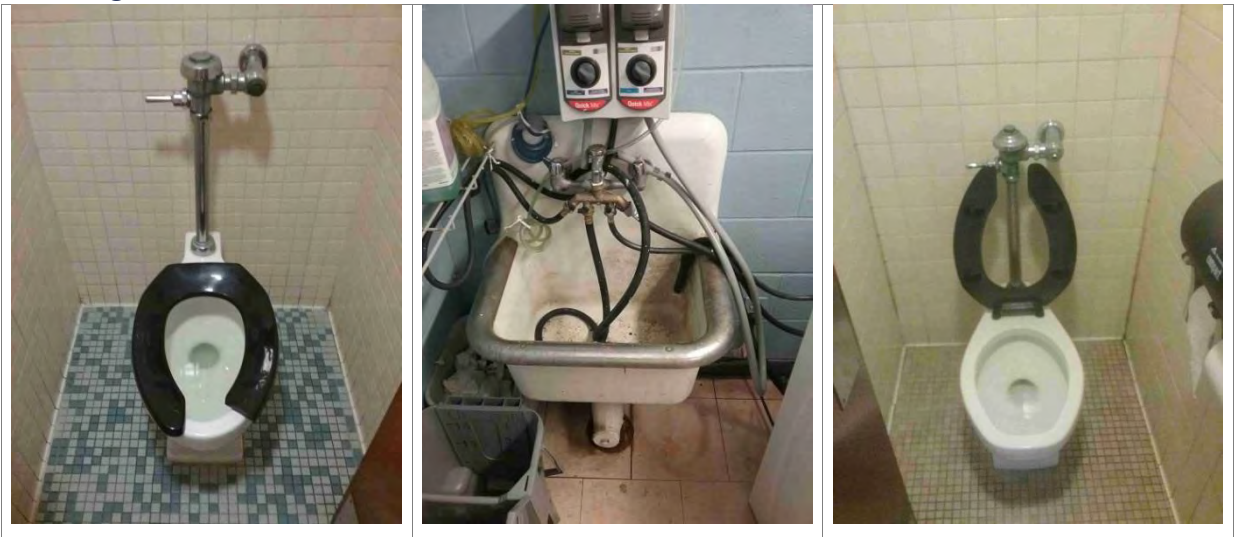
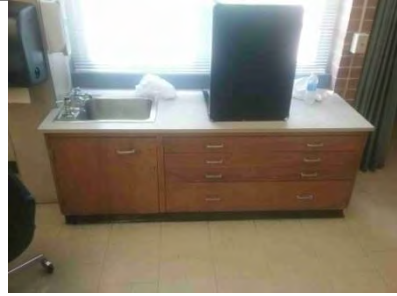
Conveying	<p>The building is outfitted with a 750-lb hydraulic two-story lift on the east end of corridor 2, provided by Garaventa Lift. The Genesis Vertical Lift, model HY-US-SW-72, was installed July 20, 2009. The lift was unable to be operated but appeared to be in working order.</p> <p>The conveying equipment appeared to be in good condition.</p>		Good
Plumbing	Plumbing Fixtures	<p>The facility contains multiple plumbing applications that service two floor levels, consisting of in-classroom student restrooms, staff restrooms, janitorial closets with service sinks, and one commercial kitchen.</p> <p>The restrooms that are located inside classrooms have vitreous china floor-mount toilets with manual flushing valves. The classroom restrooms are not equipped with sinks; however, the classrooms have laminated particle board vanities with stainless steel sink/bubbler combinations mounted inside the vanity. The remainder of the facility's restrooms have vitreous china sinks with manual or metering faucets, along with vitreous china floor/wall-mount toilets with manually operated flushing valves. There are also wall-mounted service sinks in the janitorial closets.</p> <p>Staff reported that there were not enough adult restrooms in this facility. There was only one staff restroom installed for 100 plus adults. It was also</p>	Average

System	Subsystem	Condition and Deficiency Overview	System Condition Rating
		<p>reported that old plumbing fixtures needed to be replaced.</p> <p>The plumbing fixtures were observed to be in average condition.</p> <p>The plumbing fixtures observed throughout the building were either from the facility's original construction or had been recently installed. Though there were fixtures that were aged and required maintenance, all of the fixtures assessed were functional. A typical deficiency observed was that all of the fixtures flushed and drained slowly throughout the building. An estimated 90% of the classroom restroom fixtures appeared to be from the original construction. All of the classrooms contained old sink vanities, and room 109 had a broken toilet seat flange. A janitorial closet (CC100) was observed to have an aged and outdated mop wall-mounted sink.</p>	
	Domestic Water Distribution	<p>The majority of the plumbing fixtures observed in this facility are not serviced by any domestic water distribution equipment, such as large vertical water heaters (greater than 30-gallon capacity).</p> <p>The remainder of the plumbing fixtures that are serviced by domestic water distribution equipment are located in the commercial kitchen. The fixtures in the commercial kitchen appear to be serviced by one vertical gas water heater located in the main mechanical room. The water heater has the ability to produce 200 MBH and hold 99 gallons.</p> <p>Staff reported that domestic water distribution piping under the Kindergarten building at one point in time was fractured and caused the air conditioning system to shut down due back up flow.</p> <p>There were no domestic water distribution system deficiencies noted during the assessment. The domestic water distribution system appeared to be in good condition.</p>	Good

1. Continue preventive maintenance on aged plumbing fixtures and plan for replacement of the fixtures in the future as they continue to reach the end of their useful life.
2. Replace the broken toilet seat flange in room 109's restroom.
3. Clean and service the grease trap.
4. Investigate the poor roof drainage at the front office and remedy.

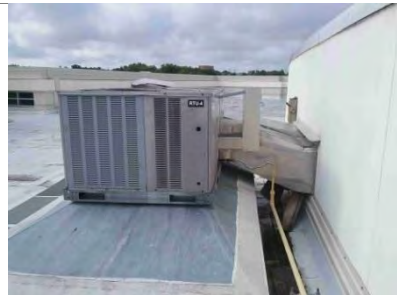
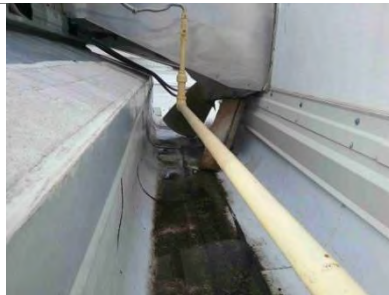
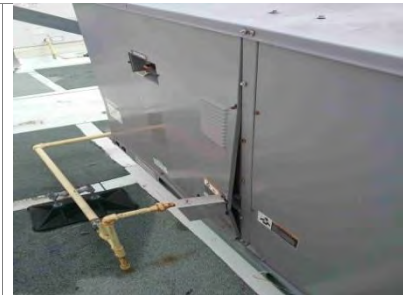
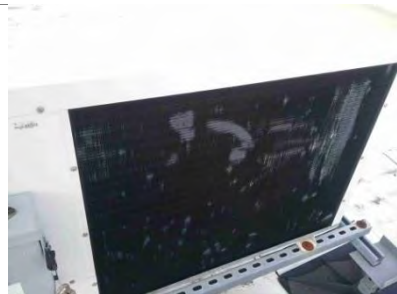
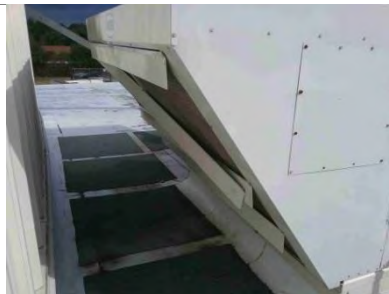
Mechanical/HVAC System Deficiency Examples

System	Subsystem	Condition and Deficiency Overview	System Condition Rating
Mechanical/ HVAC	<p>This building has multiple HVAC (heating, ventilation, and air conditioning) applications. The major mechanical equipment consists of large indoor multi-zone modular AHUs (air handling units), large roof top-mounted packaged/split air conditioning units, and roof-mounted EFs (exhaust fans). Many of the indoor modular AHUs are supported by one 200-TON centrifugal water chiller system that is serviced by a one-cell external cooling tower rated at 165-TON and one horizontal gas-fired boiler with a rated output capacity of 2,000 MBH.</p> <p>There were 18 HVAC systems assessed throughout the building. The estimated capacities of the roof-mounted EFs ranged from 200 to 1,300 CFM (cubic feet per minute), and the estimated capacities for the indoor AHUs were 2,600 to 15,000 CFM. The refrigeration capacities of the HVAC units ranged from 2.5- to 200-TON. The Staff reported that in 2015, nearly all of the HVAC system was replaced, including one centrifugal chiller, one cooling tower, several AHUs, hydronic pumps and associated ductwork and piping. It was also reported that many of the EFs in classroom restrooms did not work or did not exist.</p> <p>All of the major mechanical/HVAC equipment for this facility were replaced last year and were observed to be in good condition, however, there were many units that did not get replaced and were rated to be in average condition. Therefore this facilities mechanical/HVAC system is rated to be in average condition.</p> <p>Many of the deficiencies observed were in regards to the existing HVAC equipment that did not get replaced during the 2015 HVAC system upgrade. The deficiencies ranged from general aging of equipment and enclosure and piping/insulation damage due to excessive wear and tear. Another observed deficiency was the use of outdated R-22 refrigerant in some of the existing HVAC systems. The existing units were aged and out of date and had deficiencies such as excessive noise and vibration, damaged enclosure/associated ductwork, damaged compressor fins, and missing hardware for the enclosure. It was observed that AHU 3 located next to room 205 was aged and out of date and that the newly installed chiller seemed to be excessively loud.</p>		Average

1. Plan for replacement of and track equipment that uses R-22 refrigerant. The refrigerant is being phased out of manufacturing and construction use in the near future and will make all equipment that utilizes R-22 refrigerant obsolete.
2. Continue conducting preventive maintenance checks and services for HVAC systems. Plan to repair or replace aged and out-of-date HVAC equipment.
3. Repair or replace the non-functional exhaust fan in one of the classrooms.
4. Replace or repair damaged piping insulation.
5. Investigate excessive noise and vibration of units.
6. Repair or replace enclosures and ductwork.
7. Repair or replace damaged compressor fins.
8. Plan for replacement of AHU 3 which is beyond its typical useful life.

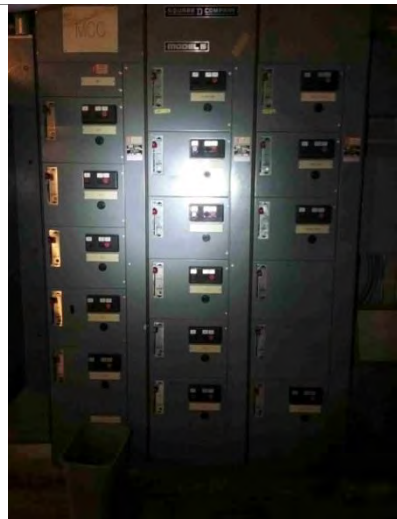
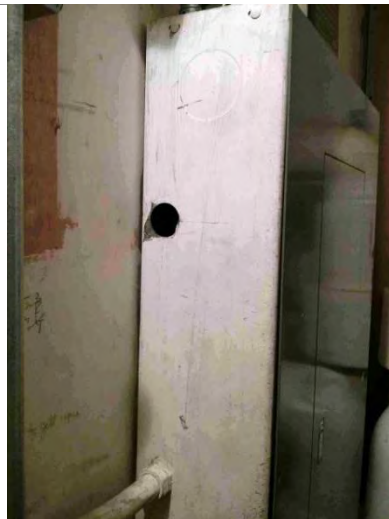
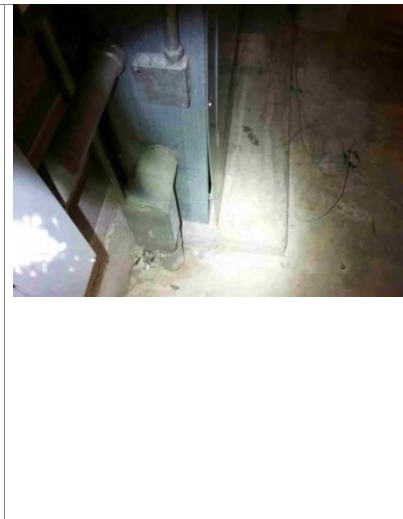
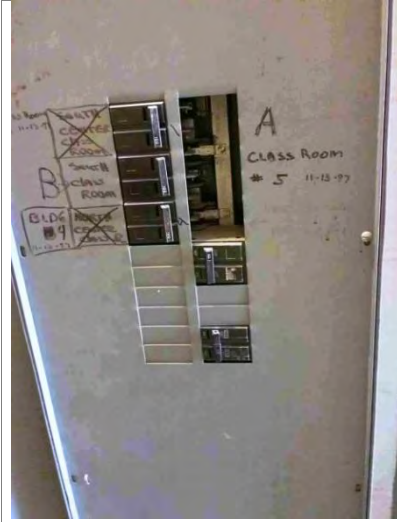
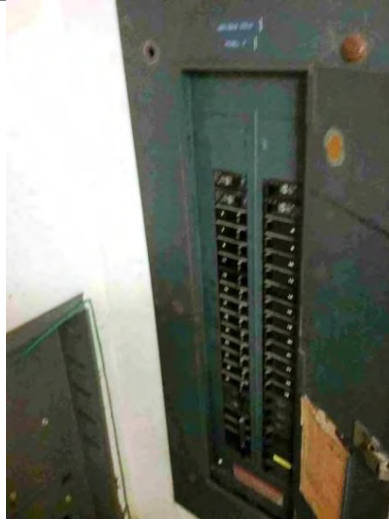
System	Subsystem	Condition and Deficiency Overview	System Condition Rating
Electrical	Electrical Distribution	<p>The electrical service (utility transformer and exterior switchboard for the facility) appear to be located on the southwest side of the campus adjacent to the gymnasium. The main mechanical room houses a 480-volt 1800-amp MCC (motor control center) and a 480-volt 800-amp panelboard that distribute power to transformers and sub panelboards. Numerous electrical rooms and storage closets house transformers and sub panelboards to supply power to the building's end devices and mechanical equipment.</p> <p>The electrical distribution equipment appeared to be in average condition.</p> <p>Panelboard "MDP" located in the main mechanical room had a gap in the front enclosure cover and the enclosure door latch was faulty.</p> <p>An unmarked GE 400-amp panelboard located in an electrical room on the east end of corridor 6 was aged and missing six slots of breakers or breaker void covers. This is a life safety issue.</p> <p>A Square D 400-amp panelboard located in a mechanical room on the east end of corridor 1 was missing a breaker or breaker void cover. This is a life safety issue.</p> <p>Panelboard F located in an electrical room on the east end of corridor 1 was nearing the end of its life expectancy.</p> <p>The facility reported the need for additional load and receptacles throughout building.</p>	Average

1. Install breaker void covers or install spare breakers in panels to keep bus bars from being exposed.
2. Consider replacing equipment nearing or past the end of its life expectancy.
3. Repair all enclosure latches, holes, and other access points not designed in electrical enclosures, especially those with medium or greater voltage.
4. Assess the facility's needs for additional receptacles and power. Install the required equipment based on findings.
5. Install additional lighting in low-light areas. Determine the space to be illuminated prior to choosing the fixtures.
6. Add support to unsupported network cabling and enclose where exposed.

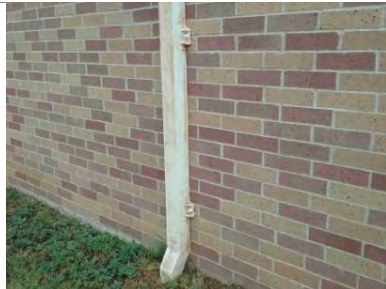
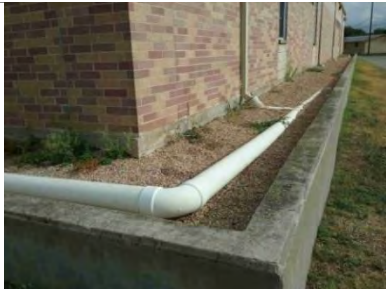
System	Subsystem	Condition and Deficiency Overview	System Condition Rating
Exterior	Exterior Walls	The exterior of the building consists of 85% brick and 20% split-faced concrete block façade. The building is one story built in 1998. The building's exterior appeared to be in good condition. The bottom six feet of the metal downspouts were rusty. The gravel gutter drain system surrounding the lower portion of the building was exposed on top in areas and needed covering with gravel similar to the rest of the system.	Good
	Exterior Windows	The windows are aluminum metal-framed inset into the brick façade and appear to be in good condition. Some of the screens were ripped and needed replacement.	Good
	Exterior Doors	There are double exterior metal doors throughout the building. The doors were observed to be in good condition.	Good
Roofing	The building has a single-ply roof that is in average condition. No obvious deficiencies were noted.		Average

1. Clean and repaint gutters on downspouts that are rusty.
2. Rescreen exterior windows screens that are ripped.
3. Add more gravel to cover the gutter system surrounding the building that receives drainage from the roof.

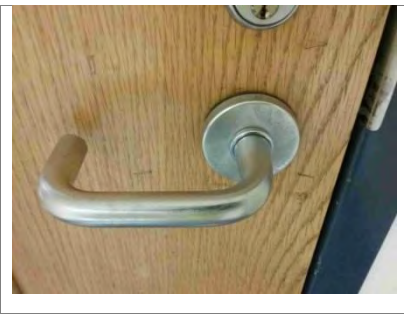
Interior Construction	Interior Walls	About 90% of the interior walls are gypsum board in the corridors and restrooms, and 10% are ceramic tile in the restrooms. The walls were functionally in good condition.	Good
	Interior Doors	About 70% of the interior doors are wood with windows in metal frames, and 30% are solid wood doors. The door handle was loose in room 301.	Good
	Interior Specialties	System not present.	N/A

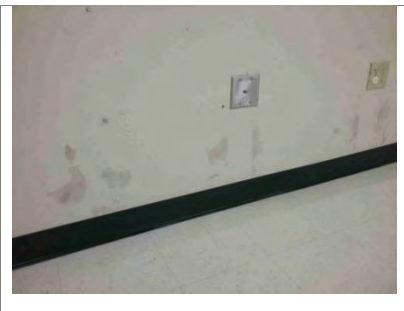
System	Subsystem	Condition and Deficiency Overview	System Condition Rating
Stairs	Exterior Stairs	System not present.	N/A
	Interior Stairs	System not present.	N/A
Interior Finishes	Interior Wall Finishes	About 90% of the interior wall finishes are gypsum board in the corridors and classrooms, and 10% are ceramic tile in the restrooms areas. The wall finishes were observed to be in average condition. There seemed to be a lot of wear at about 2 to 3 feet from the floor. Paint was peeling and needed repair.	Average
	Interior Floor Finishes	About 80% of the interior floor finishes are VCT in the classrooms and corridors, and 10% are ceramic tile in the restrooms. Floor finishes were observed to be in good condition.	Good
	Interior Ceiling Finishes	About 90% of the interior ceilings are acoustical tile in metal grid, and 10% are gypsum board in restrooms. There were stained tiles that needed to be replaced.	Good

1. Repaint walls in corridors.

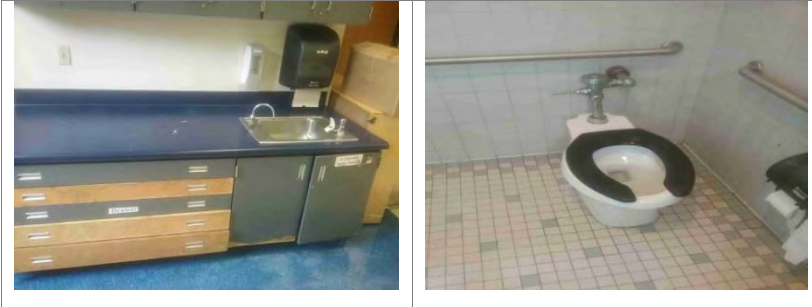
Conveying	System not present.		N/A
Plumbing	Plumbing Fixtures	The facility contains multiple plumbing applications that service one level, consisting of in-classroom student restrooms, one staff restroom, and one janitorial closet with a service sink. The restrooms located inside classrooms have vitreous china floor-mount toilets with manual flushing valves. The classroom restrooms are not equipped with sinks; however, the classrooms have laminated particle board vanities with stainless steel sink/bubbler combinations mounted inside the vanity. The remainder of the facility's restrooms have vitreous china sinks with manual or metering faucets, along with vitreous china floor/wall-mount toilets with manual flushing valves. This building's plumbing fixtures were observed to be in average condition. An estimated 90% of the classroom restroom fixtures were observed to be from when the building was originally construction and are aged and out of date. Typically, the fixtures were slow to flush and drain when operated.	Average

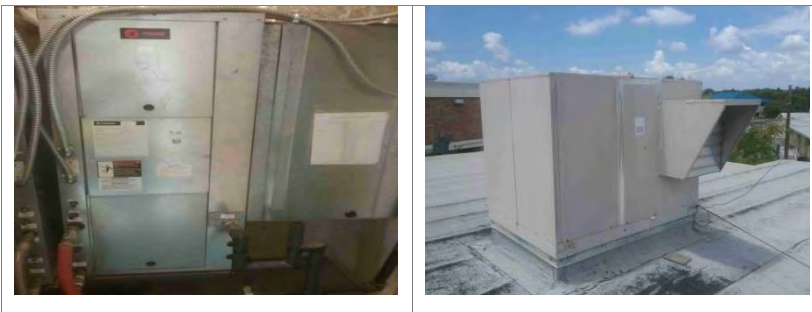
Mechanical/HVAC System Deficiency Examples

System	Subsystem	Condition and Deficiency Overview	System Condition Rating
		<p>equipped with gutters and downspouts.</p> <p>There were no staff-reported deficiencies or planned/requested renovations for this facility's other plumbing.</p> <p>The other plumbing appeared to be in good condition.</p>	
Mechanical/ HVAC		<p>This building has two types of HVAC applications that service one floor level. The major mechanical equipment consists of floor-mounted water source heat pump systems and one large roof-mounted outdoor air unit/HRU (heat recovery unit).</p> <p>There were nine HVAC systems assessed throughout the building. The estimated capacity of the large roof-mounted outdoor air unit/HRU was 3,000 to 5,000 CFM. The refrigeration capacities of the individual classroom water source heat pumps ranged from 3- to 4-TON.</p> <p>There were no staff-reported deficiencies or planned/ requested renovations for this facility's mechanical/HVAC systems.</p> <p>The classroom HVAC units observed in the facility had installation dates of 1998 and had surpassed their projected service life. The units were also charged with R-22 refrigerant. R-22 refrigerant is being phased out of use and eventually will render the equipment that utilizes it obsolete. The roof top outdoor air unit was installed in 1998 and had surpassed it projected service life. This unit also utilized R-22 refrigerant.</p> <p>The mechanical/HVAC system for this facility appeared to be in average condition.</p>	Average

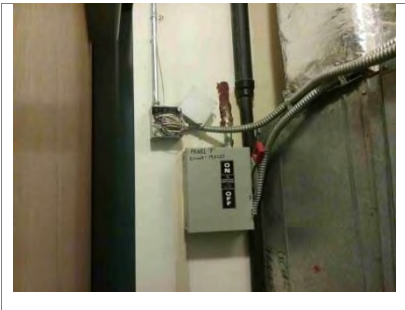
Fire Protection	Fire Alarm	<p>The building has a fire alarm system that consists of alarm and signaling devices such as horns/annunciators, strobes, horn/strobe combinations, pull stations, and detectors.</p> <p>The fire alarm system equipment was observed to be in good condition.</p>	Good
	Fire Protection/ Suppression	<p>The building is not equipped with a fire sprinkler/suppression system. It is protected by portable fire extinguishers stationed throughout the building.</p> <p>All portable fire extinguishers observed were inspected within the last year as indicated by their tags or city staff knowledge.</p>	N/A
Electrical	Electrical Distribution	<p>An electrical room is located on the northwest side of the building and houses transformers and panelboards that supply power to the building's end devices and mechanical equipment.</p> <p>The electrical distribution equipment was observed to be in good condition.</p> <p>A junction box was located in one of the mechanical rooms that did not have its enclosure cover secured, leaving cabling exposed. This is a life safety issue.</p>	Good

1. Install enclosure covers on junction boxes where missing.
