Zavala Elementary School Site Summary

Main School Building – BLDG-145A

CRAWL SPACE – Zavala ES – Main School Building (BLDG-145A)

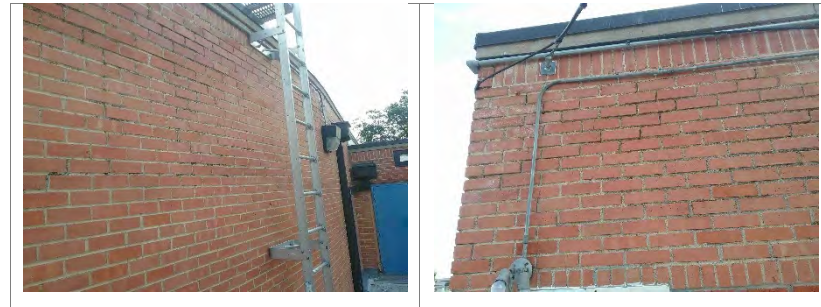
System	Subsystem	Condition and Deficiency Overview	System Condition Rating
Exterior	Exterior Walls	<p>The exterior facade of the building is brick. The older portions of the building have metal-capped parapets and scuppers with downspouts. The newer classroom addition has a continuous gutter with downspouts at its perimeter. There is a limestone window sill and a decorative masonry course above windows on some of the building facades.</p> <p>The brick facade appeared to be in good condition. One exception was deteriorating mortar observed on the south wall of the auditorium, visible from the adjacent roof. Flashing appeared to be in good condition. Sealants around mechanical louvers on the east elevation have failed, but other sealants on the exterior of the building appeared to be newer and in good condition.</p>	Good
	Exterior Windows	<p>The exterior windows are metal with single-pane glazing. Most of the windows in the older portions of the building have been replaced. There are two remaining original steel casement windows at the female restroom near the auditorium (Room WFHRRAUD). Windows above the south building entrance are wood with fixed glazing.</p> <p>The replacement metal windows in the older building areas and windows in the newer addition appeared to be in good condition. The original steel casement windows at the female restroom had no paint and were corroded and observed to be in poor condition. The</p>	Good

1. Repair and/or repoint mortar joints and brick facade where needed.
2. Replace steel windows where deteriorated.
3. Repair or replace leaking fixed wood windows over south entrance.
4. Replace deteriorated exterior doors and hardware at auditorium exit and penthouse.
5. Replace deteriorated joint sealant around mechanical louvers on exterior façade.

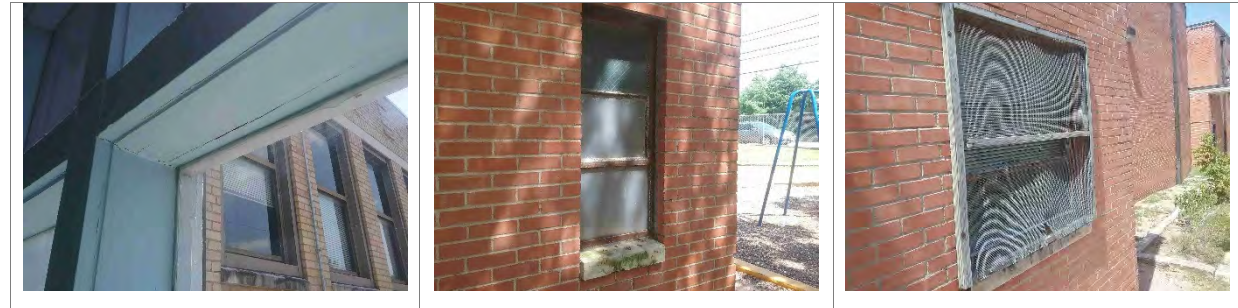
Exterior Windows

System	Subsystem	Condition and Deficiency Overview	System Condition Rating
		wood windows above the south entrance are reported to be leaking, and the wood frames were observed to have water damage.	
	Exterior Doors	<p>There are multiple public entryways to the building. These doors are metal with a metal frame and have transoms, side-lites, and vision panels. The remaining service doors around the facility are metal. There are no roll-up or overhead doors in the building</p> <p>The exterior doors were observed to be in average to good condition, depending on their age. Many of the exterior doors have been replaced and appeared to have been recently painted. The auditorium exit door to the north of the stage and the doors to the penthouse were observed to be rusted and marginally functional. The doors at the auditorium do not secure properly.</p>	Good
Roofing	<p>The roof on the original building is low slope modified bitumen with metal cap flashed parapets and scuppers with downspouts. The new classroom addition is similar but without parapets and has continuous gutters at the perimeter with downspouts. The Main School Building roof is not original to the building and the various roof areas appear to be of generally about the same age. There is a metal-covered walkway near the main entryway. There is an asphalt shingle roof on a small addition that is not indicated on the roof plan.</p> <p>The roof was observed to have blisters ranging from 1 to 10 inches in diameter. The granular surface has eroded over much of the building roof and has washed away or was observed to be ponding in low spots. The roof was observed to be in poor condition and appeared to be aged beyond its useful life. Leaking was reported in classroom 7, and ceiling tiles were observed to be stained throughout the building.</p>		Poor

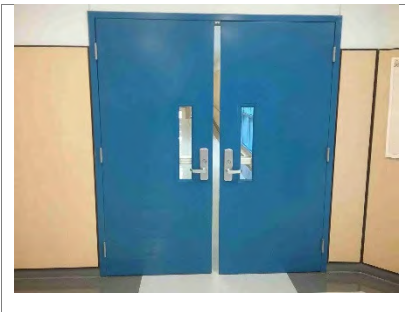
Interior Construction	Interior Walls	<p>Interior walls in the original building are solid masonry with a plaster finish. Interior walls in the newer classroom addition are metal framed with gypsum board finish. Walls near the building entrance and in the auditorium are brick. Walls at the kitchen are glazed masonry units. There are interior windows that vary from metal to wood framed with single-pane glazing.</p> <p>Interior walls were observed to be in good condition.</p>	Good
	Interior Doors	<p>The original building has wood panel interior doors and frames. The newer addition has solid core wood doors in metal frames, and the corridors have metal doors.</p> <p>The interior doors and frames were observed to be in good condition showing typical signs of wear and use. The double doors between corridors C7 and C8 were missing the astragal leaving a 2-inch gap between doors.</p>	Good

1. Install new center astragal at corridor C7 metal doors.

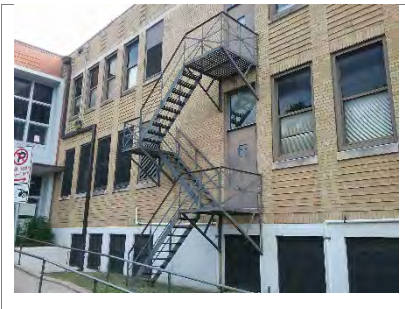
System	Subsystem	Condition and Deficiency Overview	System Condition Rating
	Interior Specialties	System is not present.	N/A
Stairs	Exterior Stairs	<p>The exterior stairs to the original building and older additions are concrete. There is a steel fire escape on the south side of the original building serving the second and first floors during emergency evacuation. The new classroom addition is built at grade.</p> <p>The exterior concrete stairs and metal railings are in average to good condition relative to their age. The fire escape stairs had corrosion showing on some of the steel members.</p>	Average
	Interior Stairs	<p>The interior stairs are concrete throughout the building, except for a single flight of steel stairs located between the gymnasium and corridor C1. Concrete stairs have a terrazzo finish with metal nosing. The steel stairs have rubber treads.</p> <p>The interior stairs appeared to be in good condition.</p>	Good

1. Remove rust and corrosion on the exterior fire escape. Paint steel with a rust-inhibiting paint to protect steel.

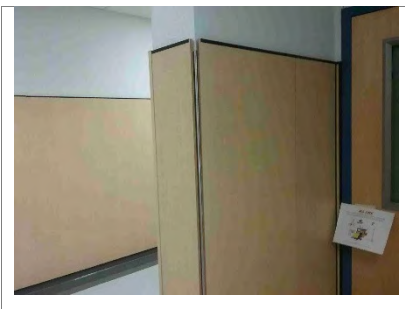
Interior Finishes	Interior Wall Finishes	<p>The interior wall finishes in the original building and older additions are painted plaster. The interior wall finishes in the more newly constructed library and classroom addition are painted gypsum board with 6-ft-high plastic laminate-covered panels along corridors. The renovated cafeteria also has plastic laminate panels on some walls and columns. There are both painted and unpainted brick interior walls near the main entrance and in the auditorium. The kitchen walls are glazed masonry units.</p> <p>The interior wall finishes throughout the building were observed to be in good condition relative to their age. There were missing moldings on the plastic laminate panels in the classroom addition.</p>	Good
	Interior Floor Finishes	<p>The floor finishes in the corridors, cafeteria, restrooms, and stairwells in the original building are terrazzo. Classrooms and administrative offices in the original building have wood flooring or have been subsequently covered with vinyl tile. The auditorium and newer classroom addition have vinyl tile with 4-inch base. The library floor is carpet. The kitchen floor and base are non-slip ceramic tile. The gymnasium has a wood athletic floor, and restrooms in the newer addition have ceramic tile floors and base.</p> <p>The floors throughout the building are in average to good condition relative to their age. A few floor tiles in corridor C7 were observed to be loose. The wood flooring on the ground floor in various areas was being</p>	Average

1. Replace missing corner molding and trim pieces on plastic laminate panels in corridors of classroom addition.
2. Replace loose and damaged vinyl floor tiles with new matching floor tiles.
3. Replace stained ceiling tiles from roof leaks throughout the building.

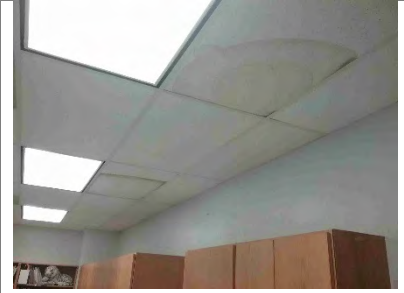
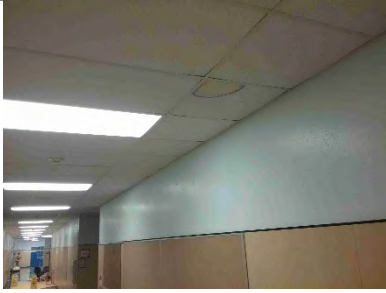
System	Subsystem	Condition and Deficiency Overview	System Condition Rating
		repaired at the time of the assessment.	
	Interior Ceiling Finishes	<p>The ceilings throughout most of the building are suspended acoustic tile. The ceiling tiles in the kitchen are vinyl covered. Ceilings in restrooms are painted gypsum board or plaster. The gymnasium roof structure and deck is exposed, and the steel joists are painted.</p> <p>The interior ceiling finishes were observed to be in good condition. There were stained ceiling tiles in various areas of the building that are likely the result of roof or mechanical equipment leaks.</p>	Good
Conveying	<p>The building is equipped with a hydraulic passenger elevator to service two levels. The elevator was noted as having a maximum weight capacity of 2100 lbs. This elevator appears to be in good condition as a recent inspection certificate issued within the last year, as required, was visible and no operational issues were reported by the facility staff.</p>		Good

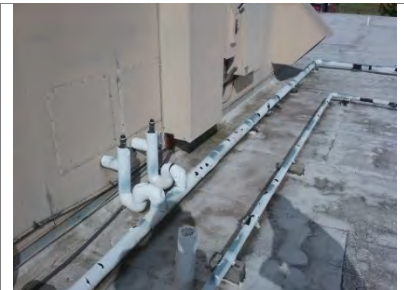
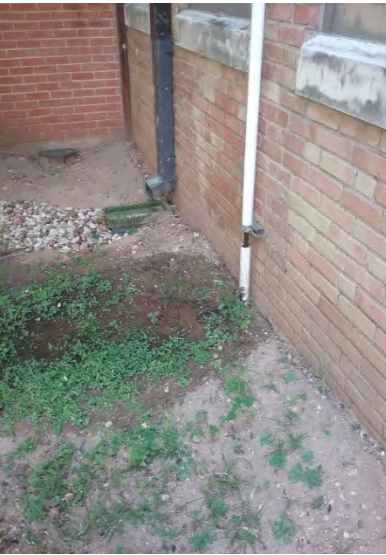
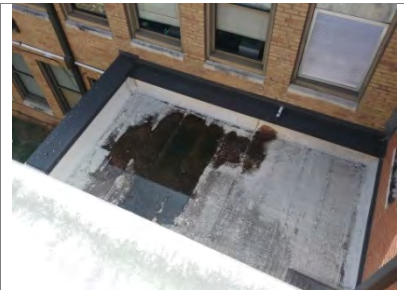
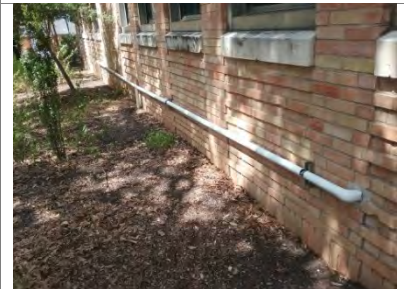
Other Plumbing	<p>Portions of the roof are equipped with gutters, while other portions are equipped with roof drains. The gutter</p>	Average

System	Subsystem	Condition and Deficiency Overview	System Condition Rating
		system appeared to drain into the storm sewer and was observed to be in good condition. The roof drains are equipped with metal grate covers to prevent debris from entering the drainage system and appeared to be in average condition. The interior floor drains were observed to be aged and in average condition.	
Mechanical/ HVAC	<p>The major mechanical equipment consists of roof top AHUs (air handling units) and split system AHUs with the associated condensing units located primarily on the roof. These serve the HVAC (heating, ventilating, and air conditioning) system. Five RTUs (roof top units), with an approximate capacity range of 3,000 to 8,000 CFM (cubic feet per minute), are located on the roof. Two heat recovery AHUs on the roof appeared to provide outside airflow to the building. Thirteen other split system AHUs are located throughout the interior of the facility and range from an estimated 1,000 to 10,000 CFM in capacity. These AHUs serve different zone locations throughout the facility. The AHUs were observed to be in poor condition with the most typical deficiency being corrosion on the housing enclosure and/or the piping associated with the AHU.</p> <p>Additional deficiencies observed include general aging of the equipment, damaged insulation, excessive noise/vibration associated with select equipment, and a few leaks. Typically, the AHUs were not equipped with preventive maintenance logs. The heat recovery unit's ductwork support framework was observed to penetrate the ductwork, and the penetrations were observed to be poorly sealed. Multiple electrical disconnects associated with the roof-mounted equipment were observed to be rusted and require replacement. Building staff reported that the evaporator serving the MDF (main distribution frame) room was weak and disintegrating. The MDF room was inaccessible at the time of the assessment. Building staff also indicated that the fan coil units in room 8 and room 10 have been breaking down frequently. The units were not operational during the assessment. Building staff reported that the outside air handling unit serving room 7 was "inefficient." Condensate drain piping insulation appeared aged, damaged, and missing in areas. Condensate drains were observed to terminate onto the ground, underground or on the roof, where ponding was observed. Condensate drains appeared to be non-functioning in areas, causing leakage to the exterior of the building.</p> <p>Supplemental mechanical equipment for the HVAC system also includes exhaust fans serving the kitchen and bathroom exhaust. Roof top exhaust fans appeared aged and in poor condition.</p> <p>The HVAC system was observed to be in poor condition with all of the prior mentioned deficiencies.</p>		Poor

1. Continue preventive maintenance on aged plumbing fixtures and plan for replacement in the future as fixtures continue to age.
2. Repair or replace any damaged or missing piping insulation as needed at all facilities.
3. Track installation year of water heater and plan for replacement as the typical design service life for a water heater is 10 to 15 years.

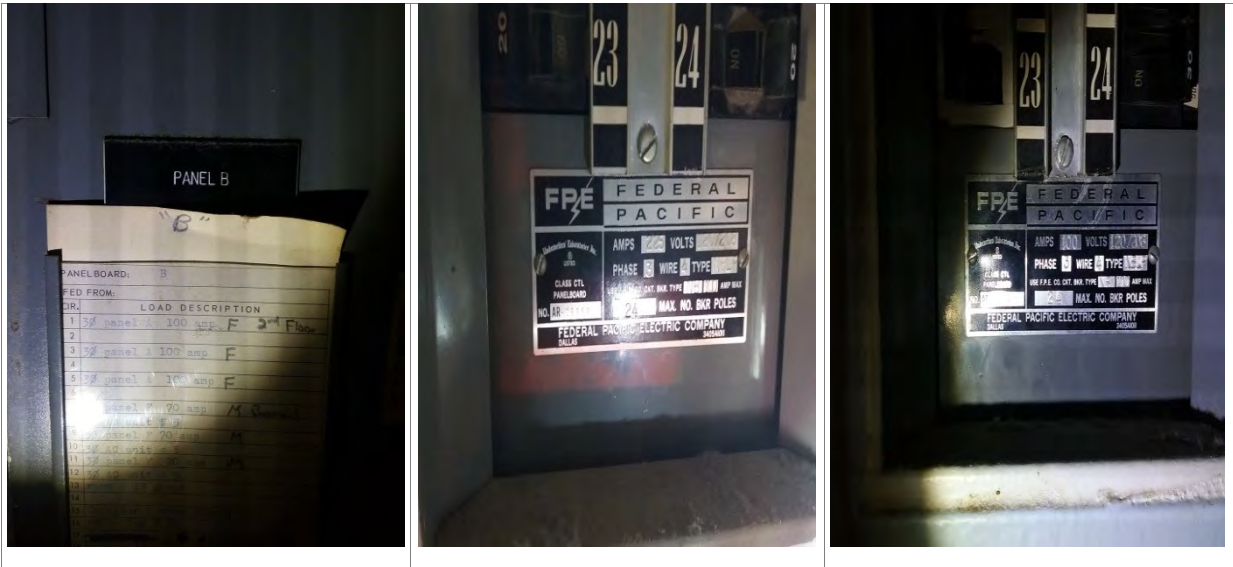
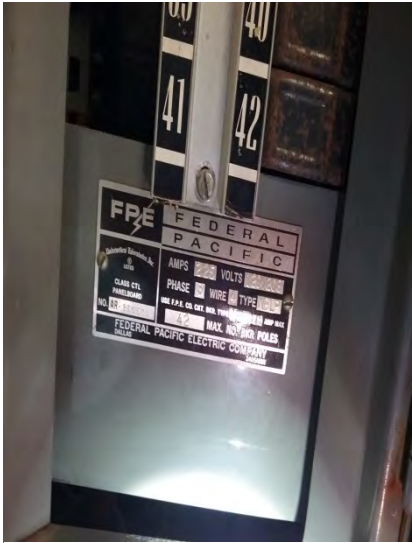
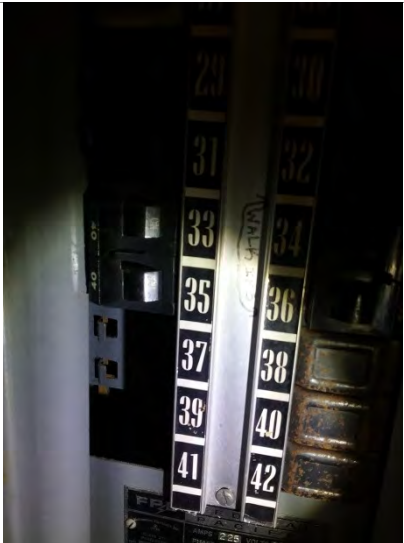
System	Subsystem	Condition and Deficiency Overview	System Condition Rating
		alarm system was observed to be in good condition, but there are areas where the fire alarm end devices are aged past their design life.	
	Fire Protection/Suppression	The building is protected by portable fire extinguishers placed throughout the facility. All observed portable fire extinguishers had inspection tags dated within the last year. It did not appear that fire extinguishers were located at all required locations.	Average
Electrical	Electrical Distribution	<p>The electrical service enters the building at the 277/480-volt 2000-amp main switchboards located in the electrical room at the rear of the building. The service feeds transformers and high-voltage panelboards that are located in various electrical rooms throughout the building. There are three distribution transformers rated at 480-volt primary that step-down to 120/208-volt secondary, which feeds power to 120/208-volt panelboards. The building does not have a lightning protection system.</p> <p>The electrical distribution equipment was observed to be in average condition. It was observed that there were several Federal Pacific panels (K21, K22, B, and B1) located on the first and second floor corridors that have been identified as a life safety hazard and are no longer manufactured, making replacement parts are difficult to find. The building staff reported that the original distribution has had issues related to the Federal Pacific panels.</p>	Average

1. Remove any floor receptacles as they are being phased out of use district-wide.
2. Replace all outdated luminaires with LED (light-emitting diode) light fixtures and dimming capabilities.
3. Replace all existing exit signs with LED fixtures and add more exit signs where required for all buildings.
1. Provide egress lighting where required for all areas.
2. Immediately replace noted Federal Pacific panels, as these instances should be considered life safety hazards.
3. Verify the condition of tele/data system/equipment in the main school, as it was inaccessible. Add additional data drops in classrooms as requested by facility staff.
4. Replace all exterior light fixtures that are cracked or have discolored lenses with LED type.
5. Replace all interior lighting with new LED light fixtures with the capability of utilizing occupancy sensors.

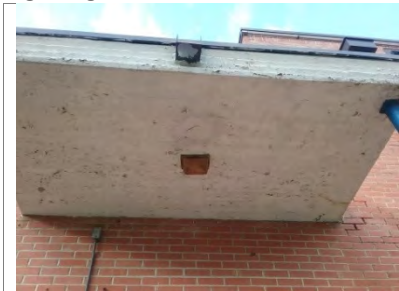
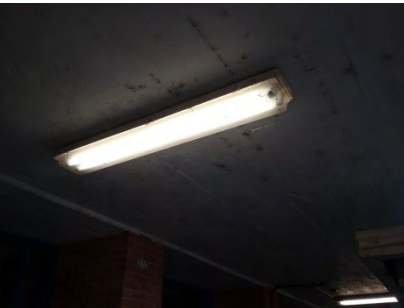
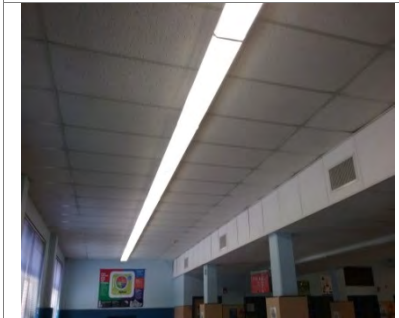
Lighting	<p>The building's exterior lighting consists of HID (high-intensity discharge) and fluorescent light fixtures that are located along the entire perimeter. The interior lighting primarily consists of T8 fluorescent light fixtures that are outdated.</p> <p>The lighting for the building was observed to be in poor condition. Many interior and exterior light fixtures appeared to be aged past their design life. Observed deficiencies included broken lenses, discolored lenses, and non-functional fixtures. There are exit signs present in the building; however, several appeared to be aged.</p>	Poor
	Communications & Security	<p>There is a Gemini security system including surveillance cameras in the building. According to building staff, there is a lack of volume to the exterior rear speakers facing the playground.,</p> <p>There are no cameras located on the second floor, and additional cameras have been requested by the facility</p>	Average

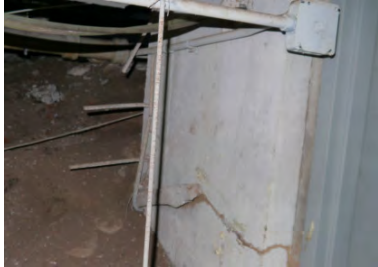
<ul style="list-style-type: none"> Access to crawl spaces is insufficient. There are only two access points to the crawl space for the entire school and thus most of the crawl space is inaccessible. 	
Exposed Structure	Exposed Columns & Tops of Foundations	<p>Foundations appear to consist of square columns on a shallow footing. All observed columns & footings appeared in good condition.</p> <p>Column/foundation deficiencies:</p> <ul style="list-style-type: none"> None 	Excellent
	Exposed Faces of Perimeter Walls / Grade Beams	<p>Original building has concrete walls around entire perimeter. Basement walls also divide the crawl space into separate areas.</p> <p>Basement wall deficiencies:</p> <ul style="list-style-type: none"> At the basement entrance to crawl space there was exposed rebar from a prior demolition. The same location had cracks in the basement wall that had been repaired with epoxy. Under women's restroom, basement walls had minor honeycombing. 	Good

Exposed rebar from previous demolition and repaired crack in wall

1. Cut, clean and seal exposed rebar from previous demolition to prevent corrosion of steel damaging basement wall.

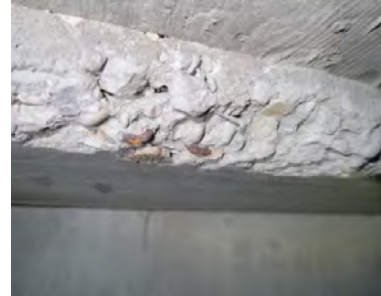
Exposed Portions of Suspended Floor Beams Above	<p>Suspended cast-in-place floor beams were prevalent within the interior of the crawl space.</p> <p>Suspended beam deficiencies:</p> <ul style="list-style-type: none"> Minor spalling at the corners of beams 	Excellent
	Underside of Suspended Floor Slabs Above	<p>Floor slabs were composed of cast-in-place two-way slabs throughout the building. Formwork nails and rods had been left in place and had minor rusting.</p> <p>Slab deficiencies:</p> <ul style="list-style-type: none"> None 	Excellent
Pipes, Ducts, Equipment & Fireproofing	Suspended Pipes & Hangers	<p>Pipe deficiencies:</p> <ul style="list-style-type: none"> Many abandoned pipes at basement access to crawl space. Multiple pipes bearing on soil and running through soil in all locations observed with empty pipe hanger above. 	Good
	Exposed Ductwork	<p>Internally insulated ducts were observed.</p> <p>Ductwork deficiencies:</p> <ul style="list-style-type: none"> No deficiencies observed in ductwork 	Excellent

Minor spalling at corners of beams

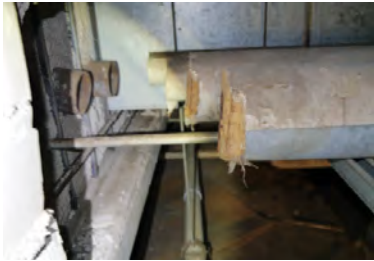
Abandoned and cut pipes

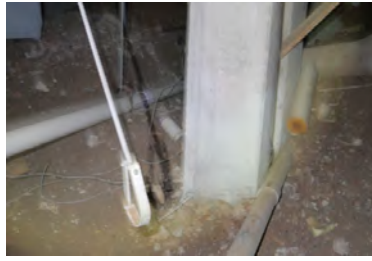
Pipes running through subgrade

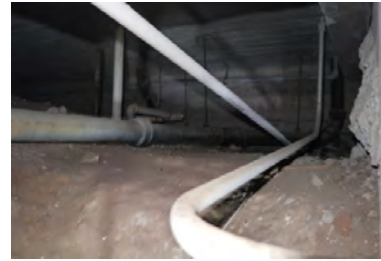
Pipes bearing on soil

1. Suspend pipes bearing on grade.

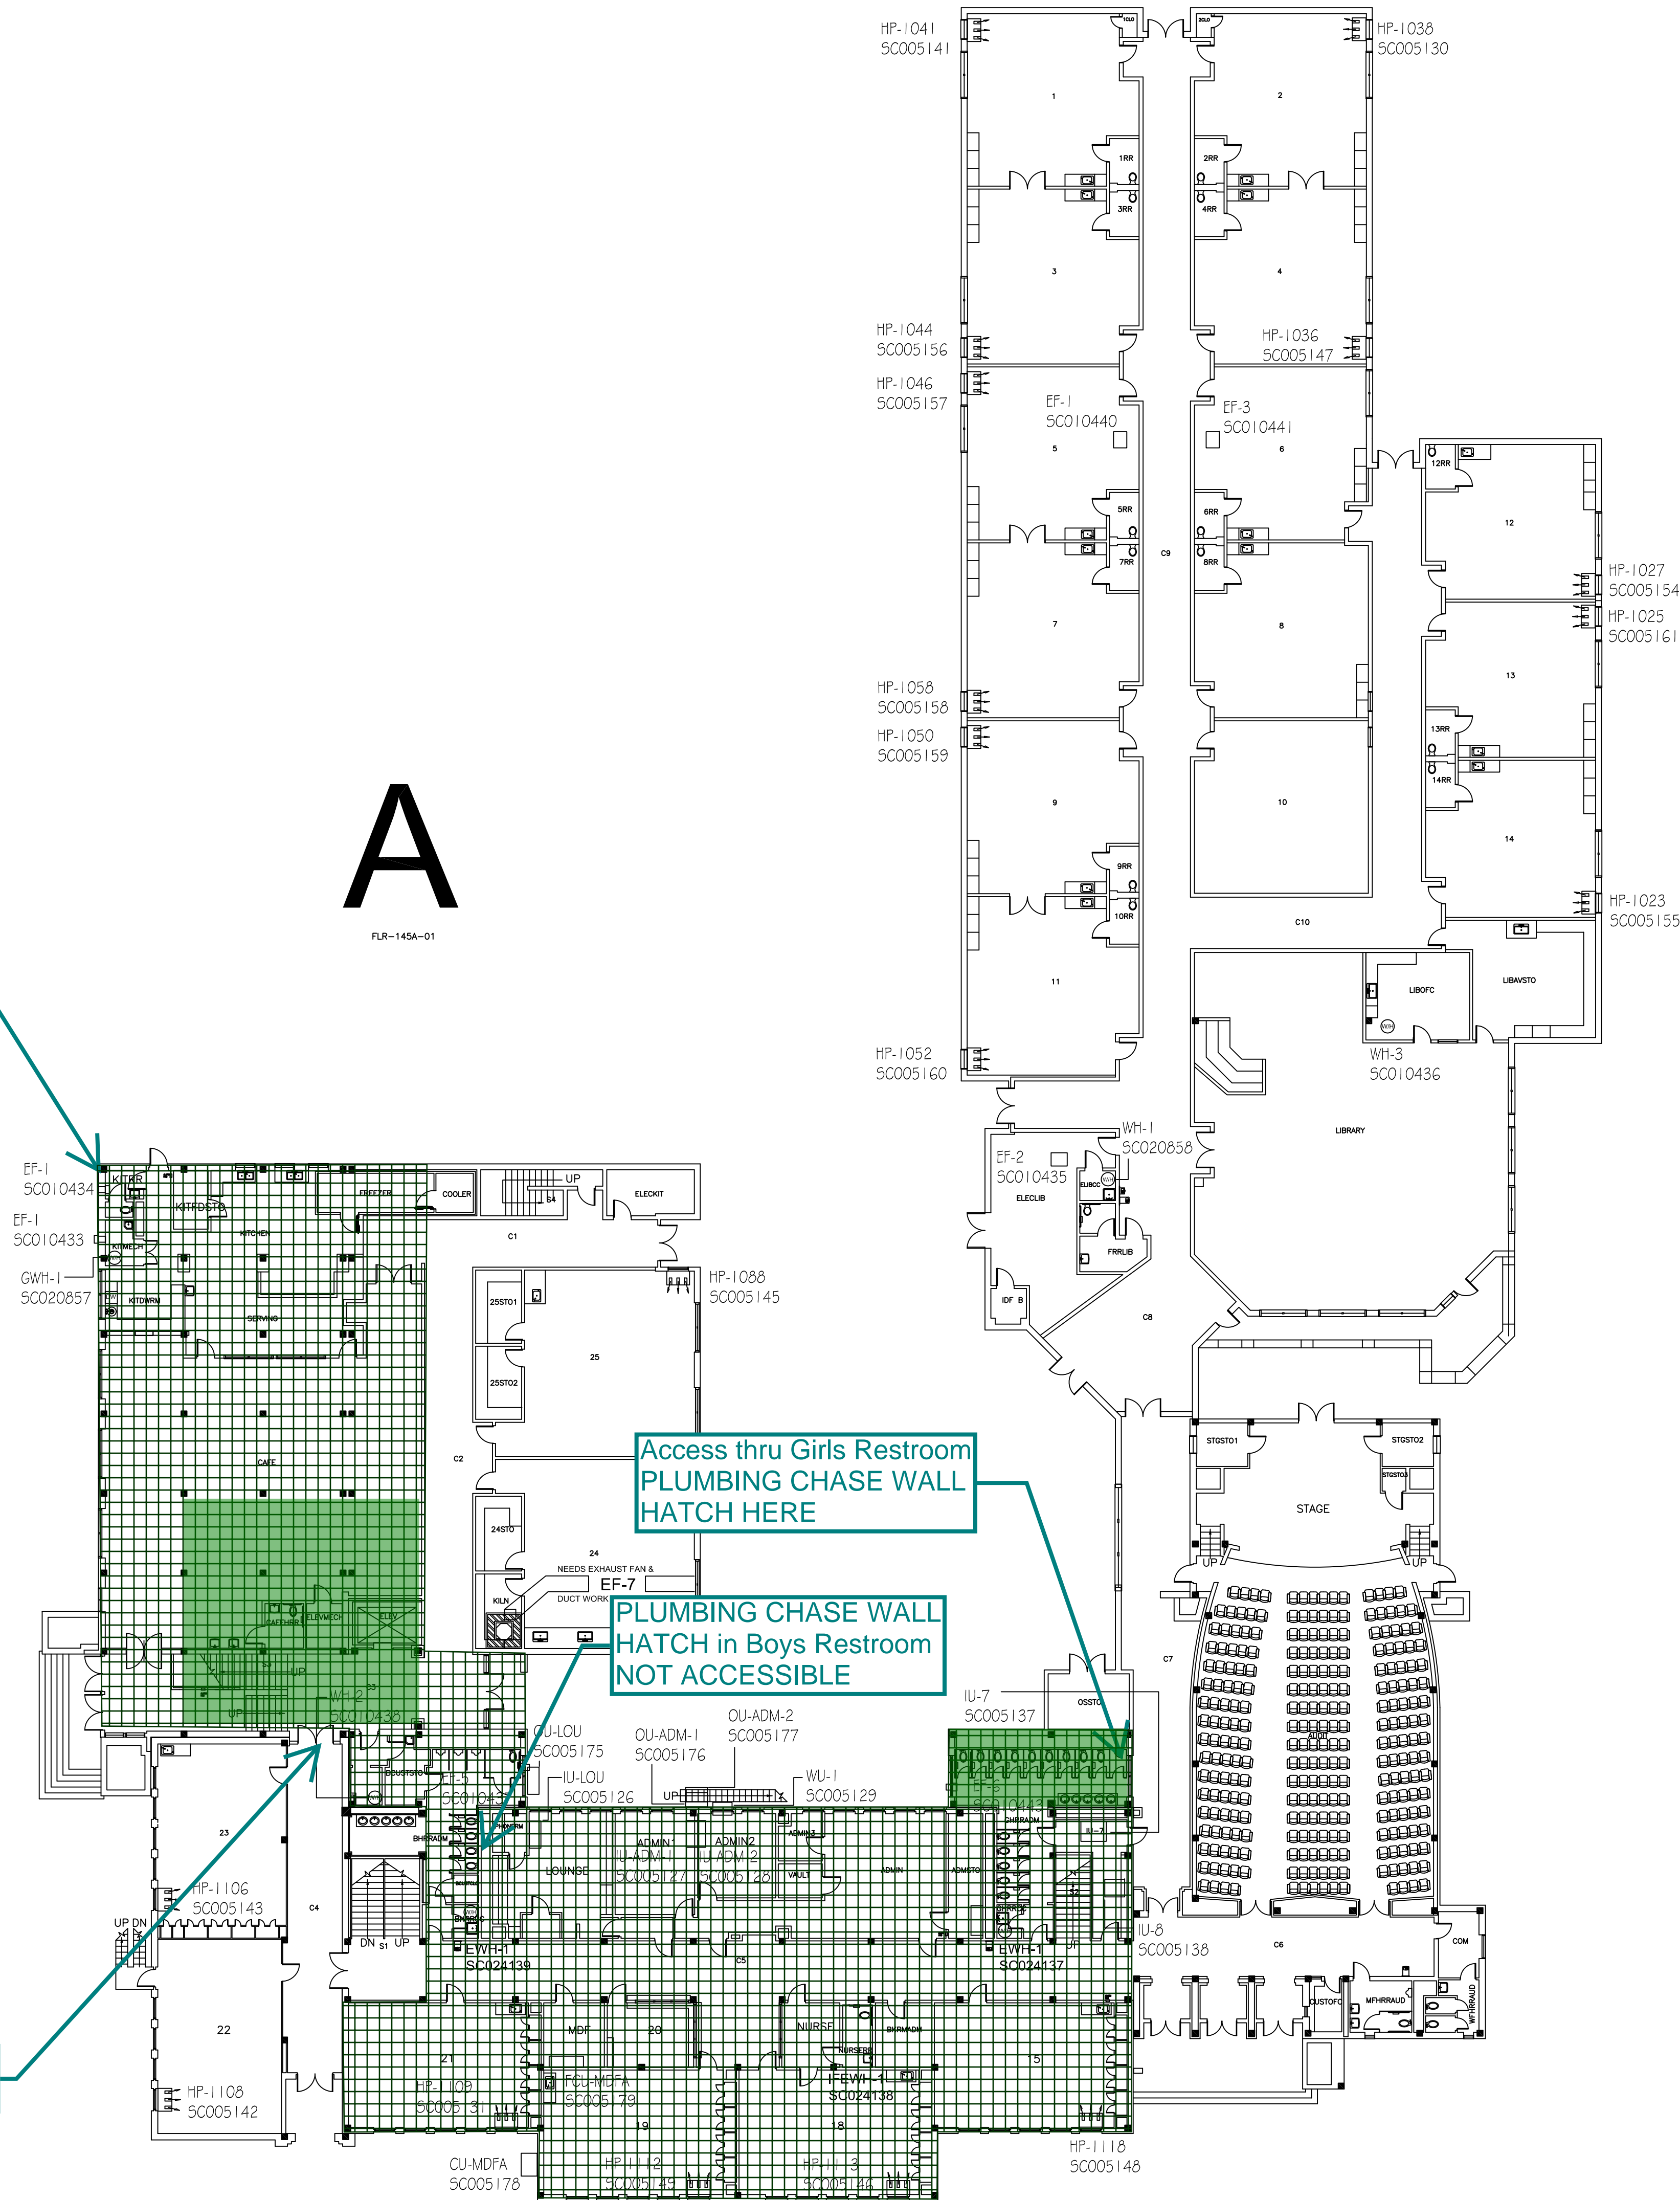
FLR-145A-01

PLUMBING CHASE WALL
HATCH in Boys Restroom
NOT ACCESSIBLE

APPROXIMATE LIMITS OF
CRAWLSPACE OBSERVED
ON 8/8/2016 SITE VISIT

1. Investigate need to improve ventilation.
2. Provide safe access to crawl space from the wall hatch in the boys' restroom (install landing & ladder)
