## Zilker Elementary School Site Summary

## Main School Building – BLDG-146A

Building Purpose	Administration Offices, Classrooms and Cafeteria
Building Area	42,029 SF
Inspection Date	August 15, 2016
Inspection Conditions	76°F – Cloudy and raining
Facility Condition Index

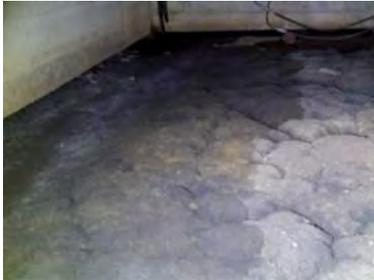
<p>Damp soil due to water infiltration around perimeter of building</p>

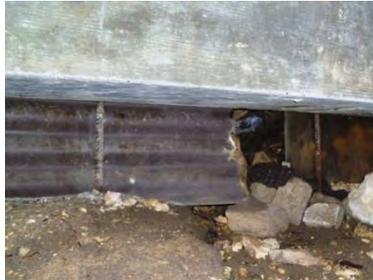
<p>Damaged/degraded soil retainer (possibly made with asbestos)</p>

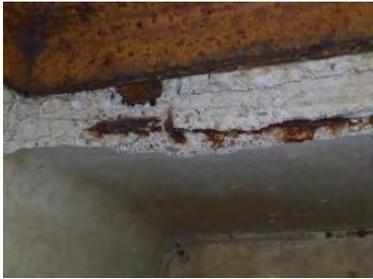
<p>Exposed/corroded reinforcement below hatch frame</p>

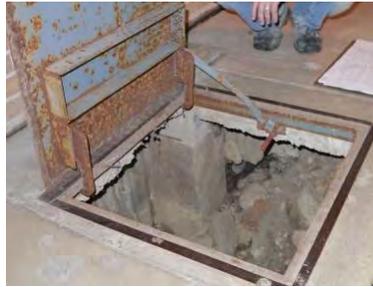
<p>Rusted hatch frame &amp; door</p>

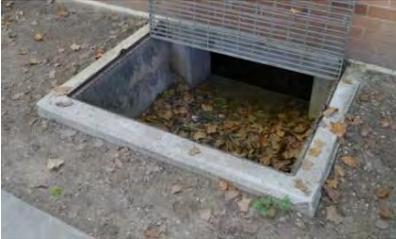
<p>Low areaway curb heights may be allowing water to infiltrate the crawl space</p>

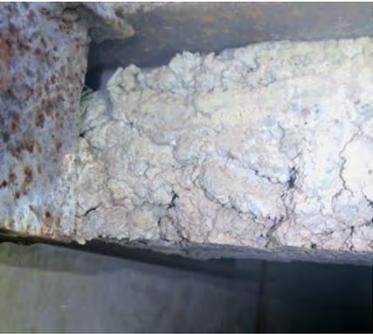
<p>Badly honeycombed beam, significantly corroded steel supports</p>

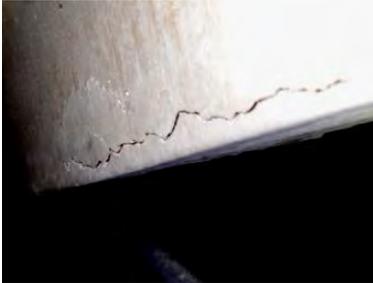
<p>Large longitudinal cracks along bottom of channel joists</p>

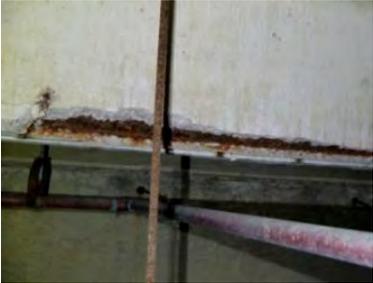
<p>Advanced spalling, exposed/corroded reinforcement at bottom of channel joist</p>

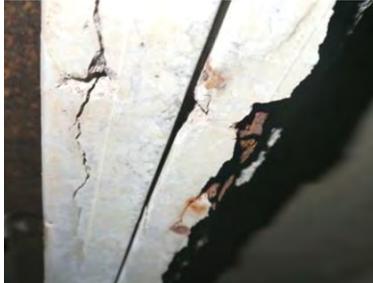
<p>Large cracks, severe spalls and advanced corrosion at bottom of channel joist</p>

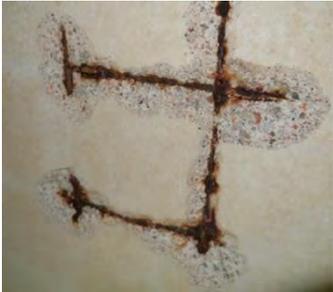
<p>Corroded reinforcement on underside of precast channel slab</p>

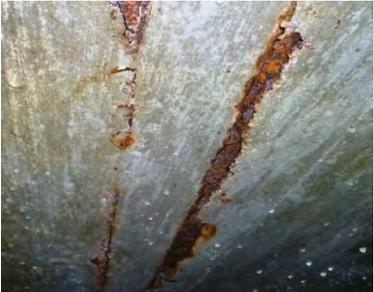
<p>Severe corrosion of misc steel items embedded in cast-in-place flat slab</p>

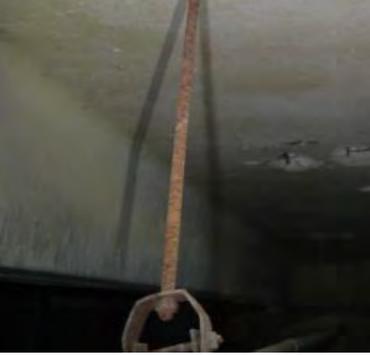
<p>Corroded pipe hanger rod</p>

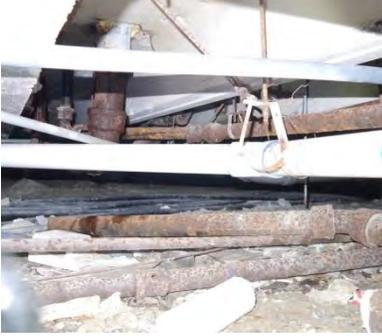
<p>Abandoned pipes limit accessibility in crawl space</p>

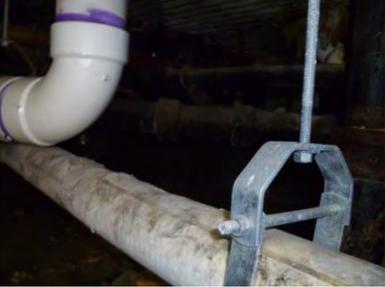
<p>Degraded/molding pipe insulation</p>

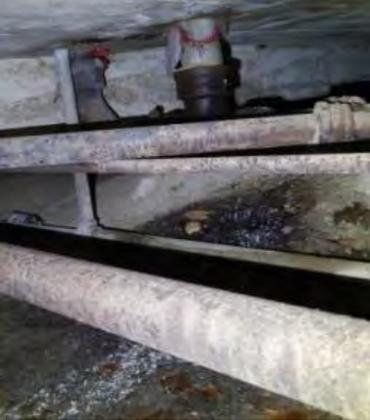
<p>Pipe leak, congested pipes limit crawl space access</p>

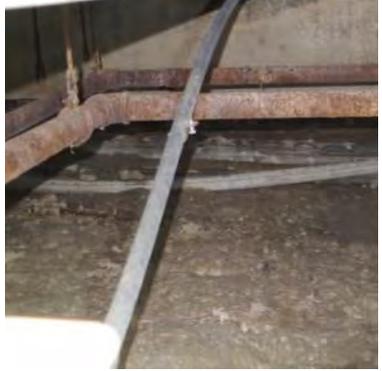
<p>Detached conduit</p>

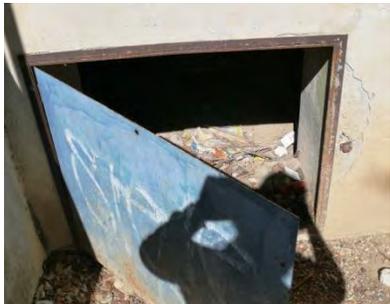
<p>Rusted frame on access door</p>

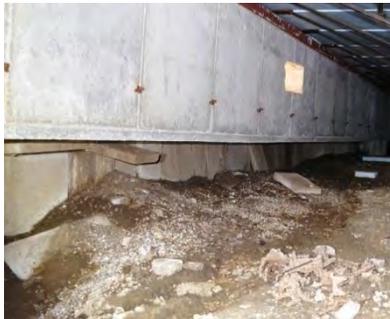
<p>Overturned soil retainers</p>

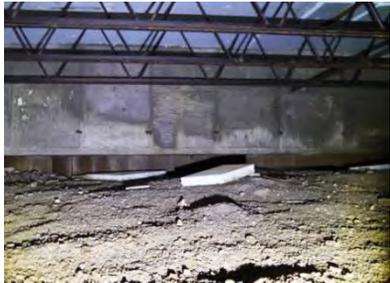
<p>Water infiltration at perimeter</p>

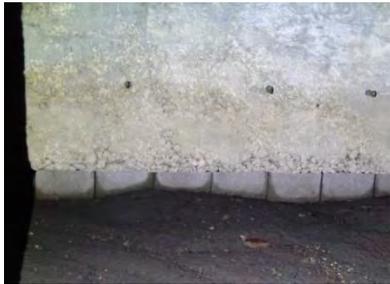
<p>Honeycombing on perimeter beam</p>

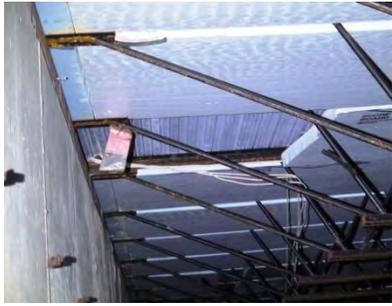
Missing insulation panels

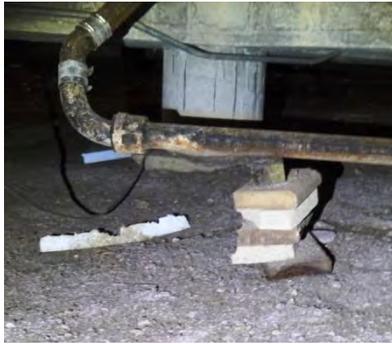
Corroded pipe and missing hanger
