Bryker Woods Elementary School Site Summary

Address	3309 Kerbey Lane Austin, TX 78703
Number of Permanent Campus Facilities	4
Original Year of Construction	1939
Total Campus Building Area (combined)	37,512 SF

Main School Building – BLDG-110A

CRAWL SPACE –) Key Woods) S – Main) Building () LDG-110A)

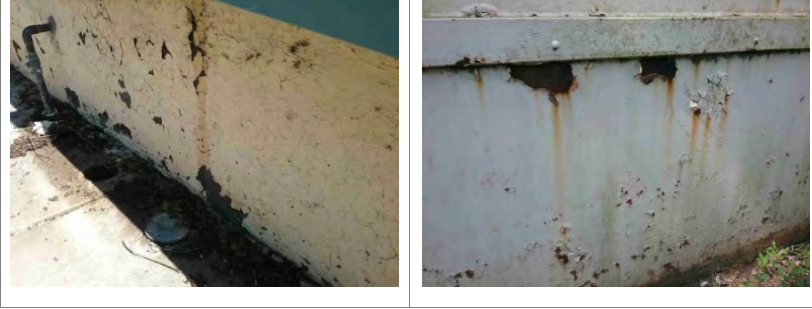
System	Subsystem	Condition and Deficiency Overview	System Condition Rating
Exterior	Exterior Walls	The exterior of the building consists of a brick façade. The exterior of the building appeared to be in good condition. The area on the north side of the building had a metal panel under the windows that was rusted and the paint was peeling.	Good
	Exterior Windows	The exterior windows are single-pane metal-framed windows inset into the brick façade. The windows appeared to be in average condition. The restroom windows had chipped paint on the inside. There was one window that was reported and observed to be broken. A number of the single-pane windows were fogged.	Average
	Exterior Doors	There are many double exterior metal doors with lites throughout the building. Some exterior doors are solid metal with no lites. The exterior doors appeared to be in good condition.	Good
Roofing	The roofing consists of a modified bitumen roof covering on the main part of the building. A small part of the roof, covering the administration offices, is a built-up roofing system. There was no evidence that trees were crushing and damaging a parapet wall or flashing as reported by staff. The roof appeared to be in average condition. The roof showed signs of wear with ponding, blistering and splitting in many areas. - Facility staff reported security and access concerns relative to the location of the existing roof access ladder.		Average

1. Repair panels under windows that are rusted and pitted.
2. Repair or replace single-pane fogged windows where applicable.

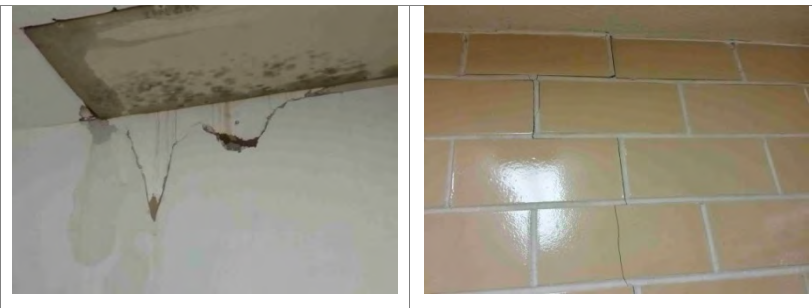
Interior Finishes	Interior Wall Finishes	The interior walls are painted and glazed ceramic tile in the classrooms, administration area, restrooms, and lobby. There is painted CMU and glazed tile in the gymnasium and cafeteria areas. There are painted gypsum board walls in the classrooms and administration areas. The wall finishes appeared to be in good condition. During a rain storm, the female restroom had water pouring down the wall from that corner. It appeared that this had been patched but was still leaking badly. The walls appeared to be in good condition. There was a crack observed in the ceramic tile restroom walls in	Good
	Interior Floor Finishes	The interior floor finishes are VCT (vinyl composition tile) in the corridors, cafeteria, and classrooms. Ceramic tile is in the restrooms and kitchen. The flooring is carpet in the library and administration offices and wood on the stage and some classrooms. Additionally, there is terrazzo flooring in the main corridor wing. There is rubber non-slip flooring on the ramp adjacent to a corridor with concrete stairs adjacent to the exit doors. All flooring appeared to be in good condition. Although the staff interview notes indicated damaged tile flooring in the art room and cafeteria, as well as unraveling	Good

1. Repair and repaint the wall and ceiling in the female restroom in the basement where a leak occurred.

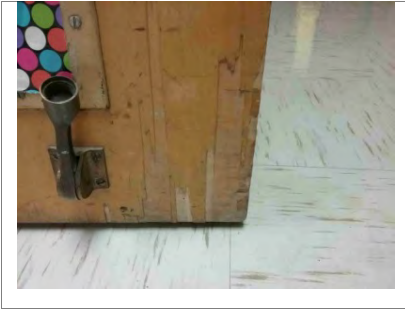
System	Subsystem	Condition and Deficiency Overview	System Condition Rating
Interior Construction	Interior Walls	The interior walls are gypsum board in the classrooms and administration area. There is CMU (concrete masonry unit) in the gymnasium and cafeteria areas. The corridors are brick, glazed ceramic tile, and gypsum board. The walls appeared to be in good condition.	Good
	Interior Doors	The interior doors are wood veneer, each with a lite, in metal frames. A number of the doors are solid wood doors without side lites. The doors appeared to be in average condition. Most of the doors were worn, and the veneer was splitting.	Good
	Interior Specialties	System not present.	N/A
Stairs	Exterior Stairs	The exterior stairs are concrete with metal handrails. The exterior stairs appeared to be in good condition.	Good
	Interior Stairs	The interior stairs leading to the music classrooms are concrete with metal non-slip edging and metal handrails. The stairs leading to the other basement classrooms are concrete covered with rubber treads, also with metal handrails. The interior stairs appeared to be in good condition.	Good

1. Repair or replace worn and delaminated doors.
2. Investigate the source of the restroom water leak.
3. Investigate crack in the glazed ceramic tile wall in restrooms of room 9.
4. Investigate cause of leak in the ceiling near the clerestory area of the kitchen and repair damages (requested by AISD Construction Management).

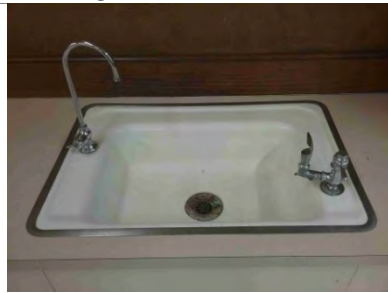
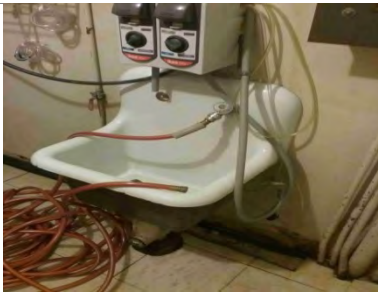
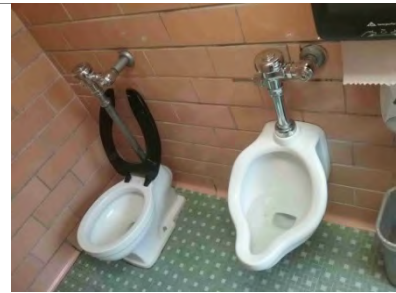
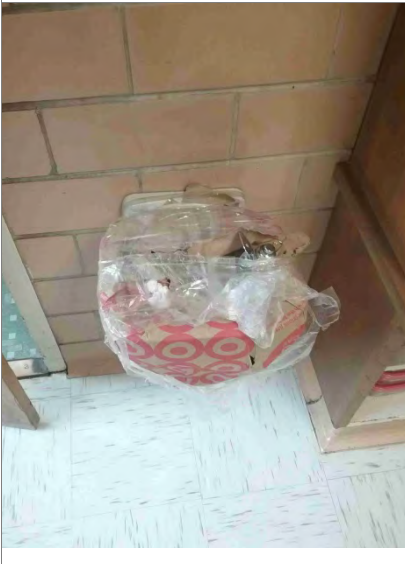
Plumbing	Plumbing Fixtures	The facility contains multiple plumbing applications that service one floor level, consisting of student restrooms, staff restrooms, janitorial closets with service sinks, and one commercial kitchen. The facility's restrooms have vitreous china sinks with manual or metering faucets, along with vitreous china floor/wall-mount toilets and urinals with manually operated flushing valves. There are also wall-mounted service sinks in the janitorial closets. The building's plumbing fixtures were observed to be in average condition. The age of the fixtures varied throughout the building, and some were observed to be fairly aged, but all fixtures were observed to be functional. Many of the plumbing fixtures had similar deficiencies, such as, inefficiently flushing/draining, being constructed of porcelain, and not being operable. Specifically, male restrooms BHRRLB & BRR10, both had urinals that flushed and drained slowly and BCC10 had an aged and outdated wall mount service sink. Additionally, classroom 11 had an outdated porcelain water fountain that was inoperable and porcelain restroom plumbing fixtures. The facility staff reported that several toilets clogged easily and that urinals were slow to flush. The staff also stated that many of faucets were aged and outdated. Lastly, staff reported that there were no floor sinks installed in the janitorial closets throughout the building	Average

1. Continue preventive maintenance on aged plumbing fixtures and plan for replacement of the fixtures in the future as they continue to age.
2. Investigate why the reported plumbing fixtures and floor drains are slow to flush or are clogging easily.
3. Investigate the domestic water system's reported low water pressure.
4. Replace aged and outdated hot water domestic water piping that services the kitchen.
5. Install additional hose bibs in order to adequately provide facility maintenance water.
6. Install floor drains for the GHRRART TOILETFH and BHRRART TOILETMH restrooms.

7. Install floor sinks in the janitorial closets throughout the building, and install a janitorial closet in the basement.
8. Investigate potential condensation leak at the door of the KITCOM.
9. Replace GWH in kitchen mechanical room.
10. Repair or replace broken water fountain in classroom 11.
11. Replace aged and outdated faucets.
12. [Install a janitorial mop sink near the kitchen \(request by AISD Construction Management\).](#)

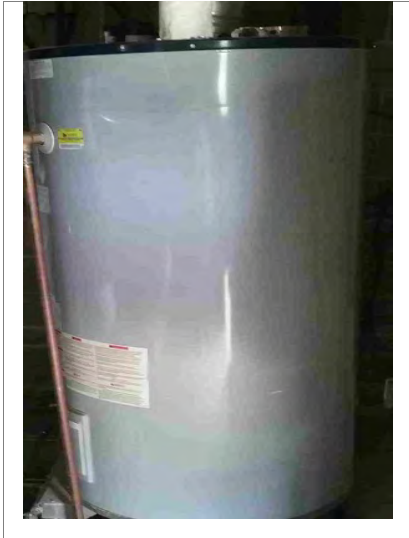
System	Subsystem	Condition and Deficiency Overview	System Condition Rating
		and that there was not a janitorial closet located in the basement.	
	Domestic Water Distribution	<p>The majority of the plumbing fixtures observed in this facility are not serviced by any domestic water distribution equipment, such as large vertical water heaters (greater than 30-gallon capacity).</p> <p>The plumbing fixtures that are serviced by domestic water distribution equipment are located in the commercial kitchen. The fixtures in this kitchen appear to be serviced by one GWH (gas water heater) located in the kitchen mechanical room. The water heater has the ability to produce 200 MBH and hold 99 gallons.</p> <p>The domestic distribution system was observed to be in average condition. The GWH near the kitchen had no reported deficiencies at the time of assessment; however, it was observed to have reached the end of its typical design service life, due to an estimated manufacturing and installation date of 1999. The facility staff also reported that the water pressure at the facility was low and that the domestic hot water piping that services the kitchen was aged and outdated.</p>	Average

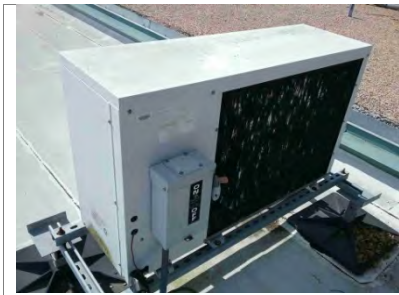
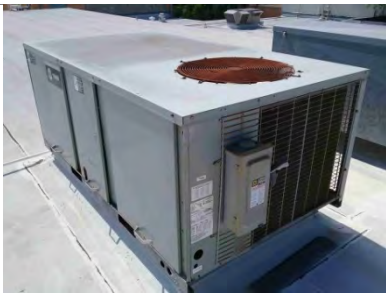
Mechanical/HVAC System Deficiency Examples

System	Subsystem	Condition and Deficiency Overview	System Condition Rating
		indoor classrooms was in average condition based on the equipment's expected typical design service life and the use of outdated R-22 refrigerant. Additionally, eight RTUs were observed to be past their expected design service life date, utilizing outdated R-22 refrigerant, or having damage to compressor fins. The facility staff reported that the HVAC system would be upgraded in 2017. The upgrades reportedly will include replacement of the existing ground well HVAC system with a closed-loop water source cooling tower system and replacement of AHUs (air handling units) and water source heat pumps. It was also reported by staff that the administration area did not maintain consistent temperatures throughout the offices. In addition, the staff stated that there was a condensation leak at the KITCOM door potentially from HVAC equipment that services that area. Lastly, it was reported that RTUs 1, 2, 3, and ADMIN were aged and outdated.

1. Plan for replacement of units that use R-22 refrigerant.
2. Continue conducting preventive maintenance checks and services for HVAC systems. Plan to repair or replace all HVAC equipment that is aged and beyond its expected design service life.
3. Replace exhaust fans in the restrooms in the kindergarten corridor (requested by AISD Construction Management).

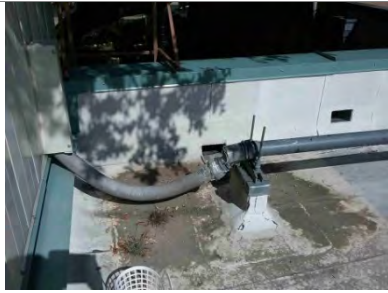
Communications & Security	<p>There is a Gemini security system currently installed with multiple keypads at various entrances. Motion detectors are installed in interior areas, and security cameras are installed throughout the interior of the building and strategically on exterior corners and walls. There are also doorframe-mount proximity card readers for access into certain entrances. A callbox and a doorbell are located at the front entrance. Multiple communication closets exist housing network switches, hubs, and routers in a rack-style configuration. The facility appears to have wireless routers installed in classroom ceilings, strategically throughout the building.</p> <p>The communications and security equipment was observed to be in good condition. There were no damaged security panels or cameras observed at the time of the assessment.</p> <p>A large conduit carrying networking cables was located on the roof at the access ladder and was observed to have a broken union. The facility staff requested a security assessment to determine where to place additional cameras.</p>	Good

1. Perform a security assessment to determine additional surveillance camera requirements and options.

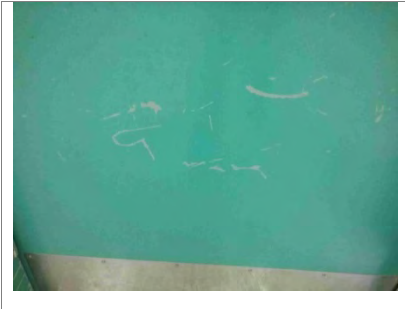
System	Subsystem	Condition and Deficiency Overview	System Condition Rating
Exterior	Exterior Walls	The building is a two-story open structure with the exterior walls consisting of a brick and metal siding façade. The exterior of the building appeared to be in good condition.	Good
	Exterior Windows	The exterior windows are double paned metal -framed and set high up near the ceiling in the metal siding panels. There are a few double-pane windows that are at ground level. The exterior windows appeared to be in good condition.	Good
	Exterior Doors	The building has double exterior metal doors with lites, and with the exception of one double door without lites. The exterior doors appeared to be in good condition. The exterior entry doors were scratched on the inside.	Good
Roofing	The building's roof is standing seam metal. The roof could not safely be assessed and was assessed from the main building roof. The roof appeared to be in good condition.		Good

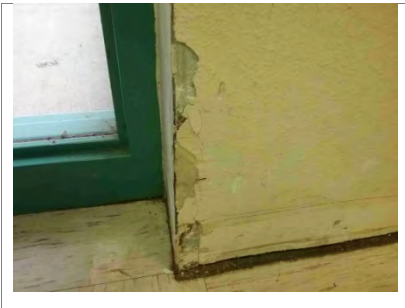
Interior Construction	Interior Walls	The interior walls are gypsum board in the lobby and restrooms, while the gymnasium walls are gypsum board and CMU. The walls appeared to be in good condition.	Good
	Interior Doors	The interior doors are wood veneer with a lite in metal frames. Some are solid wood doors without side lites. The interior doors appeared to be in good condition.	Good
	Interior Specialties	System not present.	N/A

1. Repair chipped gypsum board at wall corners.

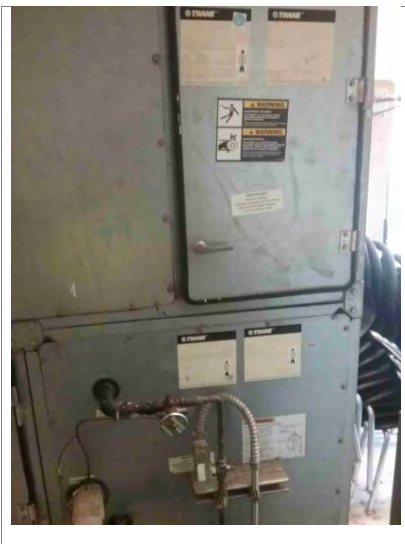
Mechanical/HVAC System Deficiency Examples

System	Subsystem	Condition and Deficiency Overview	System Condition Rating
		by staff to be past its expected design service life, and utilizing outdated R-22 refrigerant. Additionally, the staff reported that the large suspended unit heaters located in the gymnasium were also aged and outdated.	
Fire Protection	Fire Alarm	The building contains a fire alarm system that consists of alarm and signaling devices such as horns/annunciators, strobes, horn/strobe combinations, pull stations, and detectors. An electronic fire alarm control panel was not located in the building, and it is believed the system communicates back with a main control panel in BLDG-110A. The fire alarm system was observed to be in good condition.	Good
	Fire Protection/Suppression	The building is not equipped with a fire sprinkler/suppression system; however, it is protected by portable fire extinguishers stationed throughout the building. All portable fire extinguishers were observed to have been inspected within the last year.	N/A

1. Replace gymnasium unit heaters.

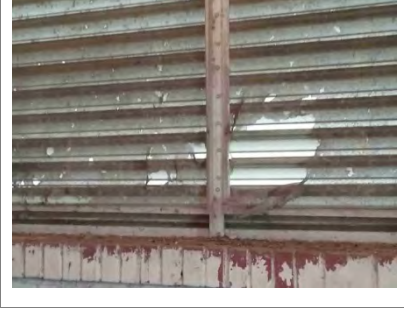
System	Subsystem	Condition and Deficiency Overview	System Condition Rating
Exterior	Exterior Walls	The exterior of the building consists of a brick façade with a metal siding on the gable end. The exterior of the building was observed to be in average condition. There was some stained brick on all sides of the building. The louver screen on the side of the wall was torn.	Average
	Exterior Windows	System not present.	N/A
	Exterior Doors	There is one set of double exterior metal doors with glass panels. The doors appeared to be in poor condition. They were very rusted and pitted.	Poor
Roofing	The building's roof is standing seam metal. The roof was not accessed due to its material and slope but was observed from the main building roof. The roof appeared to be in average condition.		Average
Interior Construction	Interior Walls	The interior walls are brick. These walls showed wear and tear and appeared to be in average condition.	Average

1. Replace the louver screen.
2. Replace the entry doors.

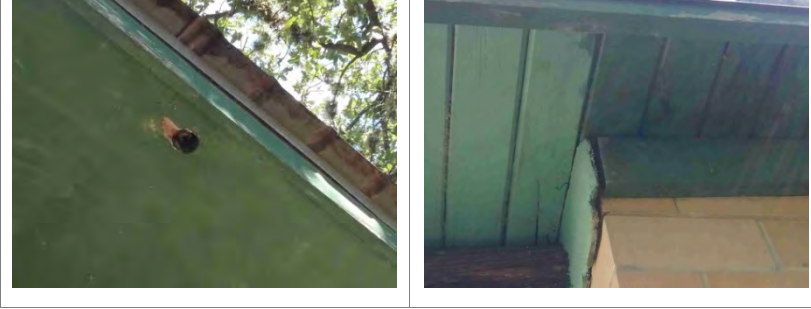
System	Subsystem	Condition and Deficiency Overview	System Condition Rating
Exterior	Exterior Walls	The exterior of the building consists of a brick façade with some CMU additions. The exterior of the building appeared to be in average condition. There was a wooden soffit beginning to rot in corner locations. In addition, there were holes drilled into the soffit on the east side.	Average
	Exterior Windows	The building has one exterior window which is a single-pane casement painted metal-framed inset into the brick façade. The window appeared to be in average condition.	Average
	Exterior Doors	There are two single exterior metal doors and one double door to the building. These doors appeared to be in average condition.	Average
Roofing	The building has a corrugated metal roof. The roof was not accessed due to material and roof slope. It was observed from the main building roof. The roof appeared to be in average condition, as it was observed to be rusting along the edges and some tree limbs were resting on the roof.		Average

1. Repair rotting wood in the soffit and fascia board.

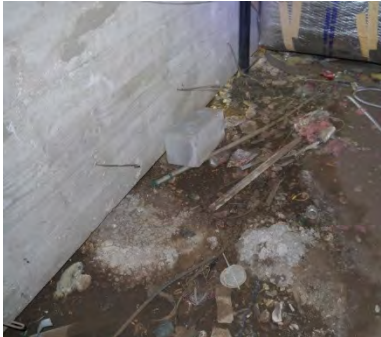
<p>Damp soil near perimeter wall 0</p>

- 1.0 Investigate need to re-grade site around building to remove air gap and to ensure positive drainage away from building perimeter.
- 2.0 Investigate need for additional ventilation.

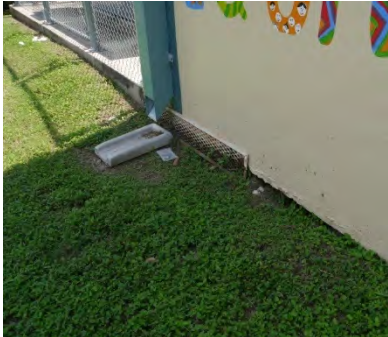
<p>Air gap below perimeter wall allowing water to infiltrate crawl space (cannot see crawl space) 0</p>

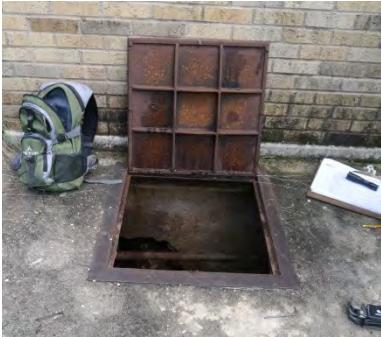
<p>Rust at access hatch frame 0</p>
--	---	---

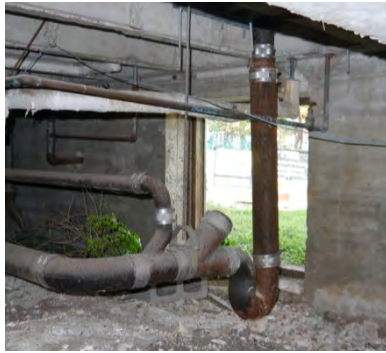
Degraded insulated & corrugated pipes

- 1.0 Repair leaking pipe.
- 2.0 Seal and protect rusted pipes from further corrosion; replace heavily corroded hangers.
- 3.0 Replace degraded/missing pipe insulation.

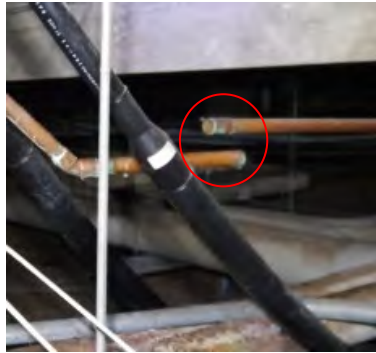
Broken leaking pipe (break circled in red)

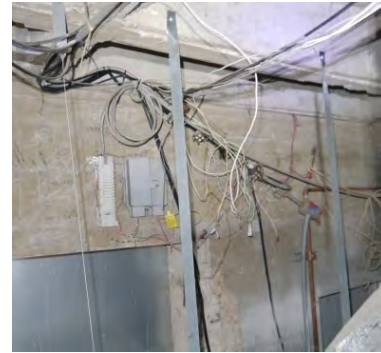
Exposed low voltage wires
