STRUCTURAL ASSESSMENT – Bryker Woods ES – Main Building (BLDG-110A)

Building Purpose	Administrative offices, Gym, Classrooms and Cafeteria
Inspection Date	September 23, 2016 (Morning)
Inspection Conditions	N/A - Indoors only

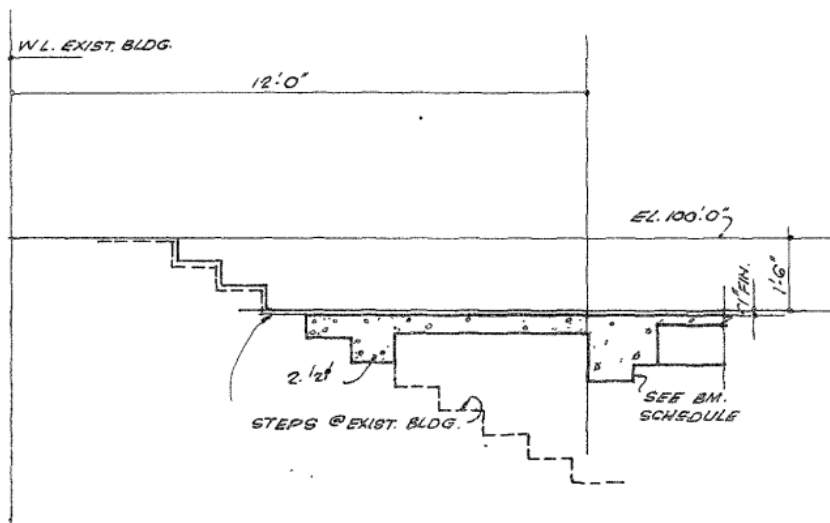
- **Review of Original Plans / Time of Ramp Renovation:** The stair in question was an exterior stair for the original 1939 construction. When the 1948 addition was constructed, the top three risers from the original stairs were retained to transition to the 1948 slab and the risers below were left in place and support a portion of the newer slab as shown in the detail below:

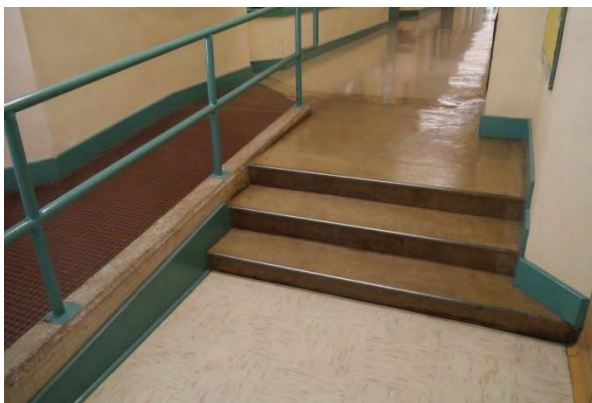
View of Stairs and Ramp from Above

The east half of the 1939 stairs and 1948 slab were demolished in 1998 to install the ramp. The ramp consists of two sloping steel wide-flange stringers supporting galvanized steel conform deck. The stringers are supported by a 1948 concrete beam at the bottom and a 1939 beam at the top of the ramp. The top portion of the existing stairs was demolished to make room for the ramp slab.

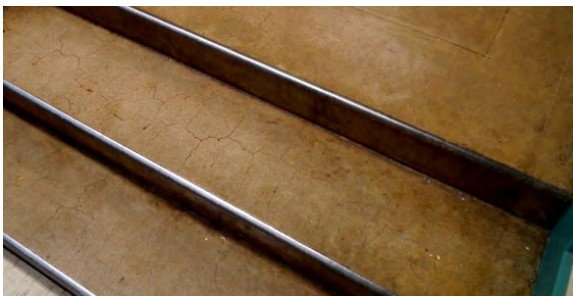
- **Cracks Above Stair:** Small cracks were observed at the top of the concrete stairs.

Shrinkage Cracking in Stairs

- a. Epoxy inject cracks to prohibit development of corrosion in the reinforcing steel
- b. Clean exposed slab reinforcing and repair spalled concrete

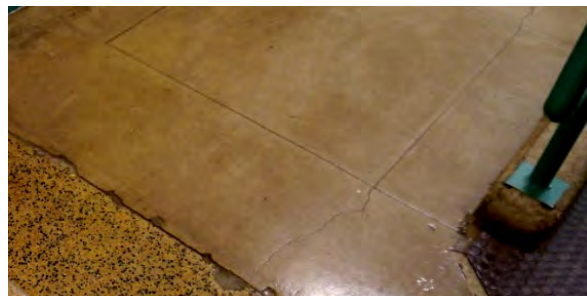
Potential Flexural Cracking in Stairs

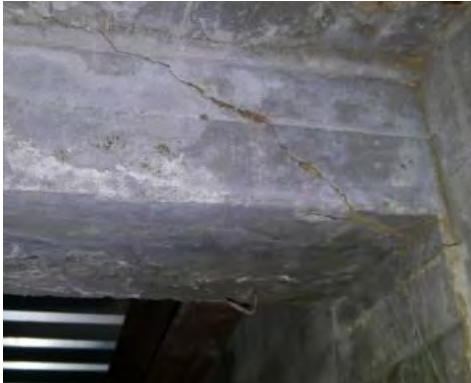
A diagonal crack is present in the side of the 1939 beam at the top of the ramp (opposite side of beam from ramp stringer connection). A longitudinal crack is present in the 1939 slab running near and parallel to the cracked beam.

Diagonal Crack in Beam at Top of Stair

The cracks observed in the stair concrete framing may be due to several different factors: 1) differential settlement between the original building construction and the addition, 2) an alteration of load path when the stair were demolished and the ramp was installed, or 3) new tension forces from the ramp. Cracking in the columns and slab indicate vertical differential movement or lateral tension, while the diagonal cracking in the beam is indicative of torsion (induced by the ramp's connection to the face of the beam where originally there was no concentrated load). The perpendicular cracks at the top of the stairs are likely due to a newly introduced cantilever condition due to demolition of the east side of the stairs.

- a. Return to the site annually for 2 to 3 years (3 additional visits) to observe the area and determine if any additional cracking has occurred. (\$2,000 for each observation visit & report)
- b. If additional cracking develops in the future, then further analysis will be required to determine if structure is overstressed. If the structure is overstressed, then the concrete may need to be retrofitted to increase its structural capacity. (Note that the need for these measures is not anticipated.)

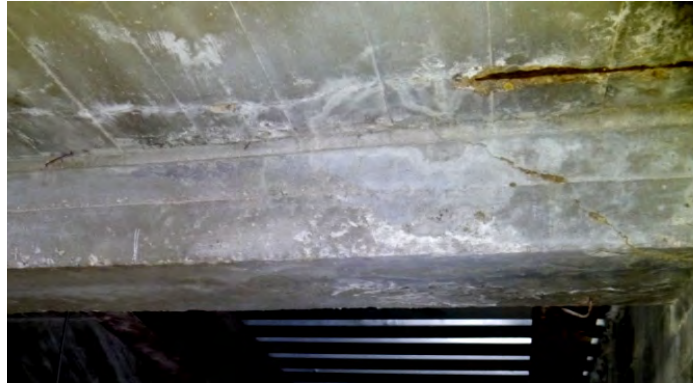
(Note that we could not determine whether this crack penetrated the full depth of the slab because the top of the slab was covered with flooring material.) The slab crack continues for the full length of the slab/beam and propagates down through both supporting walls. The crack in the east wall is visible on both sides of the wall. The opposite face of the west wall could not be observed due to pipe congestion in the crawl space.

E-W Crack in Bottom of Slab Parallel to Beam

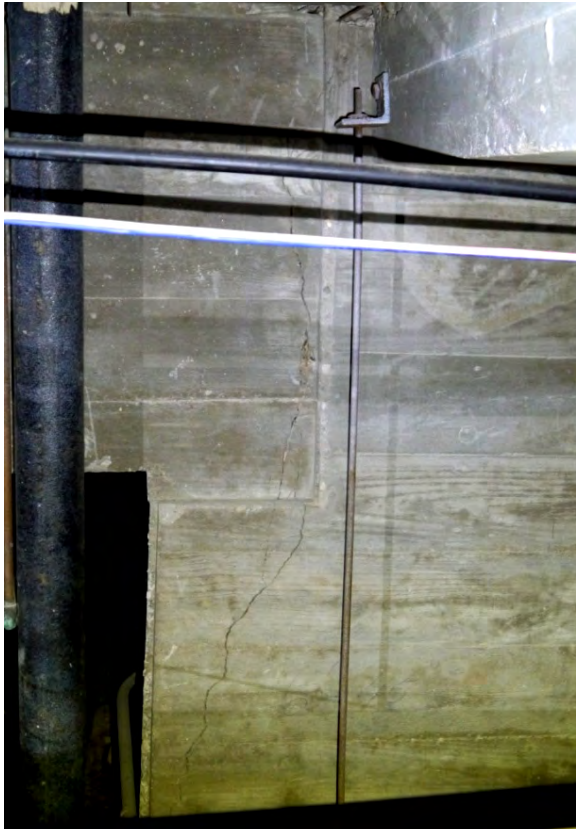
Vertical Cracking in West Wall

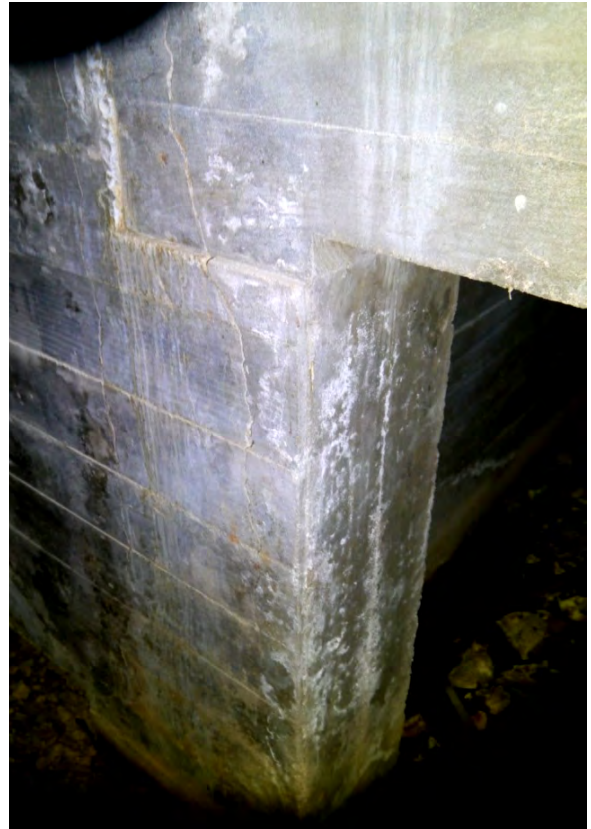
Vertical Cracking in East Wall

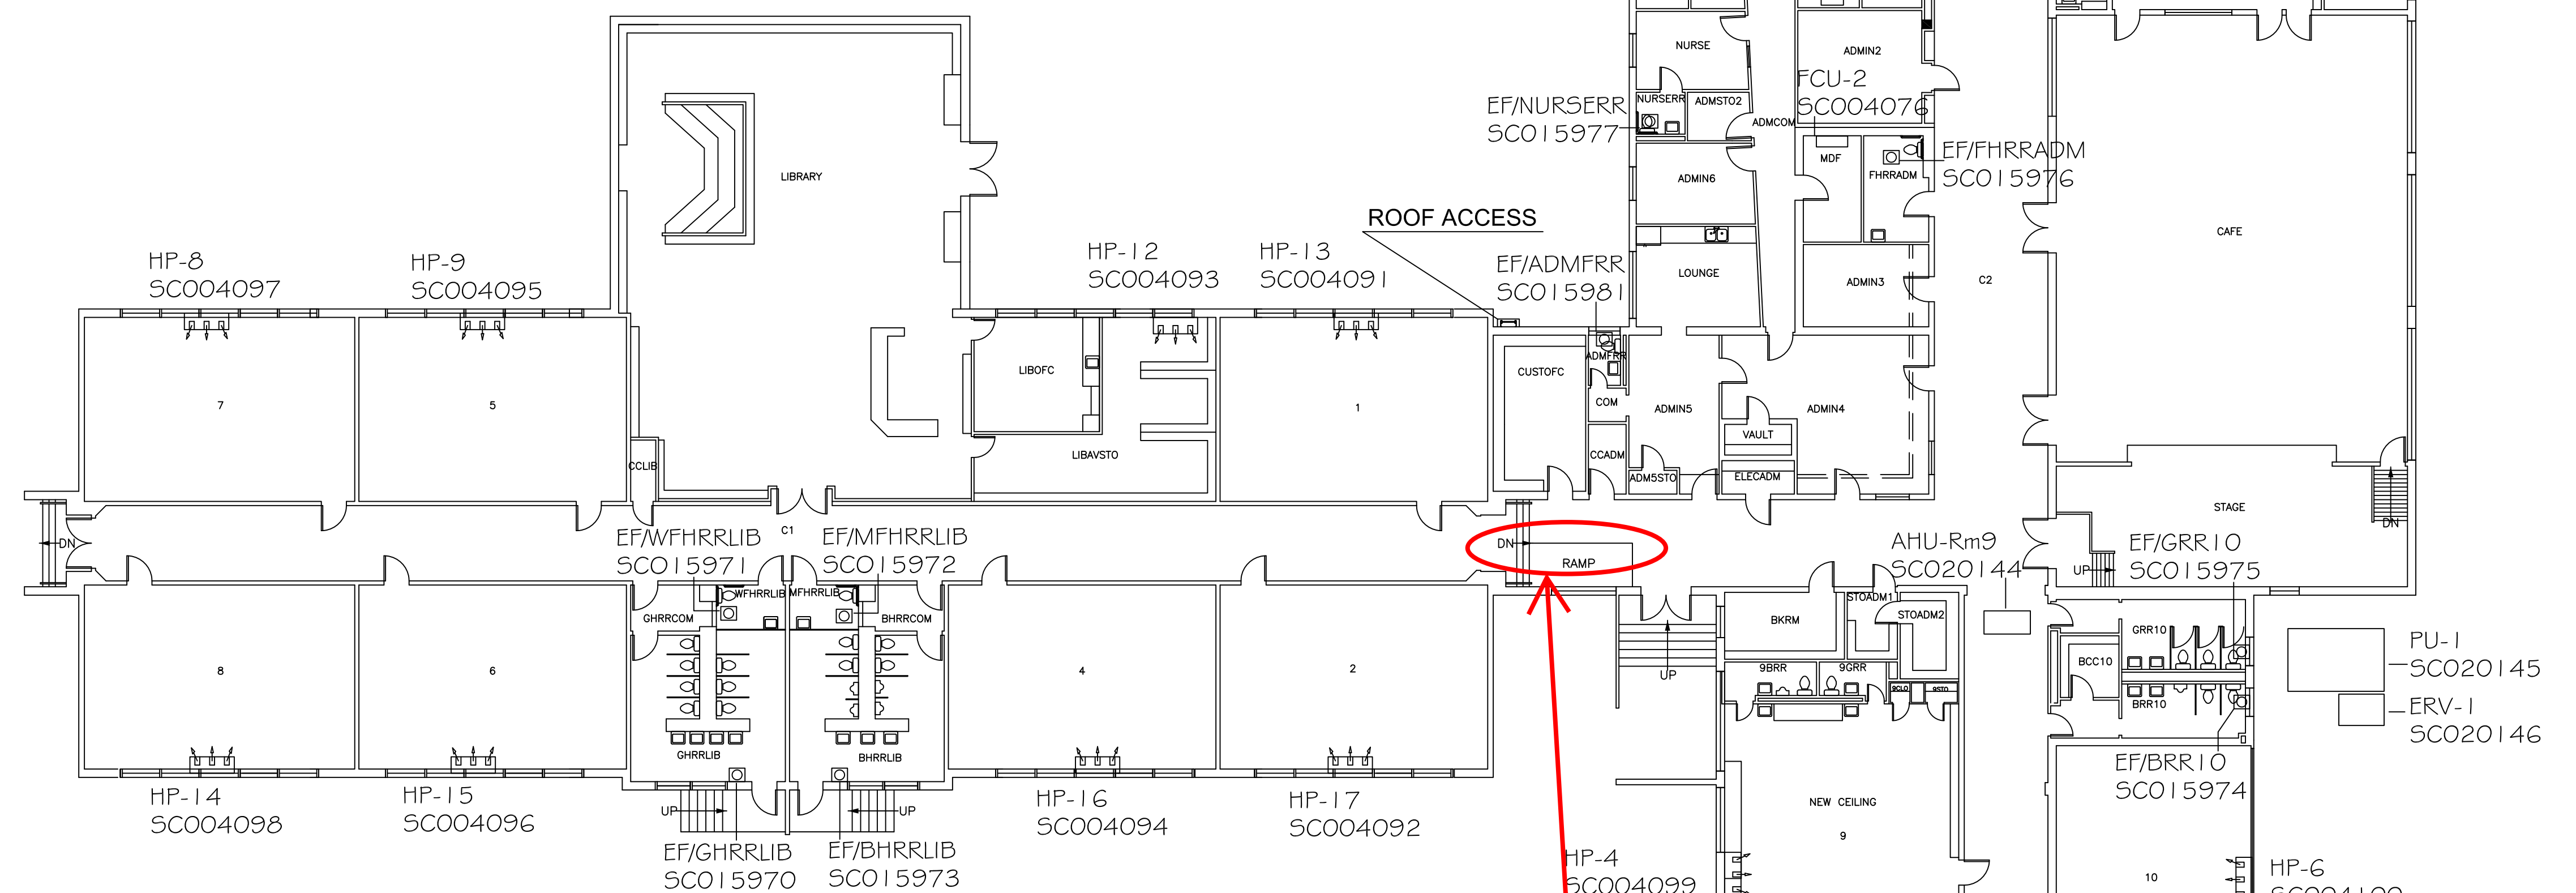
FLR-110A-01

DISTRESSED CONCRETE FRAMING IN CRAWL SPACE BELOW
