Perez Elementary School Site Summary

Main School Building – BLDG-190A

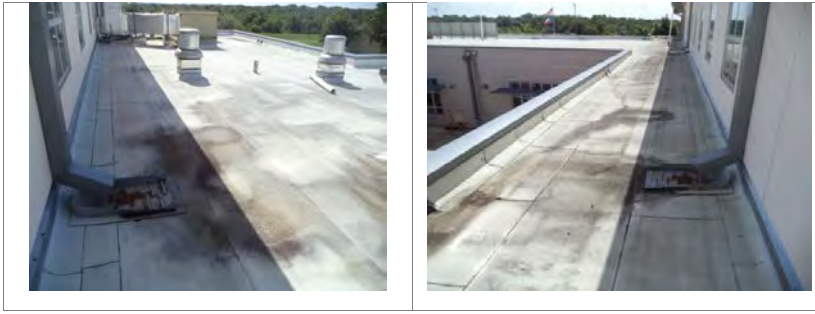
Roofing Deficiency Examples

Roofing	The roofing material consists of modified bitumen roofing and small sections of single membrane applications where HVAC (heating, ventilating, and air conditioning) equipment is stationed. Walkway canopies were completed with		Average

System	Subsystem	Condition and Deficiency Overview	System Condition Rating
		<p>single membrane Thermal Plastic Polyolefin (TPO) material and observed to be in good condition. Standing seam metal segments of roofing are on elevated sloped sections of the structure and observed to be in good condition. Some areas were observed on the modified bitumen sections where water ponding had taken place on this system. It was reported that vandalism had occurred to every aspect of the roof equipment except the roofing surface material itself. Rocks and tennis balls have been removed from gutters and downspouts and also some extended portions of vent pipes have been removed and left lying on the roof surface. It was reported the roof drainage consists of gutters and downspouts. It was reported that the configuration of the gutters themselves caused drainage problems. They have been susceptible to mischievous vandalism. The gutter system had no cleanouts, and at times, became full of leaves or debris and plugged up, causing nuisance work orders to be placed.</p> <p>The standing seam roof system as well as single membrane covered walkways was observed to be in good condition, although modified bitumen sections consists of 60% of entire system and must be rated overall as average. Also due to the original modified bitumen portion of roof materials approaching the industry-suggested life expectancy of 15 years.</p>

1. Have modified bitumen roof sections evaluated for remaining life in this system by a professional roofer as well as all flashing-applied areas for current integrity. Plan for repair or replacement.
2. Recommend security cages be installed to wall surfaces where down spouts can potentially be climbed and roof access can be gained by children. Must be addressed
3. Evaluate the need to build up some flat areas of the roof system to enhance drainage capabilities.

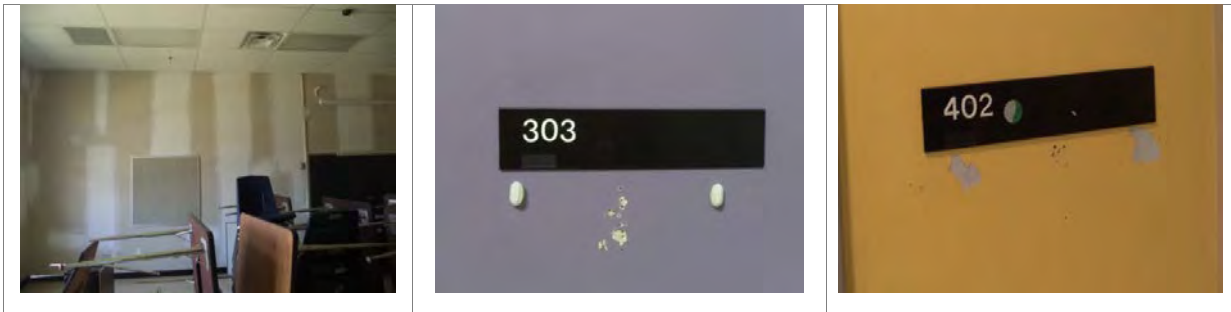
Interior Wall Finishes

Interior Construction	Interior Walls	<p>The interior walls for much of this facility consist of drywall panel and small portions of painted block completions. The administration offices, library, nurse's offices, and classrooms have these types of finished surfaces. Classrooms consist mostly of drywall with painted finishes. The gymnasium has painted block walls with wall-mounted acoustical panels located on upper portions of the walls. Restrooms consist of ceramic tile on the walls, with the upper three feet of wall being painted drywall, and one side of the restroom wall surface consisted of painted drywall finishes. This was observed as typical for all restrooms in this facility.</p> <p>The interior walls were observed to be in average condition as approximately 20% of wall surfaces showed signs of minor scathing and was observed on some wall surfaces in various classrooms within this facility. It was also observed that significant wall repairs and painting was ongoing and could possibly be expected to alleviate many of the scathing instances present at the time of this assessment.</p>	Average

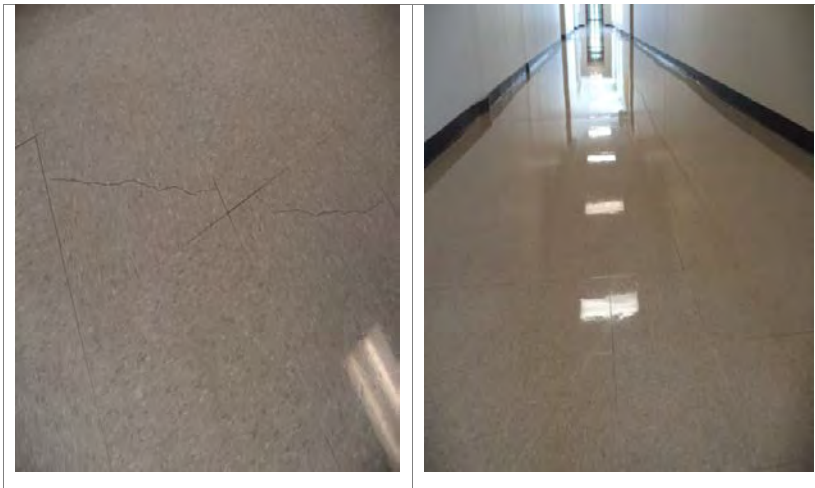
Interior Floor Finishes	It was reported that with a few exceptions, the vinyl tile was in good condition and predominant in the corridors and classroom environments. The carpet located in the administration offices, library, and computer labs showed signs of minor wear and tear. Ceramic tile floor is present in the kitchen and adult and students restrooms. It was reported that the 5% of vinyl tile surface just outside the gymnasium doors in corridor 6 was showing stress cracking beneath the tile. It was visually evident that this slab movement has not yet affected all the tile surfaces in its path but was observed extending from the gymnasium doors through corridor 6 and into the main corridor. A photograph of this deficiency could not be captured due to the reflective, glossy finish on the floor tiles due to a recent wax application. The floor system of this entire facility was observed, and the flooring finishing is rated as average overall.	Average

1. Evaluate flooring condition mentioned in hallway outside of gym further by an engineer to see if this condition observed in above flooring narrative will become worse in time. Photos could not depict this condition completely due to glossy finishes to flooring but was observed to be extensive. Custodial staff can point out the extent of this condition as he did for our team.
2. Repair or replace damaged, stained, or worn acoustic ceiling tiles as necessary.

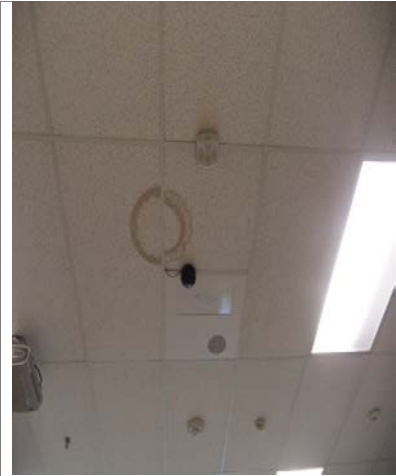
Interior Ceiling Finishes	It was reported that the interior ceiling consists of standard 2x4 acoustical fiberglass suspended ceiling panels throughout the corridors and classrooms. All restroom facilities contain hard drywall ceilings. The library, cafeteria, and gymnasium ceilings consist of	Average

System	Subsystem	Condition and Deficiency Overview	System Condition Rating
		<p>exposed painted metal trusses with a metal deck and a floating suspended acoustical ceiling in the library.</p> <p>5% of acoustical panel staining was observed facility wide and some replacement was evident. 95% of existing acoustical panels are original to this facility and will be rated in average condition due to signs of age.</p>	
Conveying	System not present.		N/A
Plumbing	Plumbing Fixtures	<p>The building has public restrooms for men, women, and students, and separate staff restrooms are located throughout the facility. The adult facilities have standard plumbing fixtures. The student's restrooms in the main corridor have standard fixtures; no sinks are present in restrooms located in conjoining classroom locations. Each classroom does have a hand wash/general purpose sink with a drinking fountain bubbler. Floor-mounted toilets with manual flushing mechanisms are present. This system includes wall-hung urinals in the male corridor restrooms with manual flushing mechanisms. There are service sinks in the janitorial and housekeeping closets, and water fountains located within the facility all observed in average condition.</p> <p>It was reported that the long-neck type faucets at the sinks in the general classroom areas were easily loosened by children tugging and pulling on them. These systems were observed as secure at the time of this assessment. Overall plumbing fixtures were observed to be in average condition.</p>	Average

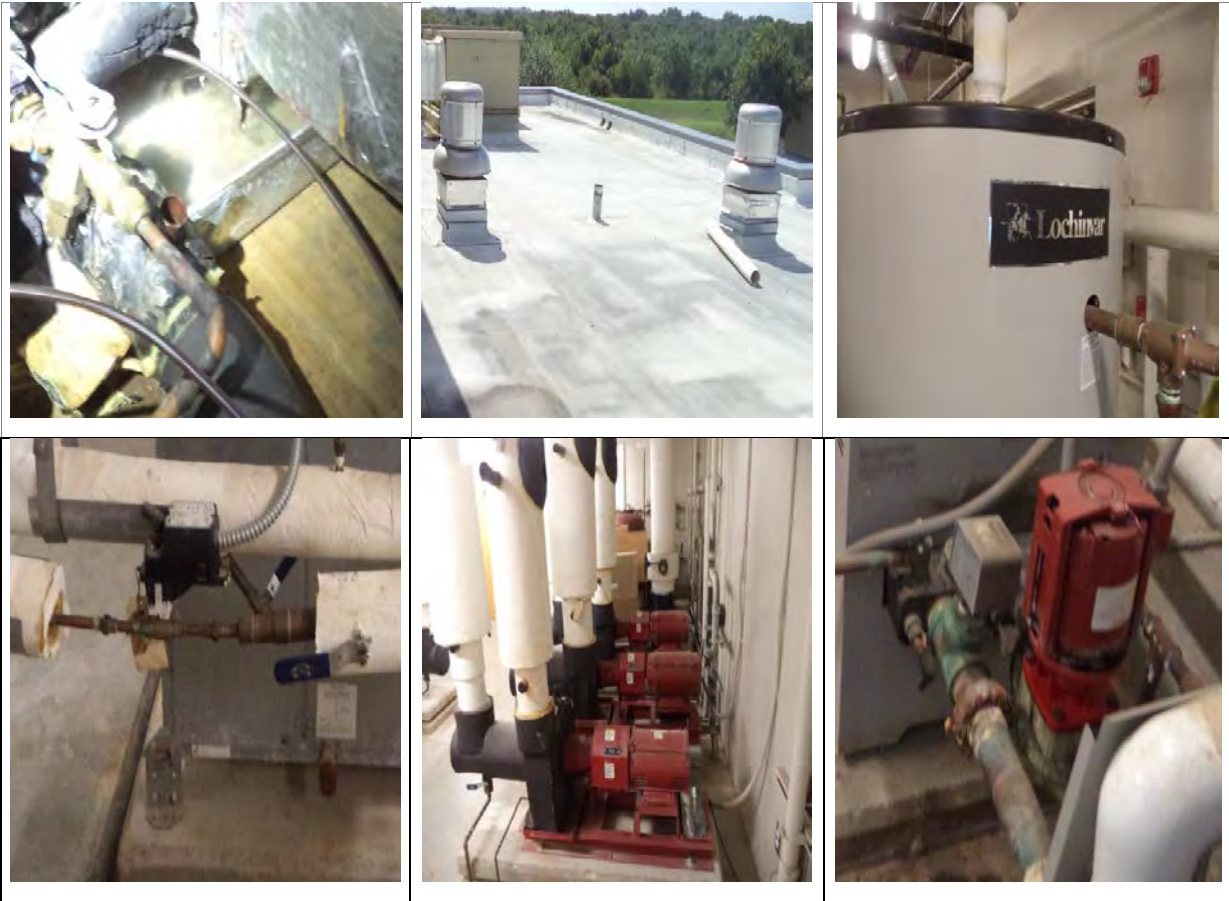
Mechanical/HVAC System Deficiency Examples

Mechanical/ HVAC	<p>This system consists of three boilers that are Lochinvar brand. Facility staff reported constant problems with this brand with the primary issue being pump failure. There are two chillers located behind the dock area that supply cold water through the system that have had no major problems reported. The major mechanical air conditioning equipment consists of four large natural gas-supplied RTUs (roof top units). There are five HRUs (heat recovery units). Supplemental mechanical equipment for the HVAC (heating, ventilating, and air conditioning) system includes exhaust fans, and five fresh air intake powered units that were reported as not functioning at all.</p> <p>It was reported that the HVAC system was working as intended with the exception of non-functioning fresh air intake units depicted in photo deficiencies. It was reported that rocks and debris were recently removed around mechanical equipment and off of roof system from children throwing rocks upon the roof and others that have accessed the roof. No physical damage was caused to this equipment by these influences. It was reported the chill water supply had too many unions in the system, which promoted leakage at fittings and periodic work orders, and it was also suggested it should be a closed-loop application.</p>		Average

1. Repair or replace all fresh air intake equipment that was reported as non-functional on the roof.
2. Repair or install a secondary drainage line for A/C condensation pans.

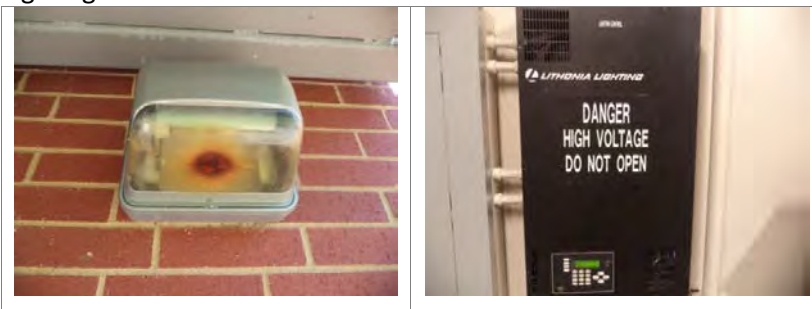
Lighting	<p>The building's exterior lighting consists of dropdown metal halide luminaires located along the parking lots. It was reported that the electrical department would prefer to replace the exterior wall washer fixtures with standard wall pack LED (light-emitting diode) units. Lenses seemed to burn from the heat generated by bulbs. Some recessed and some mounted can lighting exists in main corridors and some exit door areas.</p> <p>It was reported that the corridor fluorescent lighting was Lithonia synergy products with (smart) ballasts that are now obsolete. It was reported that all can lighting within this facility needed to be replaced due to difficulties with lamp replacement. It was reported that parking lot lighting was inadequate. The interior lighting consisted primarily of 2x4 T8 fluorescent luminaires set in troffers. Library and specific open locations have suspended low-bay fluorescent fixtures with standard T-8 florescent luminaires.</p>	Average

System	Subsystem	Condition and Deficiency Overview	System Condition Rating
		The lighting for the building was observed to be in average condition overall.	
	Communications & Security	<p>It was reported that the Wi-Fi works well at this facility, and the school has recently obtained new phones. This facility has a security system including alarms, surveillance cameras, and card readers.</p> <p>It was reported that there are not enough cameras supporting this system and the resolution has been found to be inadequate. It was reported that the public address system was working well.</p> <p>Because of vandalism to the roof, staff has requested to install mitigating controls to discourage climbing up drain pipes from the ground to the roof. It was reported that vagrants have been living under the portable structures, and at times, completely surprise staff when they pop out from hiding on the dock areas. This system was observed to be in average condition.</p>	Average

1. Have the system evaluated by an electrical engineer. The electrical system has reached its capacity and has no room for expansion for the future.
2. Convert the exterior lighting to a more maintenance-friendly fixture. Dialog must include administration and building staff. Replace all can lighting in the facility due to difficulty changing the bulbs, and when run for extensive periods of time, the socket for the bulb breaking apart. Have the Lithonia synergy lighting system replaced; maintenance of this system has become very difficult for facility staff.
