STRUCTURAL ASSESSMENT – Perez ES – Main School Building (BLDG-190A)

Building Purpose	Cafeteria, Gym, Admin, Classrooms, Library
Inspection Date	October 25, 2016 (Morning)
Inspection Conditions	75° - Cloudy and Dry

Perez ES – Summary of Structural Repair Recommendations

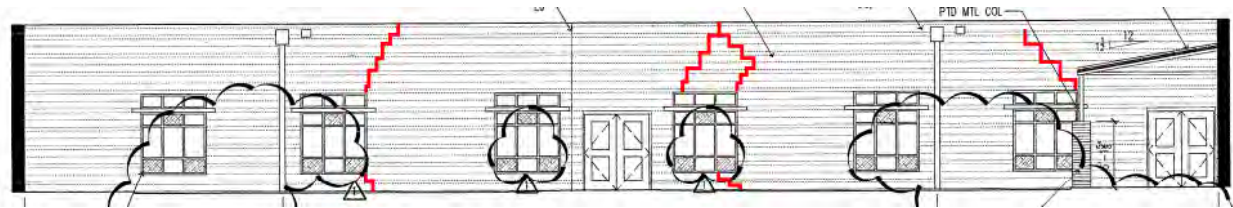
- **West Courtyard Exterior Masonry Veneer:** Multiple cracks were observed on the west wall of the courtyard. The cracks are located above and below three different windows. The expansion joint is located just south of the door near the center of the courtyard west wall. Separation was observed at the top of the expansion joint from both the interior and exterior of the wall. The cracks typically ran along the mortar joints of the masonry wall. The figure below shows the approximate locations and shapes of the cracks in red.

The wall cracks on the east and west sides of the courtyard occur where the building has the least amount of width and is therefore more flexible than the wider building widths to the north and south of the courtyard. These more flexible building area are where we would expect cracks to develop due to soil movement. It is unclear whether the wall and floor cracks are due to initial building pad settlement or expansive/contractive movement of the clay soils below the building. Typically soil settlement occurs in the years immediately following construction, so if it is the cause of the damage, more settlement is unlikely to occur and the cracks will not worsen and propagate over time. However, if they are due to soil expansion and contraction then the cracks will open and close as the moisture content in the soil changes and over time the damage will worsen.

In order to determine whether the damage is due to settlement or expansive/contractive soil movement, the cracks should be monitored for one to two years before they are repaired. If the cracks show no change over the monitored time period then it is likely that one-time settlement is the cause of the cracks. If the cracks lengthen, widen or propagate over the monitored time period then the likely cause of the damage is expansion and contraction of the in-situ clay soils. Repair recommendations will vary slightly depending on the source of the damage.

- 1) Monitor crack patterns, lengths and widths for one to two years to understand whether cracks are worsening over time.
- 2) If cracks show no sign of change over the monitoring period, then the wall cracks may be repaired by replacing any badly cracked or damaged masonry blocks and repointing the mortar joints. If desired, the cracked floor tiles can be replaced.
- 3) If cracks lengthen, widen or propagate over the monitored period, then these additional measures are recommended:
 - i. Re-grade the site so that water drains away from the building and implement drainage measures so that surface water is collected quickly before soaking into the soils.
 - ii. Add additional control joints at corners of windows and doors and seal with a flexible sealant so the masonry veneer can accommodate soil movements without causing damage.

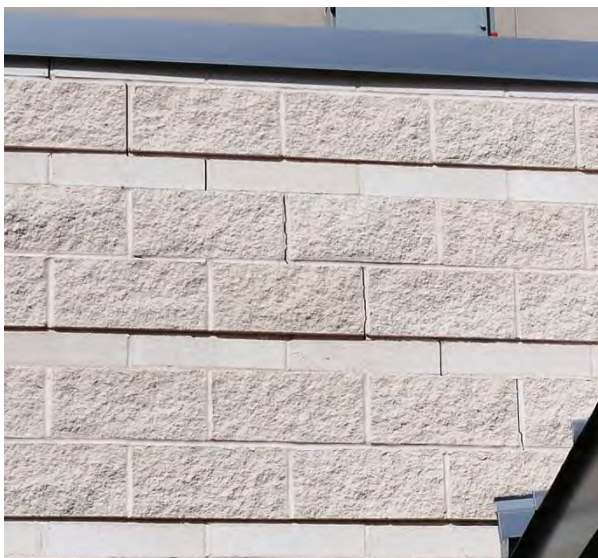
Diagonal crack near north end of wall

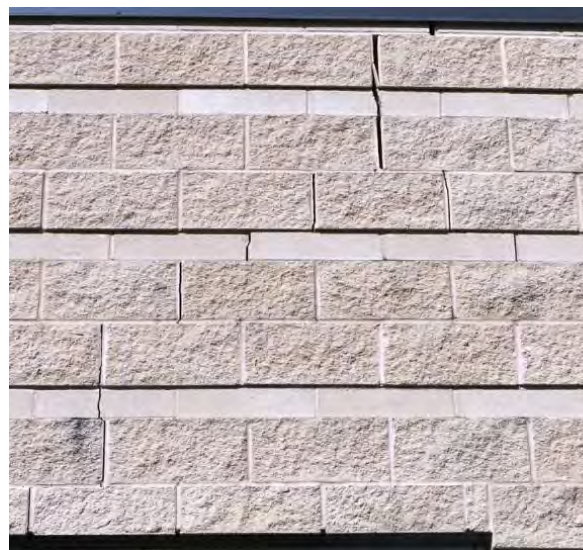
Diagonal crack over window on north side of door

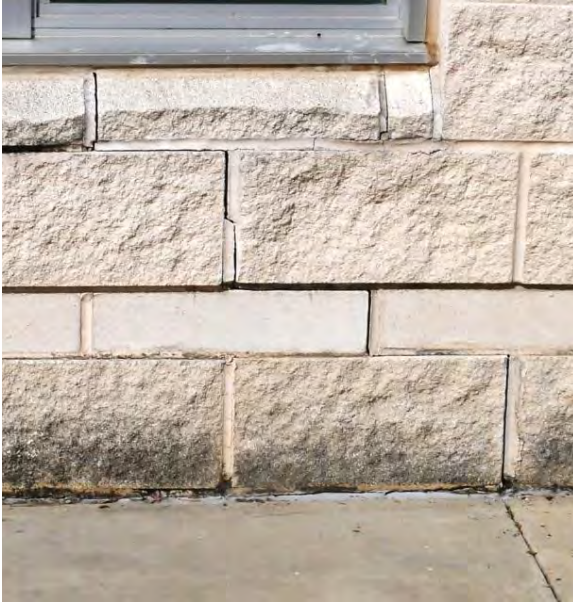
Crack under window

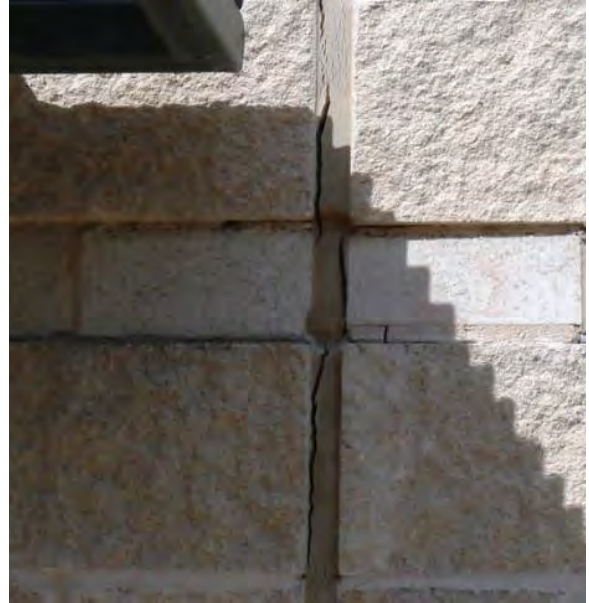
Separation at expansion joint

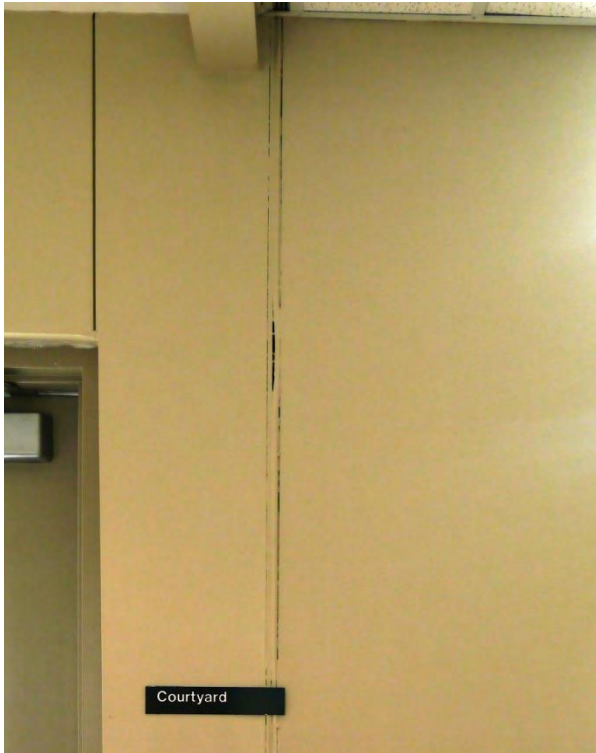
Separation at expansion joint

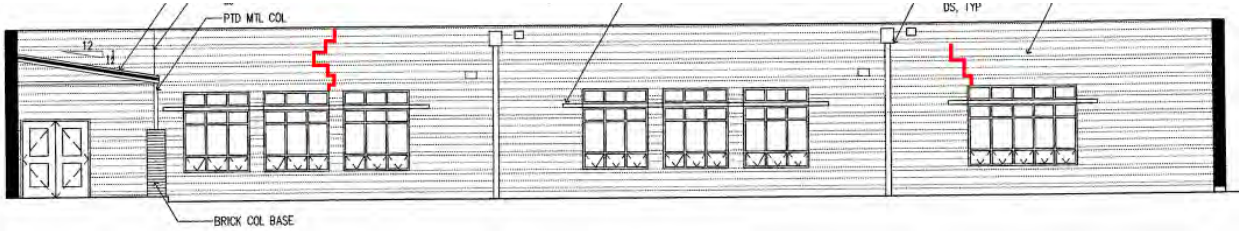
- **East Courtyard Masonry Wall:** Two smaller cracks were observed on the east wall above two different windows. The figure below shows approximate locations and shapes of the cracks in red.

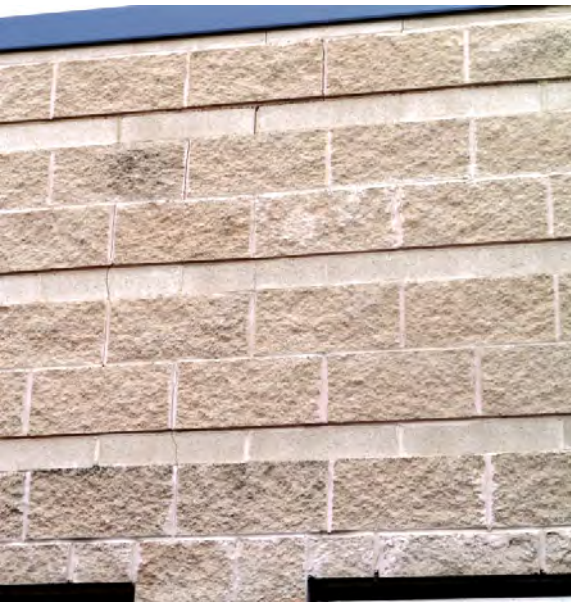
Crack over window

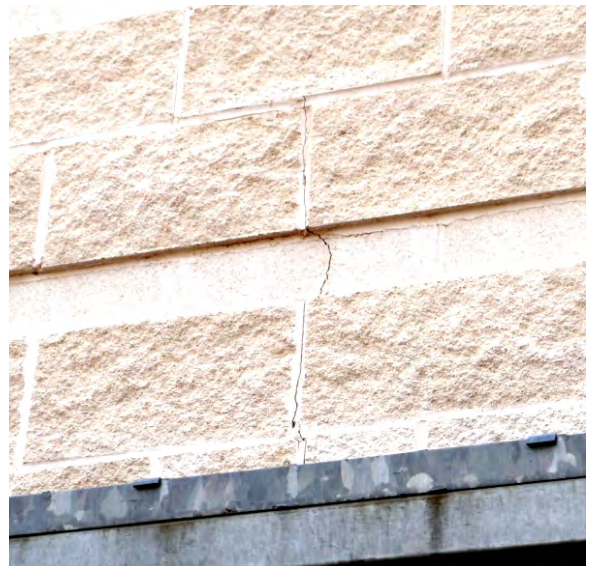
Crack over window

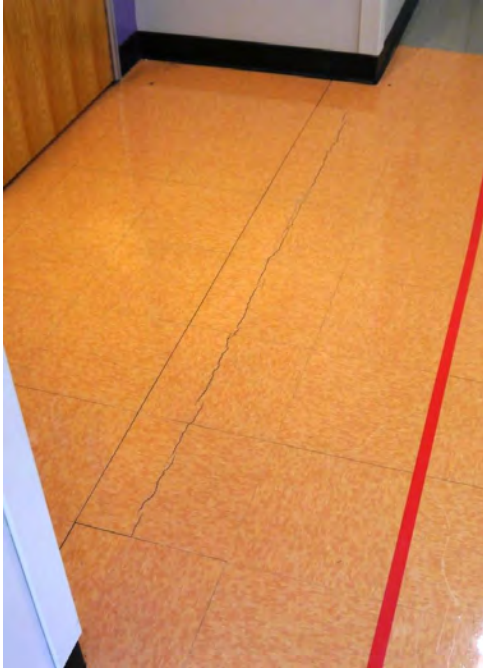
- **Interior Floor:** Cracked floor tiles were observed in front of the west library entrance door and a couple of feet away from the door at intersection of the interior hallways. Both cracks run in the north-south direction.

Cracked floor tiles near west library door
