Pleasant Hill Annex Special Campus Site Summary

Address	305 North Bluff Drive Austin, TX 78745
Number of Permanent Campus Facilities	3
Original Year of Construction	1936
Total Campus Building Area (combined)	25,758 SF

Introduction

Main School Building – BLDG-942A

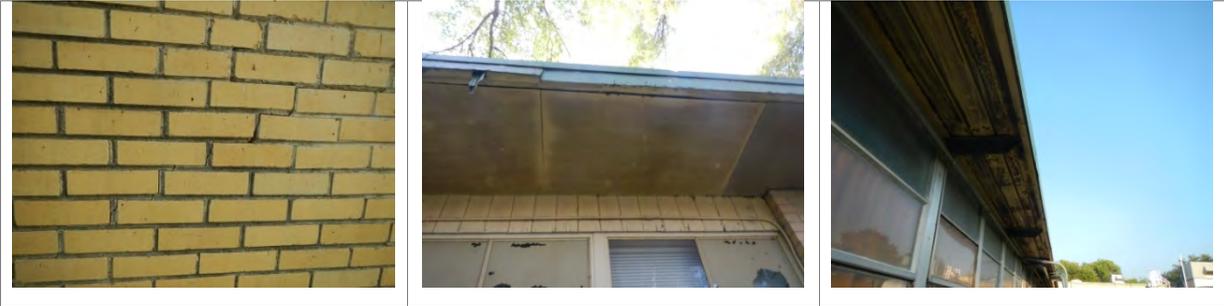
System	Subsystem	Condition and Deficiency Overview	System Condition Rating
Exterior	Exterior Walls	<p>The exterior of the building consists of a brick façade around the entire perimeter with a shotcrete panel on the south side of the gymnasium. The north wall of the cafeteria has some fiberglass paneling and the east wall of the kitchen is corrugated metal siding.</p> <p>The exterior walls were in poor condition. Micro cracks were observed in the brick façade around the entire building. A colony of bees was located on the west side of the building adjacent to the lounge. All eaves around the building were experiencing water damage.</p>	Poor
	Exterior Windows	<p>The exterior windows consist of single-pane windows in metal frames with casement windows in the lower windows throughout the building.</p> <p>The exterior windows were in poor condition. It was reported and observed that the windows around the building were experiencing corrosion and deteriorating caulking. Room 102 had a cracked window.</p>	Poor

1. Locate and seal all of the micro cracks around the building.
2. Remove the bee colony, and seal the building to prevent further bee infestation.
3. Replace the broken window outside room 102.
4. Repair the exterior metal doors adjacent to the gymnasium.
5. Replace doors that are suffering from corrosion or water damage.

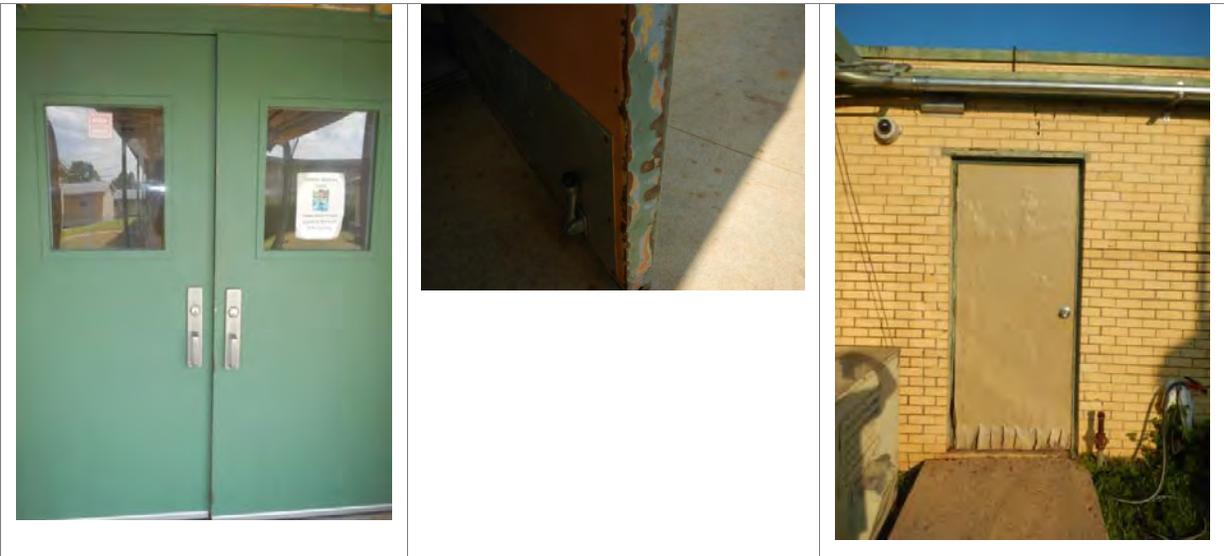
System	Subsystem	Condition and Deficiency Overview	System Condition Rating
	Exterior Doors	<p>There are three public entryways located around the building. These doors are metal doors with glass with glazing in metal frames and glass transoms. The access doors to the mechanical spaces are solid metal doors in metal frames. The classrooms of the 200-wing have exterior metal doors with glazing in metal frames.</p> <p>The exterior doors were observed to be in poor condition due to age. The south entry doors adjacent to the gymnasium did not lock properly. The exterior doors around the building had corrosion due to water damage.</p>	Poor
Roofing		<p>The roof material covering the building consists of a built-up roof with a medium granular surface and modified bitumen patchwork.</p> <p>The roof was reported and observed to be in poor condition. It was reported that the building had a new roof scheduled for construction in the current bond program. There was widespread deterioration observed in the awnings and covered walkways. All gutters were observed to be corroded. Water was leaking through the roof throughout the building. The office space had a major leak whenever there was a rain event. HVAC (heating, ventilating, and air conditioning) condensation was observed ponded on the roof above the corridor C1.</p>	Poor

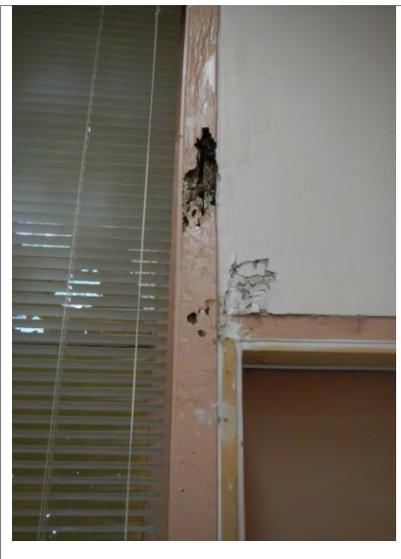
Interior Construction	Interior Walls	<p>The interior partitions are predominantly constructed of brick with the office space walls consisting of gypsum board and wood paneling.</p> <p>The interior partitions were in average condition. There was extensive damage to the window frames in the lounge room due to termites.</p>	Average
	Interior Doors	<p>The building's interior doors consist of wood doors and frames.</p> <p>The interior doors and frames were reported and observed to be in average condition. It was observed that the interior doors are experiencing minor damage due to extended use.</p>	Average
	Interior Specialties	System not present.	N/A
Stairs	Exterior Stairs	<p>The exterior stairs located around the building consist of formed concrete steps.</p> <p>The exterior stairs were reported and observed to be in good condition.</p>	Good
	Interior Stairs	<p>The interior stairs consist of wood stairs and are used to access the school stage in the cafeteria.</p> <p>The interior stairs were reported and observed to be in average condition. It was observed that the stairs have scuffing and scrapes due to age and usage.</p>	Average

1. Remove the termites and apply termite prevention product in the lounge, and replace damaged wood elements with pest-resistant materials.
2. Repair the damage to the wall caused by water leaks from the water cooler leak.
3. Seal the crack running through the 200-wing.
4. Repair and re-finish the wooden stairs of the stage with a protective coating.

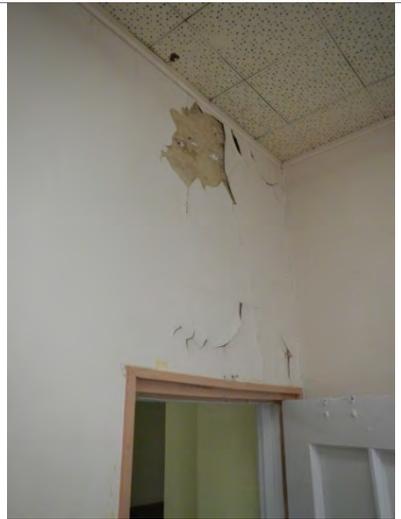
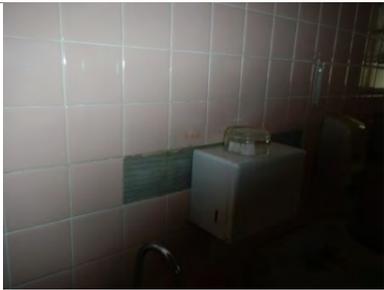
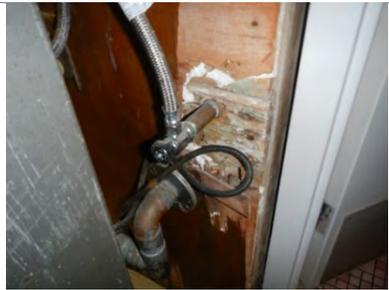
System	Subsystem	Condition and Deficiency Overview	System Condition Rating
Interior Finishes	Interior Wall Finishes	<p>The interior partitions are predominantly constructed of painted brick with the office space walls consisting of painted gypsum board and wood paneling.</p> <p>The interior wall finishes were reported and observed to be in poor condition. It was reported and observed that paint was peeling in all classrooms and storage rooms in the 100- and 200-wings. Wall tile was missing in the female restroom in the 100-wing. There was damage to the wall behind the water cooler in the 100-wing.</p>	Poor
	Interior Floor Finishes	<p>Vinyl tile flooring is found throughout the classrooms, janitorial closets, east and north west corridors, and cafeteria. Ceramic tile flooring is present in the restrooms and old kitchen area. There is a wood stage located at the front of the cafeteria.</p> <p>It was observed that the flooring in all areas was in average condition. A crack was reported and observed running through the 200-wing classrooms.</p>	Average

3. Locate sources of water damage to acoustical ceiling tiles. Repair leaks and replace acoustical ceiling tile as needed.
4. Repair roof material, and replace all water-damaged ceiling tiles throughout the building.
5. Replace the missing tiles in the female restroom in the 100-wing.
6. Remove old and peeling paint in all locations, and apply a new protective layer of primer and paint.

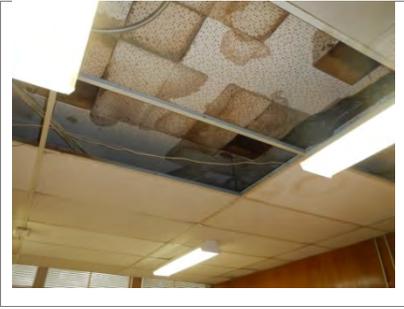
Interior Ceiling Finishes	<p>The ceiling consists predominantly of acoustic ceiling tiles throughout the classrooms, office spaces, restroom, and kitchen. The storage spaces have painted gypsum board.</p> <p>The ceiling finishes were observed to be in poor condition. All rooms and corridors exhibited water damage from roof leaks.</p>	Poor
Conveying	System not present.		N/A
Plumbing	Plumbing Fixtures	<p>Public restrooms for males and females are located throughout the building. The male and female restrooms have vitreous china wall-hung hand sinks with manual faucets, along with vitreous china floor-mount toilets with manual flushing mechanisms, and vitreous china wall-hung urinals in the male restrooms with manual flushing mechanisms. There are pedestal-mounted drain service sinks in the janitorial closets. Water coolers are located throughout the building, typically near the public restrooms.</p> <p>The plumbing fixtures were in poor condition. It was reported that the building's sinks were not functioning properly. The fixtures throughout the building have deteriorated with the exception of the toilets in the male restroom in the 100-wing as these were new. A toilet was disconnected in the 200-wing. The cafeteria appliances and plumbing had been disconnected by staff to create storage space. The water cooler in the 100-wing was observed to have a poor connection.</p>	Poor

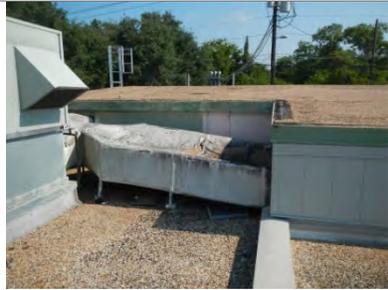
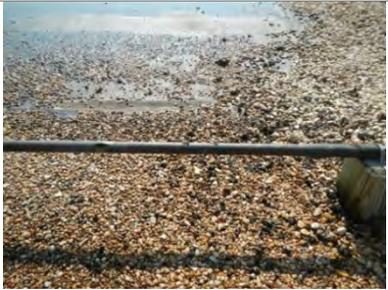
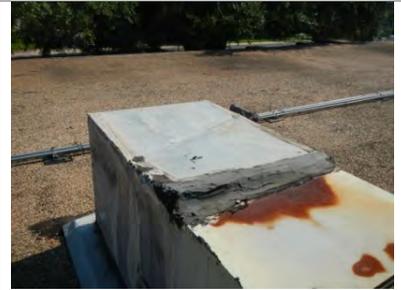
Mechanical/HVAC Deficiency Examples

System	Subsystem	Condition and Deficiency Overview	System Condition Rating
	Domestic Water Distribution	<p>There are two water heaters in this building located in the library and the 200-wing.</p> <p>The distribution for this system was rated as poor. It was reported that the water heater in the library was not connected to the building. The water coolers did not function in all of the rooms, and corrosion in the water lines made the water unappealing to drink.</p>	Poor
	Other Plumbing	System not present.	N/A
Mechanical/ HVAC		<p>The major mechanical equipment consists of four RTUs (roof top units). There are two boilers located in the mechanical room and mechanical storage room on the west side of the building. The classrooms are serviced by HPs (heat pumps). These serve the HVAC system. Supplemental mechanical equipment for the HVAC system includes eight exhaust fans located on the roof of the building.</p> <p>The mechanical/HVAC system was reported and observed to be in poor condition. It was reported that many work orders had been generated for the school's window units. The air conditioning went out frequently in the living animal area (200-wing). The AC (air conditioning) HP units located in the 100-wing classrooms were too loud to operate when classrooms were in use. All classroom heat pumps will reach the end of their useful life in in the next ten years. All AC equipment used R-22 refrigerant, which is being phased out of use. It was reported that the boiler in the library was functional but not connected. It was observed that RTU ductwork on the roof was deteriorated and collapsing. Punctured condensation drain lines were located above corridor C1. Damaged HVAC ductwork was located in roof section A-03. PM Andrew Miller reported that the current HVAC in the 200-wing frequently malfunctions and this area is used for animal storage.</p>	Poor

1. Replace the 100-wing window unit heat pumps immediately as they are aged and noisy.
2. Replace HVAC equipment for the 200-wing animal areas as they are no longer functioning properly.
3. Replace the HVAC window unit heat pumps over the next ten years.
4. Replace all of the HVAC ductwork located on the roof.
5. Connect the boiler in the library to the water distribution system to provide full functionality to the system.
6. Replace roof top HVAC casing that is damaged.
7. Replace punctured condensation drain lines located on the roof.
8. [Replace the 200-wing HVAC equipment \(requested by PM Andrew Miller\).](#)

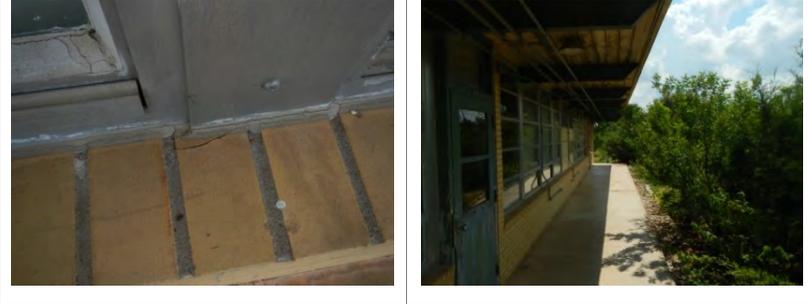
System	Subsystem	Condition and Deficiency Overview	System Condition Rating
Exterior	Exterior Walls	<p>The exterior consists of a brick façade around the entire building.</p> <p>The exterior walls were reported and observed as being in average condition. A micro crack was observed in the brick façade adjacent to room 301. The eaves had evidence of corrosion. It was also reported that water intruded at the base of the wall on the north side of the building.</p>	Average
	Exterior Windows	<p>The exterior windows consist of single-pane windows in metal frames with casement windows in the lower windows throughout the building.</p> <p>The exterior windows were observed and reported as being in poor condition. It was reported that there was a cracked window on the north side of room 301. It was reported and observed that the windows around the building were experiencing corrosion and deteriorating caulking.</p>	Poor

1. Seal the micro cracks located outside room 301.
2. Replace the broken window reported on the north side of the building.
3. Replace exterior doors with doors that fit into their frames properly.
4. Replace the exterior windows around the facility as the caulking has deteriorated.
5. Repair the eaves outside of the exterior doors.

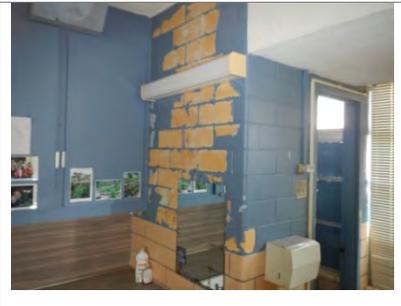
System	Subsystem	Condition and Deficiency Overview	System Condition Rating
		building had a new roof scheduled for construction in the current bond program. There was widespread deterioration observed in the awnings and covered walkways. All gutters were observed to be corroded.	
Interior Construction	Interior Walls	The interior partitions are constructed of brick. The interior partitions were in good condition.	Good
	Interior Doors	The building's interior doors consist of wood doors and frames. The interior doors and frames were reported and observed to be in good condition.	Good
	Interior Specialties	System not present.	N/A
Stairs	Exterior Stairs	System not present.	N/A
	Interior Stairs	System not present.	N/A
Interior Finishes	Interior Wall Finishes	The interior partitions are constructed of painted brick. The interior wall finishes were in poor condition. Paint was observed to be peeling from all interior wall surfaces.	Poor

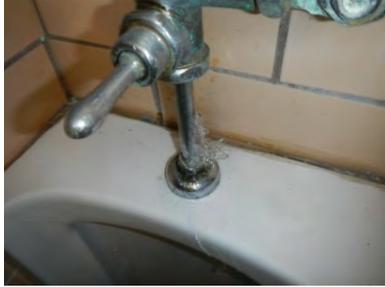
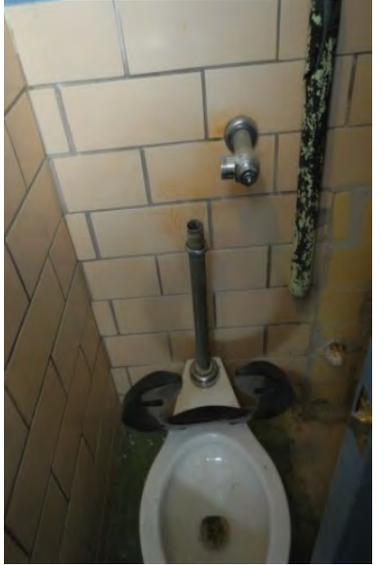
Interior Floor Finishes	The flooring consists of vinyl tile and concrete flooring. It was observed that the flooring in all areas was in good condition.	Good
	Interior Ceiling Finishes	The ceiling finish consists of sprayed insulation on roof joists. The ceiling finishes were observed to be in good condition.	Good
Conveying	System not present.		N/A
Plumbing	Plumbing Fixtures	The building has class restrooms for male and female staff. The staff restrooms have vitreous china wall hung hand sinks with manual faucets, along with vitreous china floor-mounted toilets with a manual flushing mechanism and vitreous wall inset urinals. The plumbing fixtures were in poor condition. It was reported that the toilets and urinals were not functioning well. The fixtures throughout the building are outdated. Water coolers are located in all rooms and did not function. A leak was observed in the urinal in room 302. The toilet in room 304 was observed to not be connected.	Poor

1. Replace the toilets and urinals that are not functioning well and are outdated.
2. Replace the water coolers in the classrooms with a central water cooler for staff.
3. Replace the waterline connection in the urinal in room 302.
4. Reconnect the toilet in room 304.

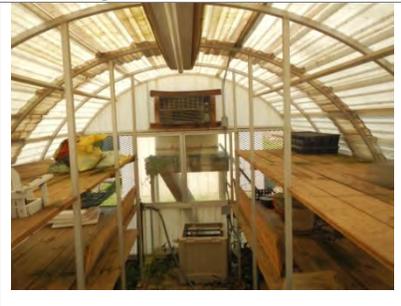
System	Subsystem	Condition and Deficiency Overview	System Condition Rating
Plumbing	Plumbing Fixtures	There is a single hose bib on the exterior of this building. This system was failing. It was reported that the hose bib was not functioning.	Fail
	Domestic Water Distribution	System not present.	N/A
	Other Plumbing	System not present.	N/A
Mechanical/ HVAC	The mechanical system in this building consists of a window unit located on the west wall of the building. The mechanical/HVAC system was failing. This unit was reported and observed as not functioning.		Fail
Fire Protection	Fire Alarm	System not present.	N/A
	Fire Protection/Suppression	System not present.	N/A
Electrical	Electrical Distribution	The electrical service to this building originates at the Main School Building from a small unknown electrical panelboard to provide service to a single receptacle, a ceiling-mounted fluorescent light fixture, and a window unit air conditioner. The electrical distribution system was failing. The electrical distribution equipment was observed as not energized or functioning.	Fail

1. Repair the hose bib to full functionality.
