## Rosedale School Site Summary

## Main School Building – BLDG-251A

## CRAWL SPACE – Rosedale School – Main School Building (BLDG-251A)

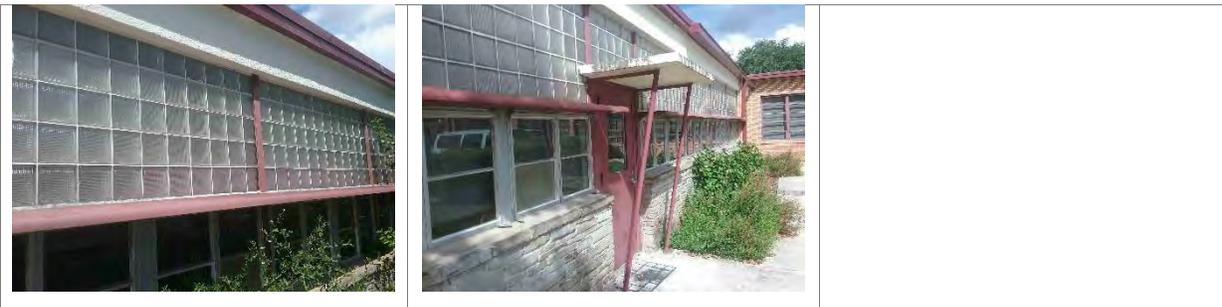
System	Subsystem	Condition and Deficiency Overview	System Condition Rating
<b>Exterior</b>	Exterior Walls	<p>The original building exterior facade is brick with decorative brick coursing. The exterior walls incorporate glass block above the exterior windows that have cut limestone sills. The subsequent building additions incorporate rough-faced ashlar stone into the brick facade.</p> <p>The exterior masonry facade was observed to have organic growth on its surface. Sealants and glass block mortar joints were dry and cracked. The exterior masonry walls are showing age and appeared to be in poor condition. It was reported by campus staff that there is a problem with rodents throughout the facility.</p>	Poor
	Exterior Windows	<p>The exterior windows are mostly original to the building dates of construction. The exterior windows are metal with single pane glazing.</p> <p>The building's exterior windows were observed to have severely deteriorated paint and areas of corrosion visible. Sealants and glazing caulk were dry and cracked. Windows were reported to not open properly. Windows were observed to be in poor condition and most likely are not weathertight. Due to student specific population, glass may not be a suitable glazing material.</p>	Poor

1. Replace leaking exterior windows. Consider and minimize the impact of changing the building's historic character. Consider safety glazing given the unique make-up of the student population.
2. Remove organic growth from masonry surfaces.
3. Re-point masonry mortar and replace sealants as needed.

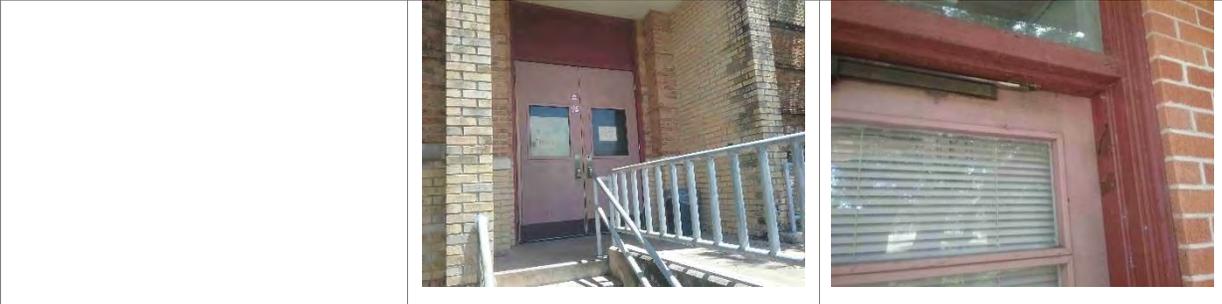
Exterior Doors	<p>The exterior doors and frames are of both metal and wood construction. Building entry doors have full lite vision panels and are part of a larger hollow metal storefront system. Some doors have been replaced but</p>	Average

System	Subsystem	Condition and Deficiency Overview	System Condition Rating
		<p>many appear original.</p> <p>The exterior doors and frames were observed to be in average condition. Painted surfaces appeared oxidized and sealants were dry and cracked. Doors were observed to function adequately. The exterior doors at individual classrooms are used as a means of egress and do not meet the requirements for use by the special needs student population, many of which are mobility impaired.</p>	
<b>Roofing</b>		<p>The roof consists of both built-up and modified bitumen with a reflective coating. Portions of the building have internal roof drains and other areas have a continuous perimeter gutter system with downspouts. The building has numerous small projecting concrete canopy roofs with no roofing membrane. There are three small roofs at the west classroom wing over building entries.</p> <p>The built-up roof over the original building (west classroom wing) was observed to be past its typical design service life and had numerous areas of ponding. The building's modified bitumen roofs range from average to poor. The reflective coating has cracked and is peeling and ponding was visible in areas. The three small roofs at the west classroom wing over building entries have no visible means of drainage and were observed to be holding water. It was reported that roof leaks, since the re-roof project, have considerably declined. There was a roof leak reported in classroom 14. Tree limbs were touching the roof over the west classroom wing.</p>	Poor

1. Replace exterior classroom doors and hardware to make functional and accessible.
2. Investigate and block access points for rodents through the crawlspace or exterior walls.
3. Re-point glass block mortar and replace sealant as required to achieve a weather-tight condition.

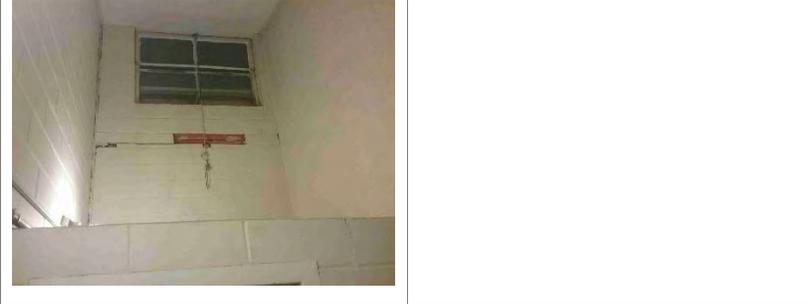
<b>Interior Construction</b>	Interior Walls	<p>The original building (west classroom wing) has solid masonry interior walls with plaster finish. The remainder of the building's interior walls are predominantly glazed masonry units that are partially painted. Ashlar stone is at both the north and south building entrances. There are metal framed interior windows.</p> <p>The building's interior walls were observed to be in average condition. The interior walls with natural finishes have endured relatively well. Plastered masonry wall surfaces were observed to have areas of spalling.</p>	Average

1. Repair damaged and spalling plaster on walls and ceilings and paint as needed.
2. Replace interior door hardware that is not functioning properly and does not meet the accessibility needs of the student population.
- 3.

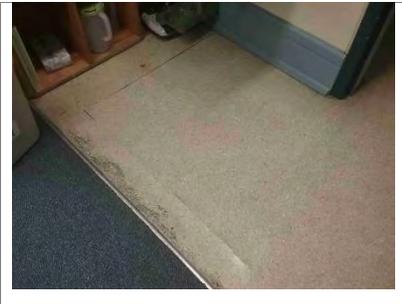
Interior Floor Finishes

System	Subsystem	Condition and Deficiency Overview	System Condition Rating
		<p>classroom spaces. The cafeteria has its original vinyl tile and quarry tile is in the kitchen areas. The gymnasium has its original wood athletic flooring.</p> <p>The building's interior flooring was observed to be in various conditions from good to poor depending on age and type. The original terrazzo, although it has minor cracks, was in good and functional condition. The vinyl tile ranged from relatively new to severely worn in a few areas. The vinyl tile in the cafeteria appears to be original and over 60 years of age. The quarry tile was in average condition. Creaking was quite noticeable in the gymnasium, but the finish was good. The carpet in the administration areas was worn.</p>	
	Interior Ceiling Finishes	<p>Both suspended lay-in acoustical tile and surface attached acoustical tile are throughout most of the building. The original plaster ceiling is in utility spaces and restrooms.</p> <p>Interior acoustical tile varies in condition from good to poor depending on age. Painted plaster ceilings were observed to be peeling. The suspended ceiling grid and tile are reported to not be in good condition.</p>	Average

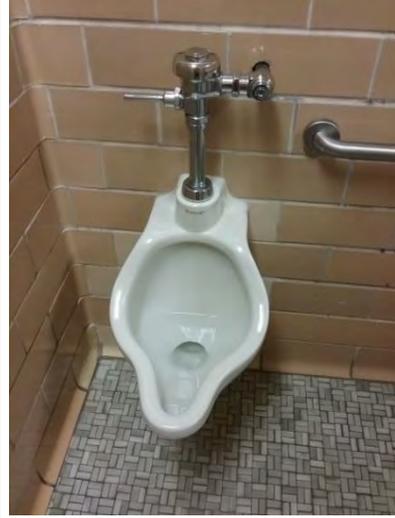
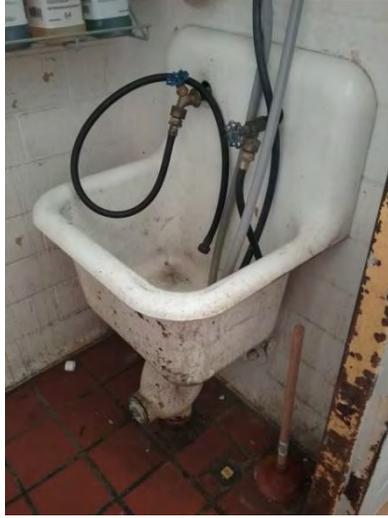
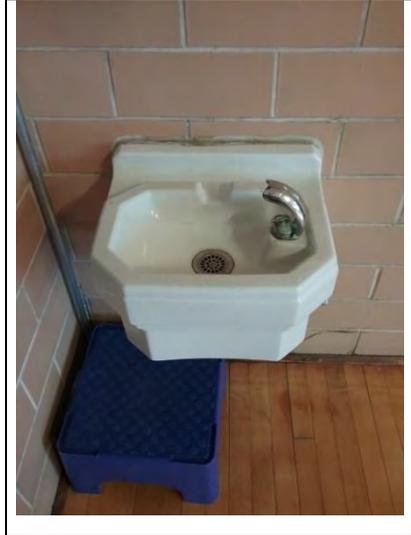
**Plumbing Fixtures**

<b>Conveying</b>	System not present.		N/A
<b>Plumbing</b>	Plumbing Fixtures	<p>The building has shared public restrooms for students and staff located throughout the facility. The classrooms are equipped with stainless steel sinks mounted in laminate counters with faucets and bubblers. The restrooms have vitreous china hand sinks with manual faucets, along with vitreous china toilets with manual flushing mechanisms. There are service sinks in the janitorial closets and water coolers located throughout the facility, typically near the public restrooms. The kitchen includes additional plumbing fixtures such as stainless steel wash sinks and a small restroom equipped with a vitreous china floor-mounted toilet and sink.</p> <p>The restroom plumbing fixtures were observed to be in average condition as the fixtures were aged but still operational with noticeable wear. Rust was observed on several service sinks in the janitorial closets. The water coolers in the corridors throughout the facility appeared to have been installed in the last 3 years and were observed to operate properly. The water fountain located in the gymnasium did not operate. Building staff requested hot water be provided to all sinks throughout</p>	Poor

1. Track installation years of water heaters and plan for replacement as the typical design service life for a water heater is 10 to 15 years.
2. Continue preventive maintenance on aged plumbing fixtures and/or plan for replacement in the future as fixtures continue to age.
3. Replace rusted and broken fixtures as needed.
4. Replace rusted roof drains as needed.
5. Repair or replace any damaged or missing piping insulation as needed.
6. Paint/protect gas lines from further rusting as needed.
7. Replace rusted service sinks.
8. Replace or repair nonfunctioning water coolers.
9. Repair or replace damaged and cracked piping insulation.

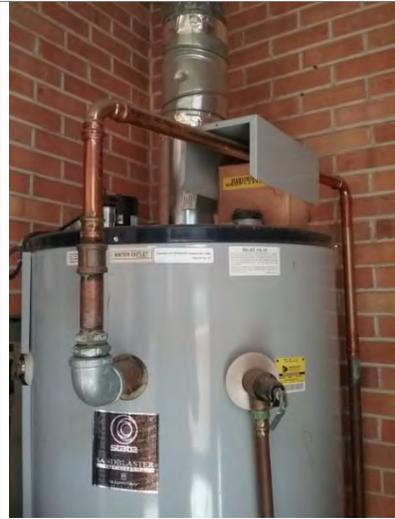
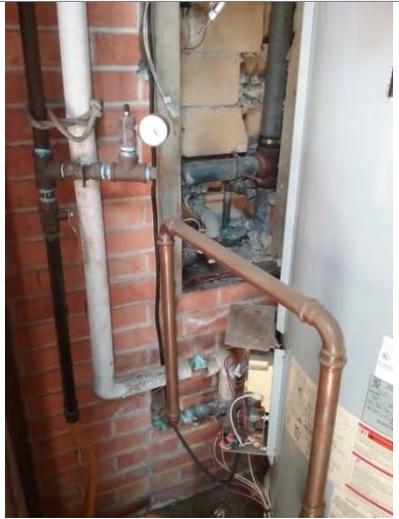
**Domestic Water Distribution**

System	Subsystem	Condition and Deficiency Overview	System Condition Rating
		<p>the facility. Building staff reported that the existing restrooms are too small for the student population and that the existing showers are too small to accommodate students needing assistance. Building staff reported that the sanitary sewer needs to be replaced and that the water supply needs to be inspected. Building staff reported that the Health Department cited the campus for not having a hand wash sink in the APT kitchen.</p> <p>The plumbing fixtures were observed to be in poor condition due to the age of the fixtures and the deficiencies mentioned above.</p>	
	Domestic Water Distribution	<p>Hot water is provided to the kitchen by GWH (gas water heater)-1 located in the kitchen mechanical room.</p> <p>The kitchen water heater was observed to be functioning, but nearing the end of its typical design service life. The hot water piping lacked insulation.</p> <p>The water distribution equipment was observed to be in average condition primarily due to age.</p>	Average

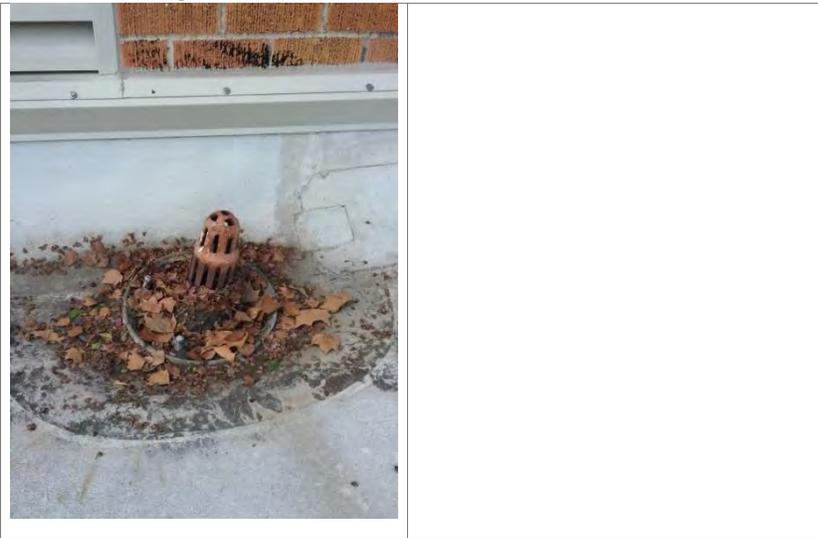
Other Plumbing	<p>The roof drainage system consists of scuppers and gutters with downspouts as well as roof drains.</p> <p>The roof drains were observed to be in poor condition due to their age and corrosion. Several roof drains were not properly seated, and multiple drains were observed to be partially clogged with debris.</p>	Poor
<b>Mechanical/ HVAC</b>		<p>The major mechanical equipment consists of RTUs (roof top units) , with an estimated capacity of 15- to 20-TON, located on the roof serving the non-classroom areas of the building, four wall-mounted split system air handling units providing cooling to select areas, two central station water-source heat pumps providing cooling to the cafeteria and auditorium, and floor-mounted ground WSHPs (water source heat pumps providing cooling in the classrooms. The 29 WSHPs are located in the classrooms, corridors, and select other areas and range from an estimated 3- to 5-TON in capacity. The condensated lines are constructed of PVC (polyvinyl chloride). Additional wall-mounted split system units were observed to serve the nurse's office, lounge, and a nearby office. A building that appeared to be a roof top mechanical penthouse was observed above the west classroom wing. Additional equipment includes roof-mounted restroom and kitchen EFs. These serve the HVAC (heating, ventilating, and air conditioning) system.</p> <p>The HVAC system was observed to be in poor condition. The RTUs appeared to be aged. The RTUs were observed to have damaged or missing insulation on condensate piping and rusting on the unit housing. The disconnects also appeared to be rusted and aged. The condensate lines were observed to be unsupported and uninsulated. The RTU condenser coils appeared to be damaged. The MDF (main distribution frame) room was inaccessible for assessment but</p>	Poor

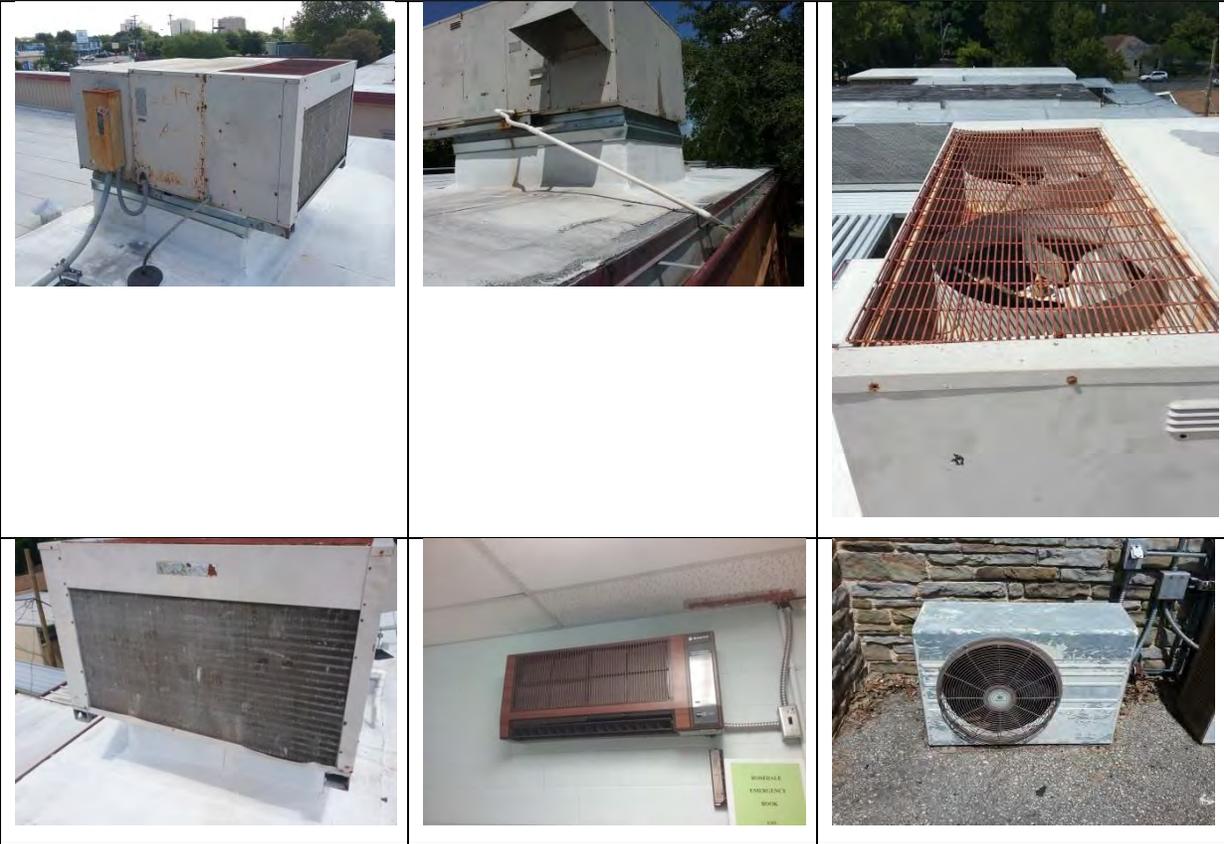
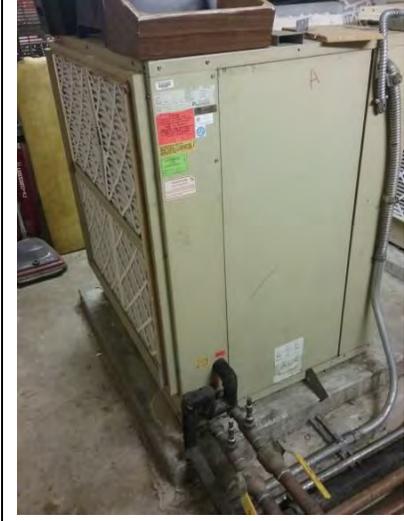
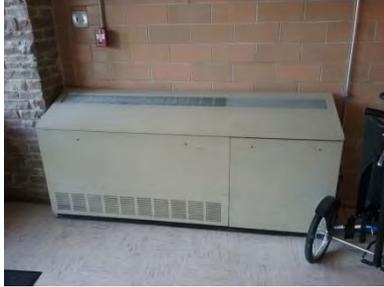
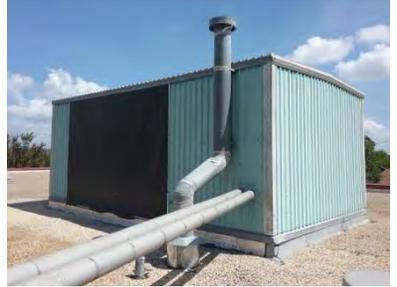
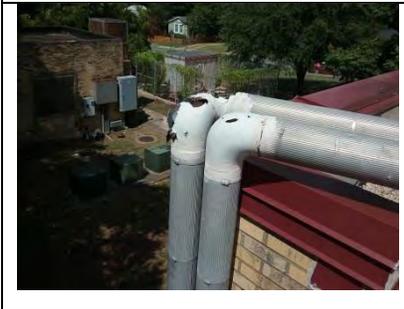
Mechanical/HVAC System Deficiency Examples

System	Subsystem	Condition and Deficiency Overview	System Condition Rating
		<p>appeared to be served by a wall-mounted split system unit. The interior units appeared to be aged and in poor condition. The associated condensing units appeared to be in poor condition. The two central station water-source heat pumps appeared to be past their typical design service life. The WSHP units were aged.</p> <p>An access door to the apparent mechanical penthouse was not present and the interior of the room could not be accessed for assessment. It appeared that hydronic piping penetrated the room and down the building into the ground. The piping insulation was cracked and damaged in multiple areas. The exhaust fans serving the restroom exhaust and kitchen exhaust appeared to be outdated and damage was observed on the housing of several fans.</p>	
<b>Fire Protection</b>	Fire Alarm	<p>The building has a fire alarm control panel by Silent Knight. The system consists of alarm and signaling devices such as horns/annunciators, strobes, horn/strobe combinations, and pull stations.</p> <p>The system appeared to be in good condition.</p>	Good

1. Plan for replacement of the ground source fan coil units as these units appear to be past their typical design service life.
2. Ensure routine preventive maintenance is conducted for cleaning ductwork to promote efficient and clean air flows to all of the facility's spaces.
3. Address any rust or corrosion observed on the equipment, its associated piping, or any other sub-asset in all facilities by cleaning, re-painting, and/or repairing by any means to prevent further deterioration.
4. Repair or replace any damaged or missing piping insulation as needed at all facilities.
5. Plan for replacement of the RTUs as these units appear to be past their typical design service life.
6. Replace window unit serving MDF room.

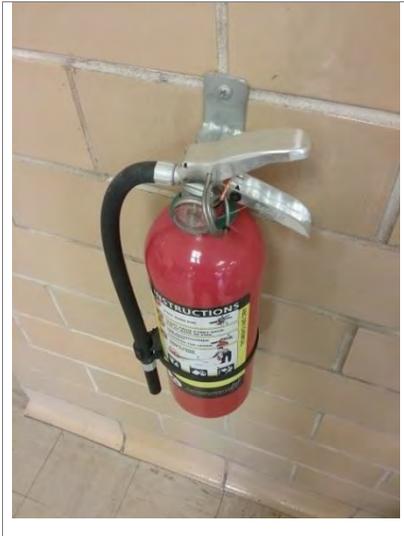
Fire Protection/Suppression	<p>The building does not have a fire suppression system. Fire extinguishers are located throughout the building.</p> <p>Fire extinguishers were observed to have been inspected within the last year for most of the building. The fire extinguisher located in the cafeteria was not equipped with an inspection tag. The fire extinguisher appeared to be aged and the manufacture date was not able to be determined.</p>	N/A
<b>Electrical</b>	Electrical Distribution	<p>The electrical service enters the building at the 120/208-volt 800-amp main switchboards located in building 251B. The service feeds low voltage panelboards, which are located in various electrical rooms throughout building 251A. The building does not have a lightning protection system.</p> <p>The electrical distribution equipment appears to be in average condition. A majority of the assets appeared to be corroded and have aged. Panel A in the electrical equipment janitorial office had a missing circuit breaker cover and was considered a life safety hazard. A panel in corridor C3 was not identified.</p> <p>Facility reported that additional parking lot lights are needed and additional convenience outlets are required in the student medical equipment room.</p> <p>Facility also reported that some student act out and begin pulling on exposed electrical conduit.</p> <p>Also facility reported that the electrical panel in the administration office and panel B needed to be</p>	Average

1. Inspect fire extinguishers to bring them up to date and replace aged fire extinguishers.

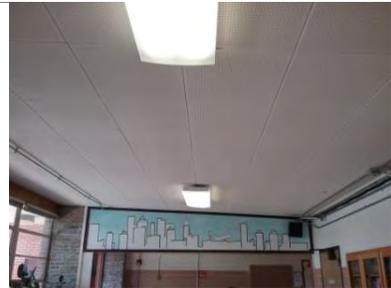
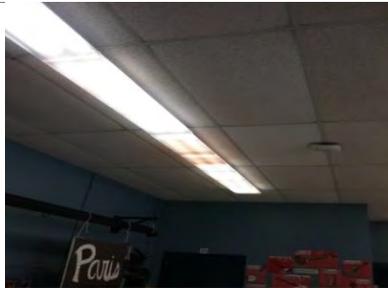
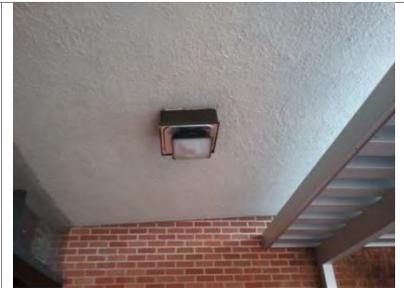
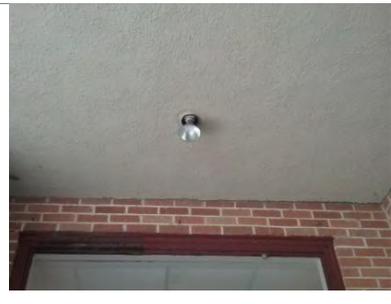
**Lighting**

System	Subsystem	Condition and Deficiency Overview	System Condition Rating
		replaced.	
	Lighting	<p>The building exterior lighting consists of downlights, HID (high-density discharge), and LED (light emitting diode) light fixtures that are located along the entire perimeter. The interior lighting consists of primarily T8 light fixtures. There are exit signs.</p> <p>The interior lighting appears to be in poor condition. Many interior and exterior light fixtures appeared to have aged past their typical design service life. Observed deficiencies include broken lenses, inconsistent color temperatures, and non-functional fixtures.</p> <p>The exit signs appeared to be functioning but are aged..</p>	Poor
	Communications & Security	<p>There is a Gemini security system including surveillance cameras in the building. There is public address system in the building. The building is equipped with telecommunications systems.</p> <p>According to facility staff, the system has had no issues.</p> <p>The public address system appeared to be in average condition; however, all the exterior horns were showing age due to the outdoor elements. All classroom still have the old Dukane paging system present but not being used.</p> <p>The telecommunications systems appeared to be in average condition.</p>	Average

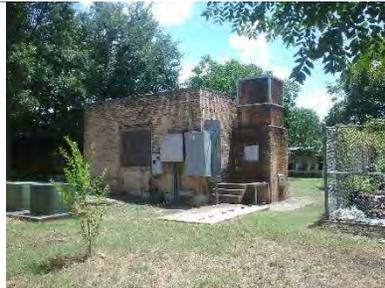
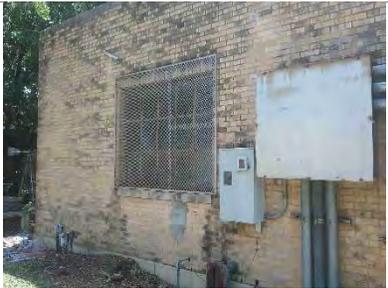
System	Subsystem	Condition and Deficiency Overview	System Condition Rating
<b>Exterior</b>	Exterior Walls	The exterior walls are solid brick with a limestone parapet cap and window sill and are original to the 1939 building.  The brick facade was observed to be in poor condition. There was significant organic growth visible and the brick mortar was observed to be dry and powdery.	Poor
	Exterior Windows	Exterior windows are original metal framed with original (or very old) glazing in place.  The metal frames have little to no remaining paint finish and numerous glass panes were broken. The sealant around the windows and the glazing caulk were deteriorated. The exterior windows were observed to be in poor condition.	Poor
	Exterior Doors	The exterior doors and frame are metal. The exterior doors have both a vision panel and a metal louver.  The doors were marginally functional and corroding. Their paint finish was deteriorated and heavily oxidized. The exterior doors were difficult to latch. The exterior doors and hardware were observed to be in poor condition.	Poor

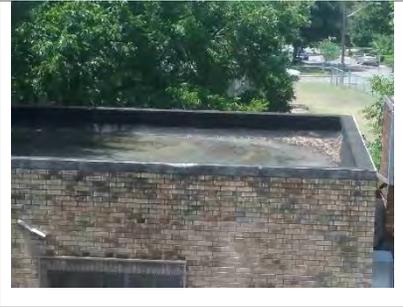
**Roofing Deficiency Examples**

<b>Roofing</b>	The roof was not accessible but was viewable from approximately 50 feet away on the adjacent building roof and appeared to be a built-up roof membrane.  The roof is observed to be ponding water. No leaks or staining was observed on the underside of the concrete roof deck. The roof appeared to be in poor condition.		Poor

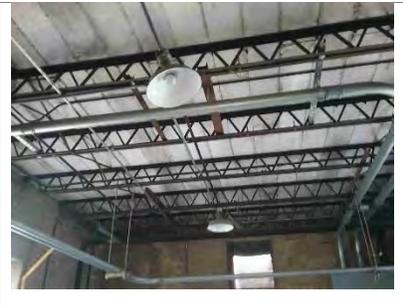
Interior Ceiling Finishes	The interior ceiling was observed to be in average condition. No cracks or discoloration was visible on the concrete deck. The bar joist roof structure did not appear to be protected from corrosion.	Average
<b>Conveying</b>	System not present.		N/A
<b>Plumbing</b>	Plumbing Fixtures	System not present.	N/A
	Domestic Water Distribution	System not present.	N/A
	Other Plumbing	The roof drainage system consists primarily of scuppers and gutters with down spouts. See architectural assessment for condition of gutters and down spouts. There were no plumbing systems observed in the interior of the building. Abandoned piping was observed penetrating from the ground through the exterior of the building.	Poor
<b>Mechanical/ HVAC</b>	System not present.		N/A
<b>Fire Protection</b>	Fire Alarm	System not present.	N/A
	Fire Protection/ Suppression	<b>The building does not have a fire suppression system.</b> A fire extinguisher is located on the interior of the building near the entrance.  The fire extinguisher was observed to have been inspected within the last year.	N/A

1. Investigate condition of roof joists and possibly paint to protect from corrosion.

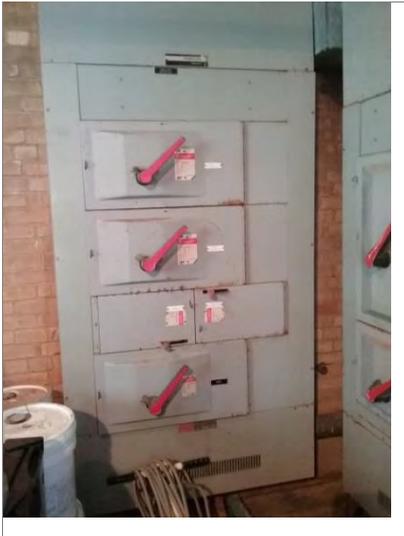
System	Subsystem	Condition and Deficiency Overview	System Condition Rating
<b>Electrical</b>	Electrical Distribution	The electrical service enters the building at the 120/240-volt 1200-amp main switchboards located in this building. The service feeds step down transformer and low voltage panelboards, which are located in various electrical rooms throughout the building. The building does not have a lightning protection system.  The electrical distribution equipment appears to be in poor condition. A majority of the assets appear to be corroded and have aged.	Poor
	Lighting	The building has no exterior lighting. The interior lighting is primarily incandescent.  The lighting for the building appeared to be in poor condition.	Poor
	Communications & Security	System not present.	N/A

1. Provide exterior light fixtures with LED light fixtures.
2. Replace all outdated interior light fixtures with LED light fixture.
3. Replace all aged and outdated main switchgear and distribution panels.

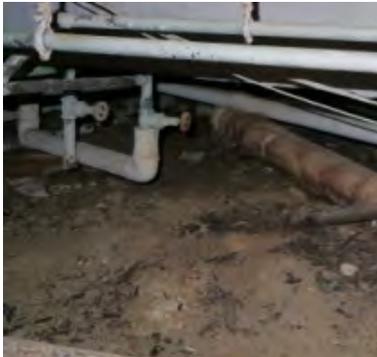
<p>Damp soil at access point near cafeteria</p>

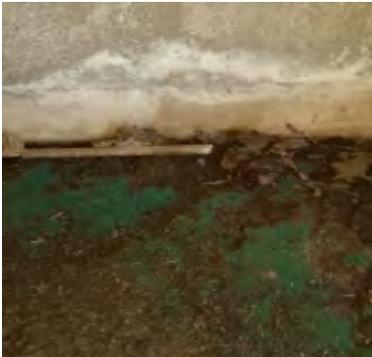
<p>Mold on ground at east classroom wing</p>

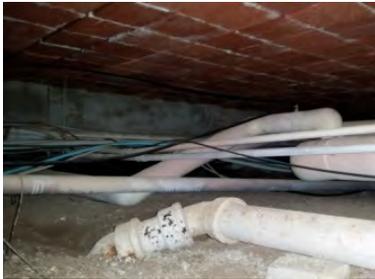
<p>Access/movement inhibited by pipes, wires, low clearance</p>

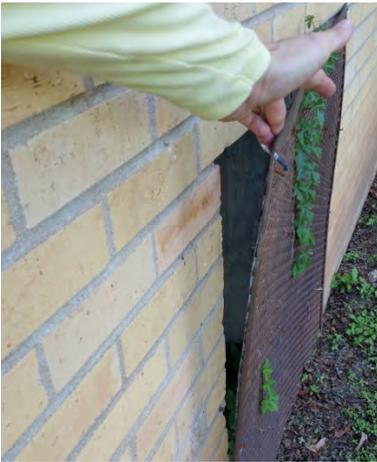
<p>Screen over exterior access to original building was screwed &amp; could not be removed</p>

1. Replace screwed on grates/screens with operable access doors at west classroom wing
2. Investigate source of damp soil near cafeteria and mitigate
3. Investigate need for additional ventilation

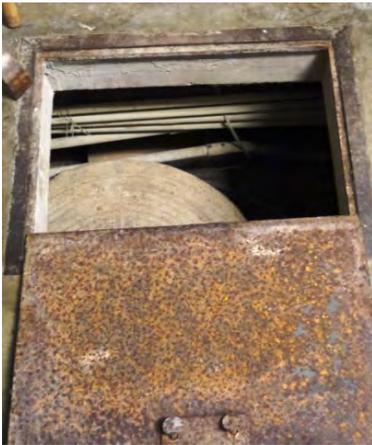
<p>Rusted access floor hatch in custodian's room</p>

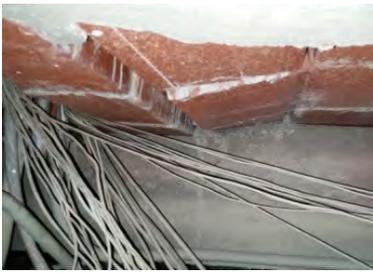
<p>Loss of mortar, failing floor system units</p>

4. Repair concrete at exposed/corroded reinforcement
5. Repair spalling on beam and around slab penetrations
6. Repair interlocking masonry slab at one location

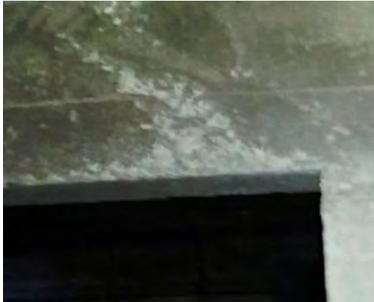
<p>Honeycombing at interior beam</p>

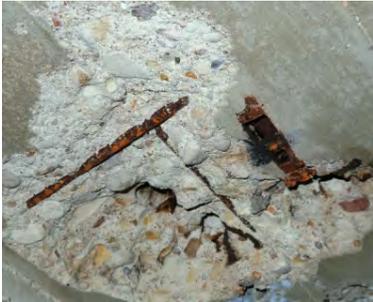
<p>Exposed reinforcement under slab in east classroom wing</p>

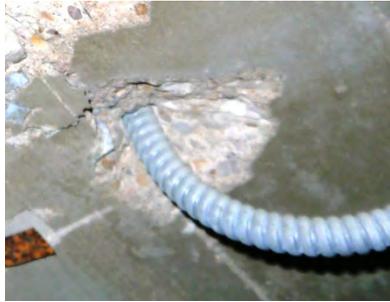
<p>Spalling under slab at east classroom wing</p>

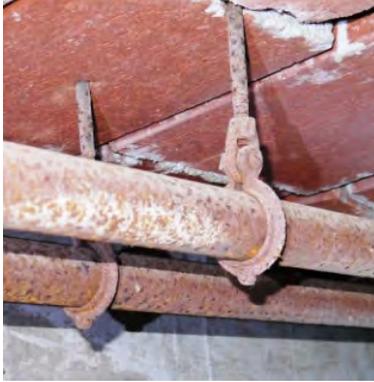
<p>Rusted Pipes and Hangers</p>

1. Clean rusted pipes and protect from further corrosion; replace badly rusted pipes as needed
2. Replace rusted hangers
3. Replace degraded pipe insulation

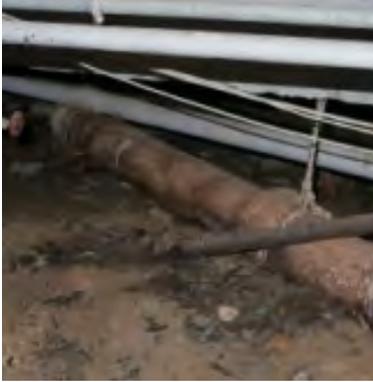
<p>Pipe supported on the ground</p>

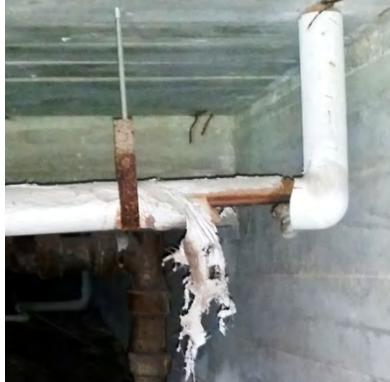
<p>Deteriorating pipe insulation</p>
---	---	--

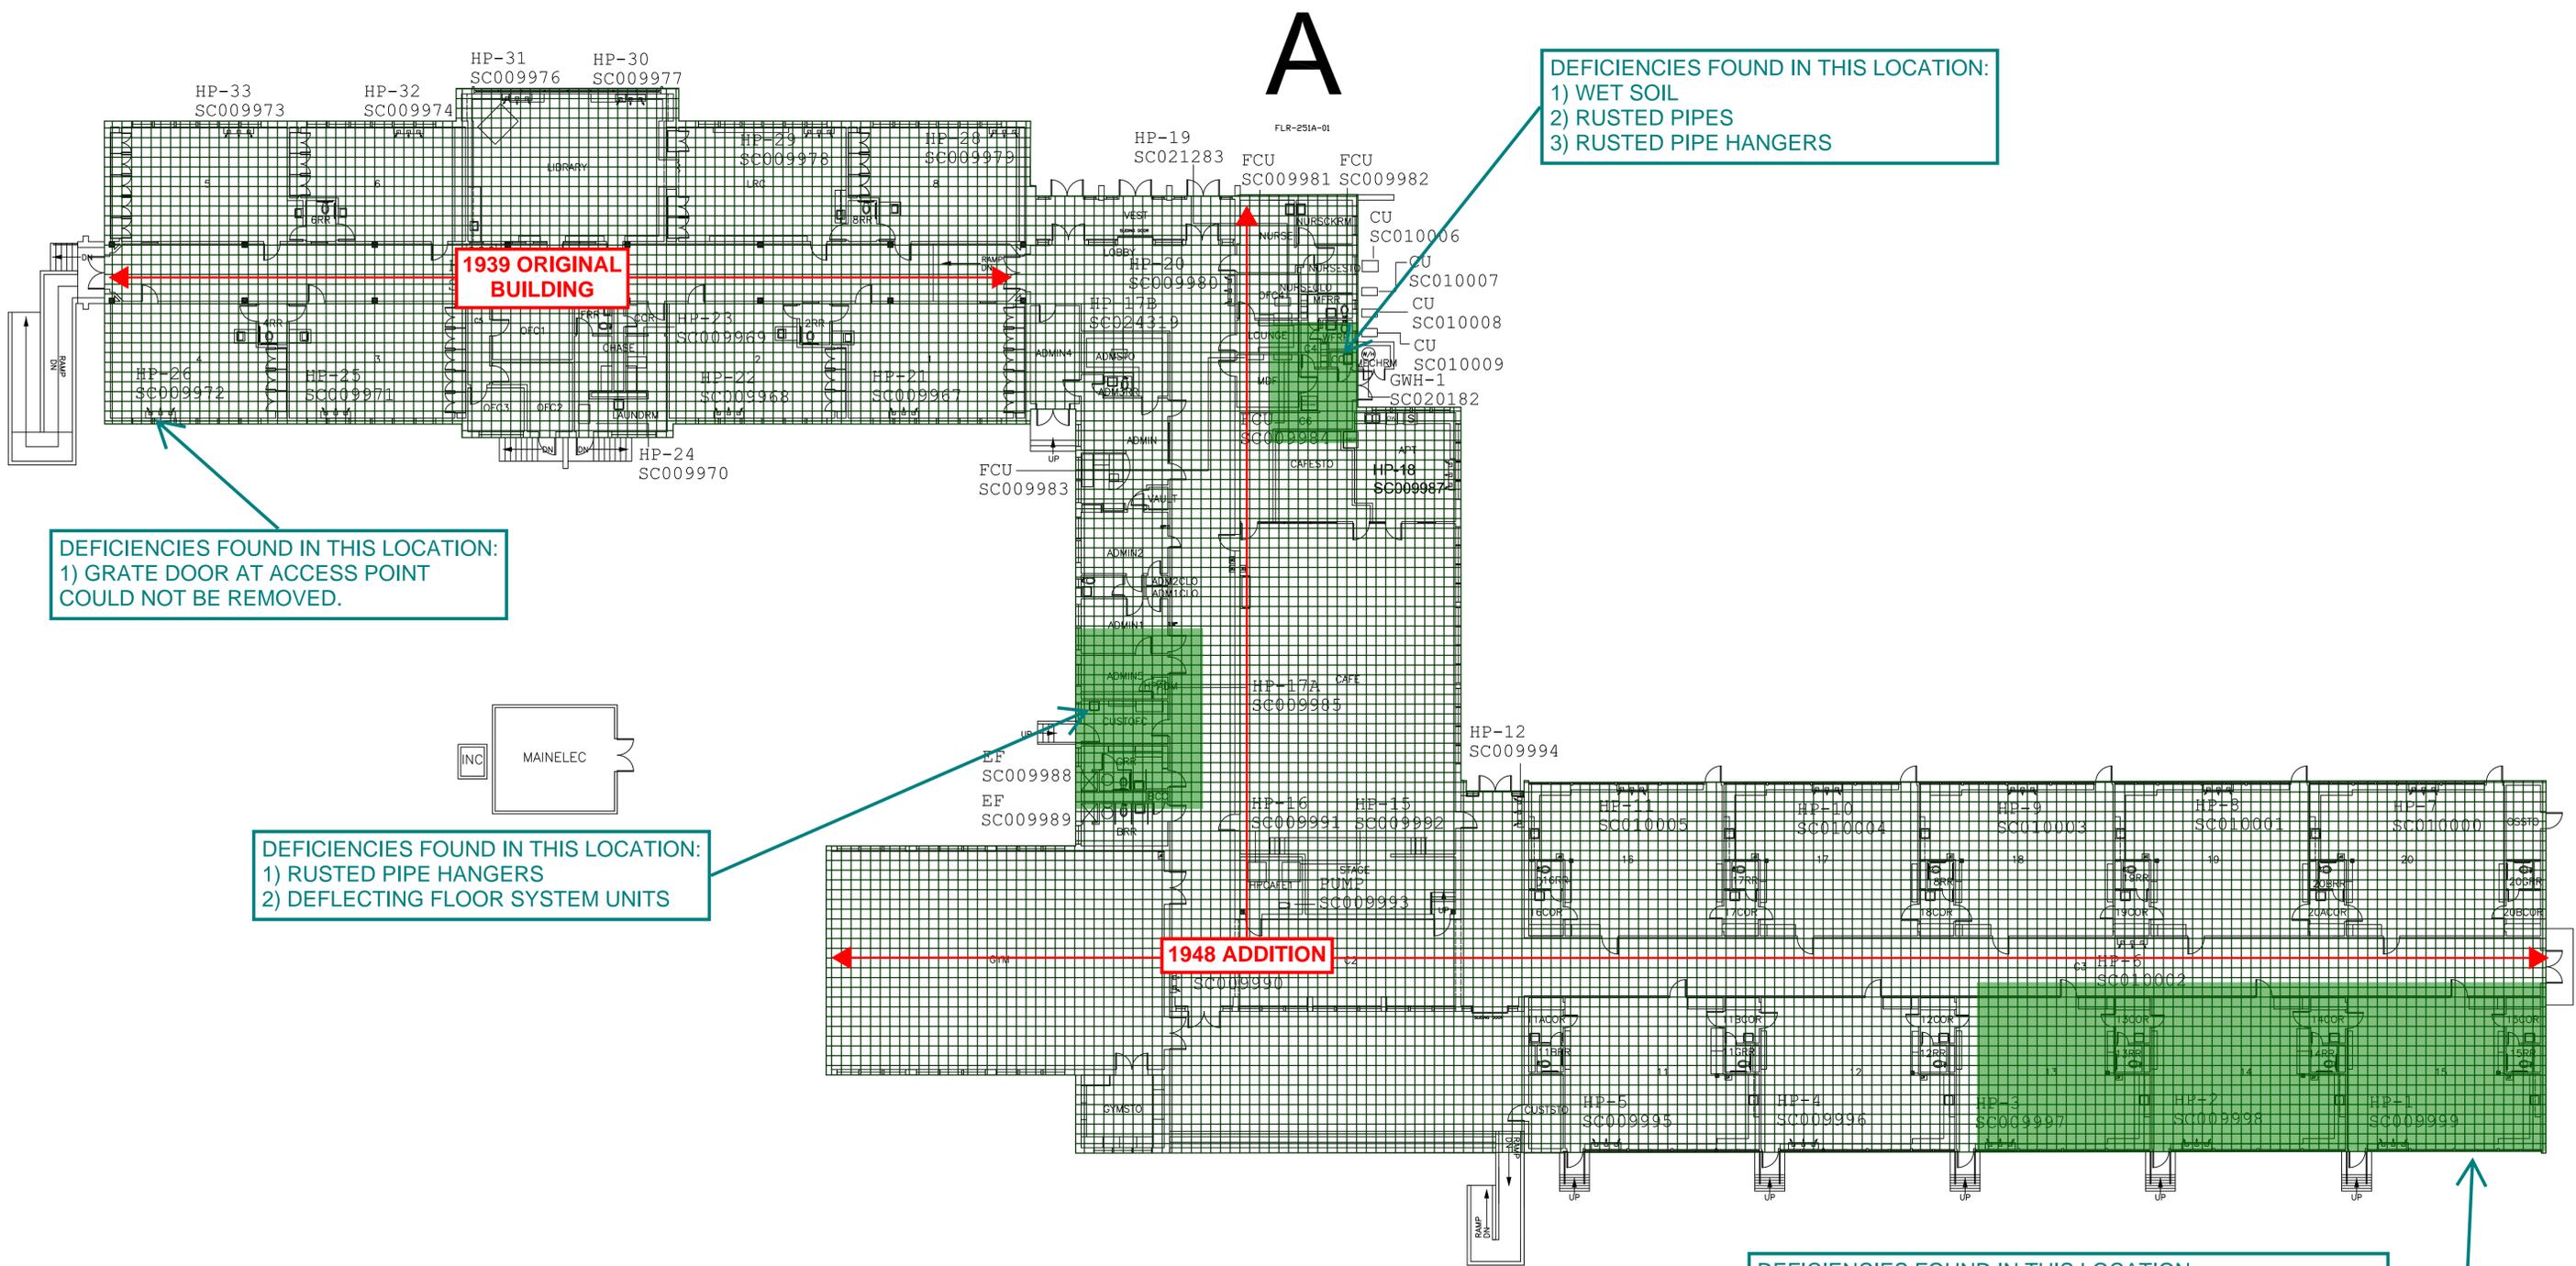
DEFICIENCIES FOUND IN THIS LOCATION:  
 1) GRATE DOOR AT ACCESS POINT  
 COULD NOT BE REMOVED.

DEFICIENCIES FOUND IN THIS LOCATION:  
 1) WET SOIL  
 2) RUSTED PIPES  
 3) RUSTED PIPE HANGERS

DEFICIENCIES FOUND IN THIS LOCATION:  
 1) RUSTED PIPE HANGERS  
 2) DEFLECTING FLOOR SYSTEM UNITS

DEFICIENCIES FOUND IN THIS LOCATION:  
 1) POOR VENTILATION (HUMID AIR, MOLD ON GROUND)  
 2) DAMP SOIL  
 3) EXPOSED/CORRODED REINFORCEMENT UNDER SLAB  
 4) SPALLING UNDER SLAB  
 5) FALLING/DEGRADED PIPE INSULATION
