Southeast Bus Terminal Site Summary

Main Office Building – BLDG-955A

Bus Service Shop - BLDG-955B

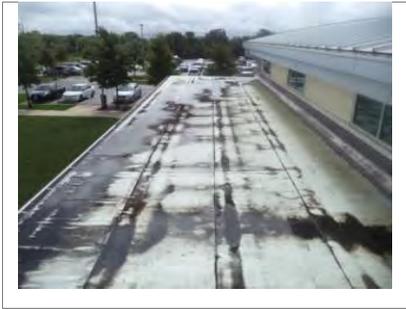
Roofing Deficiency Examples

System	Subsystem	Condition and Deficiency Overview	System Condition Rating
Roofing		<p>This roofing system consists of three separate roofing types for this structure and supporting systems. The majority of the roofing system consists of metal roofing. The next type of roof material where rooftop HVAC equipment is stationed consists of TPO (thermoplastic polyolefin membrane) roofing. A very small segment of covered walkways consists of a more robust metal paneling. The gutters and downspouts were observed to be in good condition during this survey and functioning as intended. It was reported by facility staff that they witnessed gutters function properly during rain events.</p> <p>The roofing system as a whole was observed to be in good condition. The exception to this system are isolated areas where evident ponding on TPO portion had occurred and left evaporated residual evidence. There was no leakage to report under areas where TPO surfaces existed. The metal roofing over the walkways also appeared to be in good condition with no signs of any deterioration.</p>	Good

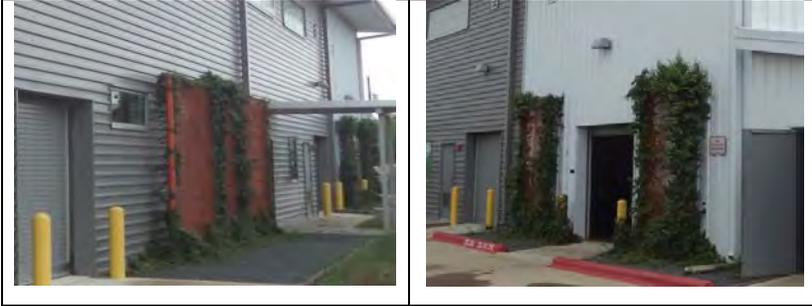
System	Subsystem	Condition and Deficiency Overview	System Condition Rating
Exterior	Exterior Walls	<p>The exterior of the building consists of a metal panelized wall system. The west side of this facility is constructed of CMU.</p> <p>The entire exterior of this facility was observed to be in good condition during visual survey. There were no known major issues to report with this system according to facility staff. Facility staff escort pointed out some vegetation growing within the walls at the east entrance area of this facility photo in deficiency section depicts areas of concern.</p>	Good
	Exterior Windows	<p>The exterior windows consist of single-pane glazing units with aluminum frames in the offices, and casement windows with frosted glass mounted on higher levels above service bay doors. The windows were functioning as intended.</p> <p>The exterior windows were observed to be in good condition. There were no known issues to report from facility staff.</p>	Good

1. Recommend having vegetation vine growth removed from the east side wall areas where facility foreman pointed out minor vine intrusion into the building. This is a minor issue that entails removing vines.
