Uphaus Early Childhood Center Site Summary

Main School Building – BLDG-177A

Exterior System Deficiency Examples

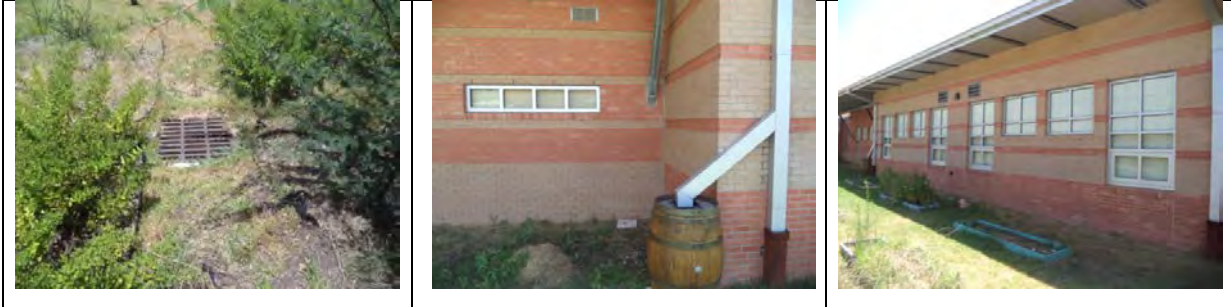
System	Subsystem	Condition and Deficiency Overview	System Condition Rating
Exterior	Exterior Walls	<p>The exterior of the building consists of a split face CMU (concrete masonry unit), common brick, and cementitious panels surfaced façade with metal-covered concrete walkways.</p> <p>It was reported that the exterior façade was in good condition. The exterior façade system was visually observed to be in good condition, with no visual signs of significant or evident stress cracking.</p>	Good
	Exterior Windows	<p>The exterior windows consist of single-pane glazing units with aluminum metal frames throughout this facility.</p> <p>These windows were observed to be functional and working as intended. Facility staff indicated that windows in room 214 had bad seals, which was evident during heavy rain events. Visual observation of this window did not reveal the seal as being unseated or deteriorated. The building operator present at the interview made notes and advised school staff to place a work order to have this window resealed. The remaining system was in good working order with no deficiencies to report.</p>	Good

1. Continue with a more robust/consistent preventive maintenance program around the exterior to include maintaining extensive foliage that impacts this facility.
2. Recommend a further investigation of the exterior drainage system where diversionary downspouts have effect on the designed drainage for section of the courtyard, where gardens and plant activities have become part of this landscape.

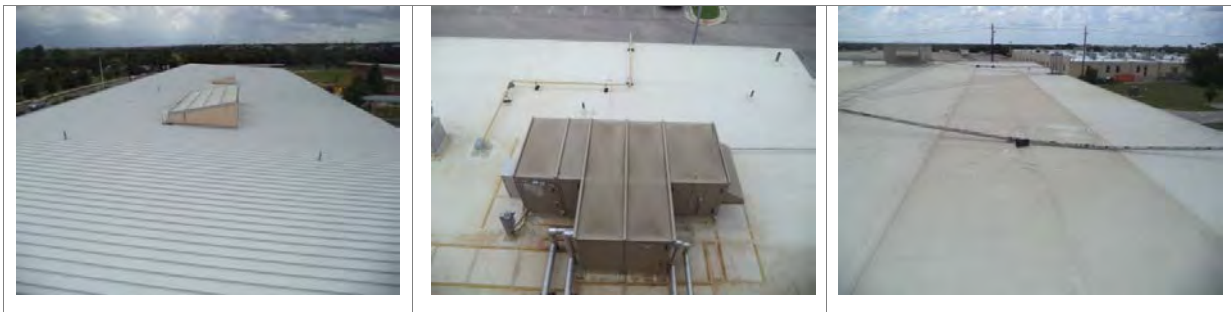
Roofing Deficiency Examples

System	Subsystem	Condition and Deficiency Overview	System Condition Rating
Roofing	<p>The roof material covering the building consists of TPO (thermoplastic polyolefin membrane) synthetic rubber roofing on 40% of this system, where all roof HVAC (heating, ventilating, and air conditioning) equipment is placed. The remaining 60% of the roof system consists of standing seam metal roofing.</p> <p>It was reported that re-occurring leaks have been detected over the 200-wing clerestory and over the kitchen. It was reported that leaking has occurred in rooms 217 and 301 during rain events. It was also reported that leaking has occurred over the 100-wing corridor and the common areas located in the 200- and 300-wings. Building staff reported that the leak over the kitchen was determined to be a bolt hole from equipment on the roof. The roof surfaces were visually observed to be in good condition with no evidence of holes or breaks on seams of the TPO roofing. The standing seam metal roofing could not be walked on so as not to cause damage to the surface and due to safety concerns and thus not directly observable except partially from afar. The areas above the common zones where suspected leaking had taken place had a standing seam roof present with fiberglass sandwich panel skylights and drainage support diversion crickets applied over these areas. It could be that the seals around the skylights were causing the water intrusion during substantial rain events.</p> <p>Covered walkways appeared to be in good condition with no signs of major degradation. Minor deficiencies were observed with areas of discolored surfaces where metal paneling meets with base structure.</p>		Good

1. Further investigate and evaluate the entire TPO synthetic rubber roof portion of this roof system on BLDG-177A – where HVAC equipment has been stationed, obvious signs of wear and tear with appearance of extensive activity either by staff or children accessing roof was present at the time of visual assessment. The standing seam metal roofing of this structure was reported to have water intrusion in common areas within this facility during strong rain events.
2. The assessment revealed a common industry shortcoming with regard to skylighting locations on a standing seam metal roof with cricket diversion applications. This may be the reason water is encountered in the common areas during rain events. Seals need to be evaluated and repaired if necessary.
3. Recommend further evaluation by a certified professional in roofing applications and standards.

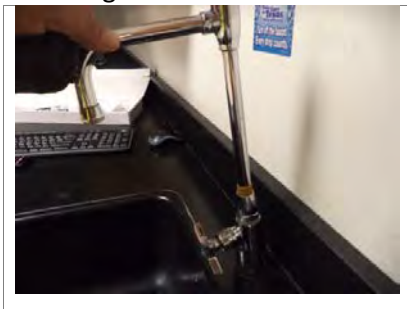
Conveying	System not present.		NA
Plumbing	Plumbing Fixtures	<p>The building has public restrooms for men, women, and students, and separate staff restrooms located throughout the facility. These restrooms have traditional sinks and fixtures with manual faucets, along with floor-mount/wall toilets with manual flushing mechanisms, to include wall-hung urinals in the male restrooms with manual flushing mechanisms. There are service sinks in the janitorial and housekeeping closets, and water-chilled dispensers located within the facility, typically near or between male and female restrooms.</p> <p>The restroom plumbing fixtures were observed to be in good condition, as the fixtures were operational and showing no signs of malfunctioning parts. It was reported that the long-neck type faucets servicing the general classroom areas were easily loosened by children tugging and pulling on them. These systems were observed as functioning as intended at the time of this assessment.</p>	Good

1. Repair and maintain all long necked plumbing fixtures as necessary, consult facility staff for recommendations on this issue.
2. Recommend as a maintenance activity to periodically pour water down floor drains in the kitchen area where dry drainage conditions have presented themselves as foul smelling odors being emitted from the drains.

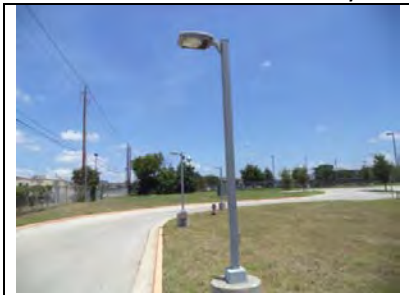
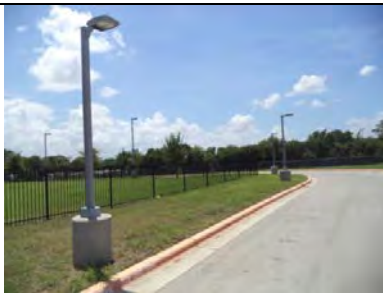
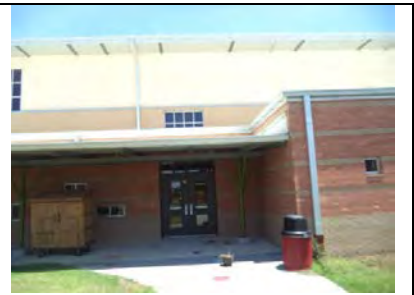
Communications and Security

Lighting	<p>The building's exterior lighting consists of down lights and HID (high-intensity discharge) luminaires that are located along the entire perimeter. It was reported that the exterior wall pack lights are slowly being upgraded to LED (light-emitting diode) fixtures.</p> <p>It was reported that lighting was inadequate with regard to light strength as well as coverage needed for staff safety/security on the southwest side of the school where vagrants have used the area as a dwelling.</p> <p>The interior lighting primarily consists of T8 fluorescent luminaires set in troffers in the 300- and 400-wings with some areas containing pendant T-8 fluorescent luminaires such as the library and 100- and 200-wings.</p> <p>The lighting for the building was observed to be in average-condition. Many exterior luminaires appeared to be aged.</p>	Average
	Communications & Security	<p>This facility has a security system that includes alarms, surveillance cameras, and card readers as well as a functioning public address system. It was reported that during a lockdown situation, the public address system can only be accessed from one phone in the main office, which can be a safety issue during an emergency situation. According to facility staff, the system is functional but could use some upgrades. It was reported that only nine cameras exist outside the perimeter of this facility with limited view and inadequate resolution. It was reported that on the South West side of the property areas have been populated by vagrants and have no camera coverage in this area. It was reported that neighborhood children have climbed drainage downspouts and have accessed the roof in the past Photo attached access point.</p> <p>The facility staff reported that there are no issues with Wi-Fi.</p>	Poor

System	Subsystem	Condition and Deficiency Overview	System Condition Rating
		The condition of this subsystem is rated as poor because of the deficient cameras and single access point of the public address system in an emergency situation. This includes reported insufficient lighting in areas where vagrants have used as a habitat.

5. Replace security camera systems with newer system to include adding additional cameras from a system with better resolution capabilities, for adequate coverage of entire facility to include flexibility of coverage where it has been reported that on the southwest side of the school, a homeless group dwells at times, which has caused staff to request more extensive security measures be implemented with additional lights and security cameras being placed to cover these areas of security concern
