## STRUCTURAL ASSESSMENT – Burger Athletic Complex Stadiums (BLDG-951M&N)

| Building Purpose | Stadium Seating |
| Inspection Date | September 23, 2016 and<br>November 14, 2016 |

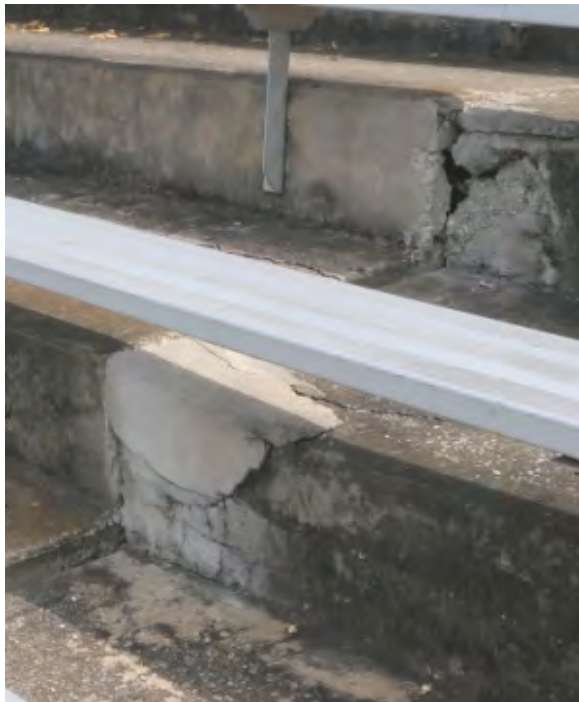
Horizontal & vertical separation at south expansion joint; New damage at previously repaired concrete  
(East Stadium, View from Top of Deck)

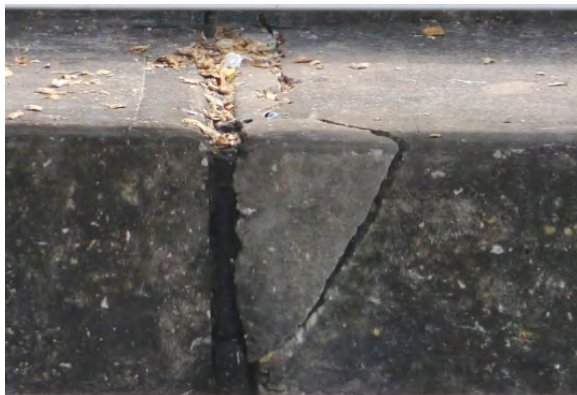
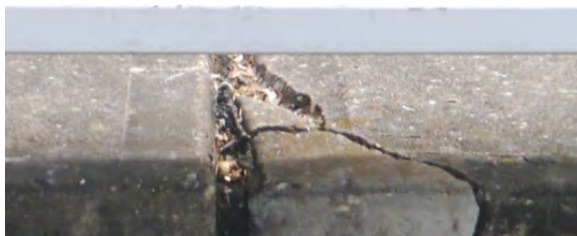
New concrete damage at expansion joint (since 2006 repair work)

(East Stadium, View from Top of Deck)

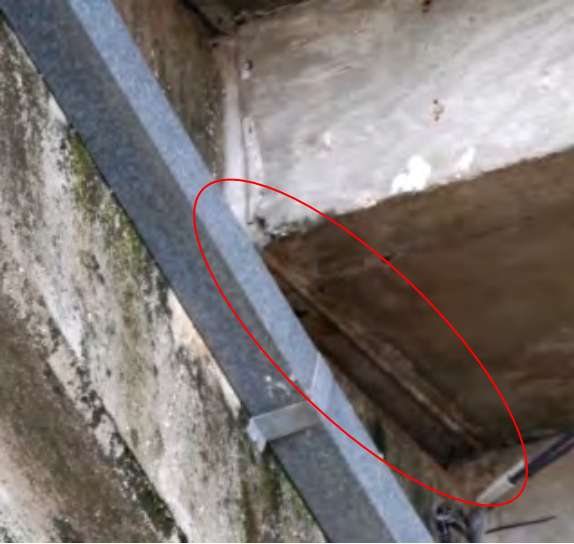
Vertical and horizontal separation of isolated deck and supporting beam at south intermediate expansion joint  
(East Stadium, View from Below Deck)

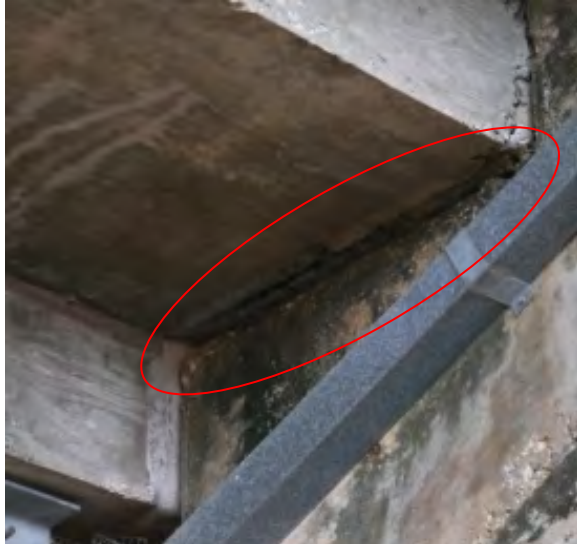
Vertical and horizontal separation of isolated deck and supporting beam at north intermediate expansion joint  
(East Stadium, View from Below Deck)

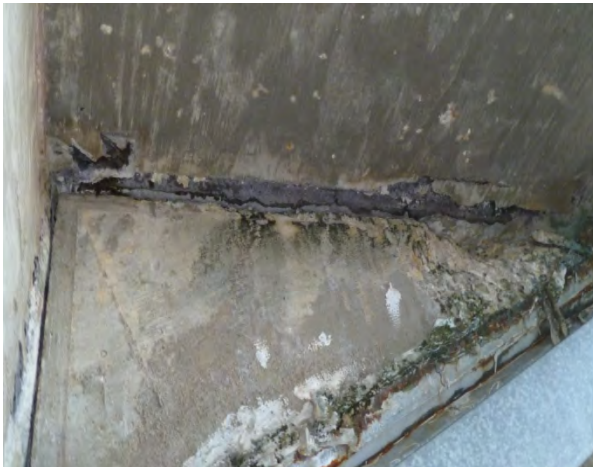
Horizontal separation of the supporting beam and isolated deck

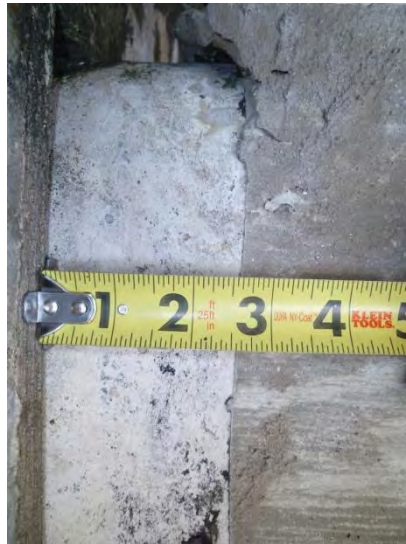
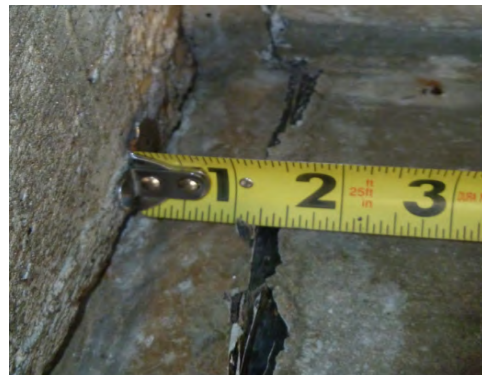
Horizontal separation of supporting beam and isolated deck

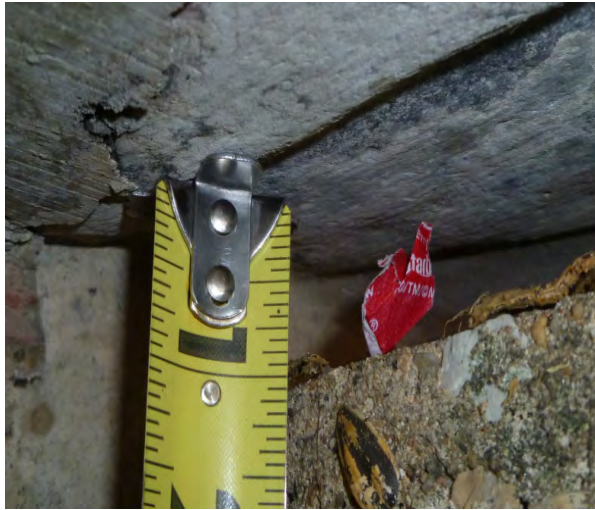
Vertical gap between supporting beam and isolated deck

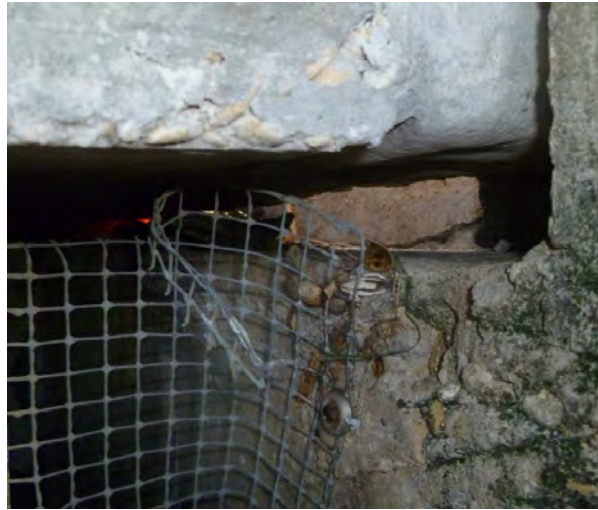
Daylight visible between supporting beam and isolated deck

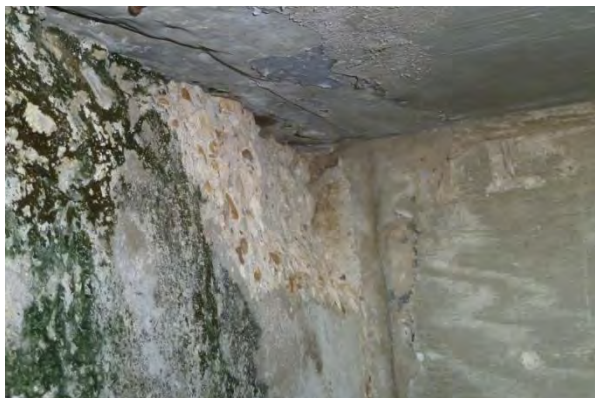
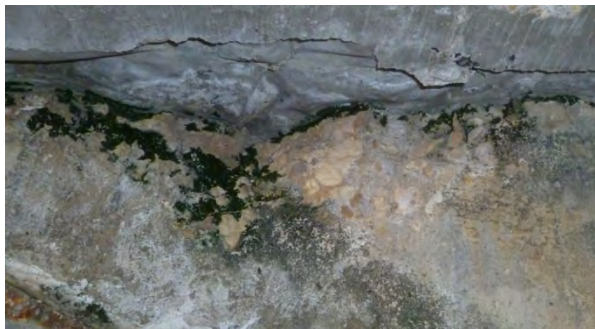
Concrete at the top corner of the supporting beam is spalling  
(below isolated deck)

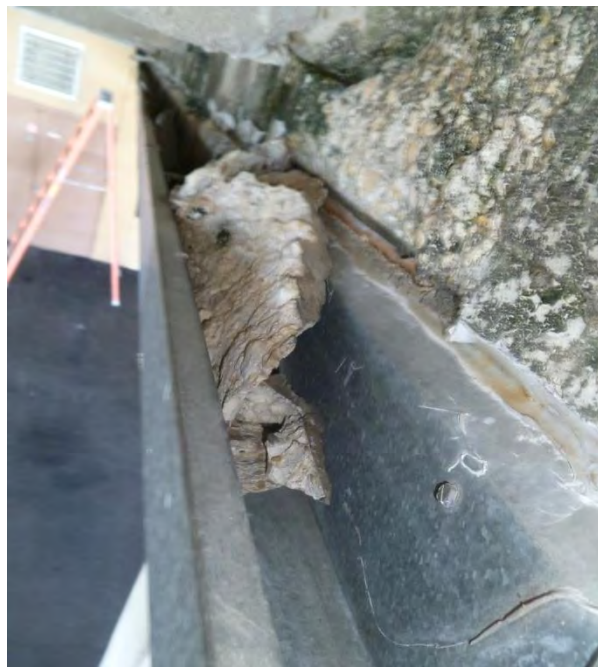
Spalled beam concrete caught in the gutter

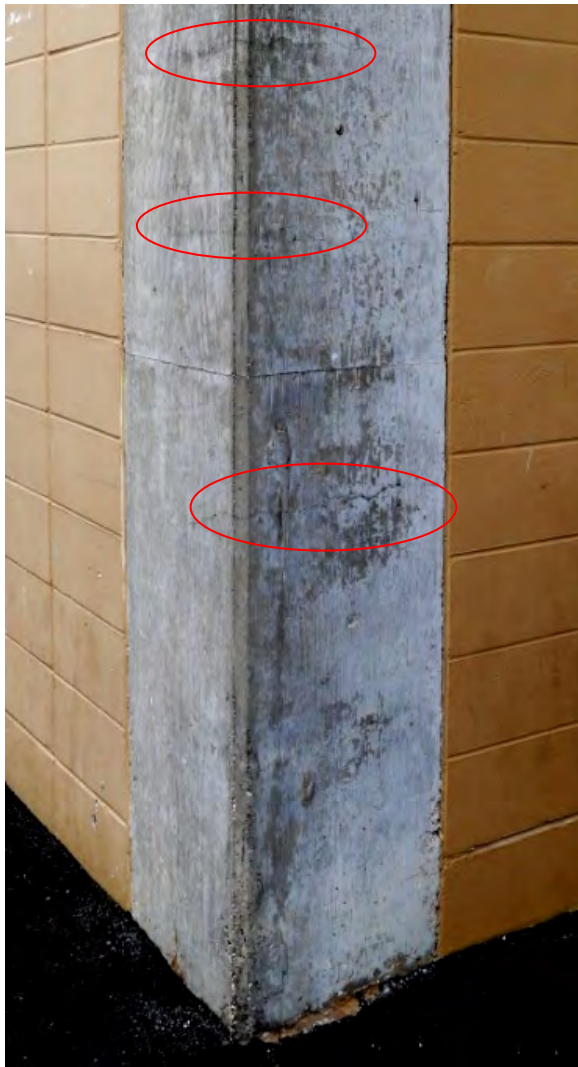
Flexural Cracking Near Bottom of Column

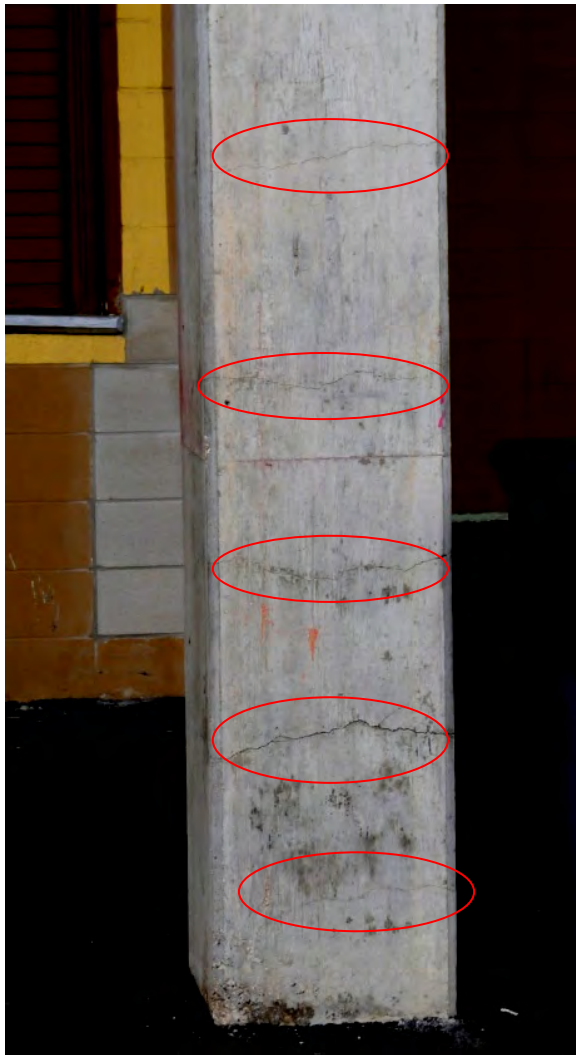
Flexural Cracking Near Bottom of Column

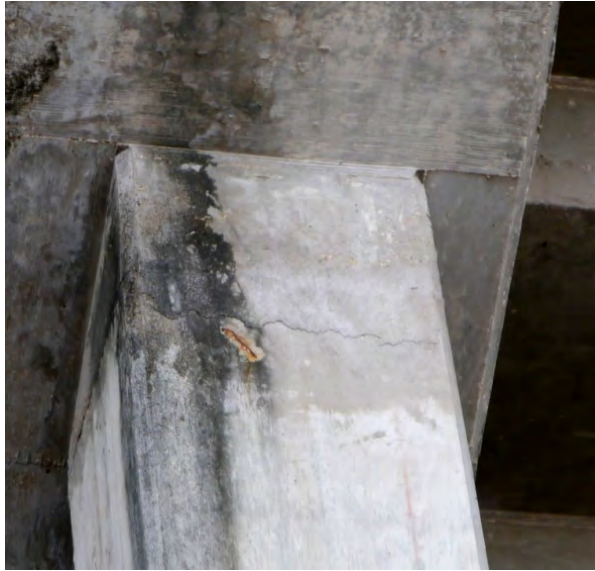
Previously repaired cracks at top of column have re-opened

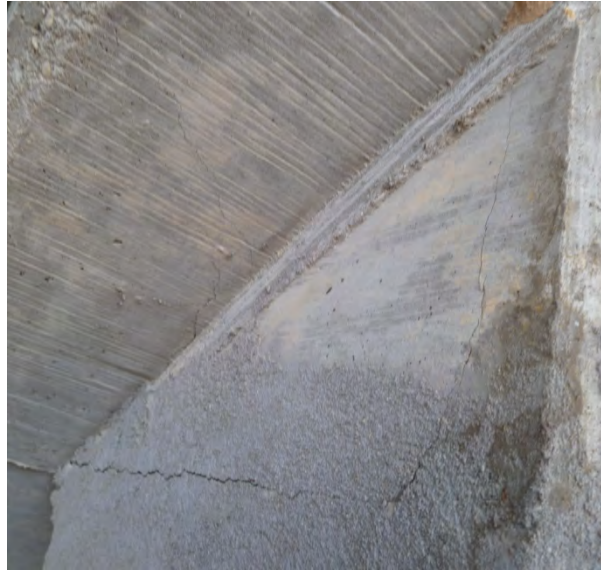
Previously repaired cracks at top of column have re-opened and new cracks have developed

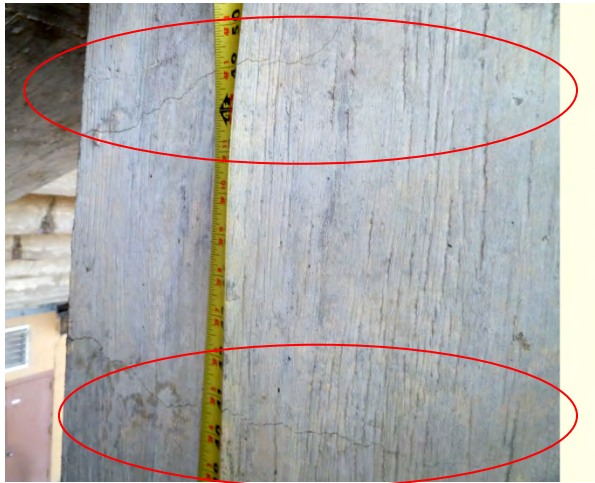
Cracks in the top of column extended as far as 4'-8" from the top of column

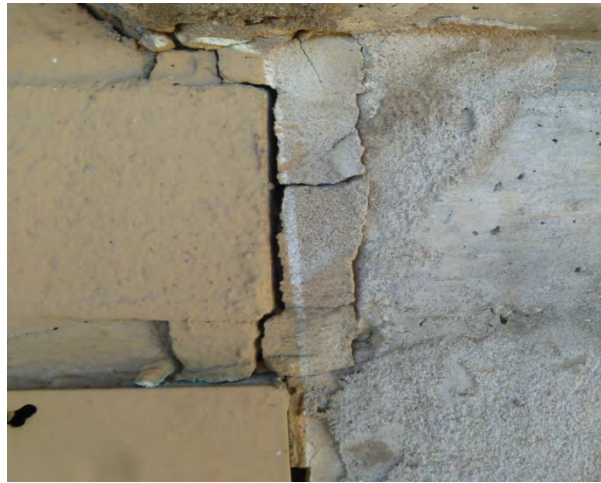
Edge column has separated from CMU wall

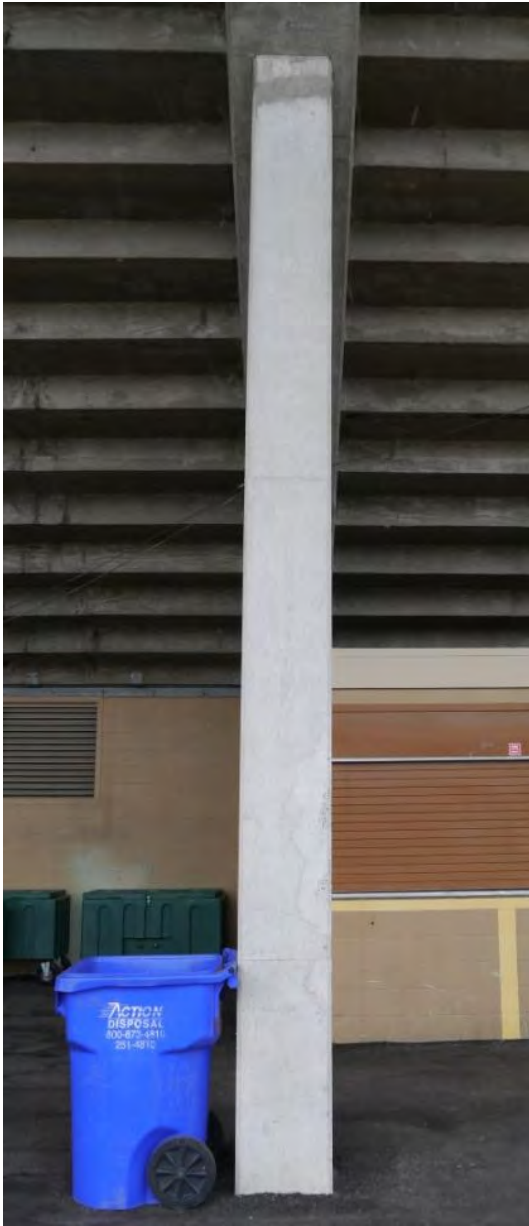
Lateral deflection at top of column

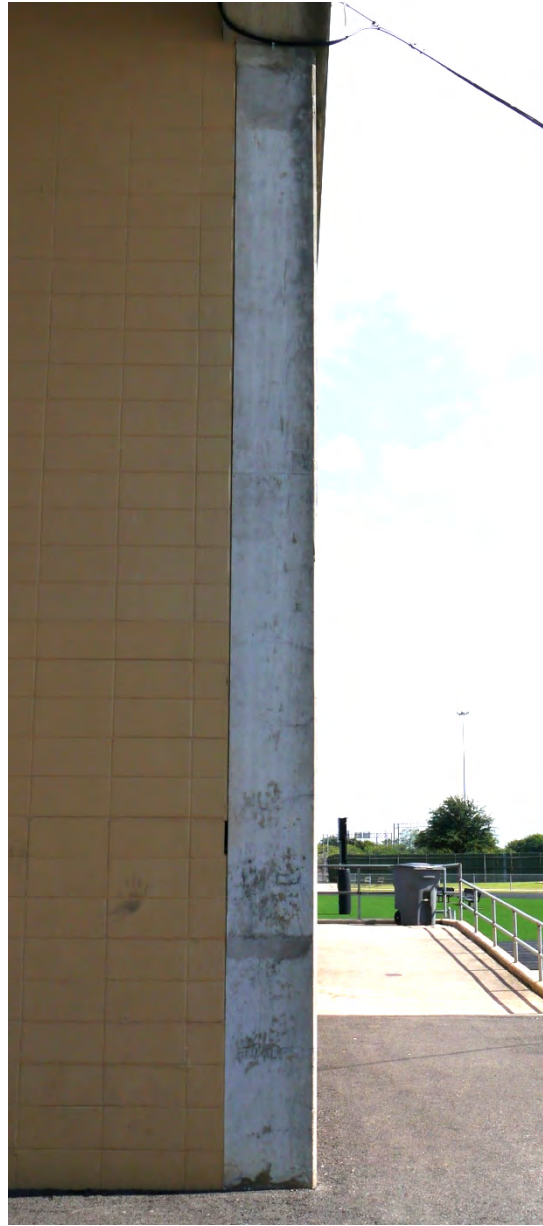
Lateral deflection at top of column – top portion of column has separated from CMU wall

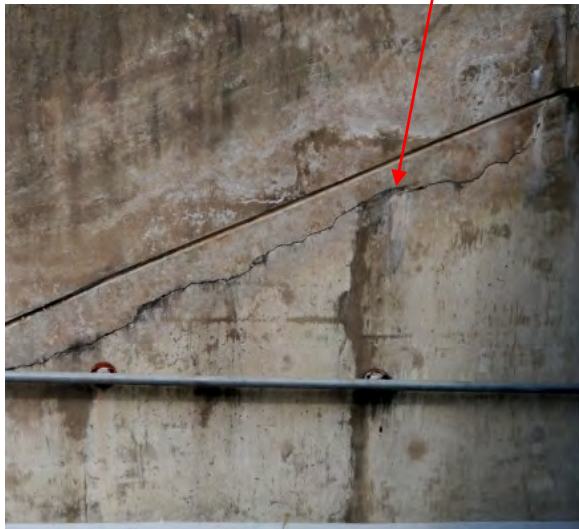
Cracks at south ramp wall do not appear to have been repaired via epoxy injection

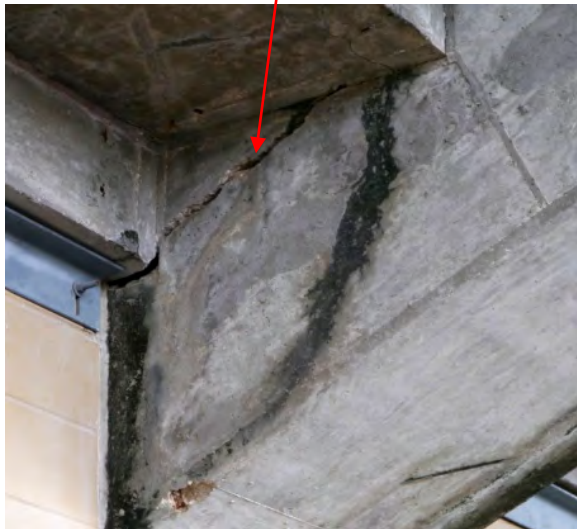
Cracks at nearby beam do not appear to have been repaired via epoxy injection

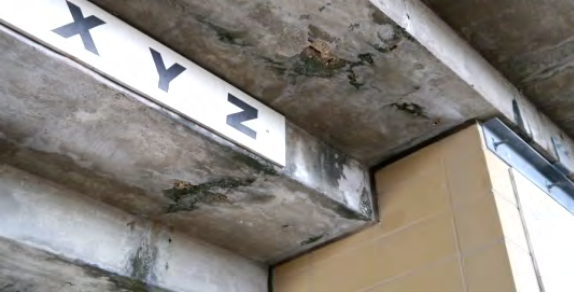
Significant cracking in deck and joists; Water stains due to water infiltration thru deck cracks

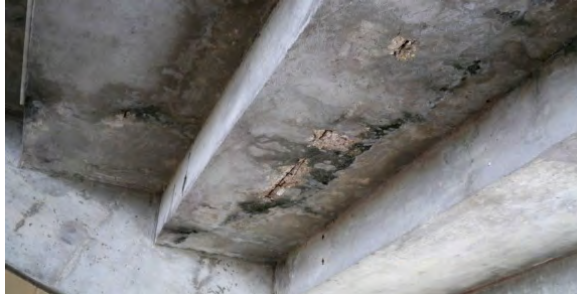
Spalling with exposed/corroded reinforcing at underside of deck;  
Water stains due to water infiltration thru deck cracks

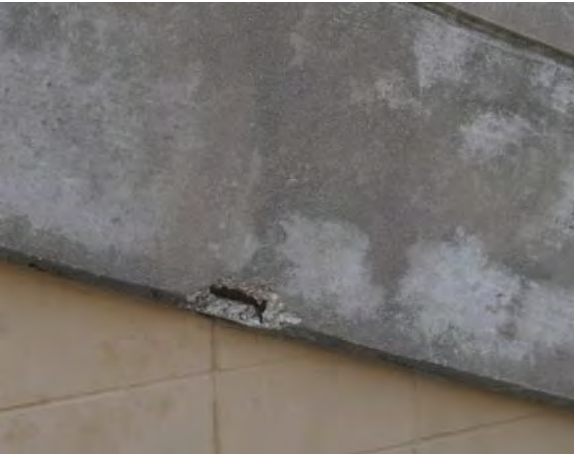
Exposed/corroded beam reinforcing

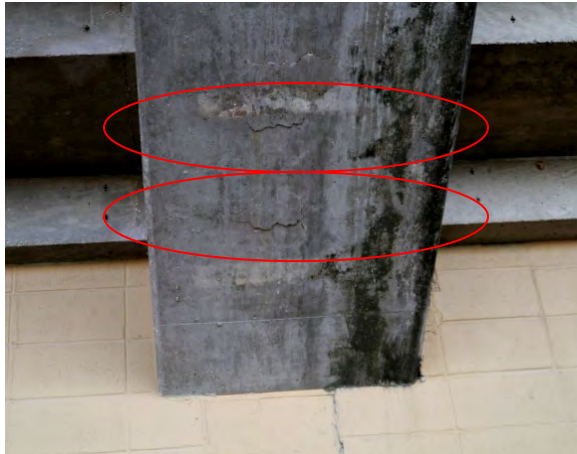
Cracked beam soffit

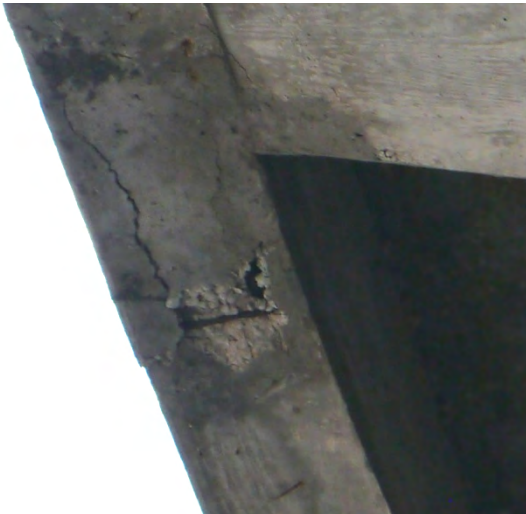
Failing concrete repair patch on beam soffit; Exposed/corroded  
beam reinforcement

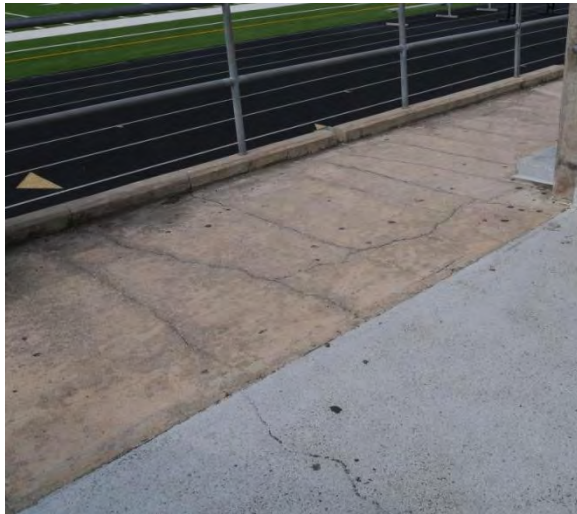
Prevalent cracks on top of deck allow water to infiltrate the  
concrete & exasperate progression of damage

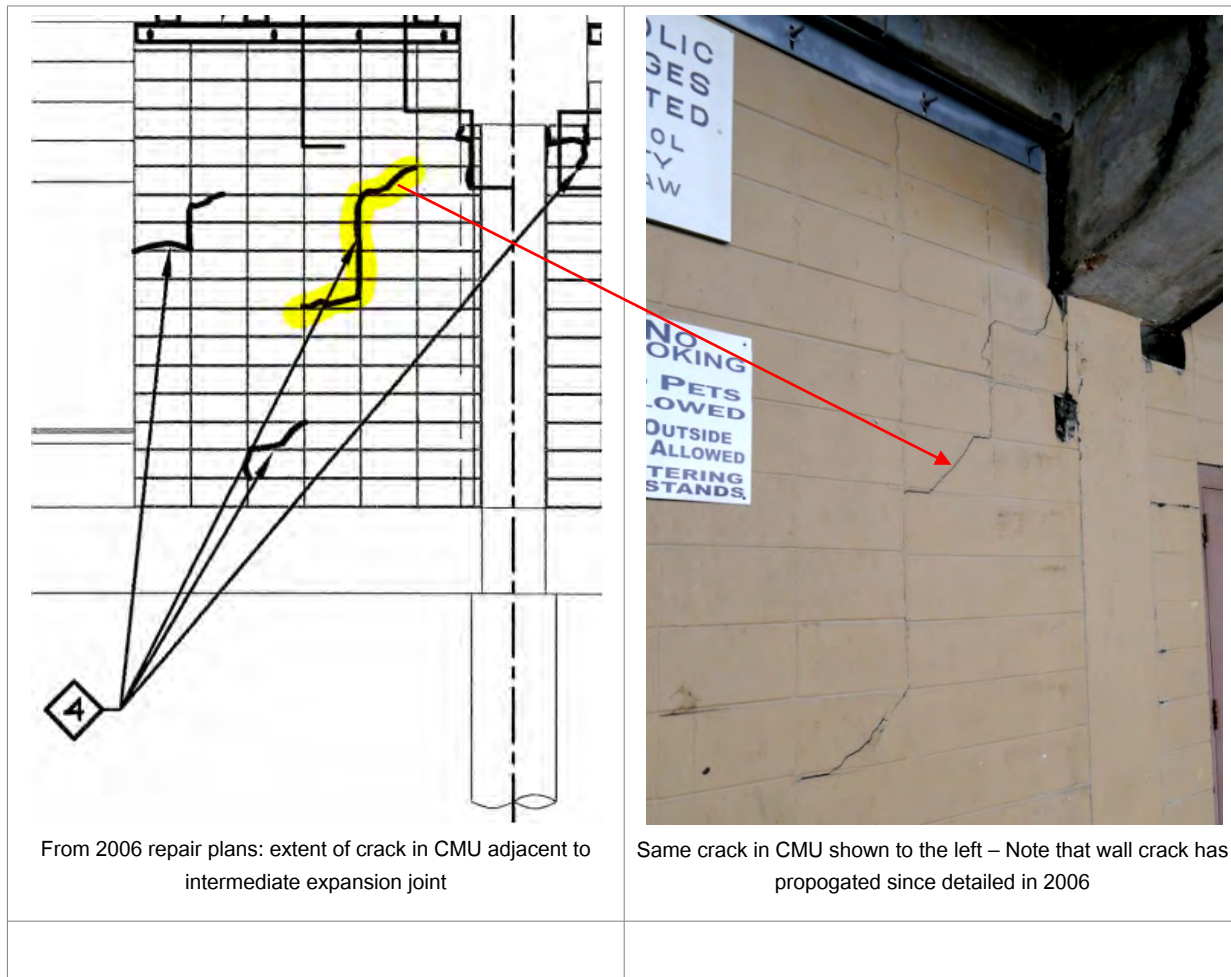
- **CMU Walls:** Old and new cracks were prevalent in the CMU walls below the stadium seating.

In the 2006 repair work, the top of the CMU walls were retrofitted at their connection to the concrete stadium framing because, according to the 2006 repair documents, the concrete framing had settled vertically and was inadvertently loading the non-load bearing CMU walls and causing wall distress.

Several cracks that were supposed to be epoxy injected in 2006 did not appear to have been repaired, and some of those cracks appear to have worsened.
