## STRUCTURAL ASSESSMENT – Delco Activity Center (BLDG-284A)

| Building Purpose | Event Center |
| Inspection Date | September 8, 2016 (Morning) |

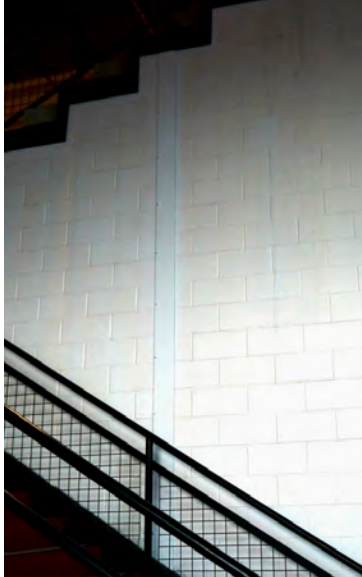
**Reported Structural Concern:** Exposed control joints in the CMU walls at building entryways have widened near the top of the walls. One CMU control joint has opened so much that maintenance personnel installed a vertical cover plate to conceal the joint. Delco Activity Center has also developed mild to advanced cracks in exposed concrete floor slabs throughout the facility.

Vertical Cover Plate Concealing Opened CMU Control Joint at NW Entry

**4. Cracked CMU Walls:** Seal larger cracks with a flexible sealant. Existing control joints that have opened can be cleaned and resealed with a flexible sealant.

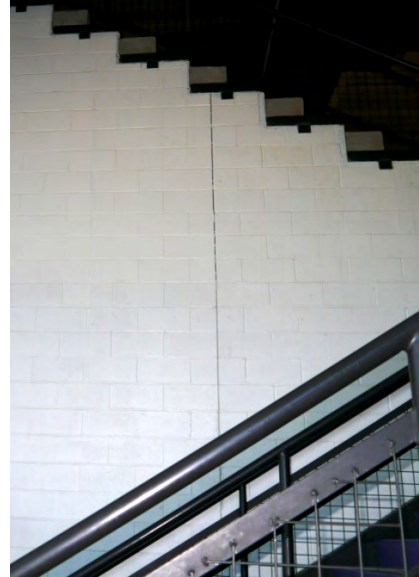
- **CMU at Corner Entries:** Long, tall CMU walls are exposed at the ends of the bleacher seating adjacent to the entry stairs at each corner of the building. Vertical control joints in the exposed CMU walls at the NW and SW entryways had visibly opened (widened) near the top of wall. The joints appeared normal (typical width) lower on the walls (closer to slabs). The vertical control joints in the same CMU walls at the NE and SE entryways appeared normal width for the full height of the walls.

Partially Opened CMU Wall Control Joint at SW Entry

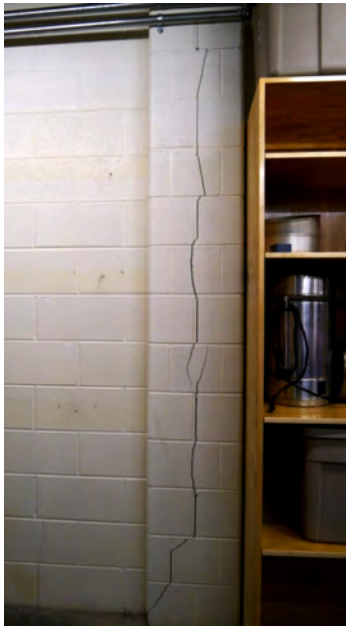
Large Vertical Crack in CMU Pilaster

We suggest treating CMU wall cracks and where abutting walls are separating in a similar manner – fill with a flexible sealant.

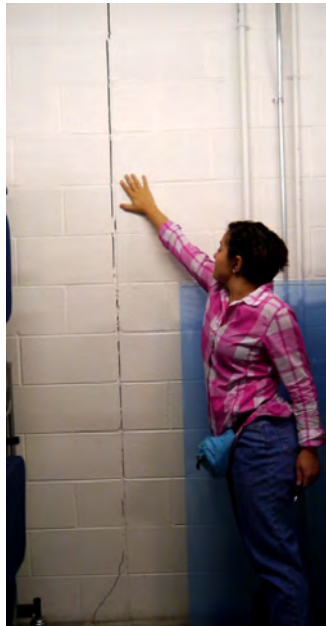
Widened Control Joint in Interior CMU Wall

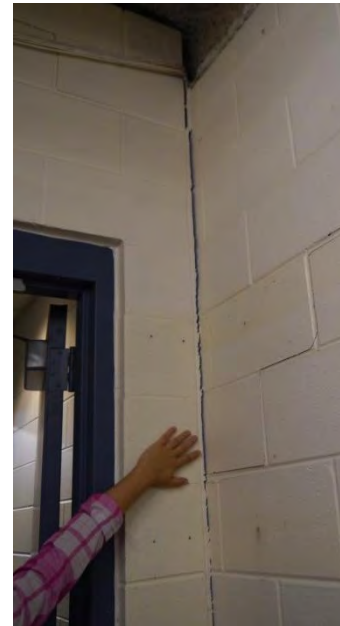
Separation at Abutting CMU Walls

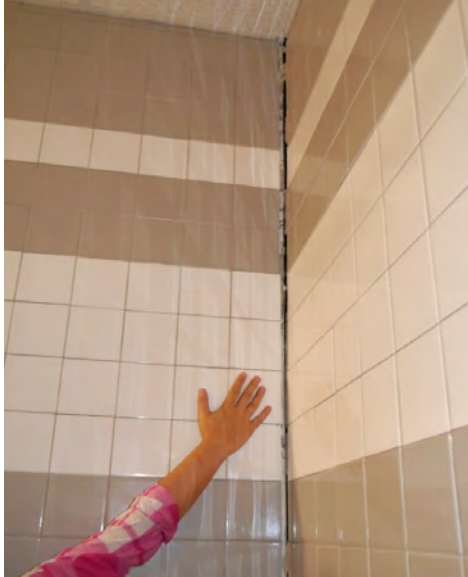
Separation at Top of Abutting Interior Walls

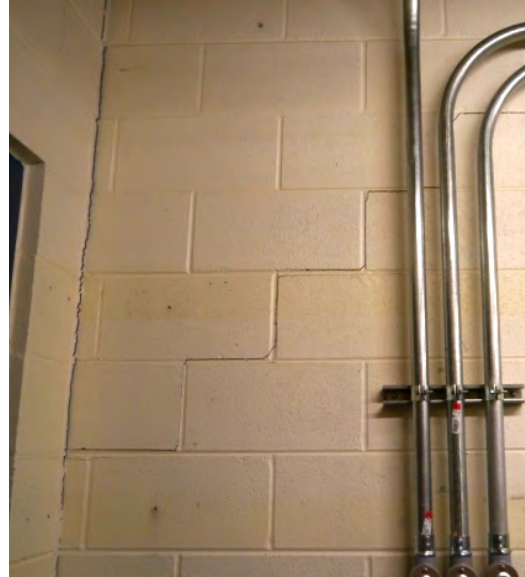
Abutting Interior Walls Have Separated, Diagonal Cracks in Interior CMU Wall

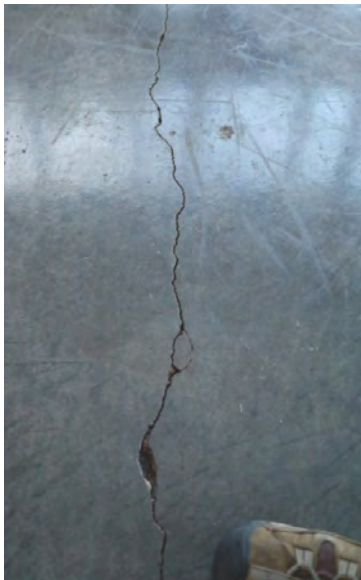
- **Slabs at Corner Entryways:** Large cracks were observed in the exposed concrete slabs at the corner entryways. The cracks typically ran from the perimeter of the building to the stairs leading up to bleacher seating.

Large Slab Cracks at Corner Entryways

**3. Cracked Topping Slab:** Rout and seal larger cracks and cracks exposed to foot traffic with a flexible sealant.

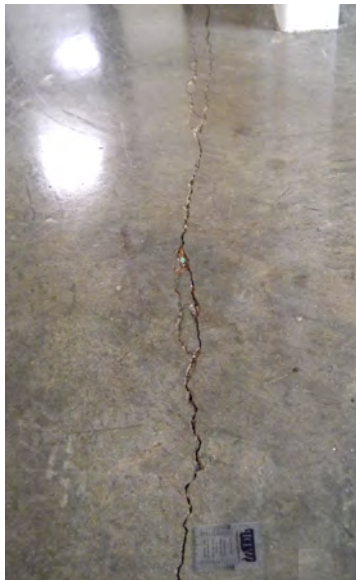
Large Slab Cracks at Corner Entryways

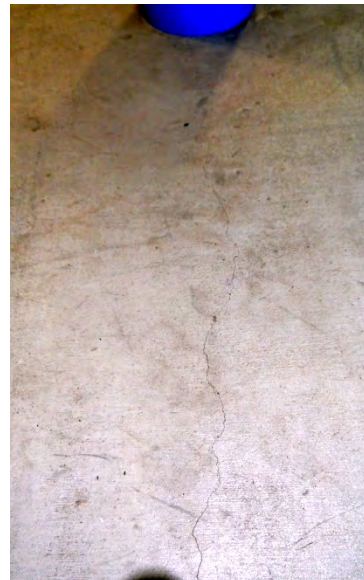
Slab Cracks at Top of Entryway Stairs

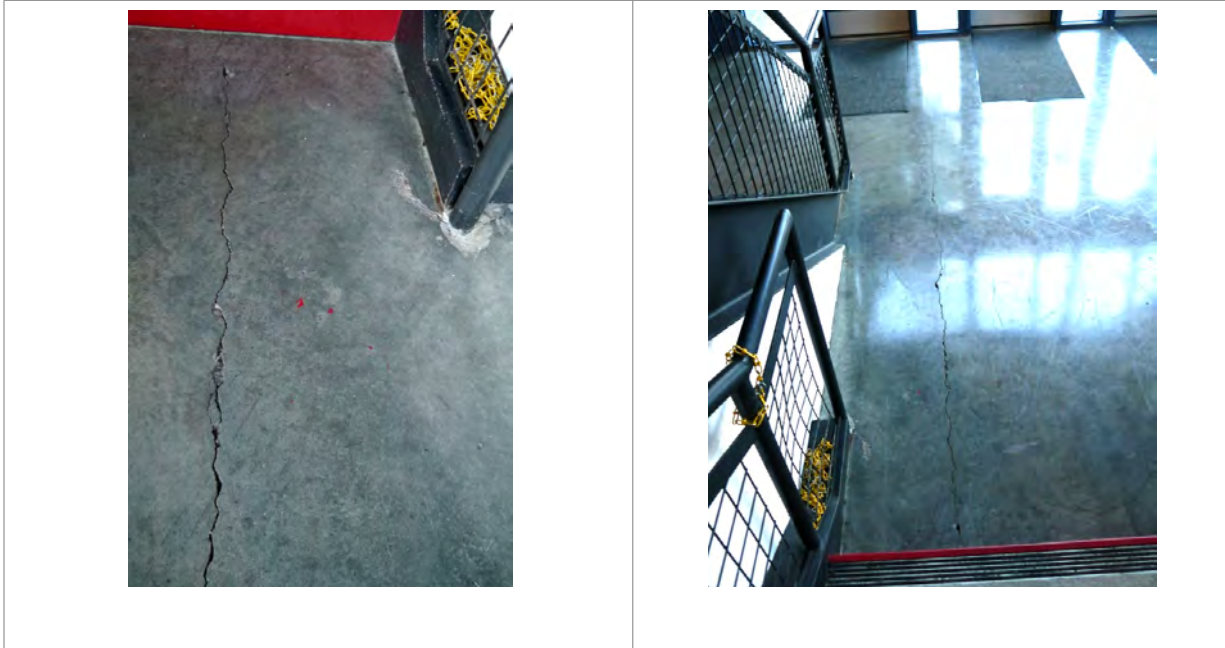
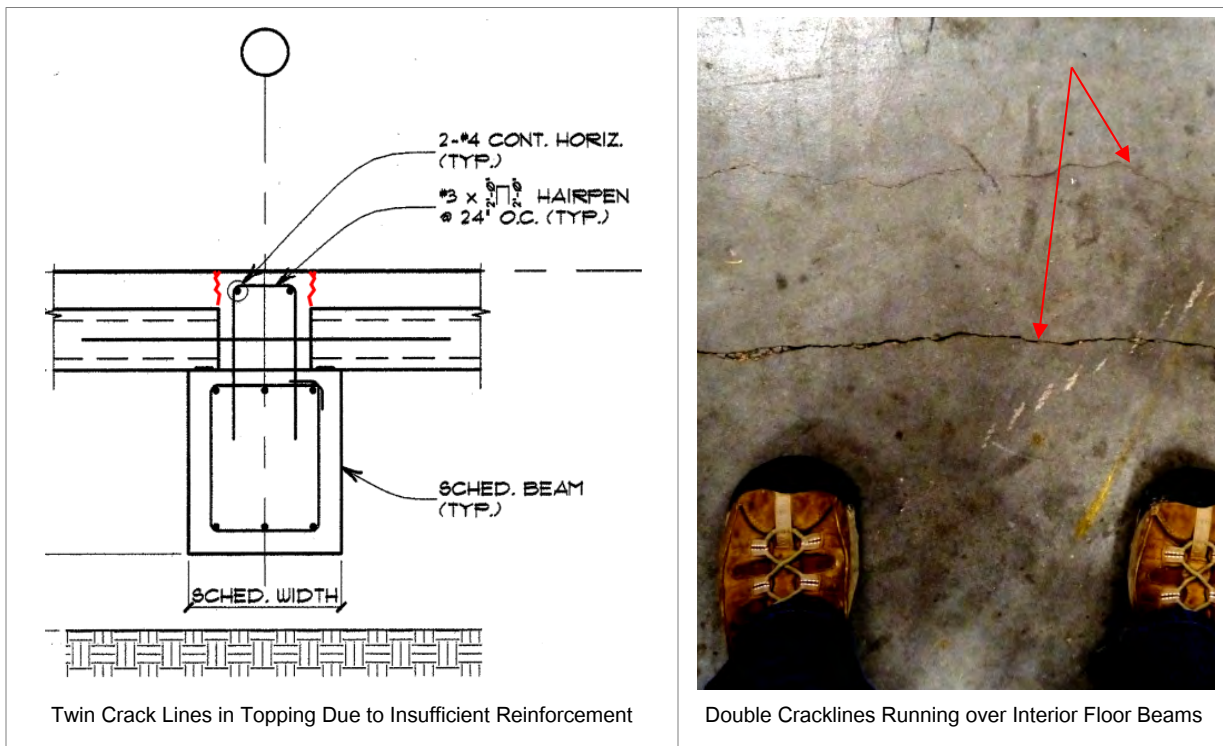
- Slab Twin Crack Lines:** Small- to large-sized twin crack lines were observed in the topping slab throughout the facility; the double crack lines run parallel to each other roughly 12" apart. The observed crack lines generally ran in the north-south direction and seemed to coincide with beam lines. Similar cracks ran north-south adjacent to existing double control joint lines (also over beams). These cracks are likely reflective cracks occurring over the hollow-core plank ends bearing on the floor beams, and this type of cracking is relatively common in topping slabs with insufficient reinforcing to support the tension forces in the top of slab either because enough steel area wasn't provided or the slab reinforcement was not chaired properly during construction. See detail below – the red line represent the twin crack lines.

The slab cracks should be treated otherwise they are likely to worsen over time. We suggest routing the larger cracks in walkways and public-use areas and sealing with a flexible sealant that will accommodate future movement. The double crack lines over ends of hollow-core planks can be left alone if small, or if cracks are large or if foot traffic causes the cracks the worsen over time then they can be treated in a similar fashion to the entryway cracks (rout and seal).

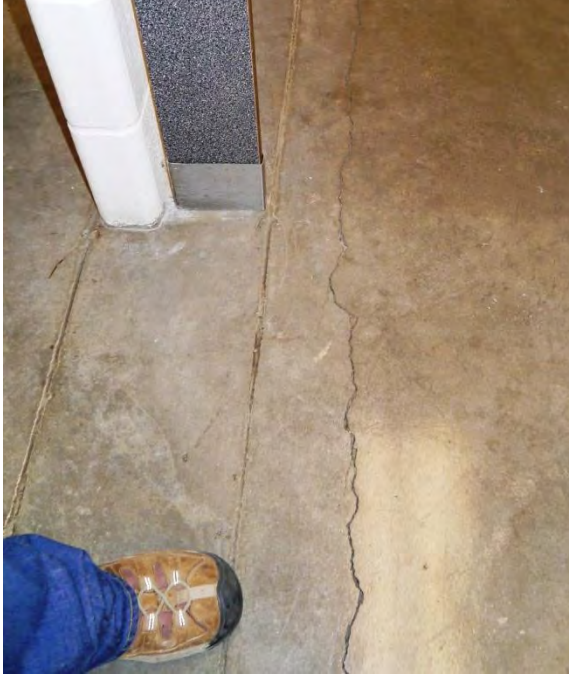
Large Slab Cracks Adjacent to Double Control Joints

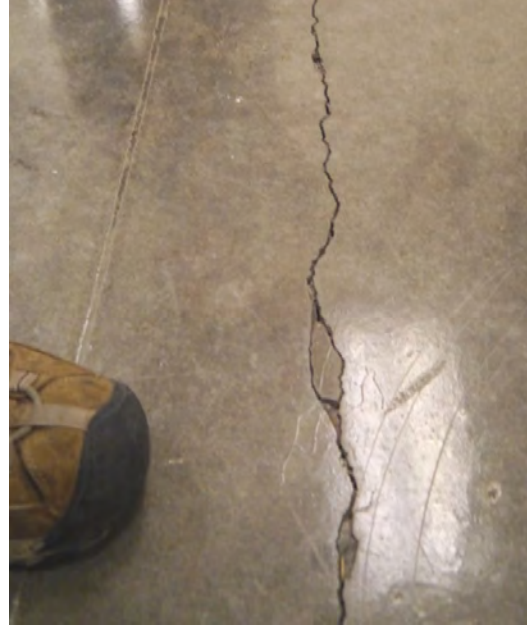
Large Slab Cracks Adjacent to Double Control Joints

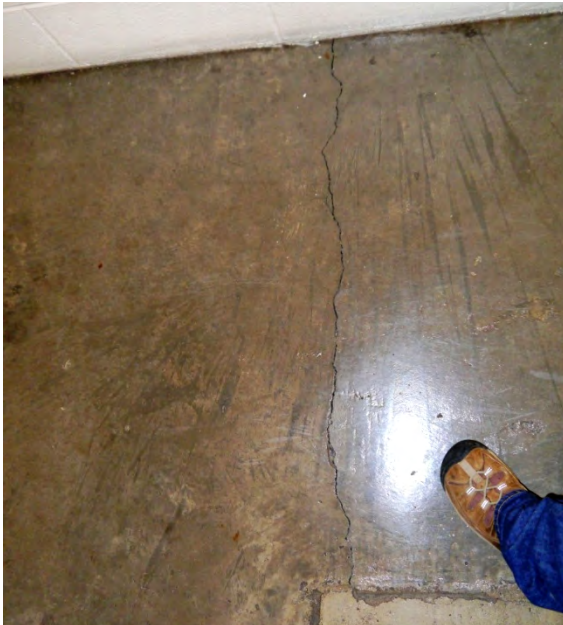
Slab Topping Crack in Walkway in Front of Bleacher Seating

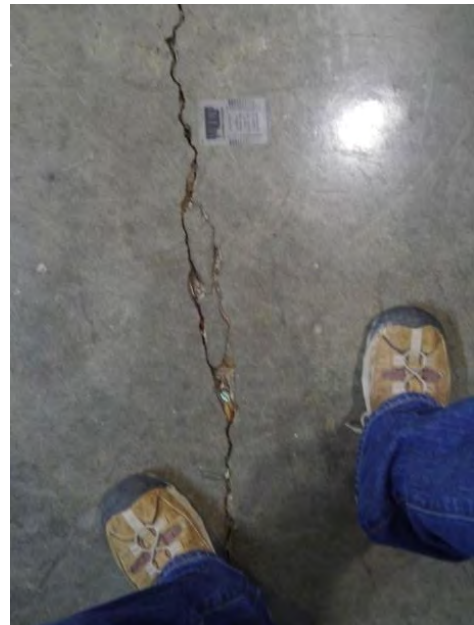
Large Slab Crack Near Central Chiller Room

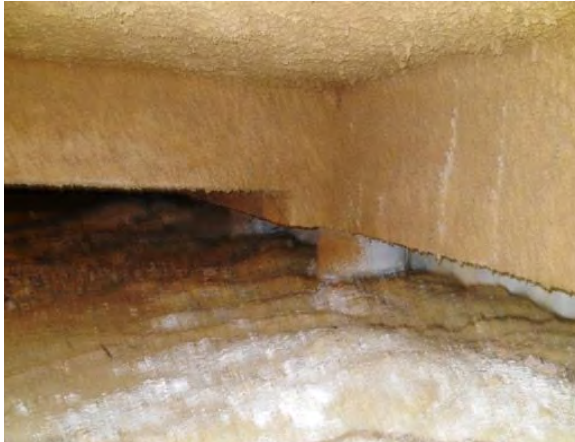
- **Structure in Crawl Space:** Floor framing in crawl space was concealed behind spray-on fireproofing and could not be closely observed. This is unfortunate because we were not able to evaluate the condition of the concrete framing supporting the corner entryways and perhaps better understand the behavior causing the wall and slab cracks above.

Concrete Floor Framing Obscured by Spray Fireproofing

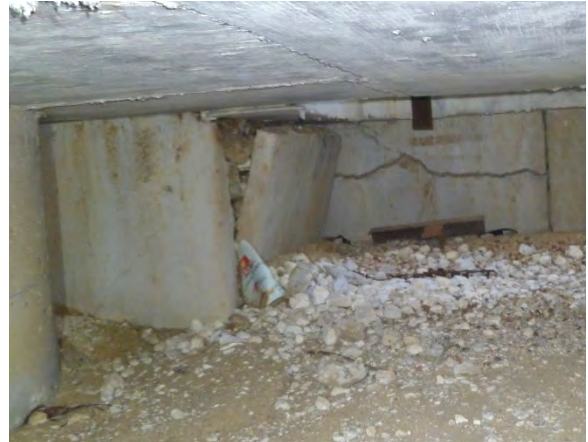
No obvious signs of structural distress such as spalling or large cracks were detected through the spray-on fireproofing. Most soil retainers appeared in good condition, although a few retainers were cracked or had caved allowing exterior soil in fill in the void below the perimeter beam. Columns and piers also appeared to be performing well; all seemed plumb and cleanly cast (no mushroom tops, honeycombing or apparent stress cracks).

Cracked and Caving Soil Retainers

- a. Re-grade soils in crawl space to effectively carry surface water to existing storm drains. Lower drain inlets if required to maintain a minimum 2% slope downward to the storm drain inlets.
- b. Replace all broken and collapsed soil retainers, remove any caved soils in contact with bottoms of beams

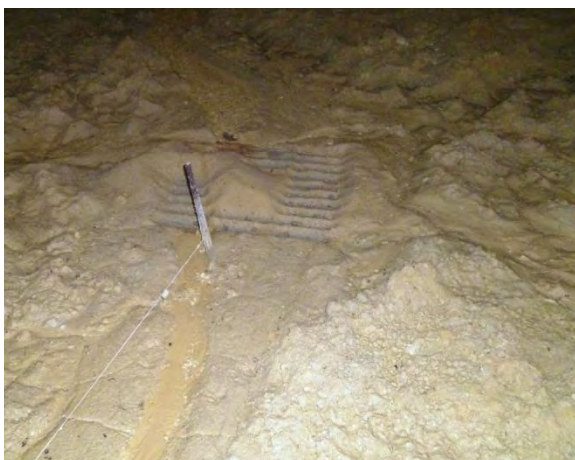
- Soil in Crawl Space:** Soils in the crawl space were damp to very saturated at the time of our site visit, which indicates a substantial amount of water is infiltrating into the crawl space below the building either through the areaway openings or from heavily saturated soils around the exterior of the building. Likely water is getting into the crawl space through both means: clear signs of water flow from several areaways was apparent from the track marks visible in the soils. There were two floor drains inside the crawl space and soil was very wet around both of them, which indicates water is not flowing into the floor drains quickly and is instead soaking into the surrounding clay soils. Soils in the crawl space appeared mostly flat and are likely not maintaining positive drainage into the floor drains.

Flat, Saturated Soils Surrounding Floor Drain

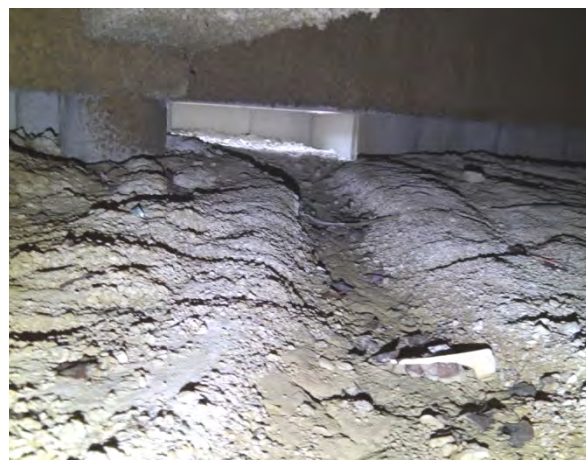
Clear Flow Lines in the Soil Leading From Areaway Openings

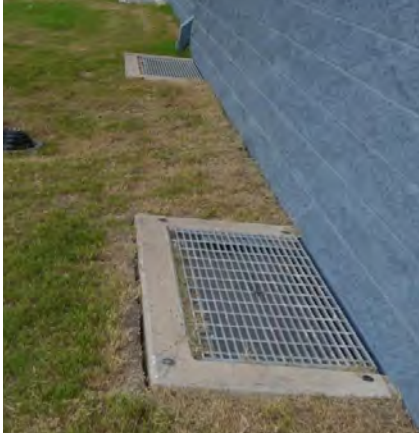
- Areaways:** Several areaways around the perimeter of the building seemed to have very low curb heights that likely do not effectively prevent surface water around the perimeter of the building from flowing down into the crawl space.

Low Areaway Curb Heights Allow Water into Crawl Space

An additional measure to help control soil moisture is to minimize exposed ground surface around the building by constructing a continuous concrete apron around the building perimeter. Areaway curbs should also be retrofitted so they are at least 3 inches above the surrounding ground/concrete surface.

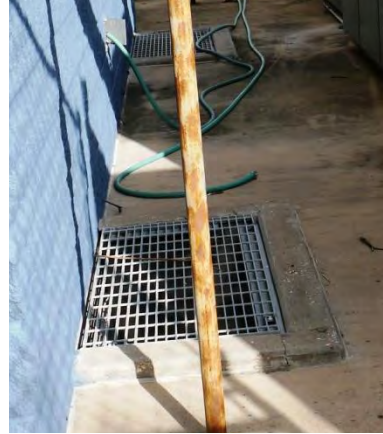
Low Areaway Curb Heights Allow Water into Crawl Space

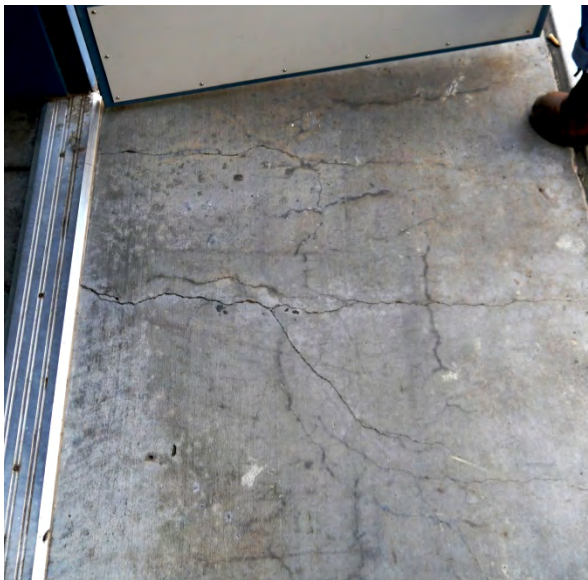
- **Exterior Slabs and Flatwork:** Cracks in the topping slab at corner entryways extended to the topping slab outside the doors. In addition, concrete flatwork adjacent to the building was cracked; cracks were even observed in flatwork that appeared to have been recently replaced.

Exterior Topping Slab Cracks at Corner Entryways

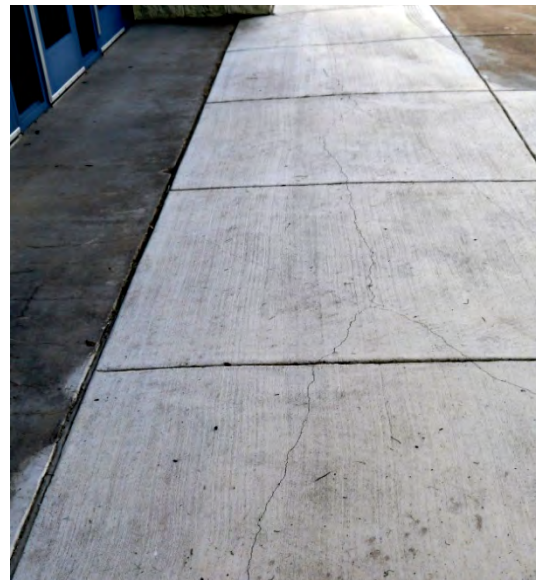
Cracks in Newly Replaced Flatwork

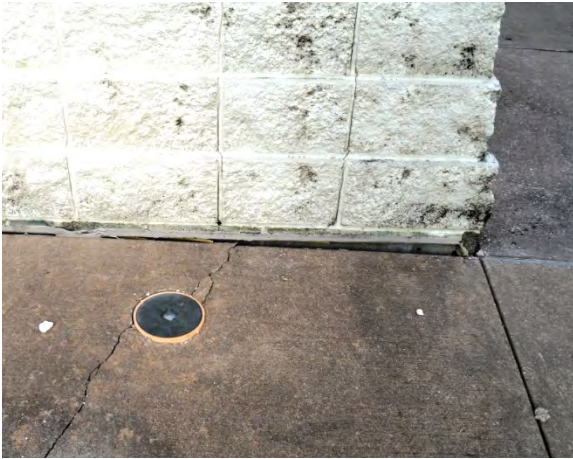
Exterior Flatwork Around Corner Column has Settled

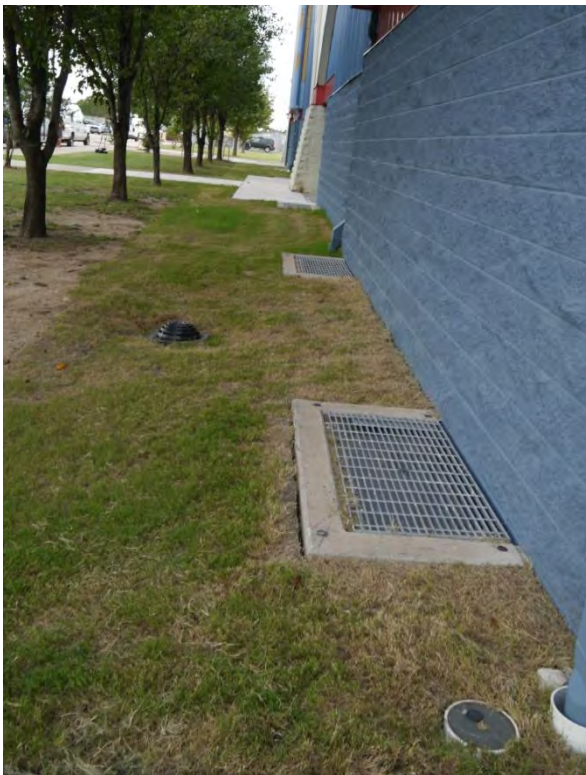
- **Site Grading & Drainage:** Grading around the perimeter of the building appeared flat in several areas and is likely not effectively draining water away from the building.

Flat Grading Around Perimeter of Building

The most important repair effort to limit building movement is to address exterior site grading and drainage. Chan & Partners Engineering, LLC outlines a comprehensive plan to overhaul grading and drainage across the site in their Preliminary Drainage Investigation Memo (dated 11/24/2015): they recommend acquiring a current topographical survey around the building to understand existing grades, testing the existing storm drainage system to confirm it is fully operational, re-grading landscaped areas and flatwork surrounding the building to promote positive drainage to the storm drains, sealing cracks in the perimeter roadways to limit moisture intrusion. They estimate the repairs will cost roughly \$175,000. We recommend executing all of their suggested repairs, but we suggest allotting an increased budget of \$250,000 to perform the work.

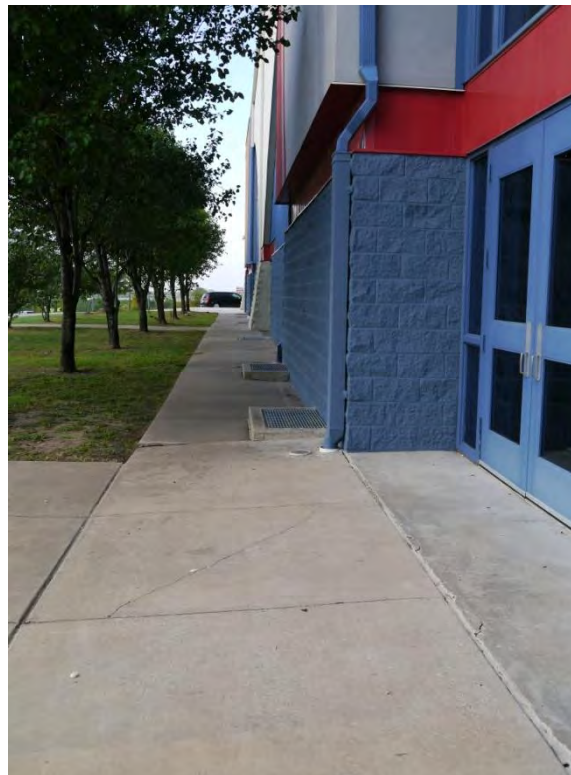
Flat Grading Around Perimeter of Building

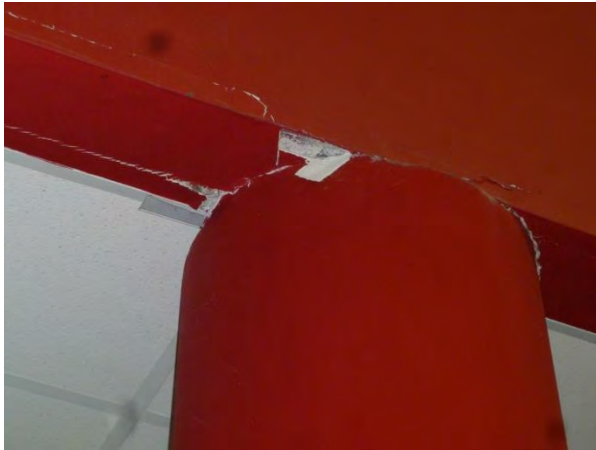
Finish Damage at Top of Red Column Near NW Entryway

**5. Interior Finishes:** Damage to interior finishes was minimal but can be repaired if desired. Any repairs to finishes are purely cosmetic and are not required structurally. Also, please note that differential soil movements may cause finishes to crack and separate in the future, so it may be worthwhile to monitor finishes after other repairs are made to verify damage will not recur before repairing.

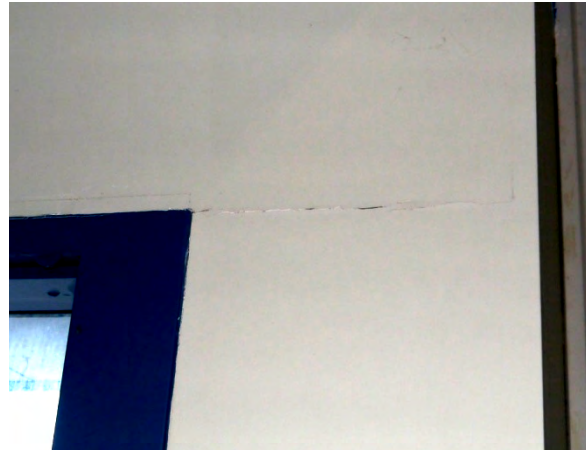
Crack in Wall Finish at Entryway Window Corner

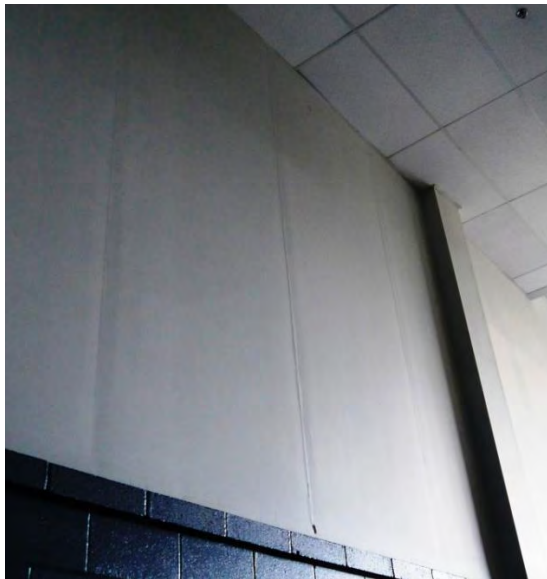
Perimeter Wall Finish Damage Above CMU in Outer Corridor

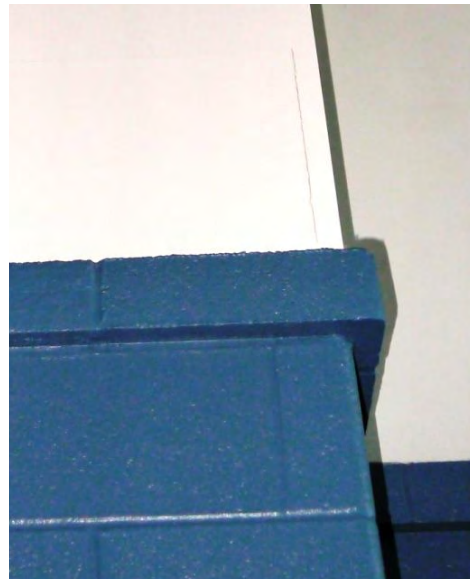
Wall Finish Damage Above CMU Pilaster in Outer Corridor
