ALC Ridgeview Special Campus Site Summary

Main School Building – BLDG-012A

CRAWL SPACE – Ridgeview ALC – Main School Building (BLDG-012A)

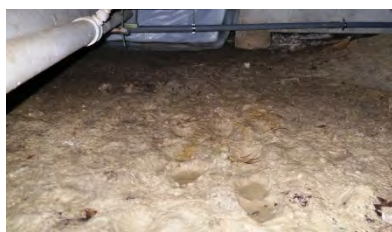
Saturated soil

1. Investigate need for site re-grading to promote drainage away from building & limit damp soils in crawl space.
2. Investigate need for ventilation in crawl space areas.
3. Clean rusting hatch frames and grates and protect from further corrosion
4. Secure exterior access doors with padlocks to prevent unauthorized access into the crawl space.

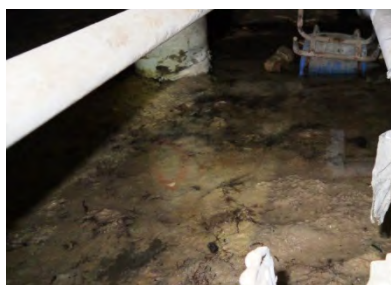
Standing water

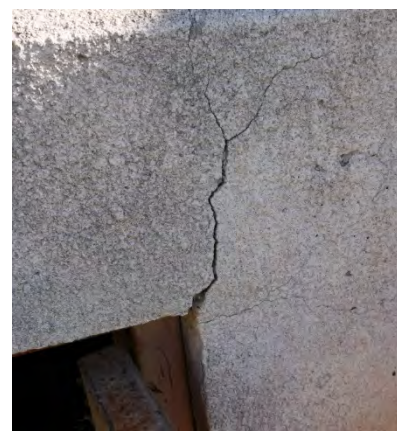
Cracking at corner of access hatch

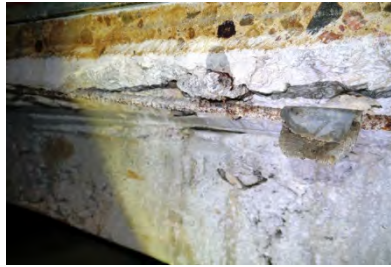
Exposed rebar around access hatch

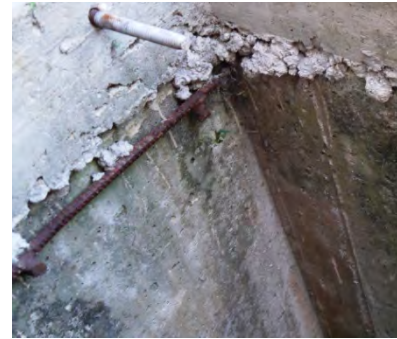
Exposed rebar around areaway

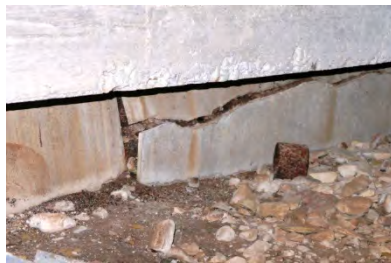
Cracked soil retainers

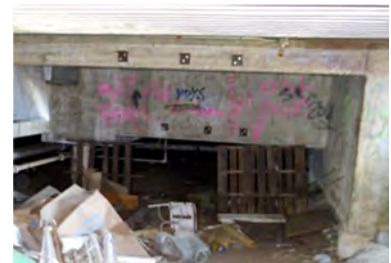
Signs of unauthorized intrusion

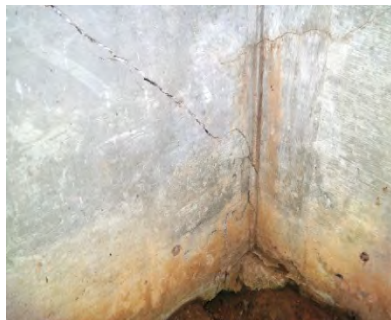
Exposed Faces of Perimeter Walls / Beams	<p>Large cracks were observed on the perimeter beams in the 400 classroom wing addition. Most cracked perimeter beams were located on the east wall. Cracks appeared at openings in the beam for access hatches and vents. The worst cracking was found where the interior beams tied into the exterior beams. Exposed rebar near the bottom of perimeter beams was also observed on perimeter beams in the classroom addition. Perimeter beams in the original construction were generally in good condition with the exception of small cracks on the perimeter beams in the 100 classroom wing. Form ties were left in place on most perimeter beams in the original construction.</p> <p>Perimeter wall/beam deficiencies:</p> <ul style="list-style-type: none"> • Significant cracking • Exposed/corroded rebar 	Poor
	Exposed Portions of Interior Floor Beams Above	<p>Suspended interior floor beams are supported by columns and perimeter beams. Most observed beams in the original construction were in good condition with some having honeycombing on the face of the beams and exposed rebar.</p> <p>Beam deficiencies:</p> <ul style="list-style-type: none"> • Honeycombing • Exposed/corroded rebar 	Average

Cracks in perimeter beams

1. Repair badly spalled/honeycombed areas of the slab, beams and columns.
2. Clean exposed slab reinforcement and protect from corrosion.
3. Perform additional structural investigation to determine extent of damage to the 1962 classroom addition and appropriate retrofit measures.
4. Repair cracks in columns and perimeter beams in the classroom addition building pending results of structural investigation.

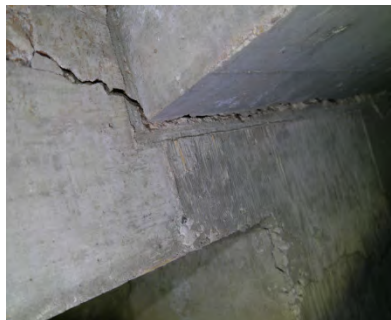
Cracking at exterior and interior beam connection

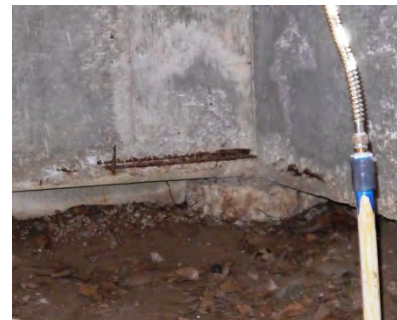
Exposed rebar at bottom of perimeter beam

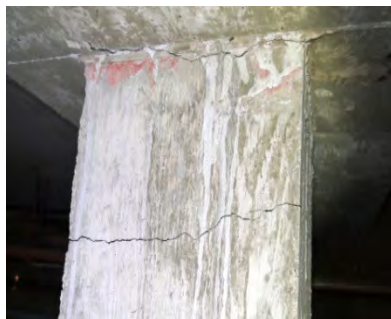
Crack on inside face of column

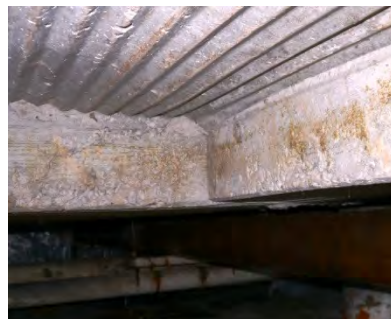
Honeycombing on interior beams

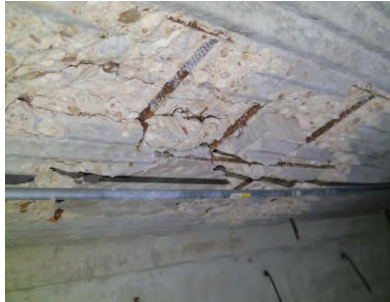
Underside of Suspended Floor Slabs Above	<p>The suspended floor system consisted of a flat slab in both the original construction and the classroom addition. Exposed rebar in the slab was observed at access Access #4, Access #6, and Access #8. Large spalls had led to the exposed reinforcing at Access #4".</p> <p>Slab deficiencies:</p> <ul style="list-style-type: none"> • Exposed/corroded rebar • Spalls on underside of slab 	Average
Pipes, Ducts, Equipment & Fireproofing	Suspended Pipes & Hangers	<p>The crawl space had many suspended pipes. Deficiencies observed included heavily rusted pipes and hangers.</p> <p>Pipe deficiencies:</p> <ul style="list-style-type: none"> • Rusted pipes & pipe hangers • Moldy/degraded pipe insulation 	Average
	Exposed Ductwork	Ductwork was only found in Access #5 under the hallway next to room 502. The duct had rusting on all visible parts of it.	Poor
	MEP Equipment	N/A – No MEP equipment was present in the crawl space areas observed.	N/A

<p>Exposed rebar in slab</p>

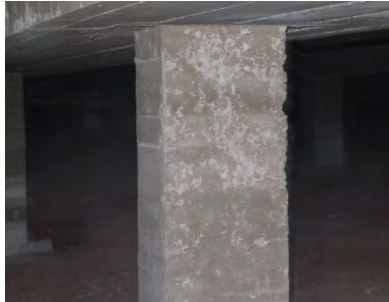
<p>Honeycombing on column</p>

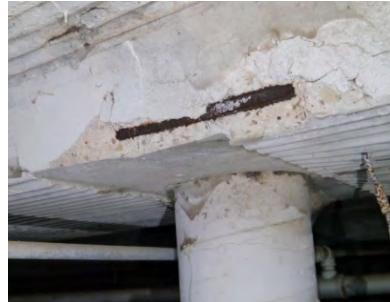
<p>Exposed rebar on interior beam</p>

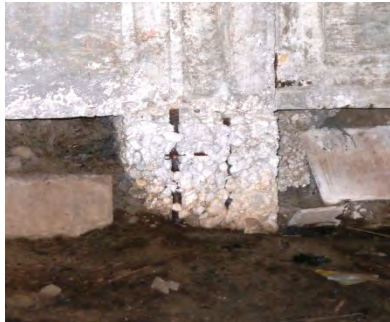
<p>Honeycombing and exposed rebar on column</p>

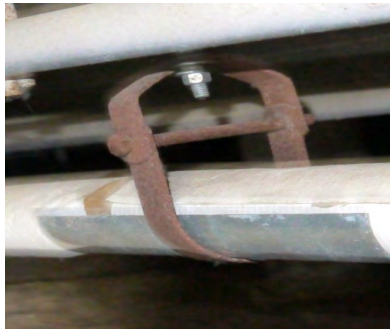
<p>Rusted pipe hanger</p>

1. Repair leaking pipe.
2. Clean and protect rusted cast iron pipes from further corrosion.
3. Replace heavily corroded hangers.
4. Replace missing/degraded and wet spray-on fireproofing.
5. Replace/repair rusted ductwork

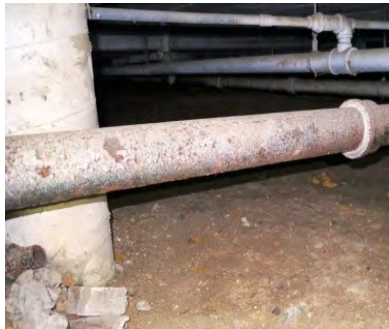
<p>Rusted pipe</p>	  <p>Rusted ductwork, moldy pipe insulation</p>

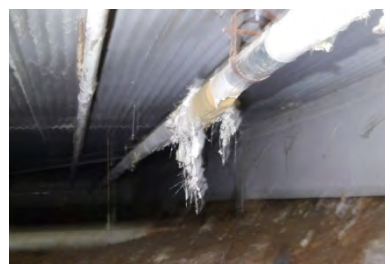
<p>Degraded pipe insulation</p>
