## STRUCTURAL ASSESSMENT – Ridgeview ALC – Main School Building (BLDG-012A)

Building Purpose	Administrative, Classrooms, Gym, and Cafeteria
Inspection Date	October 25, 2016 Afternoon
Inspection Conditions	79° - Cloudy & Dry

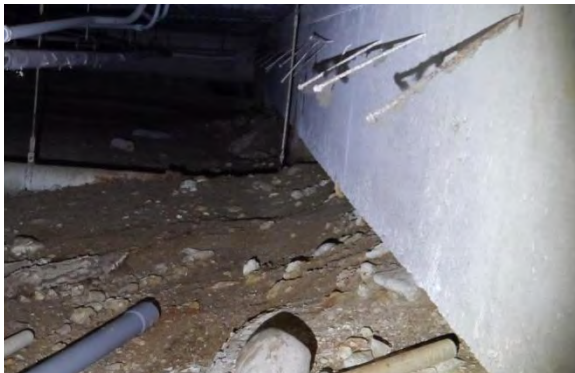
Damp soil around perimeter of building

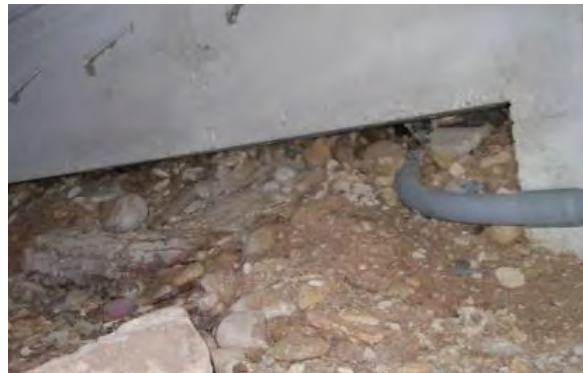
Void space below perimeter beam is filled with soil

8. Replace all damaged or caved soil retainers and restore void spaces below perimeter beams.
9. Inspect roof drains, gutters, etc. and repair as needed. Collect all water from roof and discharge at least 20ft away from the building (preferably collect in a storm sewer).

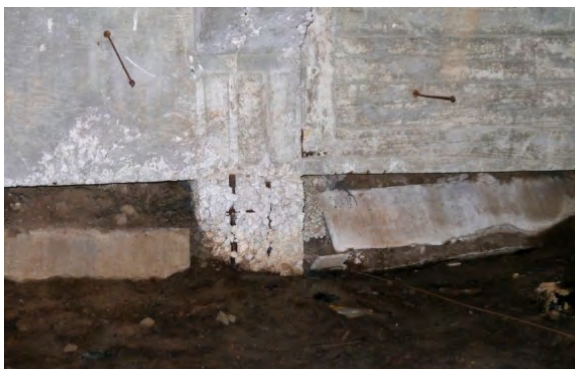
Damp soil, Failing soil retainers, Honeycombing and exposed/corroded column reinforcement

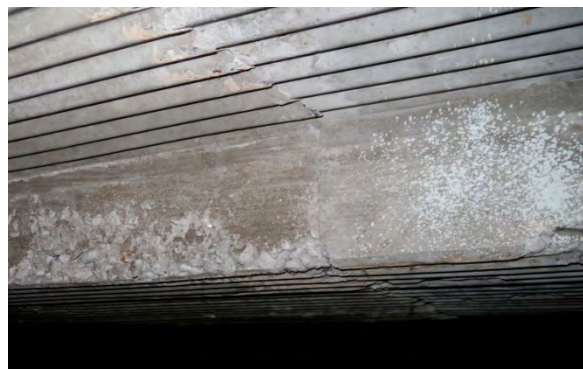
Concrete honeycombing on face of interior floor beam

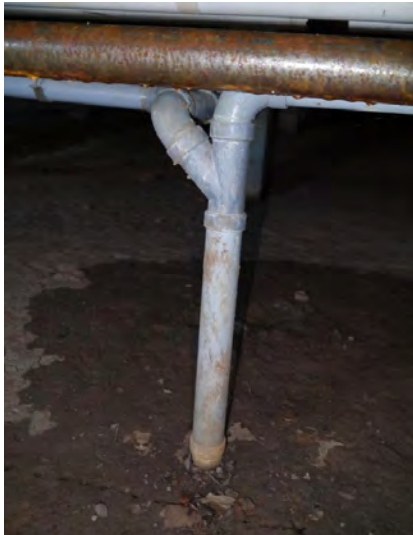
Condensation on pipes, potential pipe leak

6. Properly vent the crawl spaces by adding new areaways and a mechanical ventilation system.
7. Inspect crawl space pipes and repair all pipe leaks found.

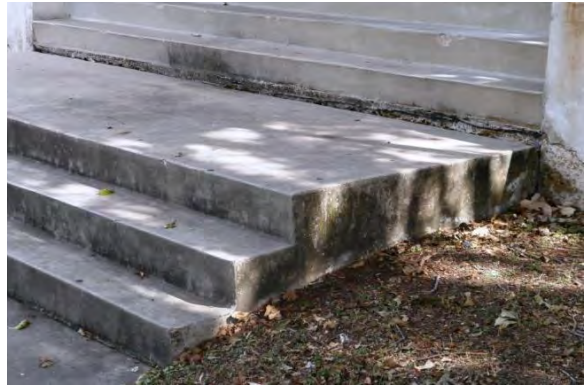
Grade-supported stairs have displaced vertically

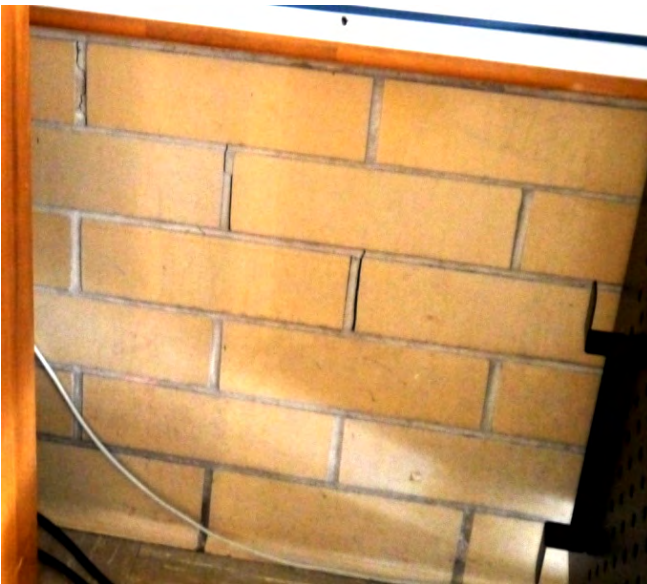
Cracks in classroom brick wall

16. Seal interior wall cracks with a flexible caulk.

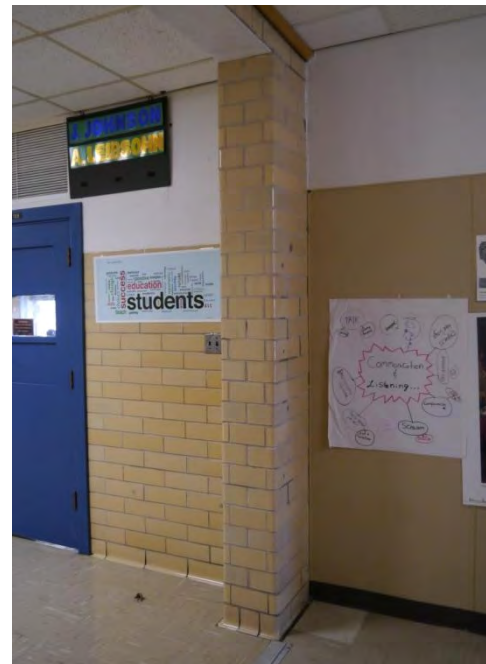
Cracks on hallway column at expansion joint between original building & 1958 west addition

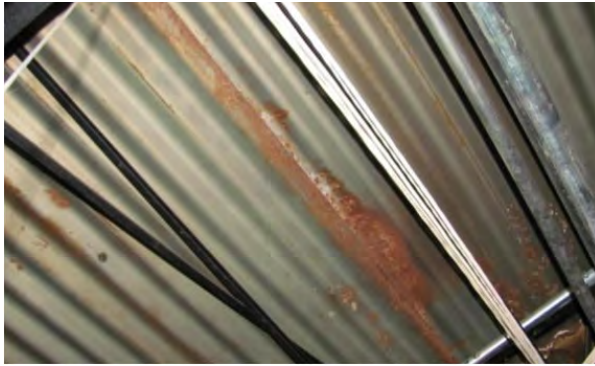
Significant deck corrosion at lap joints

10. Replace the roof membrane and repair any damage due to past leakage.
11. Once existing roof membrane is removed but before new roof system is applied, thoroughly clean the more heavily rusted areas of the metal deck. Add strips of new decking at end laps and side lap joints, etc. that are in particularly poor condition. Weld or fasten new decking to existing support members and existing deck.

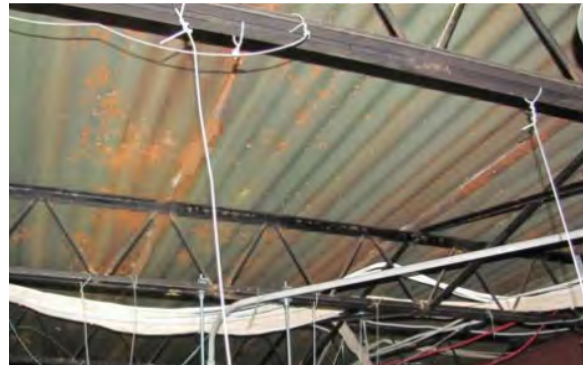
Significant deck corrosion

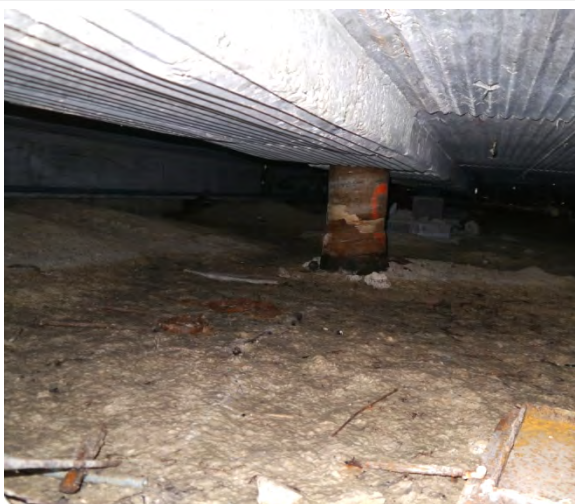
Saturated soils in crawl space

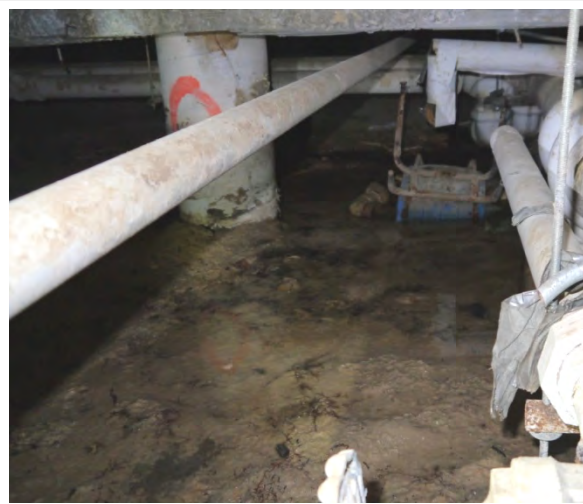
Standing water in crawl space

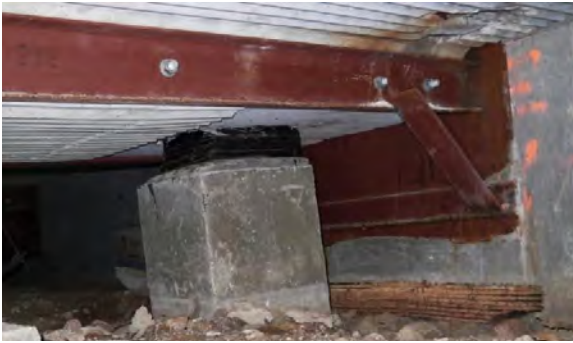
200 Wing floor framing retrofit appears in good condition

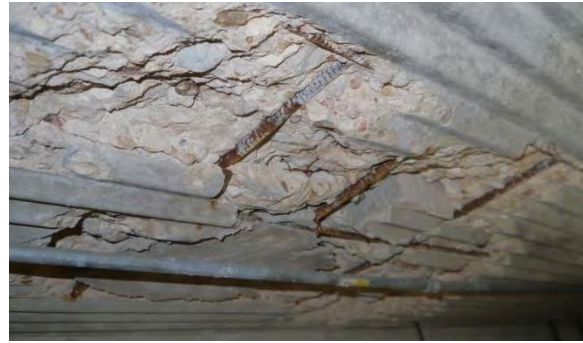
200 Wing slab spalling with exposed/corroded rebar

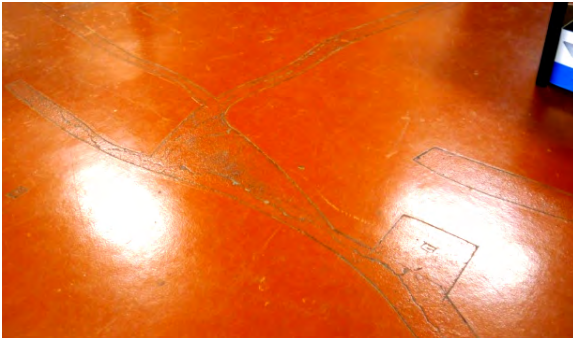
200 Wing Kitchen reopened slab cracks

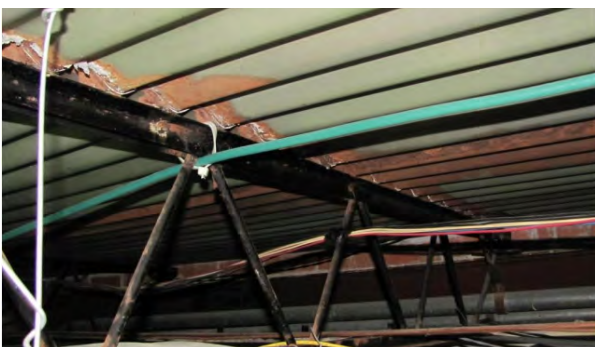
Advanced deck corrosion, joist corrosion

12. Perform a thorough inspection of the roof framing currently concealed by ceilings and identify all areas with significant corrosion. Once all areas are identified, clean rust from the open-web joists and/or steel framing and paint with a rust-inhibitive primer to prevent further corrosion. Repair deck as noted above.

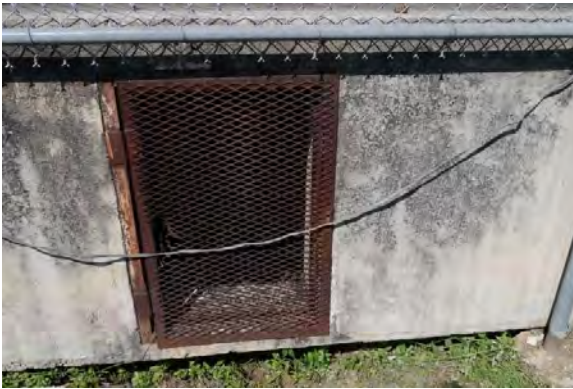
Crawl space hatch door is welded shut

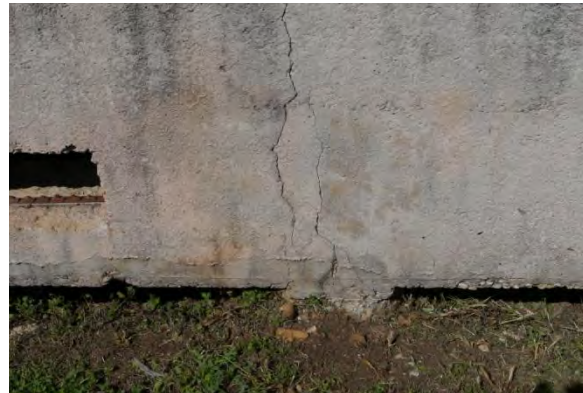
Outside face of perimeter beams show signs of structural distress

5. Either remove the existing concrete floor framing for the demolished 200 and 300 Wings or fill with a flowable fill material. If filled with flowable fill, regular vent holes should be used to verify no air gaps remain.

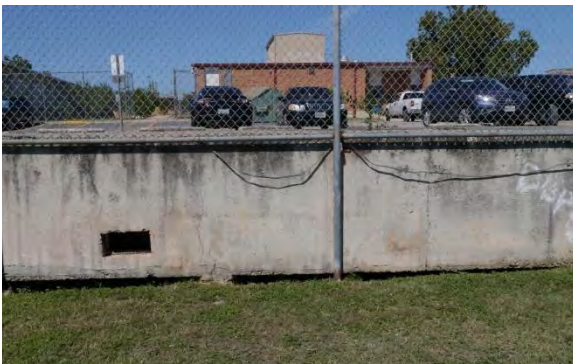
300 Wing floor framing is currently being used to support parking

**Demolished 300 Wing and eastern portion of 200 Wing:** The concrete floor framing for the eastern portion of 200 Wing and the 300 Wing that remains in place and is being used as a parking surface needs to be removed or filled with a flowable fill. **Occupying the compromised floor framing is potentially dangerous and should be avoided.**

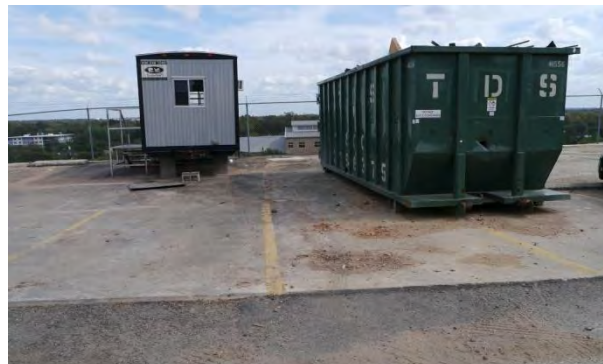
300 Wing floor framing is currently being used to support a dumpster and construction offices

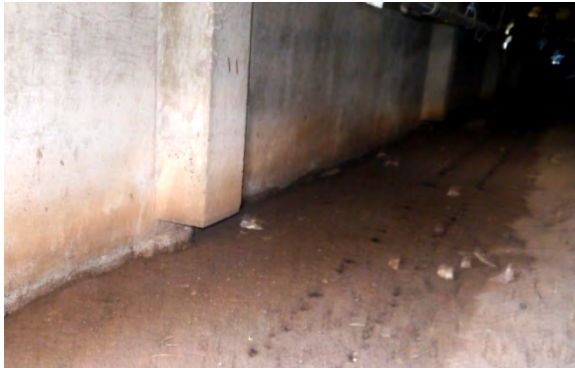
Soil damp around perimeter of wing

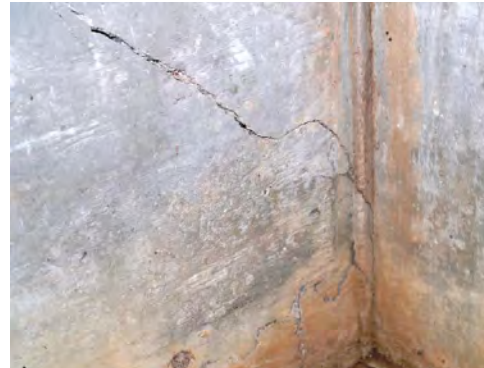
Diagonal crack at southeast corner

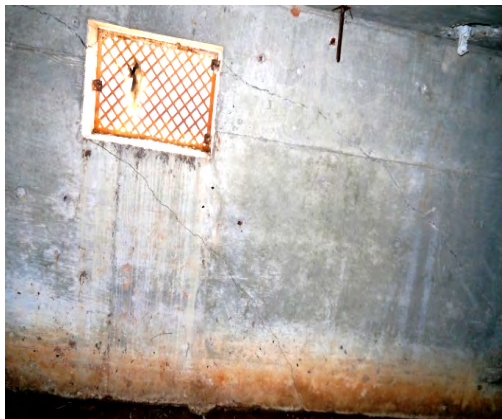
Diagonal cracks around vent opening

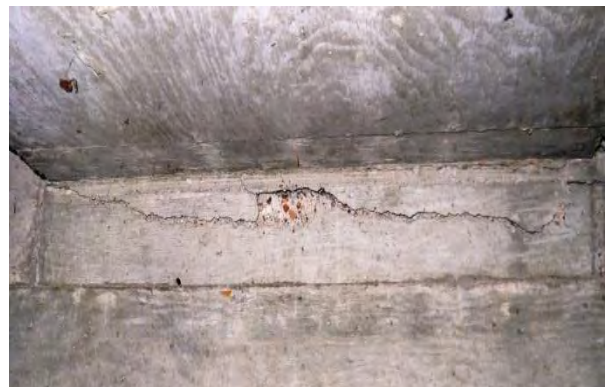
Horizontal crack under interior beam

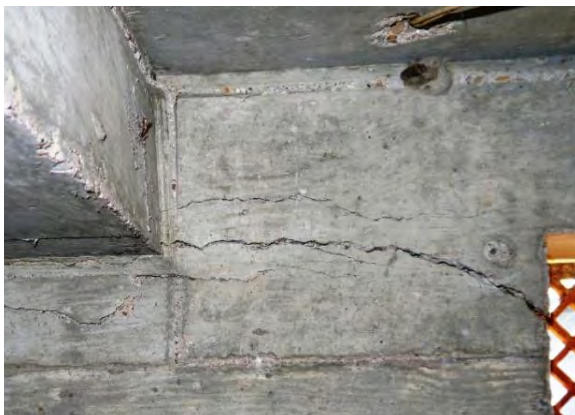
Crack from bottom of interior beam to vent

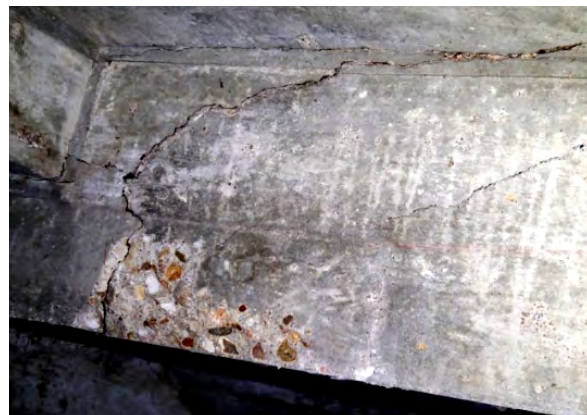
Cracks on 400 Wing east perimeter beam at abutting interior beam (near stairs)

**400 Wing:** The interior column cracks observed in the 400 Wing crawl space are likely due to soil movement and would not continue to worsen if the moisture content of the surrounding soil is controlled. The damage at the east perimeter beam, however, appears to be due to the scarp creep. The perimeter beam appears to be separating from the rest of the floor framing and is sliding eastward down the scarp. Implementing drainage measures to keep the scarp soils relatively dry can help reduce the downward creep of the soil. The east perimeter beam will also need to be retrofitted with deeper foundations to isolate it from the creeping soil.

13. Repair connections of crawl space interior beams to the perpendicular east perimeter beam of the 400 Wing. Use epoxy-injection and concrete repair mortar to fill cracks and spalls.

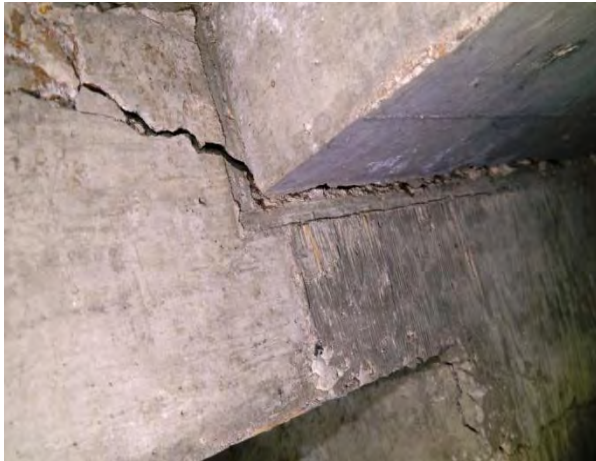
Diagonal crack on 400 Wing east perimeter beam near bottom of abutting interior beam and (near stairs)

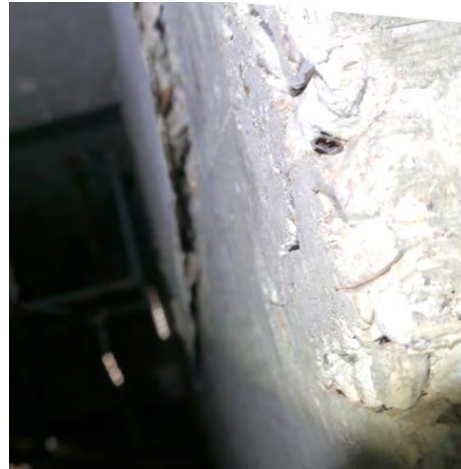
East perimeter beam is shifting eastward and pulling away from perpendicular interior beams

14. Widen the 400 Wing east perimeter beam and add up to five new deep piers (for pricing assume 30ft depth) to isolate the beam from scarp movement.
15. Seal exterior brick cracks with a flexible sealant.

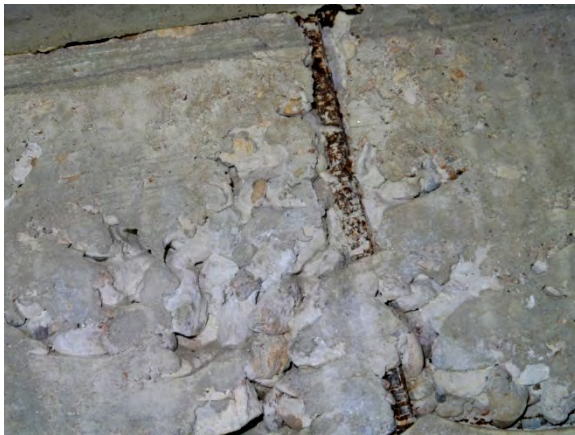
Concrete honeycombing, exposed/corroded reinforcement

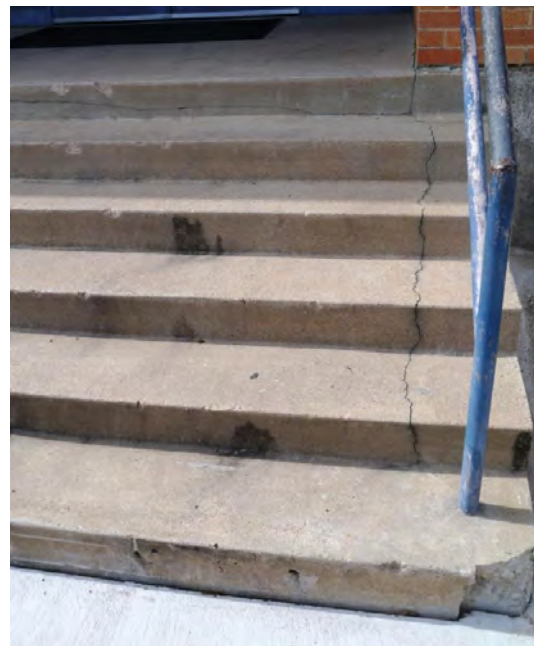
Exterior vertical crack on 400 Wing east exterior stairs

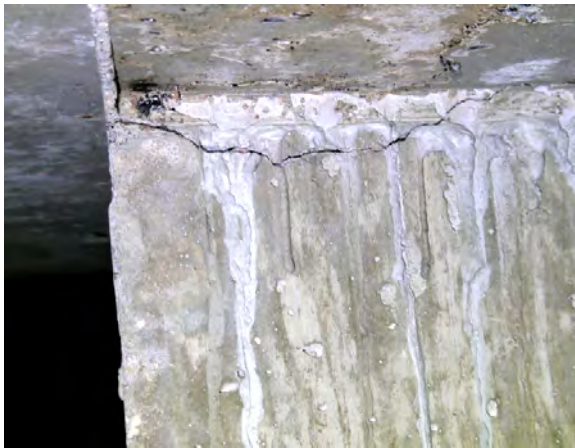
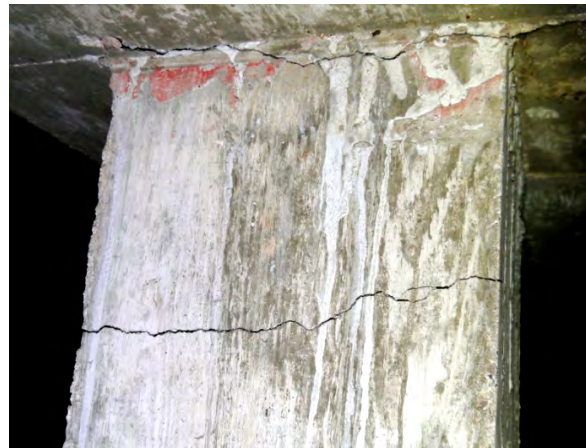
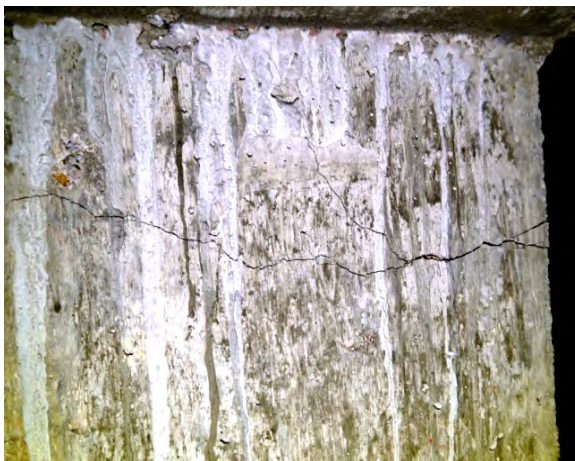
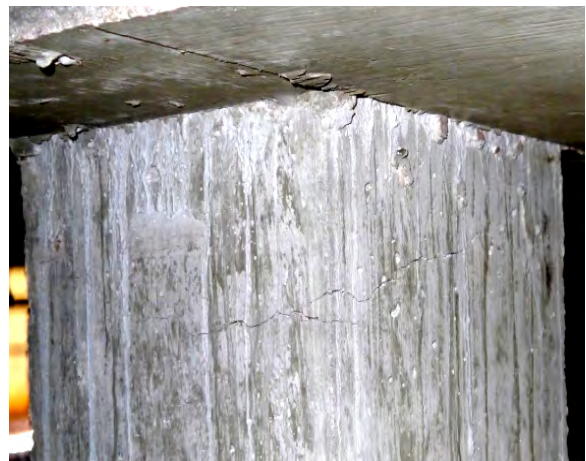
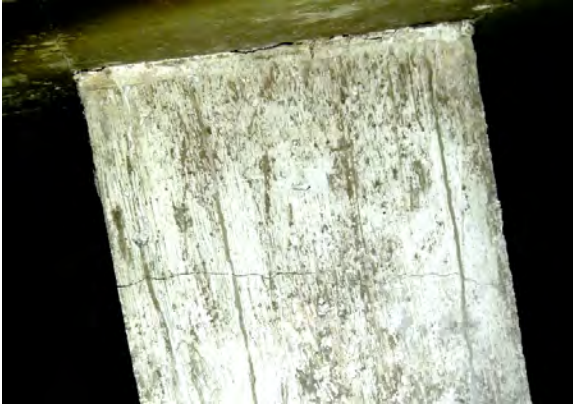
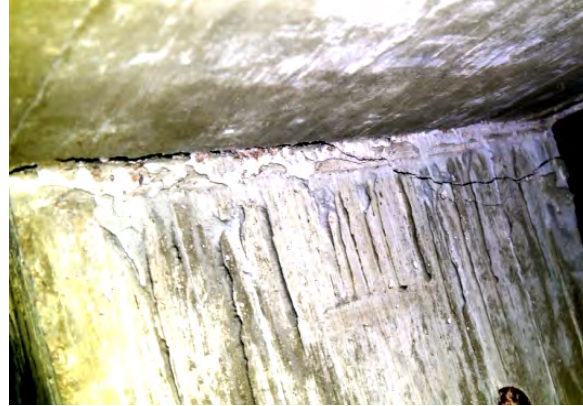
Several interior concrete columns in the crawl space had horizontal cracks near the connection to the interior beam above. The cracks sometimes travelled to the underside of the interior beam. The largest cracks were observed on the inner faces of the columns. The crack widths get smaller on each column as they progress westward along the length of the wing. Smaller horizontal cracks were observed on west column faces. The figure below identifies the faces of the columns with horizontal cracks. The two outer rows of interior columns were also observed but no obvious signs of distress were apparent.

400 Wing Column Horizontal Crack

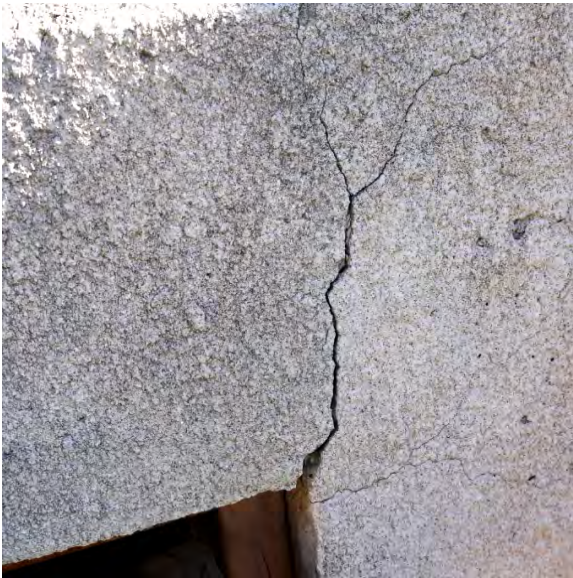
Diagonal crack at top of access hatch

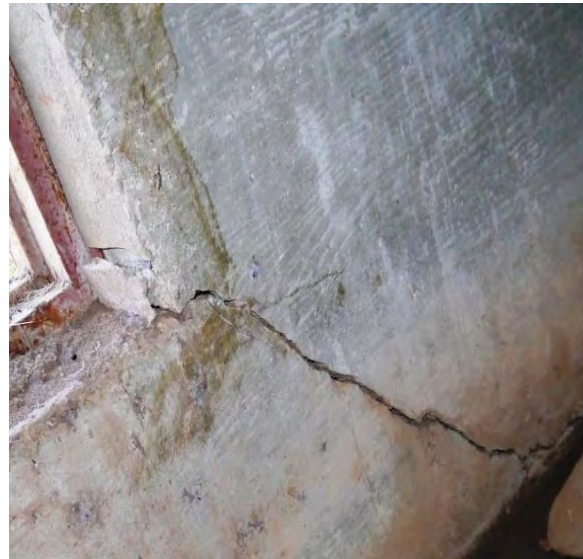
Access hatch diagonal crack from interior

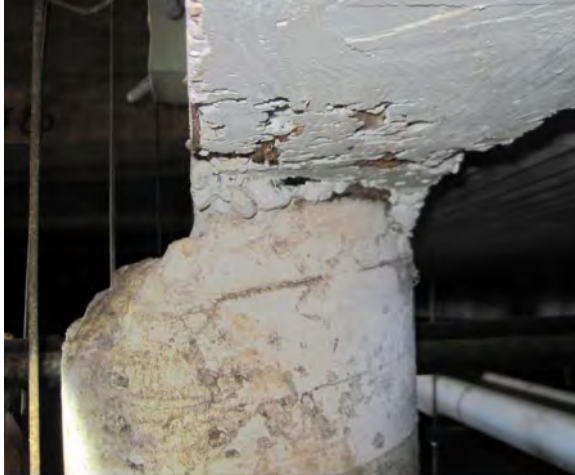
Exposed/corroded beam rebar, beam not centered over pier

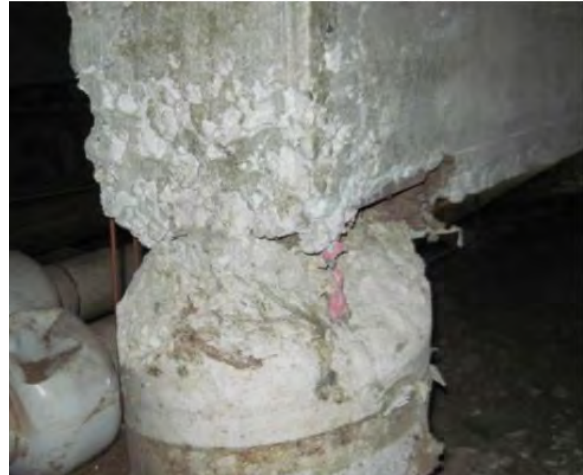
Exposed/corroded beam rebar, extensive honeycombing at pier-beam connection

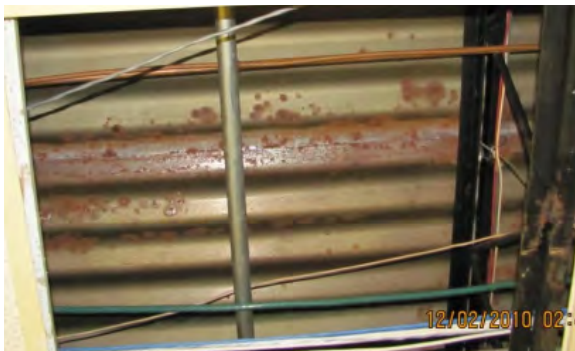
Advanced roof deck corrosion

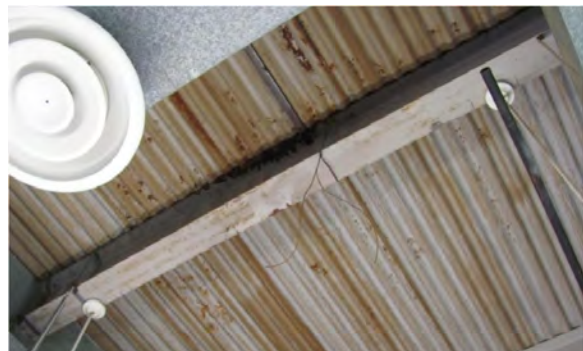
Roof deck corrosion

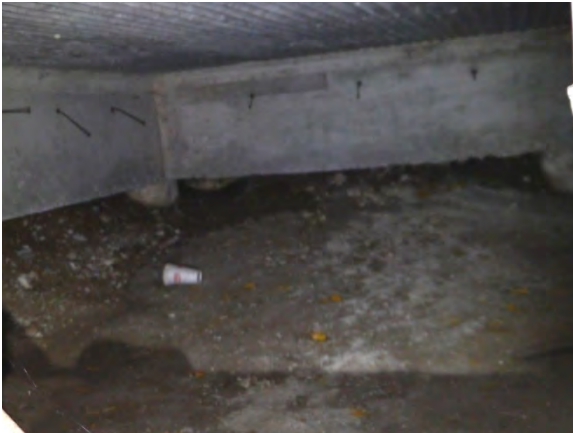
Damp soil

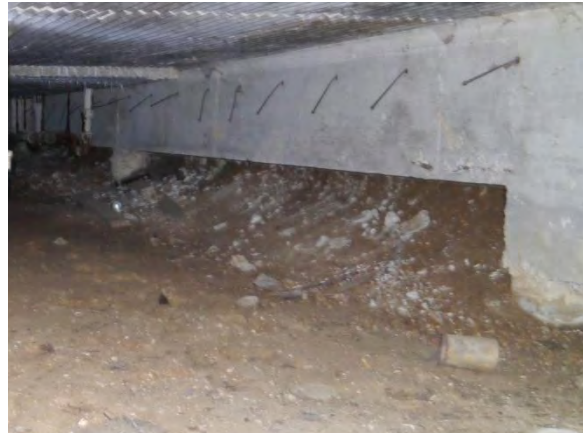
Void space below perimeter beam is filled with soil

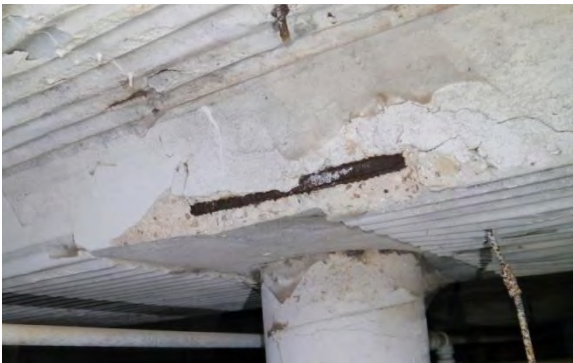
Spalling concrete interior beam and exposed/corroded rebar

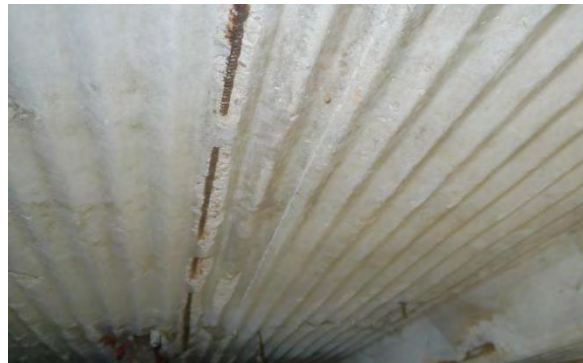
Spalling concrete deck and exposed/corroded rebar

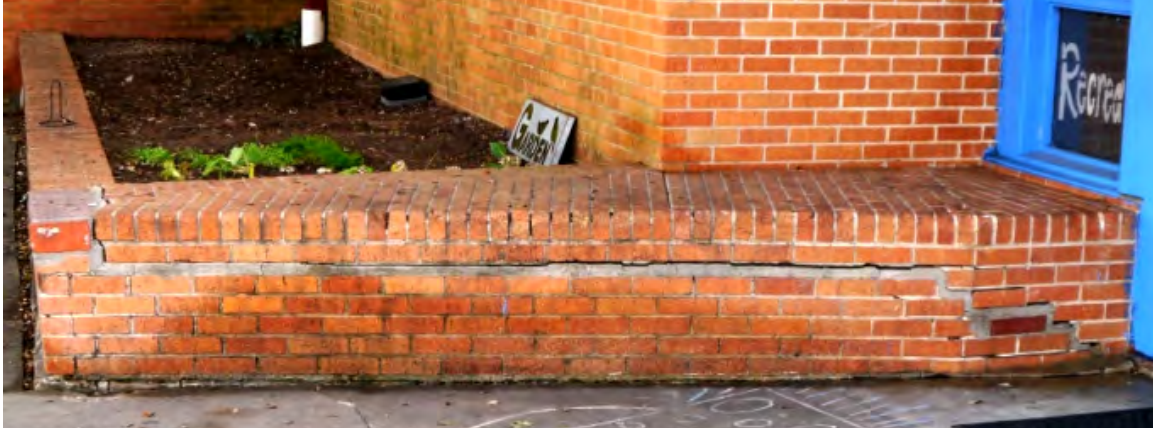
Horizontal crack on planter masonry

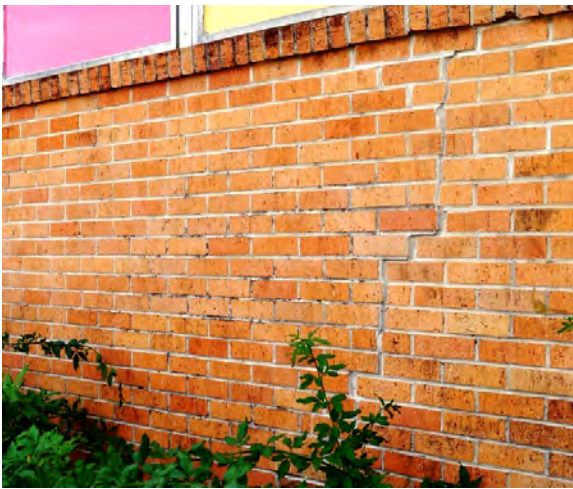
Vertical/diagonal crack below window

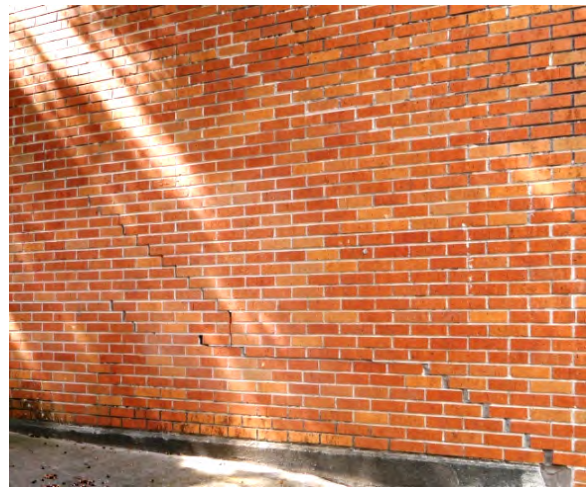
Gym recreational room diagonal cracks (some previously repaired)

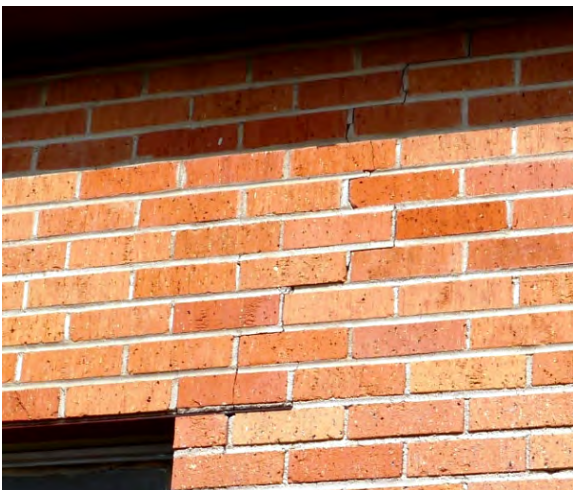
Crack at window opening on west wall of gym

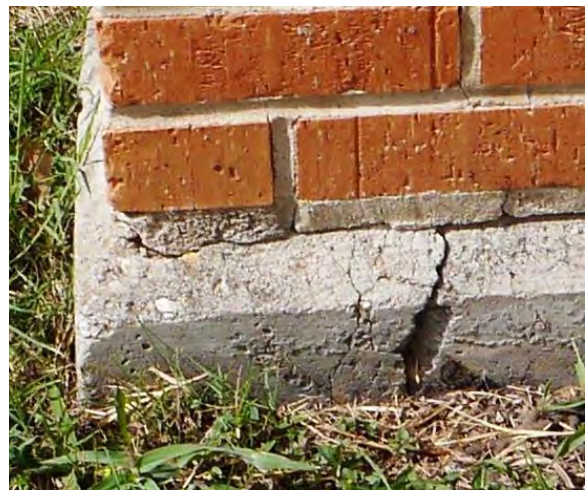
Perimeter beam crack below exterior brick

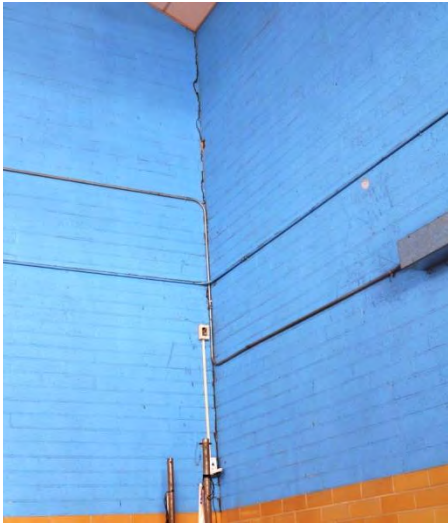
Crack on corner of main gym east and north walls

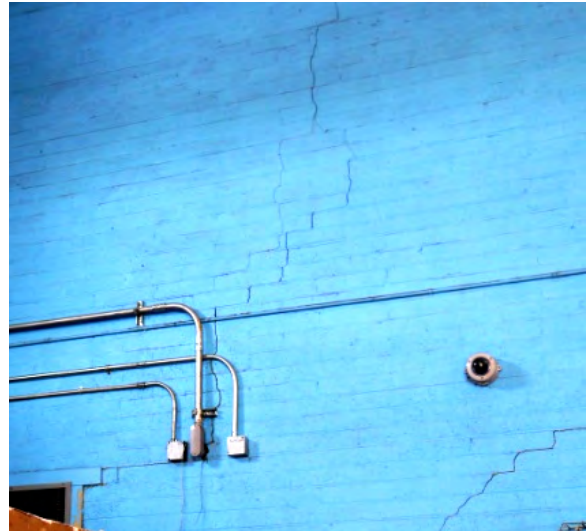
Diagonal cracks on main gym north wall

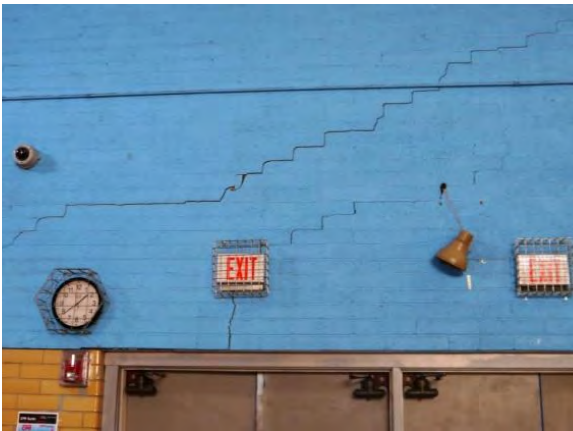
Diagonal cracks on main gym north wall

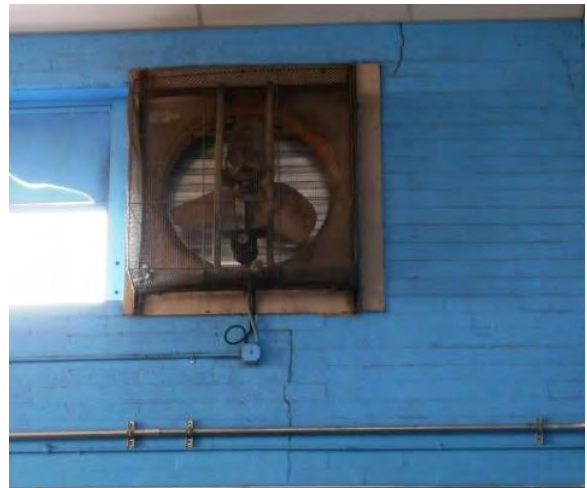
Vertical cracks on west wall

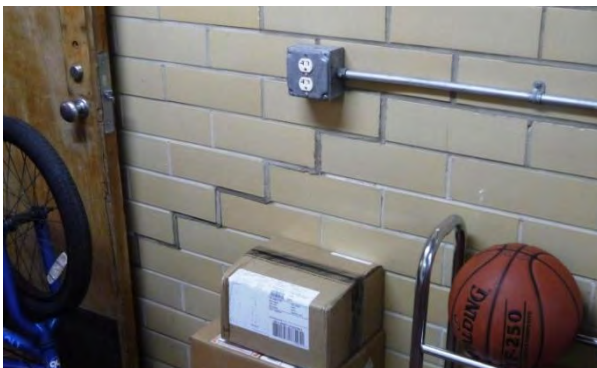
Patched crack in Men's Locker Room

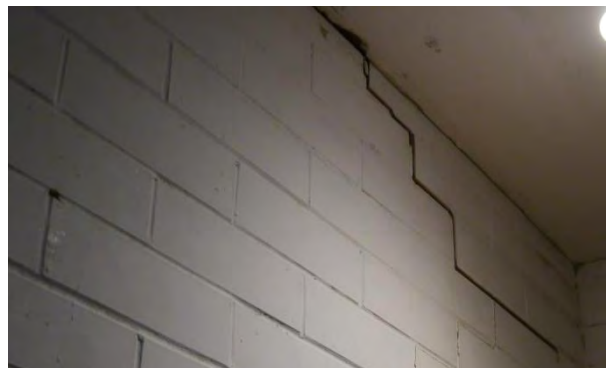
Diagonal crack in Men's Locker Room

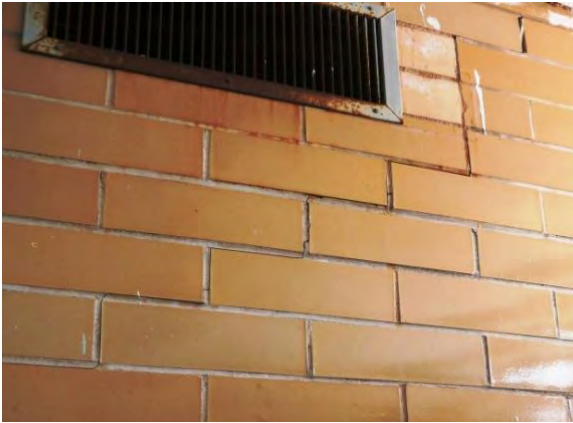
Reopened crack in Men's Locker Room

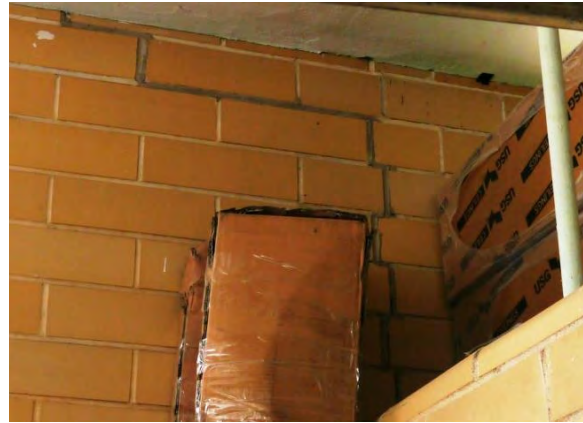
Reopened crack in Men's Locker Room

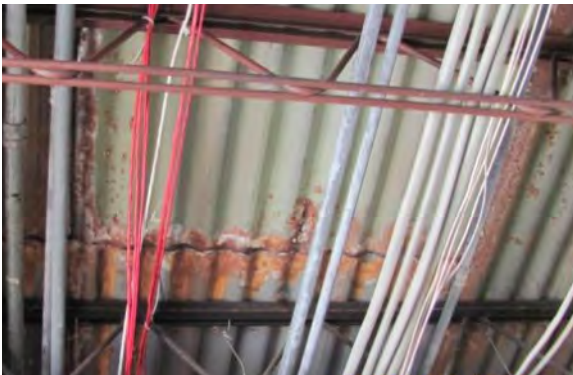
Advanced deck corrosion

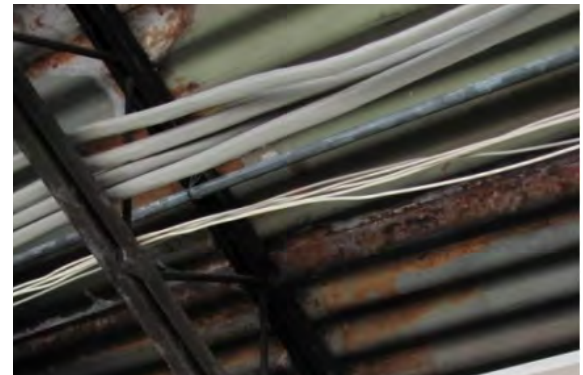
Advanced deck corrosion
