Akins High School Site Summary

Address	10701 S. 1 st Street Austin, TX 78748
Number of Permanent Campus Facilities	7
Original Year of Construction	2000
Total Campus Building Area (combined)	346,839 SF

Introduction

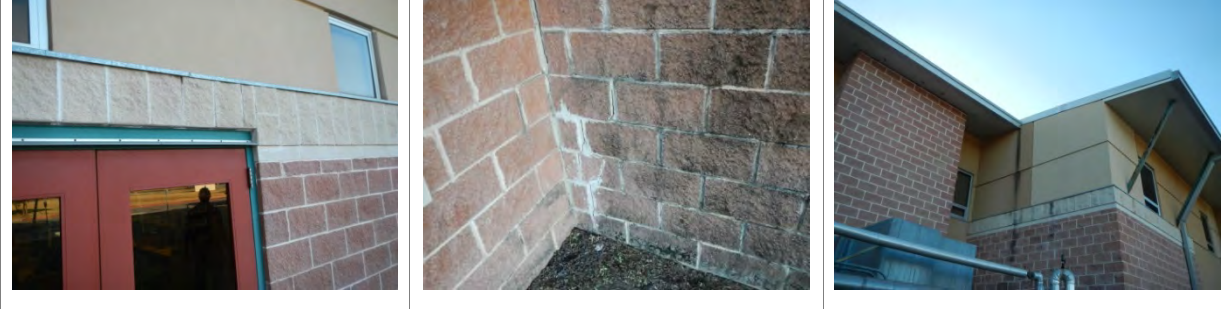
System	Subsystem	Condition and Deficiency Overview	System Condition Rating
Exterior	Exterior Walls	<p>The exterior of the building consists of a CMU (concrete masonry unit) and shotcrete panel façade.</p> <p>The exterior walls were observed to be in good condition and had normal wear due to age and use of the facility. Vertical cracks were observed in the CMU grout above the east library exit door. There were cracks in the CMU walls located in the outside mechanical equipment area adjacent to room 133. Minor wall stains were observed around the facility due to leaking gutters.</p>	Good
	Exterior Windows	<p>The exterior windows consist of single-pane glazing units with metal frames. Classroom windows typically have an upper fixed pane and a lower casement pane. Other windows observed included a fixed pane and single pane with metal muntins. The windows are original to construction.</p> <p>The windows were observed to be in good condition and had normal wear due to age and use of the facility. One classroom window was observed to be shattered outside room 154. It was reported that the windows of rooms 156, 160, 162, 166, stairwell S1, the west end of the second-floor corridor C4, and the second-floor crosswalk to BLDG-017F had a history of leaking during intense rain events.</p>	Good

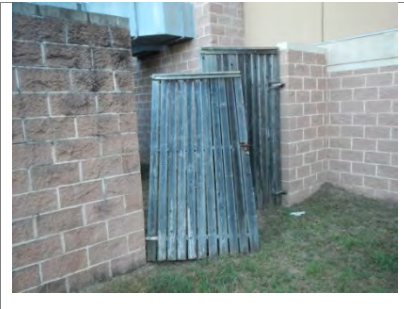
Exterior Doors	<p>There is one main public entryway located at the west side of the building; these doors consist of three pairs of double doors that are metal with interior glazing and a</p>	Good

System	Subsystem	Condition and Deficiency Overview	System Condition Rating
		<p>metal frame and glass transom. The remaining access doors around the facility are metal double doors with interior glazing and metal frames with the exception of the mechanical and electrical room service doors, which are solid single metal doors in metal frames. Mechanical open air spaces enclosed by CMU walls have a wood picket door access. There are card readers at all exterior entrances.</p> <p>The doors were observed to be in good condition and had normal wear due to age and use of the facility. It was observed that the wood picket door located adjacent to room 135 was severely damaged.</p>	
Roofing	<p>The roofing material covering the building consists of modified bitumen and a standing seam metal roof, which is original to the building. The majority of the roof is standing seam metal. The roof drainage collects in a series of gutters and downspouts and discharges to a series of at-grade splash blocks along the front of the school or a subgrade rainwater drainage system.</p> <p>Access to the modified bitumen portion of the roof was not available during the assessment. It was reported that the modified bitumen roofing throughout the facility was experiencing bubbling and roof leaks.</p> <p>The roof was observed and reported to be in average condition.</p>		Average

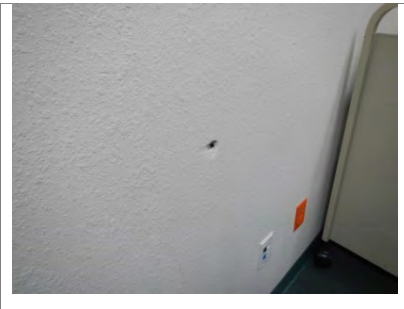
Interior Construction	Interior Walls	<p>The school entry foyer consists of CMU on the lower portion of the walls with a mixture of shotcrete and gypsum on the upper sections of the wall. Corridors consist of gypsum walls. Stairwells consist of gypsum on the upper walls and ceramic tiles finish on the lower walls. Restrooms consist of ceramic tile walls.</p> <p>The interior walls were observed and reported to be in good condition. Damage was observed throughout the school with minor cracks, chipping, and scraping on the gypsum walls due to normal wear and use.</p>	Good
	Interior Doors	<p>The portions of the building original to construction have wood doors with metal frames and metal-framed interior windows.</p> <p>The interior doors were observed and reported to be in good condition.</p>	Good
	Interior Specialties	<p>The corridors of the schools have painted metal lockers attached to the walls.</p> <p>The lockers were observed to be in good condition and had normal wear due to age and use of the facility.</p>	Good

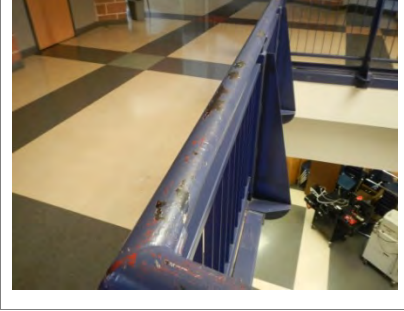
Interior Stairs

System	Subsystem	Condition and Deficiency Overview	System Condition Rating
		length along each corridor. The stairs are metal pan stairs with poured concrete steps and vinyl non-slip surfaces. The interior stairs were observed to be in good condition. The stair handrails were observed to have deteriorating paint with exposed metal railing.	
Interior Finishes	Interior Wall Finishes	The school entry foyer and corridors consists of painted interior surfaces of CMU, shotcrete, and gypsum board. The classrooms and office spaces consist of gypsum board. Restrooms consist of ceramic tile walls. The interior wall finishes were observed to be in good condition. Instances of minor cracking, chipping, and scraping were observed throughout all wall surfaces due to normal use and wear.	Good
	Interior Floor Finishes	VCT (vinyl composition tile) flooring is present throughout the common areas along common corridors, classrooms, and janitorial spaces. The VCT is original to construction. There is carpeting in the library, office spaces, conference rooms, and elevator. The restrooms have ceramic tile flooring. The floor finishes were observed and reported to be in good condition. Missing tile was observed in the male restroom adjacent to room 256.	Good

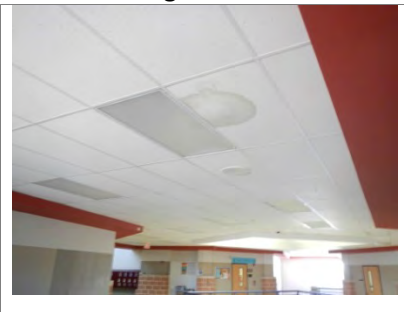
Interior Ceiling Finishes	The interior ceiling consists of standard 2'x4' acoustical fiberglass ceiling panels located throughout the classroom corridors, office spaces, and janitorial closets. Painted gypsum board is in the mechanical closets and corridors. The library ceiling consists of a mixture of exposed metal roofing and girders and 2'x4' acoustical fiberglass ceiling panels. The ceiling was reported and observed to be in good condition. Minor water damage was observed to 2'x4' acoustical ceiling tiles throughout the facility.	Good
Conveying	The building is equipped with a hydraulic passenger elevator to service two levels. The elevator was observed to be in average condition It was reported that holes were present in the elevator's interior. A recent inspection certificate issued within the last year, as required, was visible, and no operational issues were reported.		Average
Plumbing	Plumbing Fixtures	The building has public restrooms for males and females, students, and separate staff restrooms located throughout the facility. These restrooms generally have counter-mounted vitreous china hand sinks with manual faucets, along with vitreous china floor-mount toilets with manual flushing mechanisms, and vitreous china	Good

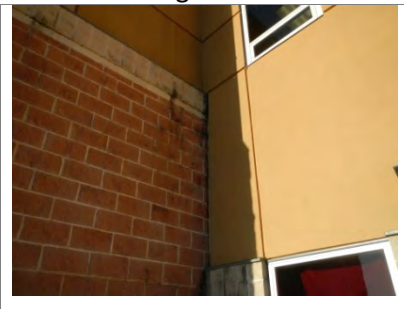
Other Plumbing	<p>It was reported that the french drains for the HVAC (heating, ventilating, and air conditioning) system had failed around the facility. It was observed that the roof downspouts and gutters around the facility were experiencing leakage.</p> <p>The roof drainage plumbing was rated in average condition.</p>	Average
Mechanical/ HVAC	<p>The major mechanical equipment consists of eight HRUs (heat recovery units), 11 RTUs (roof top units), and 13 EFs (exhaust fans) as well as FCUs (fan coil units) located in every classroom and one CU (condenser unit) located on the roof of the school. There is a cooling tower to service the campus located on the east end of the facility outside the kitchen. These serve the HVAC system. The boilers that service the school are gas-fired.</p> <p>The system was rated as poor based on reports and observations and the overall age of the equipment. It was reported that the RTUs use R-22 coolant, which will no longer be manufactured after the year 2020. The cooling tower had a leak that was being managed and the tower was close to the end of its typical design service life. It was reported that the HVAC system was at or just over its capacity.</p>		Poor

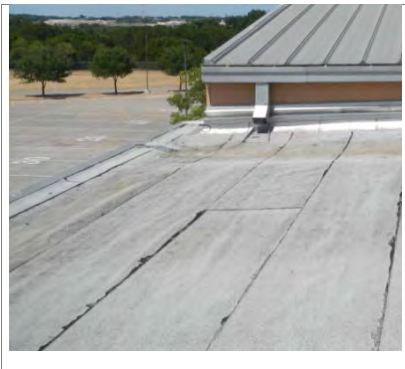
System	Subsystem	Condition and Deficiency Overview	System Condition Rating
		<p>grade splash blocks.</p> <p>Based on reports and observations, the roof condition was rated as average. Water leaks were reported in the ceiling above the Band Hall. The sheetrock above the ceiling tiles in these locations had not been replaced. It was observed that the roof downspouts and gutters around the facility were experiencing leakage. It was observed that the modified bitumen roofing throughout the facility was experiencing bubbling.</p>	
Interior Construction	Interior Walls	<p>The walls consist of CMU on the lower portion of the walls and gypsum board on the upper sections of the wall. Corridors consist of gypsum walls. Theater space has gypsum board walls. Restrooms consist of ceramic tile walls. Music rooms contain gypsum and acoustic fiber wall tiles.</p> <p>Based on reports and observations, the interior walls were rated as average. Damage was observed throughout the school with minor cracks, chipping, and scraping in the walls due to normal wear and use.</p>	Average

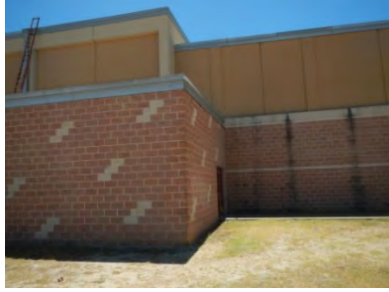
System	Subsystem	Condition and Deficiency Overview	System Condition Rating
Exterior	Exterior Walls	<p>The exterior of the building consists of a CMU and shotcrete panel façade.</p> <p>The exterior walls were observed to be in good condition and had normal wear due to age and use of the facility. Minor wall stains were observed around the facility due to leaking gutters.</p>	Good
	Exterior Windows	<p>The exterior window consists of a single-pane glazing ticket window with a metal frame.</p> <p>The window was observed to be in good condition and had normal wear due to age and use of the facility.</p>	Good
	Exterior Doors	<p>There is one main public entryway located at the west side of the building; these doors consist of three pairs of double doors that are metal with interior glazing and a metal frame. The remaining access doors around the facility are metal double doors with interior glazing and metal frames and solid single metal doors in metal frames.</p> <p>The doors were observed to be in average condition and had normal wear due to age and use of the facility.</p>	Average

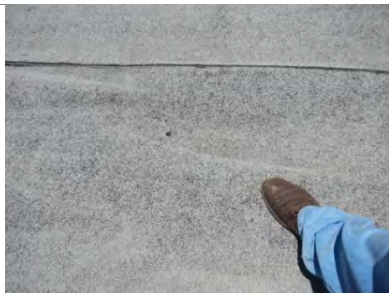
Roofing	<p>The roofing material covering the building consists of modified bitumen and standing seam metal, which is original to the facility. The majority of the roof is modified bitumen. The roof is serviced by a series of downspouts and gutters that discharge to at-grade splash blocks.</p> <p>Based on reports and observations, the roof condition was rated as being poor. It was observed that the roof downspouts and gutters around the facility were experiencing leakage. The roof drainage plumbing was in average condition. It was observed that</p>		Poor

System	Subsystem	Condition and Deficiency Overview	System Condition Rating
		the modified bitumen roofing was experiencing bubbling and ponding from HVAC condensation discharge.	
Interior Construction	Interior Walls	The gymnasium walls consist of CMU on the lower portion of the walls with shotcrete on the upper sections of the wall. Corridors consist of CMU walls. Based on reports and observations, the interior walls were rated as good.	Good
	Interior Doors	The interior doors consist of wood doors with metal frames and metal-framed interior windows. It was reported that the interior door handles were in need of replacement. Based on reports and observations, the interior doors were rated as good.	Good
	Interior Specialties	System not present.	N/A
Stairs	Exterior Stairs	System not present.	N/A
	Interior Stairs	System not present.	N/A
Interior Finishes	Interior Wall Finishes	The gymnasium walls consist of painted CMU on the lower portion of the walls with shotcrete on the upper sections of the wall. Corridors consist of painted CMU walls. Instances of minor cracking, chipping, and scraping in the paint were observed throughout all wall surfaces due to normal use and wear. The interior wall finishes were observed to be in average condition.	Average

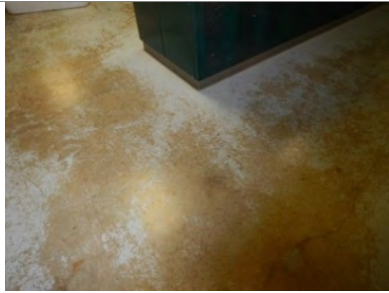
Interior Floor Finishes	VCT flooring is present throughout common areas along the common corridors and janitorial spaces. Ceramic floor tiles are present in the restrooms. Painted concrete floors are in the locker rooms and office spaces. The gymnasium used for basketball has hardwood. The gymnasium used for weight training has rubber flooring. The floor finishes were observed to be in average condition based on reporting and observation. It was observed that the painted concrete floors had wear and tear removing the protective paint layer in the male and female locker rooms.	Average

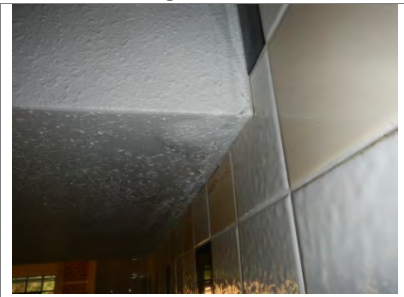
Interior Ceiling Finishes

System	Subsystem	Condition and Deficiency Overview	System Condition Rating
		The ceiling was reported and observed to be in average condition. It was observed that ceiling gypsum board above the serving line exhibited minor water damage from an unknown source.	
Conveying	System not present.		N/A
Plumbing	Plumbing Fixtures	<p>The building has public restrooms for males and females, students, and separate staff restrooms located throughout the facility. These restrooms generally have counter-mounted vitreous china hand sinks with manual faucets, along with vitreous china floor-mount toilets with manual flushing mechanisms, and vitreous china wall-hung urinals in the male restrooms with manual flushing mechanisms. There are water coolers located throughout the facility, typically near the public restrooms. The kitchen contains various stainless steel faucets, sinks, and dishwashers.</p> <p>Based on reports, the plumbing fixtures were rated as being in average condition. It was reported that toilets were loose fitting and required new flanges. It was reported that the restrooms were not large enough to handle the volume of students during lunch hours. It was observed that a kitchen drain discharge line was dislodged from its mounting.</p>	Average

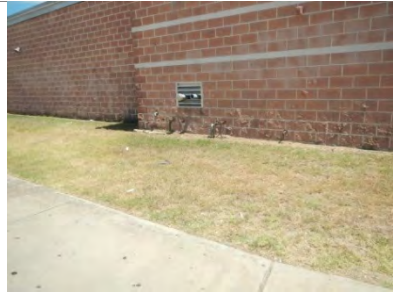
Domestic Water Distribution	<p>All of the plumbing fixtures and piping is original to the facility. The plumbing distribution equipment was reported and observed to be in good condition.</p>	Good
	Other Plumbing	<p>HVAC condensation lines drain condensate from the RTUs to a discharge point outside the building.</p> <p>It was reported and observed that the lines discharged adjacent to a sidewalk where the water caused ponding.</p>	N/A
Mechanical/ HVAC	<p>The major mechanical equipment consists of five RTUs and five EFs located on the roof. There is a cooling tower to service the campus located on the east end of the facility outside the kitchen. These serve the HVAC system. The boilers that service the school are gas-fired.</p> <p>It was reported that the direct expansion (DX) units for this building were at or just over capacity due to their age. It was reported that three HVAC VFDs (variable frequency drives) in this building required replacement as they were non-functional and had reached the end of their design service life. It was reported that the kitchen EFs were experiencing corrosion and would require replacement. It was reported that the boiler pump was not fully operational because a drive was damaged. The boilers were approximately six years old and required maintenance staff to reset them often. It was reported that the chill water pumps were functional but would require replacement within the next ten years.</p> <p>The system was rated poor based on reported and observed conditions and overall</p>		Poor

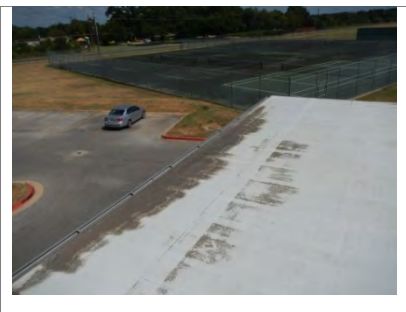
Roofing Deficiency Examples

Roofing	The roofing material covering the building consists of a white membrane EPDM. Based on reports and observations, the roof condition was rated as being good. Minor ponding areas were observed around the perimeter of the building.		Good

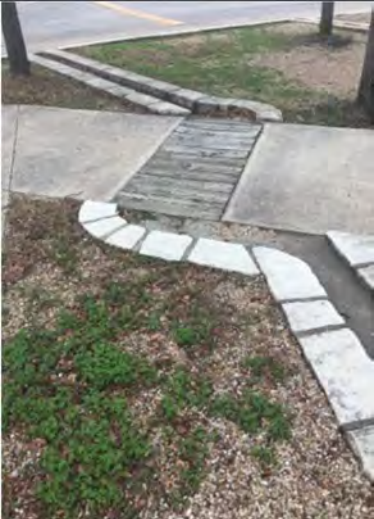
Pedestrian Paving

Broken sidewalk to replace	Remove wood clogged drain path

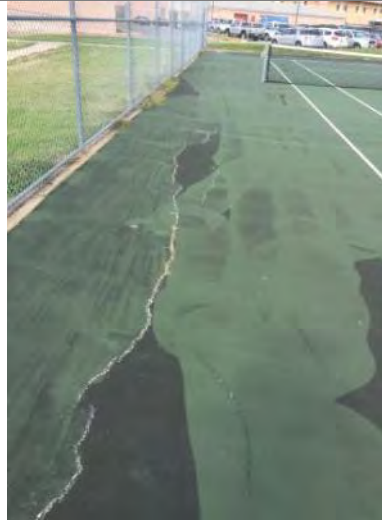
Wide cracks

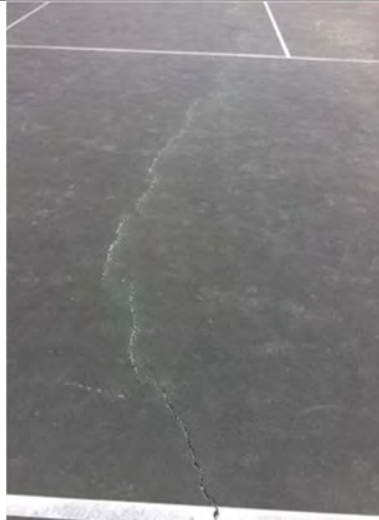
Longitudinal crack

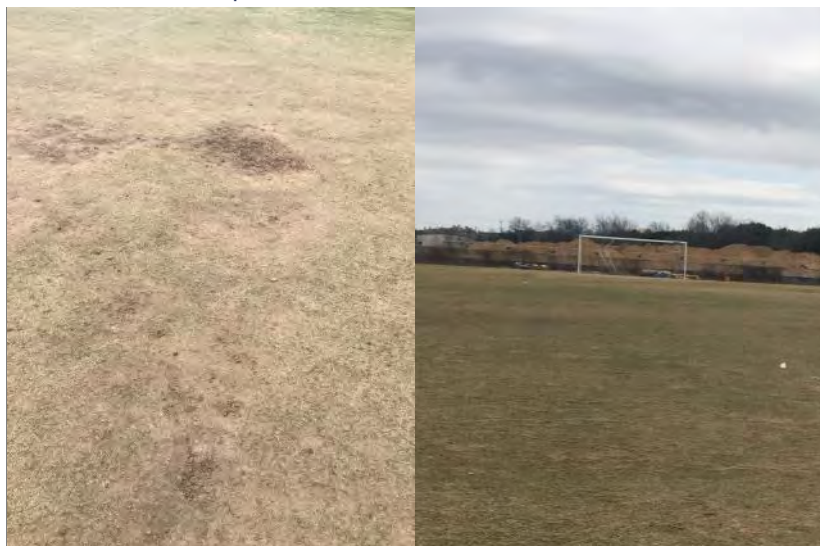
Soccer Field/Multi-Purpose Field

Worn grass on soccer field	Missing soccer nets
----------------------------	---------------------

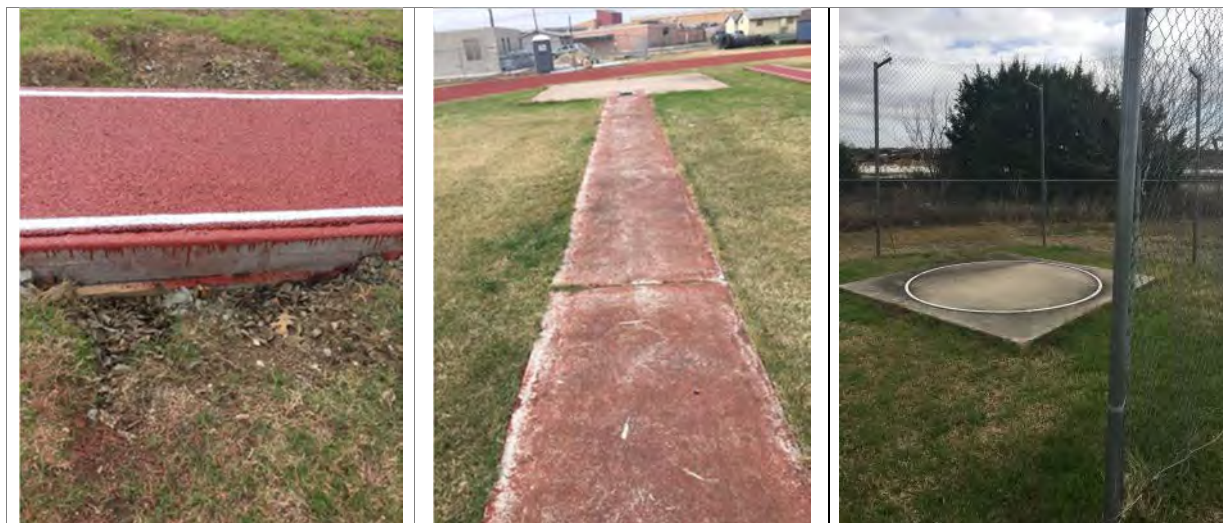
Track

Long jump runway needs back fill	Unused long jump runway	Damaged shotput fence
----------------------------------	-------------------------	-----------------------
