Anderson High School Site Summary

Address	8403 Mesa Drive Austin, TX 78759
Number of Permanent Campus Facilities	5
Original Year of Construction	1973
Total Campus Building Area (combined)	338,434 SF

Introduction

Main School Building – BLDG-009A

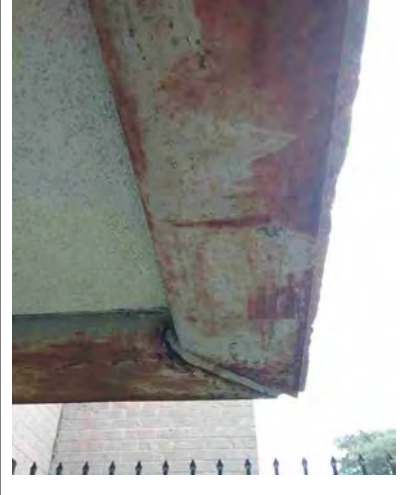
System	Subsystem	Condition and Deficiency Overview	System Condition Rating
Exterior	Exterior Walls	The exterior of the building consists of a brick façade. The building is three stories in height and has two open-air atriums. The soffit covered halls and staircases are open-air. Where the second floor extends over the first floor, the soffit lintels on the cantilevered overhangs were rusted. Expansion joints at the pea gravel surfaced concrete sidewalk adjacent to the building walls were deteriorated.	Good
	Exterior Windows	The windows are aluminum metal framed and single pane glass. They were observed to be in good condition.	Good
	Exterior Doors	There are many double exterior metal doors throughout the building connecting air-conditioned – corridors to non-conditioned corridors. The exterior doors were observed to be in average condition due to age and high usage. Door thresholds were observed to be deteriorated or there were no thresholds at all. Principal Sammi Harrison reported the doors have rust all over exterior sides and have multiple layers of paint in varying shades of blue that are peeling and chipped.	Average

1. Repair and repaint lintels at building cantilever areas throughout this building.

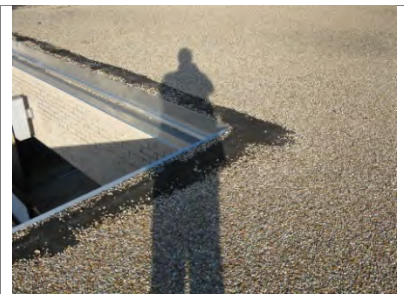
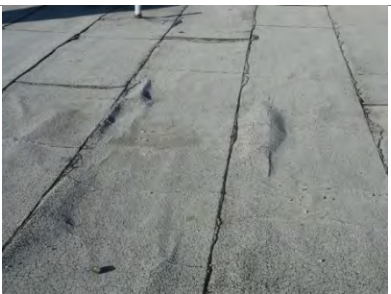
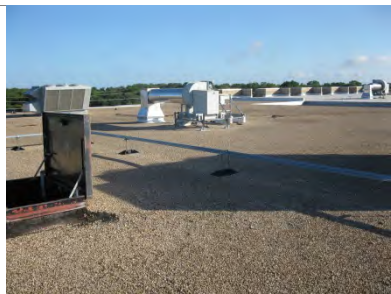
Roofing Deficiency Examples

Roofing	The roof of this building is in three sections, south, middle, and north. The south and north roof areas consist of a single ply membrane. The middle roof area over the administration area is built-up asphalt with a granular topping. The		Good

System	Subsystem	Condition and Deficiency Overview	System Condition Rating
		entire parapet wall has new flashing. Some bubbling and cracking were observed in the south roof area and it was in average condition. The middle roof area was observed to be in good condition. The north roof area was also observed to be in good condition. The middle roof area drain was rusted and appeared to be leaking into room 320. In addition, ceiling staining was observed in the open two-story area of the 2 nd floor counselor offices.	
Interior Construction	Interior Walls	The interior partitions original to the building are predominately constructed of CMU (concrete masonry unit) that are painted with glazed tile on the lower portion of the wall. The administration offices and the library had painted gypsum board construction, CMU, or brick walls. Principal Sammi Harrison reported the front office has asbestos panels and wall spaces are not able to be utilized.	Good

1. Replace south wing roof of this building in the next few years, it is bubbling and cracking.

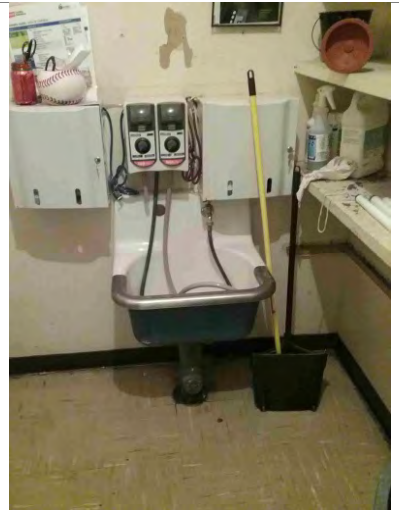
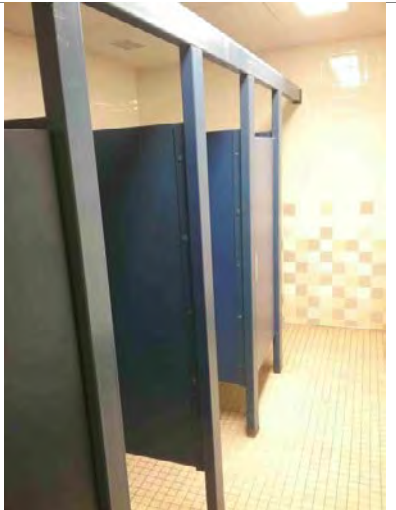
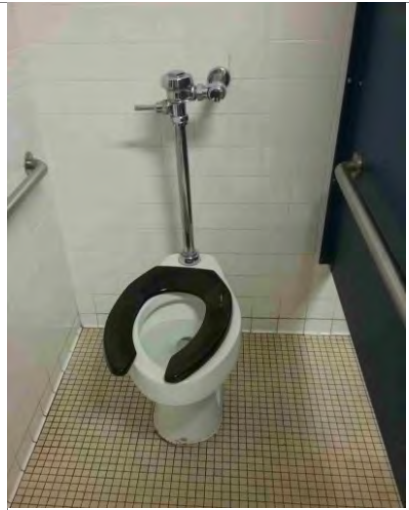
Plumbing Fixtures

System	Subsystem	Condition and Deficiency Overview	System Condition Rating
		<p>classrooms with laboratory sinks.</p> <p>The building's fixtures are serviced by various vertical EWHs/GWHs (electric/gas water heaters) ranging from 150-200 MBH and larger horizontal boilers ranging from 1,800-2,500 MBH. Many of the heat generating and cooling systems are not original to this building and are possibly fed from Building B's boiler/chiller mechanical room.</p> <p>The building's restrooms typically consist of metal wall/floor mounted washstands with stainless steel sinks mounted in composite plastic countertops, vitreous china floor/wall mounted toilets, and wall mounted urinals. The restroom fixtures throughout the facility are equipped with manual push metering faucets and manual flush valves. The restroom fixtures in this building are typically aged, but all in good working condition.</p> <p>This building has the following deficiencies: service closets contain old janitorial sinks that are ergonomically inefficient (scheduled to be replaced with floor style sinks/mop basins), restroom stalls are missing privacy doors, and toilet lids are loose.</p>

1. Recommend replacing old janitorial sinks that are located in service closets with more ergonomically efficient floor style sinks/mop basins.
2. Tighten or replace toilet seats that are damaged through the facility.
3. Continue preventative maintenance on aged plumbing fixtures throughout facility.

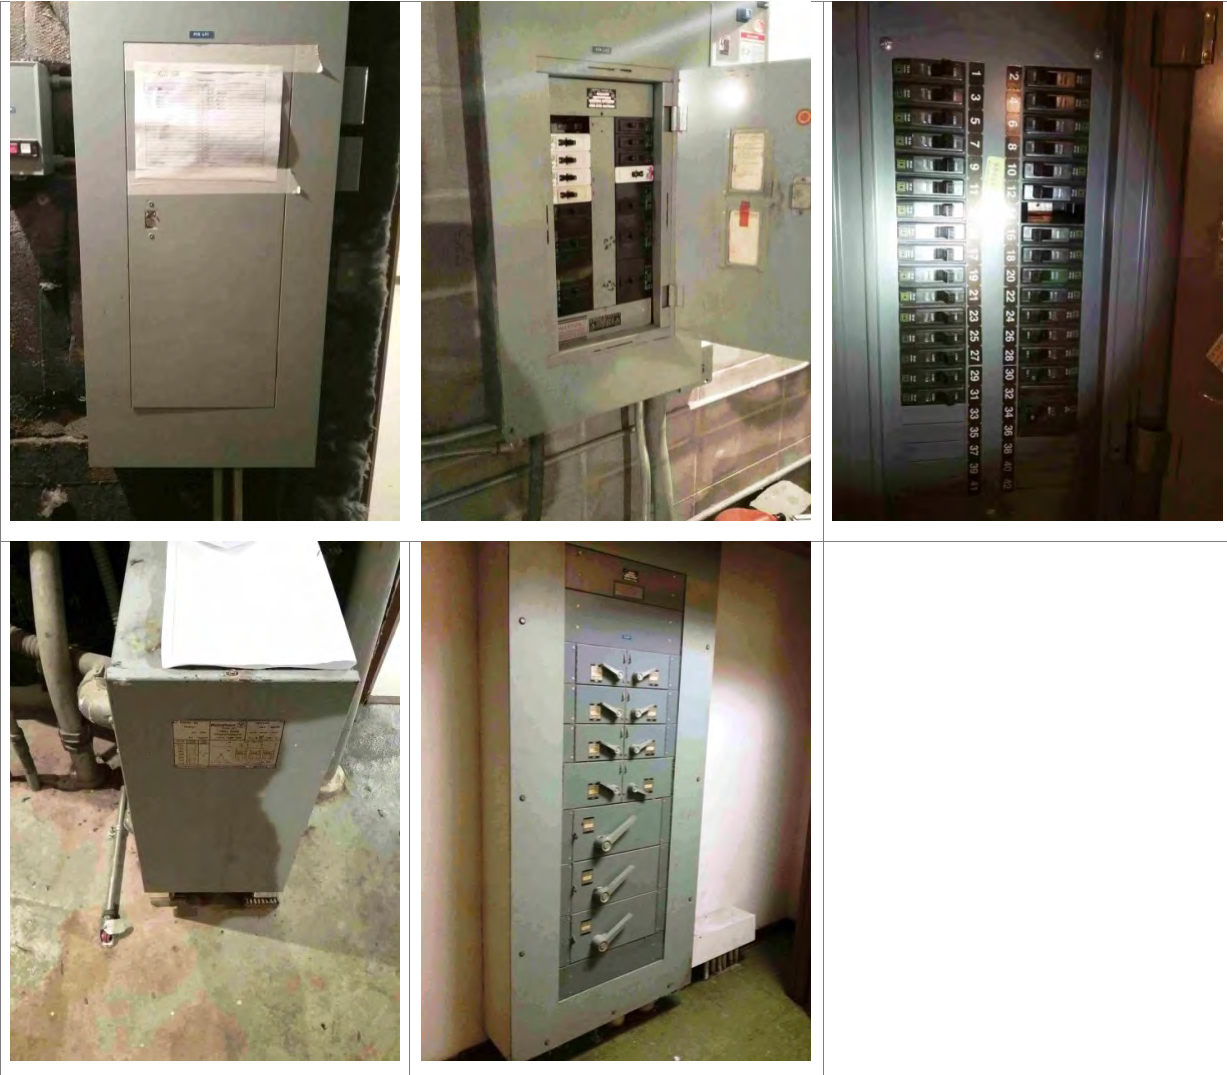
System	Subsystem	Condition and Deficiency Overview	System Condition Rating
	Fire Protection/Suppression	The building is predominately serviced by a dry standpipe system routed throughout the facility. Some rooms, such as dry storage or janitorial, are equipped with wet standpipe systems (automatic). The building is also protected by portable fire extinguishers that are stationed throughout the building. All portable fire extinguishers observed were inspected within the last year.	Good
Electrical	Electrical Distribution	<p>The electrical distribution for this building consists mainly of 1,200-amp original switchboards and various sized transformers feeding subpanels in electrical rooms throughout the three floors.</p> <p>The electrical distribution equipment is in average condition. The majority of the equipment observed in average condition is due to age, as the transformers, panelboards, and switchboards in this category appear to be original to building construction. It should be noted that the majority of the panelboards and transformers are outside of their expected design service life expectancy and were documented as having ten years of design service life remaining.</p> <p>Panelboards LA3 and TP3A are missing a breaker leaving a void in panel assembly. A spare breaker or breaker space cover should be installed to fill the void as this is a life safety hazard.</p> <p>The enclosure latch was defective on numerous panels observed in both average condition.</p>	Average

1. Address panels that have breakers missing and install a breaker space cover or spare breaker to fill void. This is a life-safety issue.
2. Develop a phased program for replacing panels that are beyond their expected design service life.
3. The conveying equipment needs additional testing to determine causes for undesired stops.
4. Assess the fire alarm system as it relates to the VOIP telephone system.

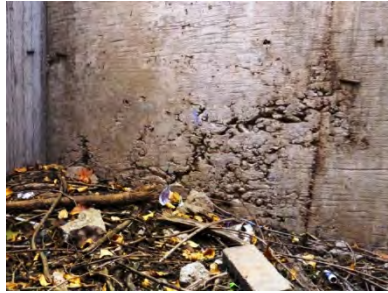
Honeycombing in areaway

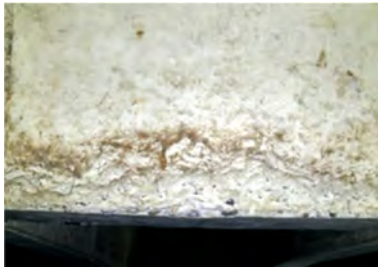
Honeycombing in pan joist diaphragm

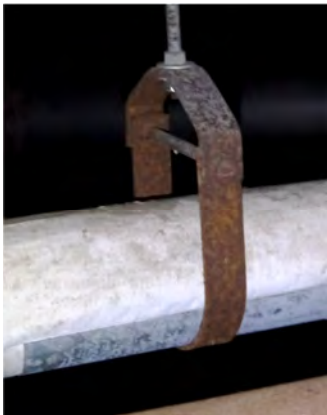
Rusted pipe hanger

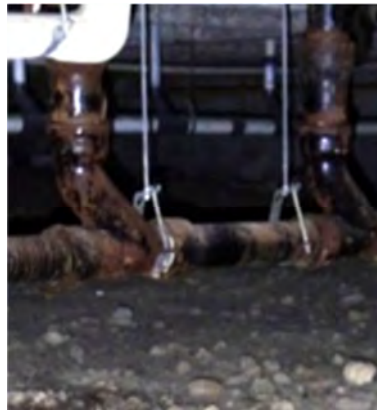
Rusted cast iron pipes

1. Clean corroded cast iron pipes & protect from further corrosion or replace
2. Replace degraded/moldy pipe insulation

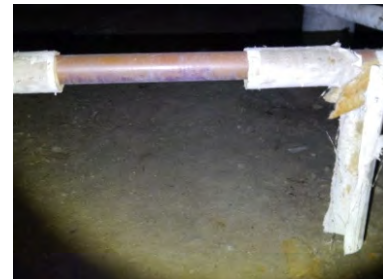
Missing/degraded pipe insulation

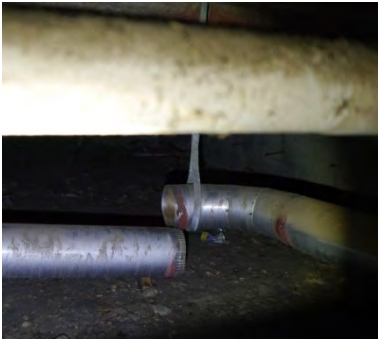
Broken pipe

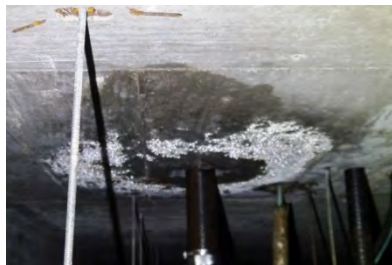
Condensation under slab

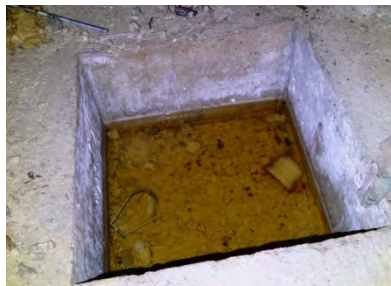
Standing water in drainage pit

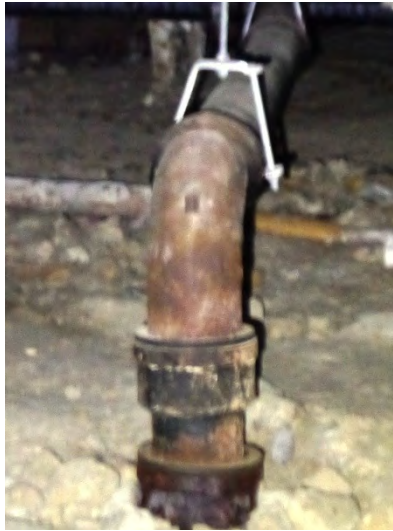
Slightly rusted Pipe

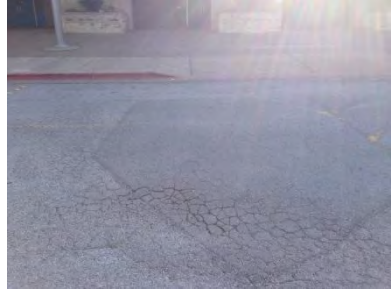
Roadways

R1 asphalt cracking	R2 utility trench patches	R1 alligator cracking

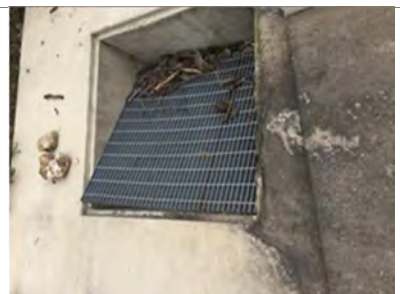
Outfall grate collapsed

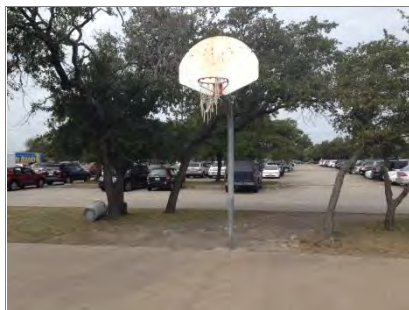
Deteriorated rim and backboard

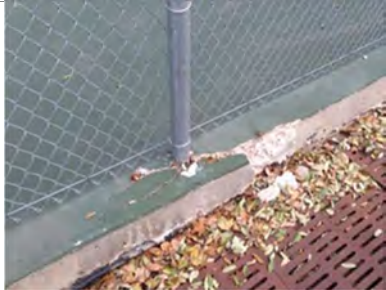
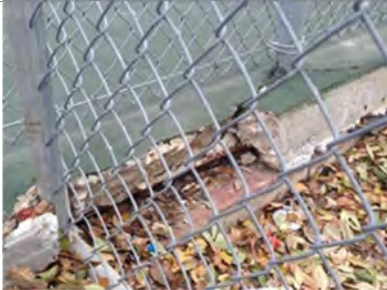
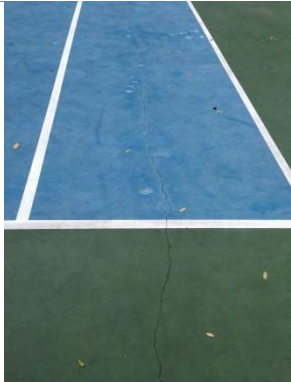
Tennis Courts

Spalling at fence post base	Exposed rebar	Minor cracking

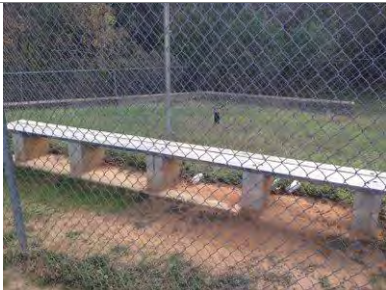
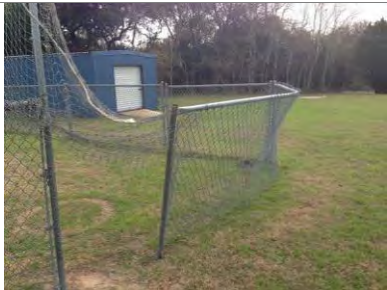
Baseball/Softball Field

Vegetation and debris in dugout	Broken fence in outfield

1. Clean out vegetation and debris in dugout.
2. Fix broken fence locations around perimeter.
