Ann Richards YWLA School Site Summary

Address	2206 Prather Lane Austin, TX 78704
Number of Permanent Campus Facilities	3
Original Year of Construction	1958
Total Campus Building Area (combined)	123,686 SF

Main School Building – BLDG-028A

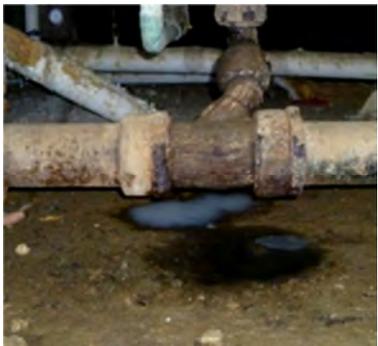
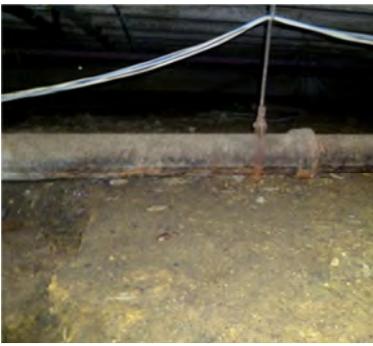
<p>Pipe leak</p>	<p>Pipe laying on soil (should be suspended)</p>	<p>Heavily rusted pipes</p>

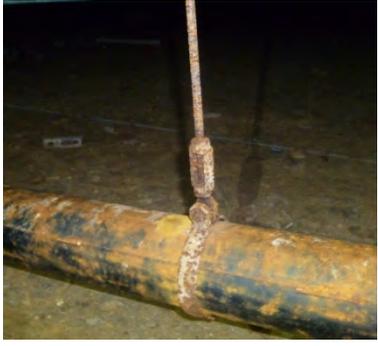
<p>Rusted pipe & pipe support</p>	<p>Failed pipe insulation</p>	<p>Moldy pipe insulation</p>

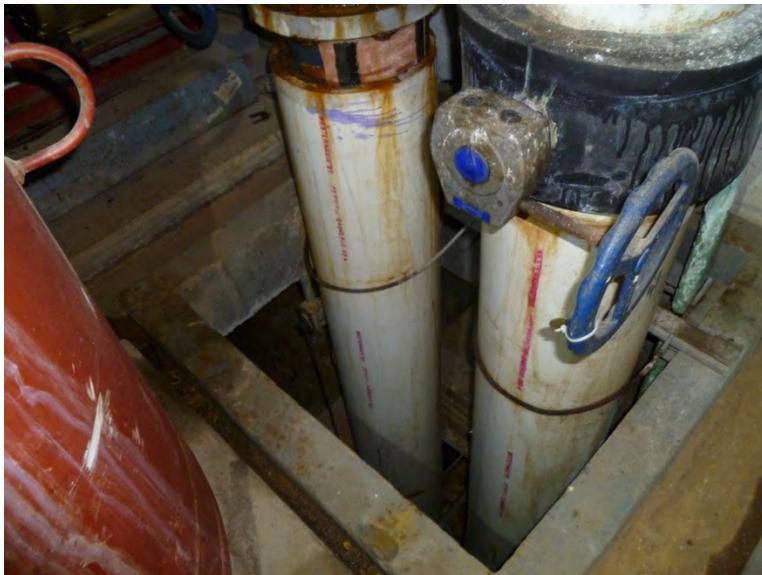
Building B has an inaccessible crawl space as the floor hatch is completely blocked with the built-in pipes shown in the photo below.

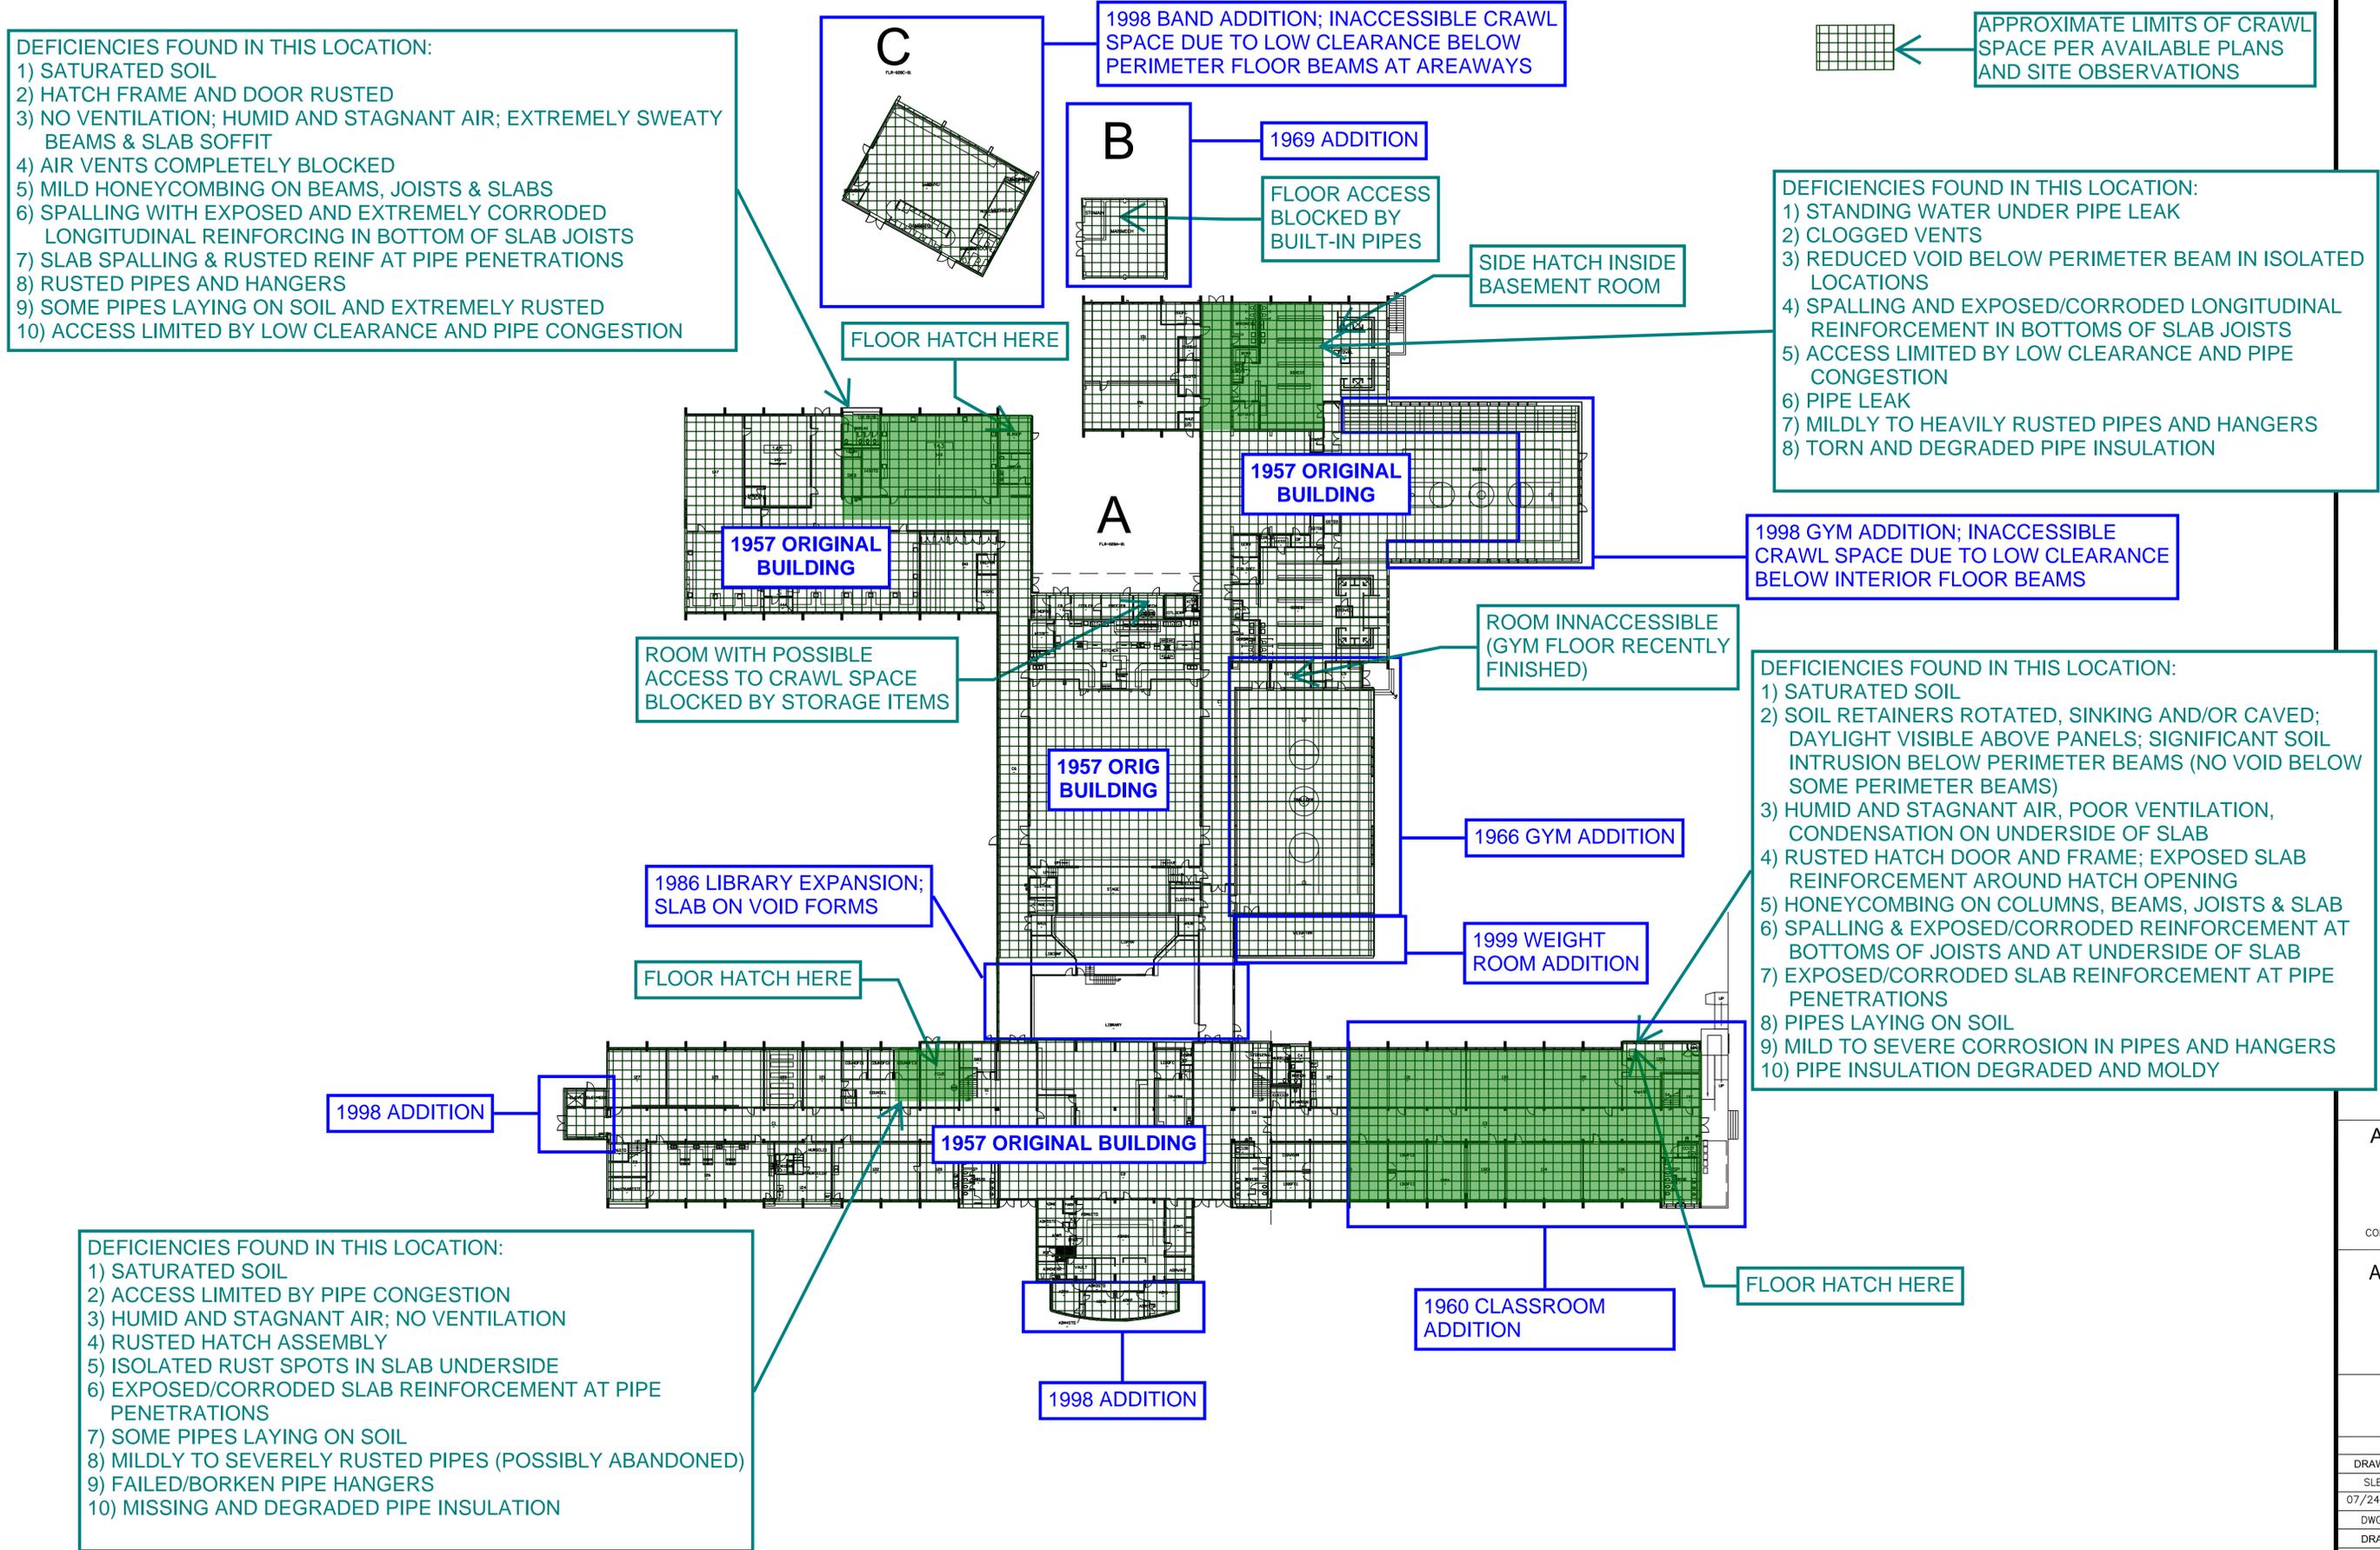
DEFICIENCIES FOUND IN THIS LOCATION:

- 1) STANDING WATER UNDER PIPE LEAK
- 2) CLOGGED VENTS
- 3) REDUCED VOID BELOW PERIMETER BEAM IN ISOLATED LOCATIONS
- 4) SPALLING AND EXPOSED/CORRODED LONGITUDINAL REINFORCEMENT IN BOTTOMS OF SLAB JOISTS
- 5) ACCESS LIMITED BY LOW CLEARANCE AND PIPE CONGESTION
- 6) PIPE LEAK
- 7) MILDLY TO HEAVILY RUSTED PIPES AND HANGERS
- 8) TORN AND DEGRADED PIPE INSULATION

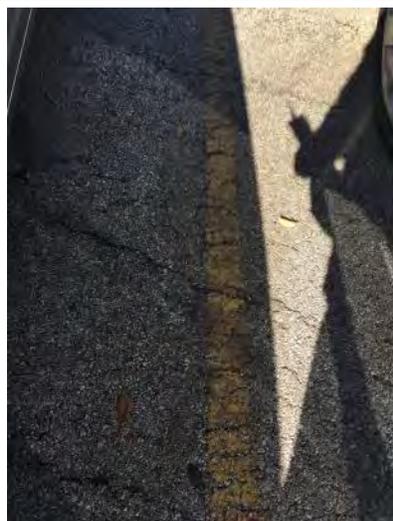
Cracks in the parking area

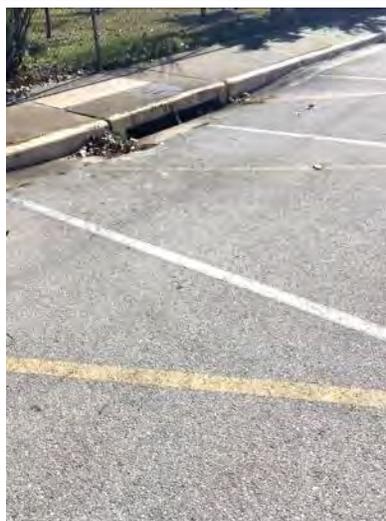
Striping conflict in side parking

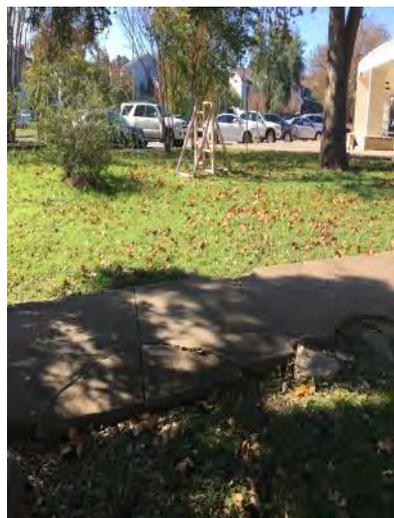
Broken sidewalk leading to the front of the school

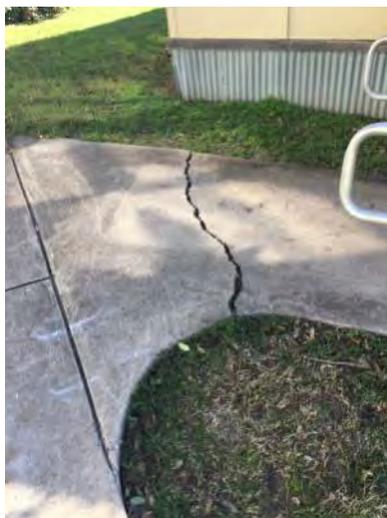
Cracked sidewalk leading to portables

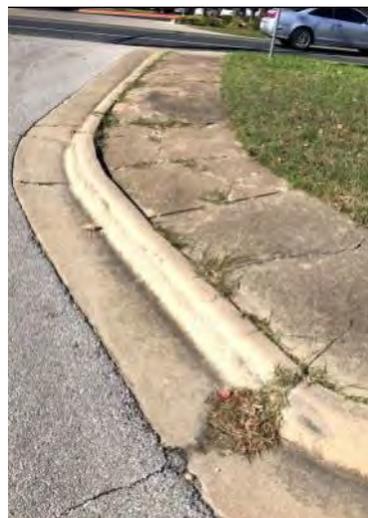
Cracked and sunk in sidewalk located from side parking to city sidewalk

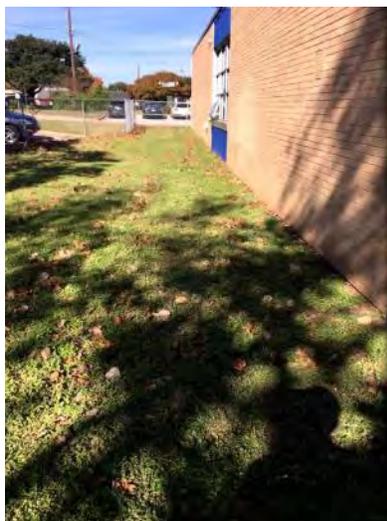
Slope is toward the building

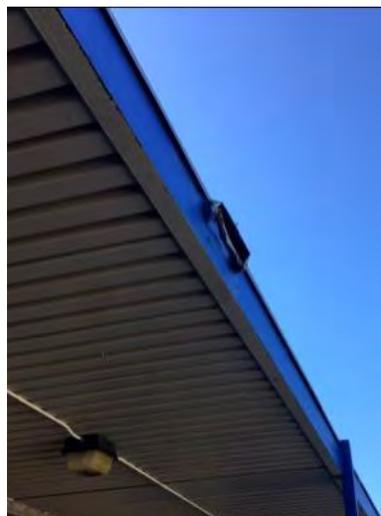
Broken gutter

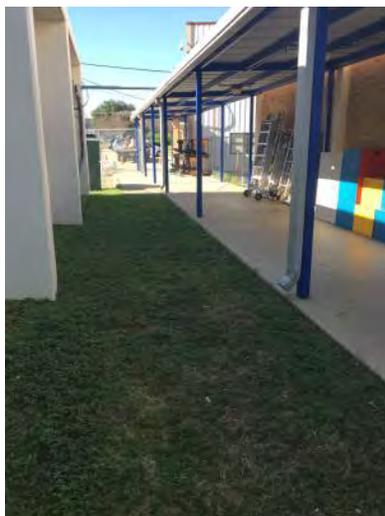
Downspouts do not flow into underground system

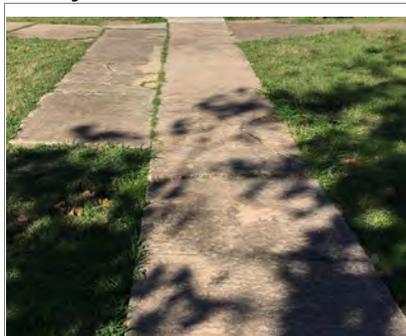
Sidewalk repair

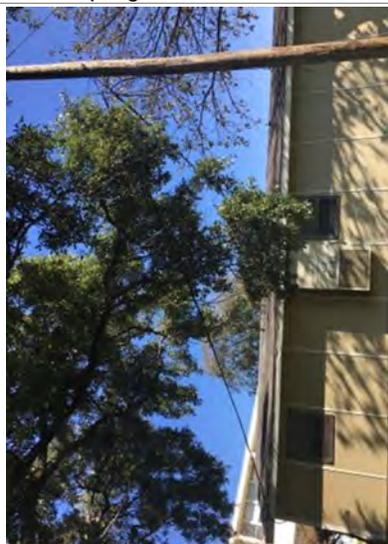
Tree branch in overhead line

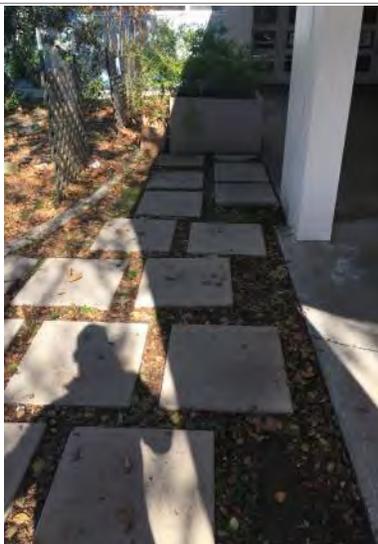
Broken steps and filler needed in between

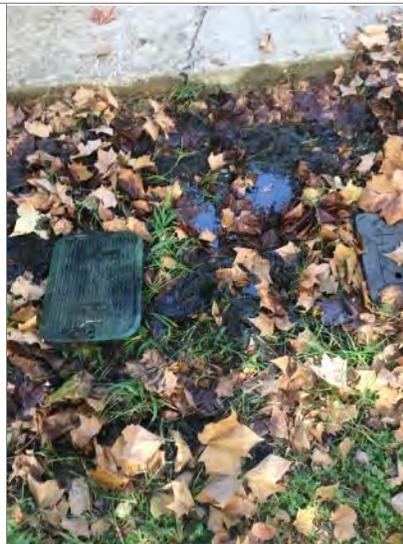
Irrigation box has possible leak

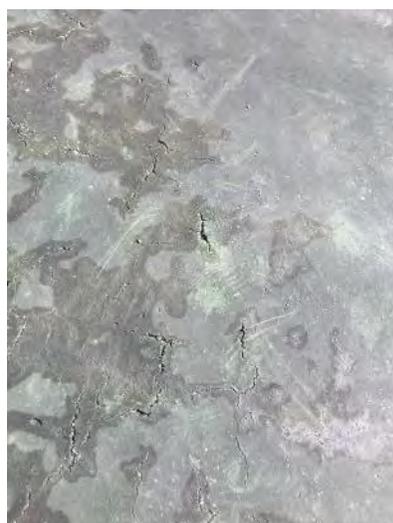
Tennis court is cracked

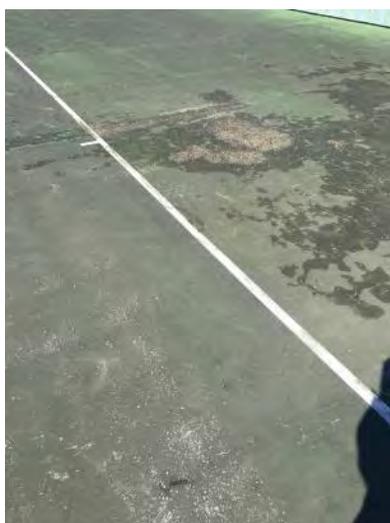
Tennis court has slippery black sections

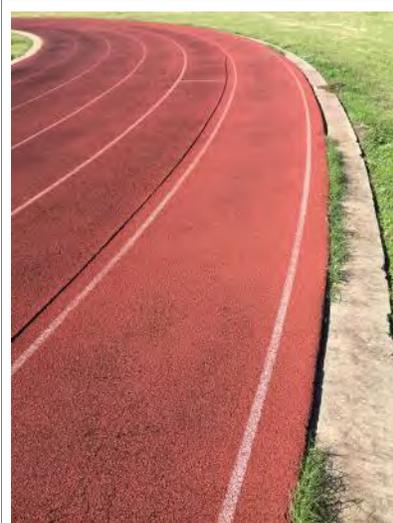
Track splitting apart creating level issues

1. Replace the track and track event surfaces and repaint after the replacement of track surfaces is complete.

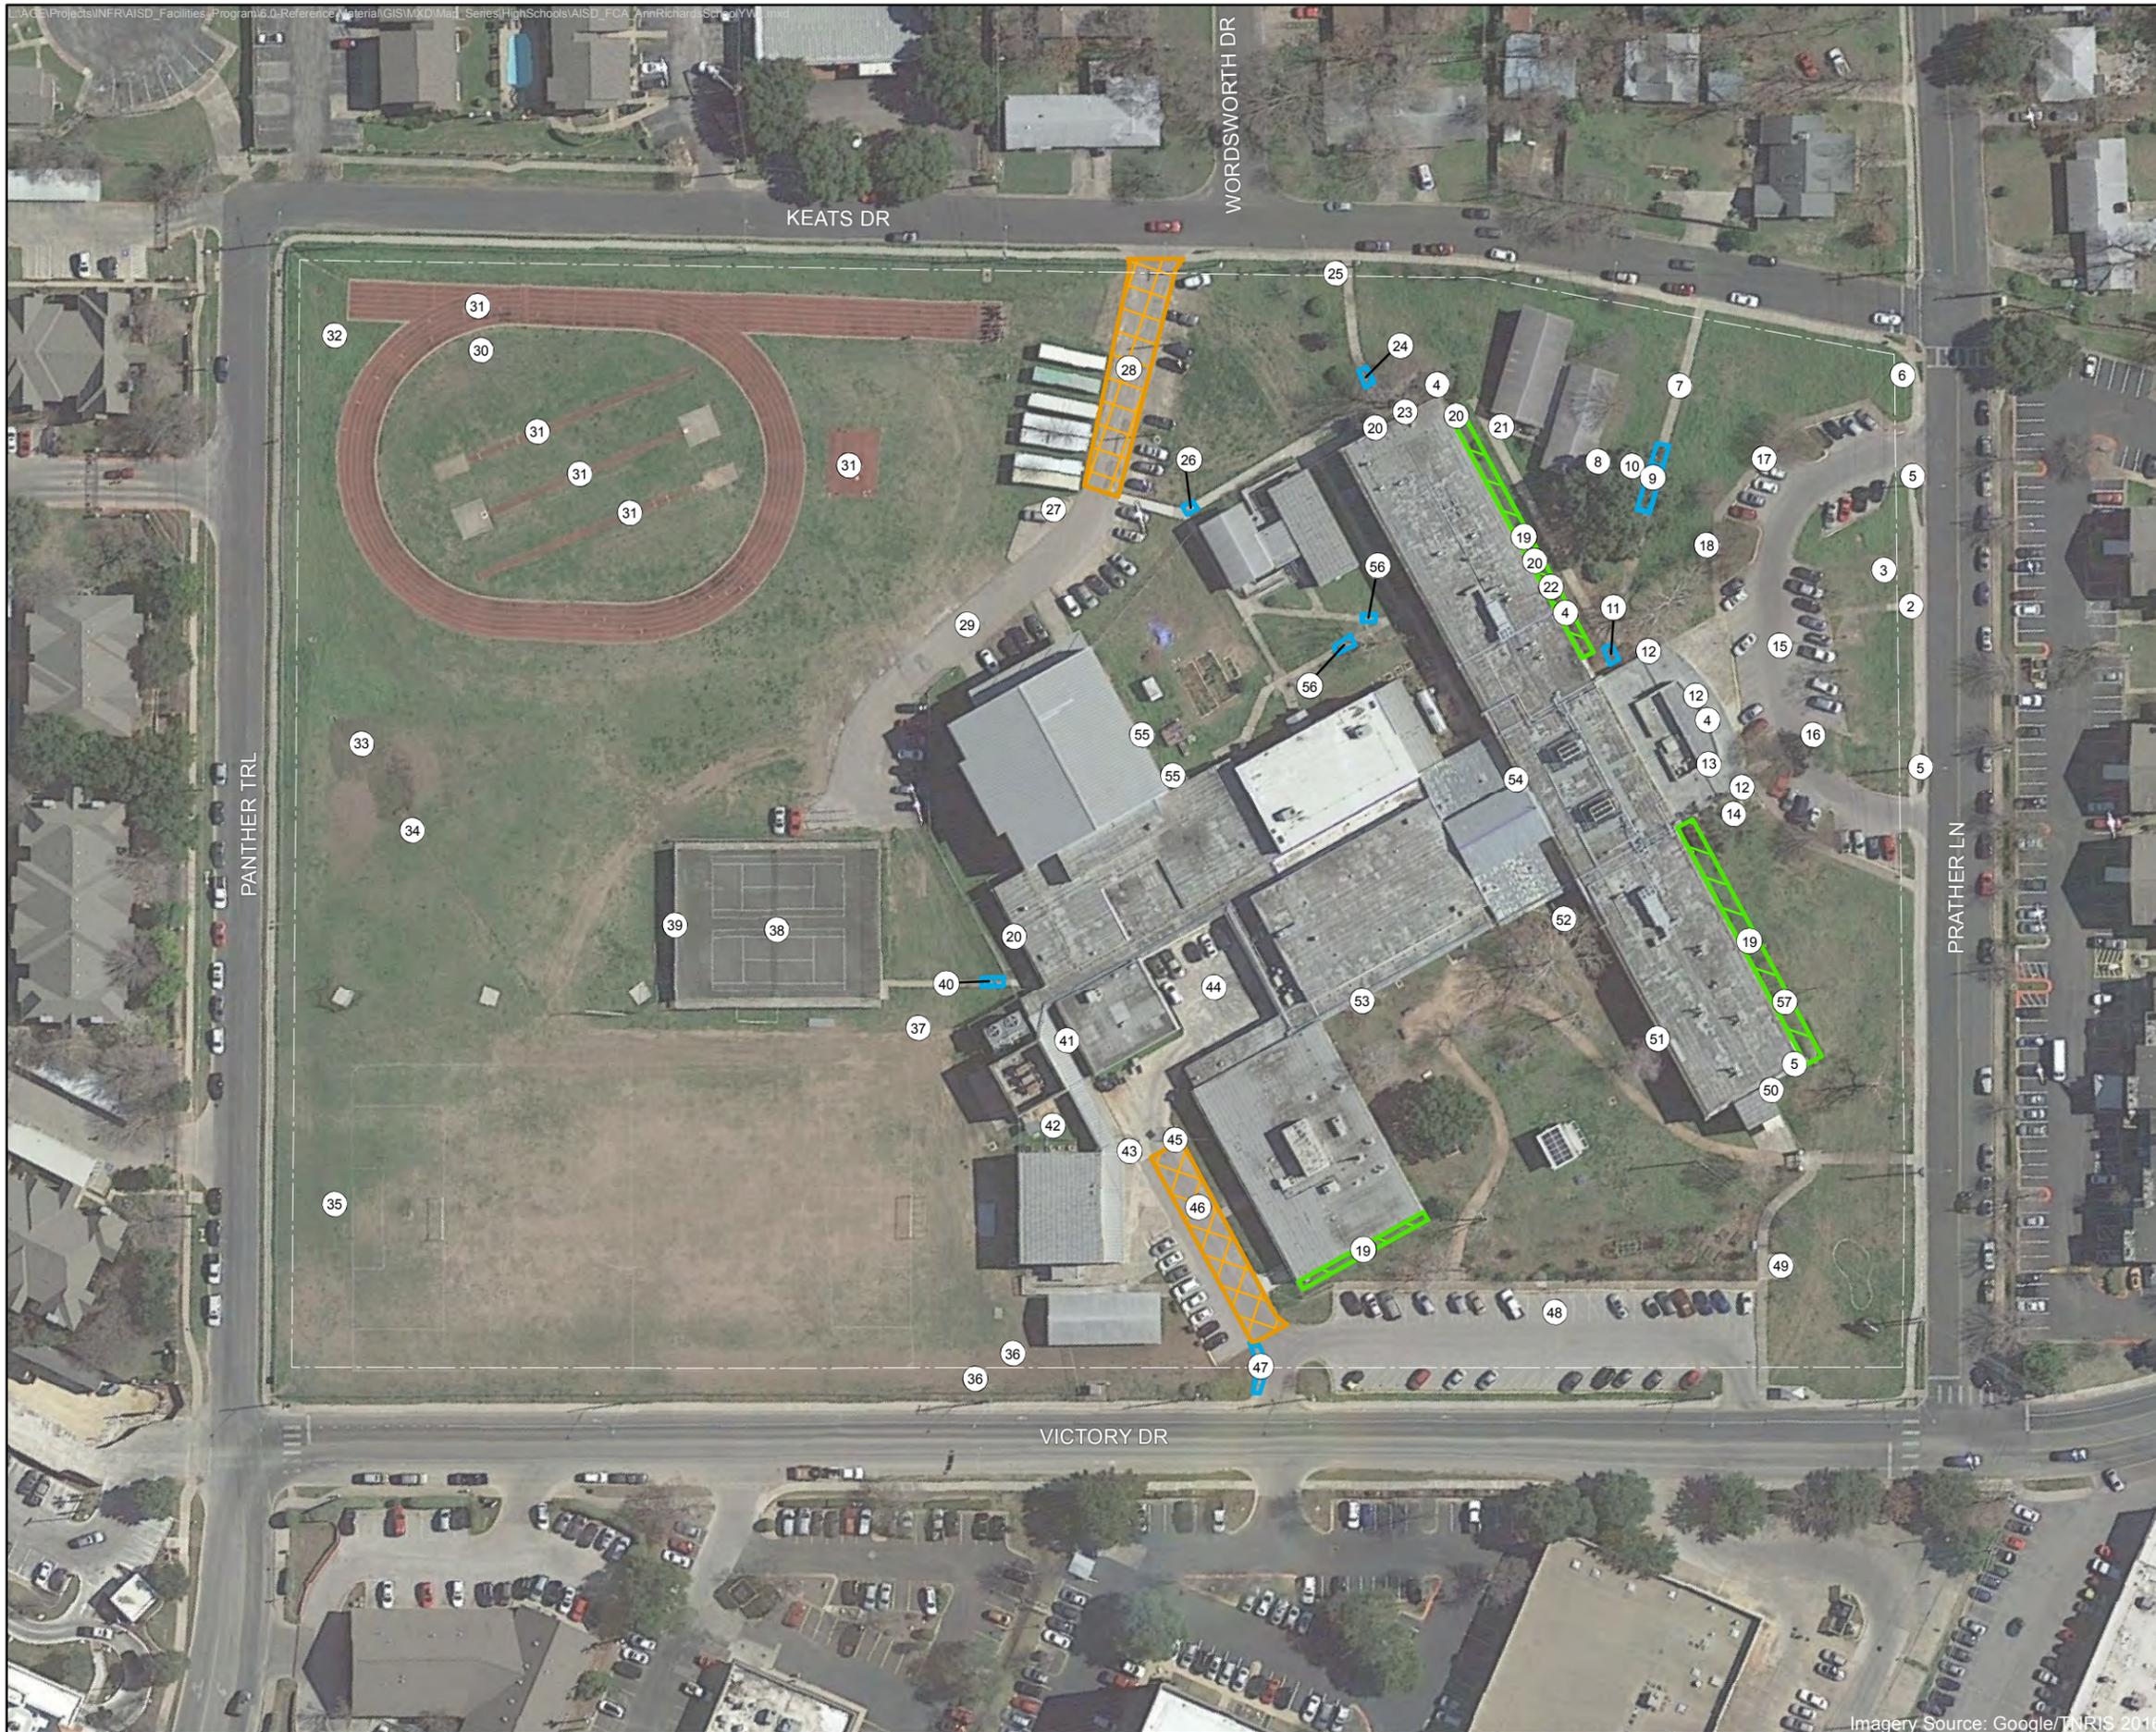
- NOTES:**
1. WATER VALVE.
 2. ADD PAINT OR REFLECTOR FOR STEP DOWN.
 3. POTENTIAL LEAK IN THE WATERLINE.
 4. SECURITY CAMERA.
 5. LIGHTING.
 6. NO FIBERGLASS HOUSING FOR WASTEWATER LINE.
