## Austin High School Site Summary

## Main School Building – BLDG-002A

## Theater Building – BLDG-002B

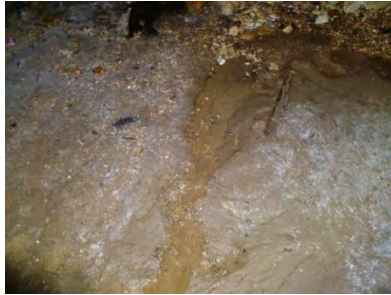
Saturated soil

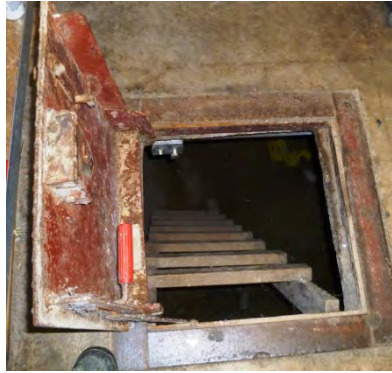
Rusted access hatch

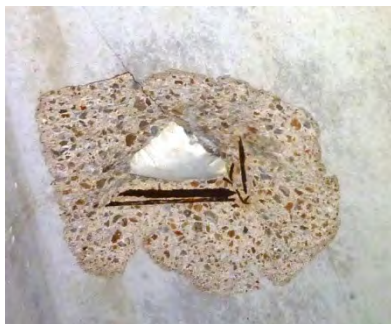
Deck spall and exposed/rusted slab reinforcement

1. Repair spalls under precast deck
2. Remove corrosion and add concrete cover where reinforcement is exposed

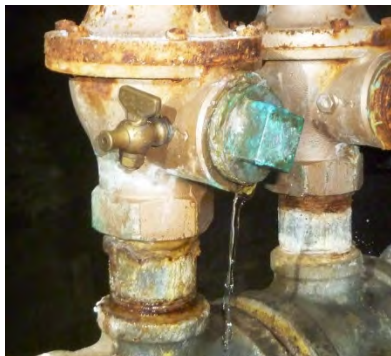
Badly leaking pipe

1. Repair leaking pipes
2. Replace broken glass pipe
3. Replace significantly corroded pipes; clean and protect pipes with moderate corrosion
4. Replace significantly corroded pipe supports
5. Replace degraded/moldy pipe insulation

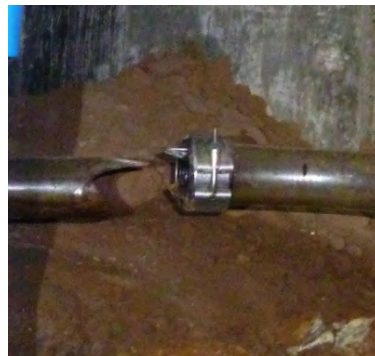
Broken glass pipe

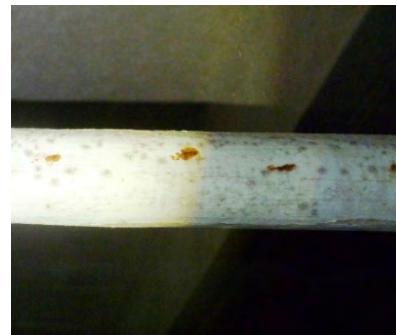
Rusting pipes behind insulation

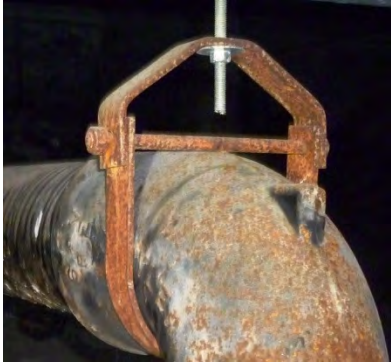
<p>Rusted pipe &amp; support</p>

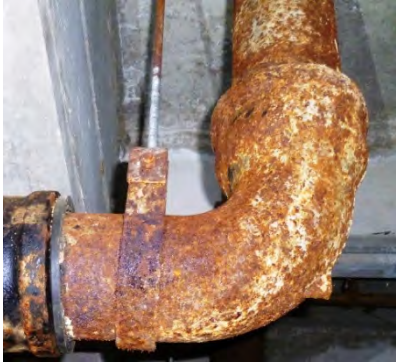
<p>Rusted pipe &amp; support</p>

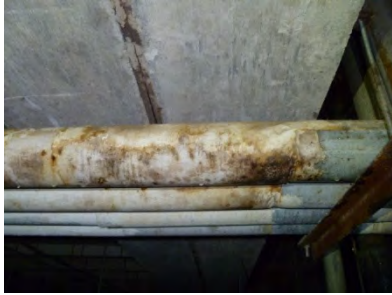
<p>Moldy/degraded pipe insulation</p>

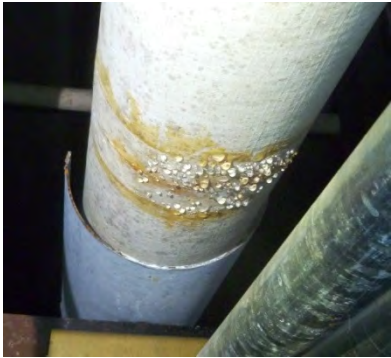
<p>Sweaty pipe</p>

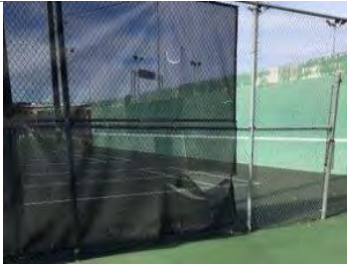
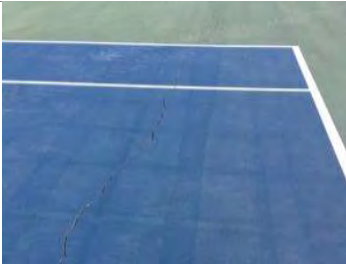
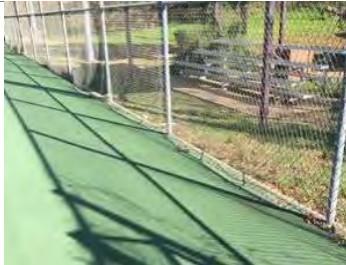
Broken tarp	Cracking in court	Bottom rail of chain link fencing
