Bowie High School Site Summary

Address	4103 W. Slaughter Lane Austin, TX 78749
Number of Permanent Campus Facilities	7
Original Year of Construction	1988
Total Campus Building Area (combined)	422,688 SF

Introduction

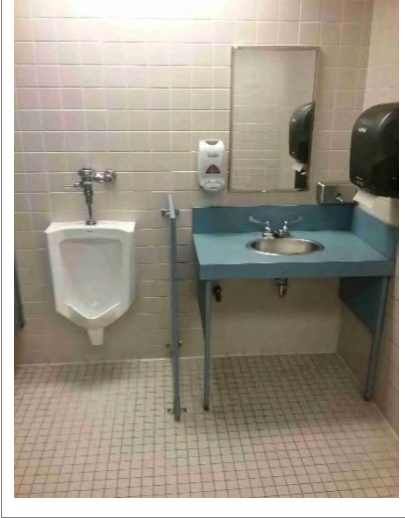
Plumbing Fixtures

System	Subsystem	Condition and Deficiency Overview	System Condition Rating
		are floor-mounted, vitreous china. The sinks are stainless steel with manual faucets, and the toilets and urinals have manual flush valves. The public male and female restrooms do not have a hot water line. There were several observed deficiencies with the plumbing fixtures. The building was observed to have low water pressure and the urinal in the male faculty restroom did not flush properly.	
	Domestic Water Distribution	There is an EWH (electric water heater) located in the main mechanical room. The EWH appeared to be original to the building. The water heater was observed to be rusted and aged. The water did not become warm for the fixtures that had hot water lines. This unit was observed to be in poor condition.	Poor
	Other Plumbing	System not present.	N/A
Mechanical/ HVAC	The major mechanical equipment in this building consists of three indoor draw-thru AHUs (air handling units) and a FCU (fan coil unit). The thermostats throughout this building were observed to be aged. The AHUs were aged as well, although it was observed they had been repaired at some point. One of the AHUs had a new fan belt, while the exterior was corroded in some areas. These AHUs appeared to be original to the building and aged past their design service life.		Poor

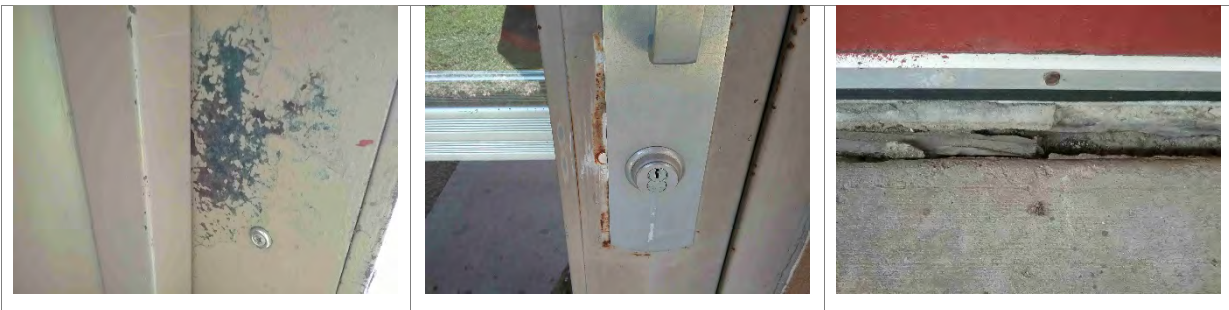
Exterior Doors	The main entry exterior doors exist on the north side of the building. There are six glazed double doors with transom windows above them. The doors are painted metal, as are the frames. The remaining service doors are also metal, most with full glazing. Worn paint was observed on the doors at typical spots of high use. Rust was also observed to exist behind the door hardware on the exterior side of some doors and	Average

System	Subsystem	Condition and Deficiency Overview	System Condition Rating
		on the frames of other doors. The threshold sealant leading through the main doors was observed to be deteriorated or missing.	
Roofing	The roof is a standing seam metal roof. The roof was inaccessible due to its steep slope. The roof was observed to be in good condition from ground level.		Good
Interior Construction	Interior Walls	The interior walls are constructed of metal studs covered with drywall. A few of the classrooms have fabric folding partitions dividing them. The interior walls were observed to be in good condition, except that the operable partitions were observed to be difficult to operate.	Good
	Interior Doors	The interior doors are metal in metal frames. The classroom doors have wired narrow side lites. There are two overhead steel shutters recessed into the ceiling at each end of the corridors in the building. The interior doors were observed to be in average condition with typical scuffed frames and scratched paint. The frames exhibited some rusting at the bases. The overhead shutters were recessed at the time of assessment, but the tracks appeared to be in poor condition; some tracks were observed to taper at the bottom or be dented in the middle, prohibiting proper shutter deployment.	Average

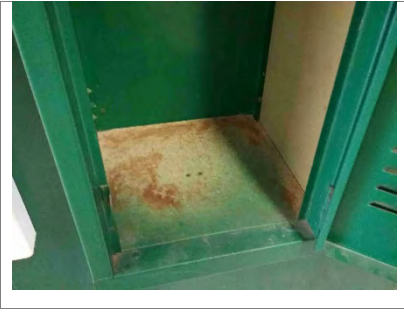
Interior Specialties	There are wall-mounted painted metal lockers in the corridor of the building. The lockers were observed to be in average condition; the exterior was observed to be in good condition, but the interior of the lockers showed signs of rust.	Average
Stairs	Exterior Stairs	System not present.	N/A
	Interior Stairs	There are many interior stairs in the building. They are all cast-in place concrete with metal nosing. The handrails are painted metal. The interior stairs were observed to be in average condition due to use and age. Spalling was observed on many of the stair risers. Some rebar was observed to be exposed at spalled portions. The paint on the handrails was observed to be excessively scratched and peeling.	Average

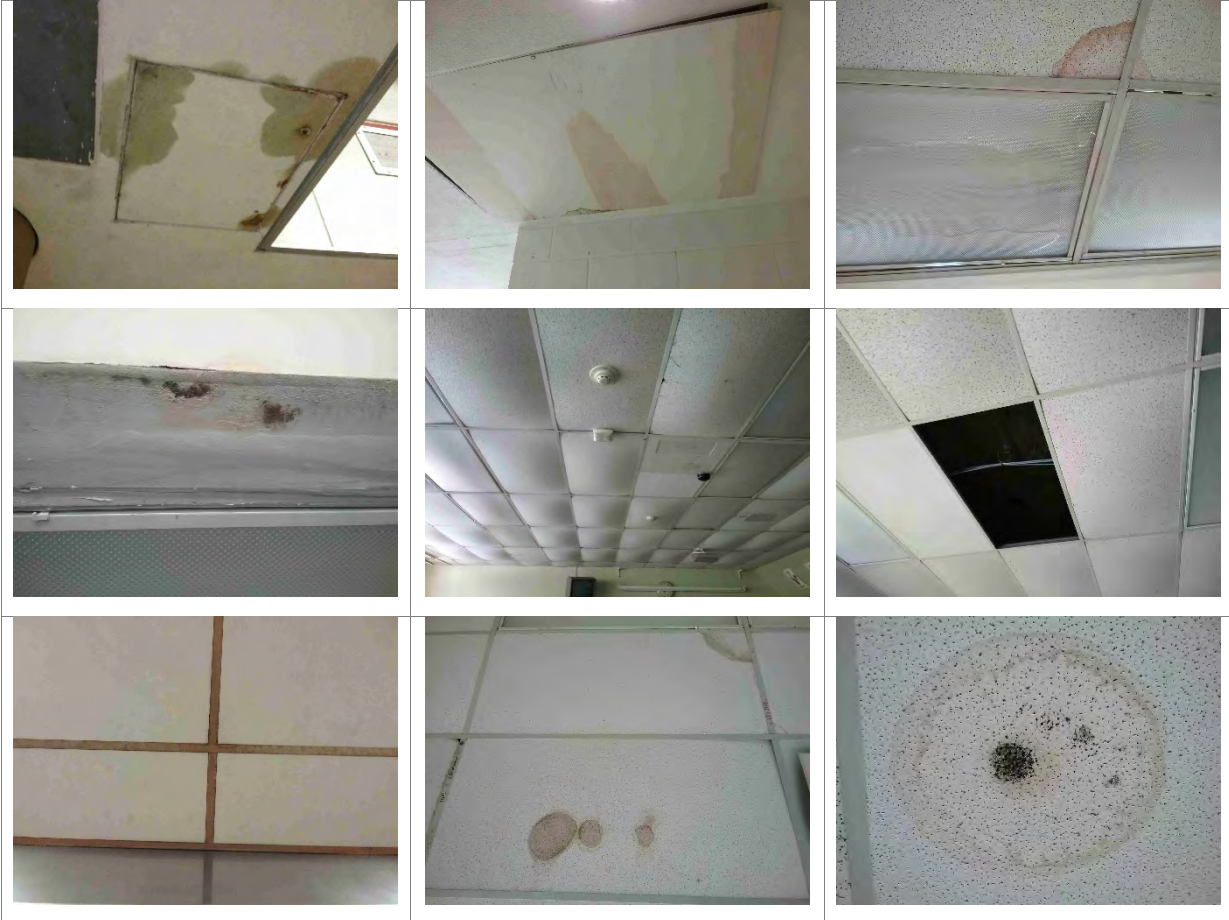
Interior Ceiling Finishes	The first floor of the building does not have ceiling in the corridor; the concrete waffle slab of the floor above is exposed. The ceiling of the second floor is painted drywall, as are the ceilings of the restrooms. The classrooms have ACT ceilings. The library ceiling is metal panel and drywall. The culinary room ceiling is water resistant ceiling tiles. Water damage was observed on a soffit near the male restroom on the first floor. The ceiling access panel in another male restroom on the first floor was observed to have water damage as well. Water damage was observed in the mechanical ductwork soffit of one wing of the building. Water was observed inside one light fixture, and the ceiling tiles themselves were damaged and bowing. Suspected mold was observed where this soffit was covered in drywall facing. This condition was observed on both sides of the B-wing. The majority of the ACT tiles in the building were observed to be bowing. A few ceiling tiles were observed to be missing. Discolored and deteriorating ceiling tile tees were observed in the culinary room. The auxiliary room between rooms 207 F and 209 F was observed to have water-damaged ceiling tiles with evident mold.	Average

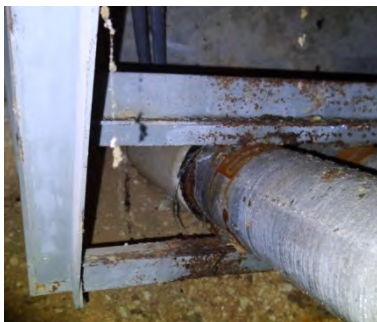
Condensation on pipe

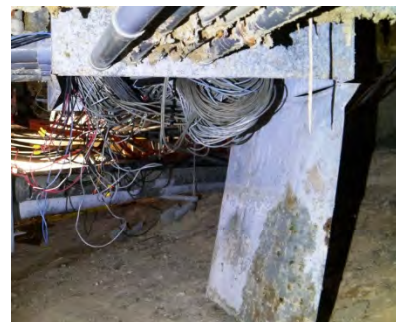
Rusted pipe hangers

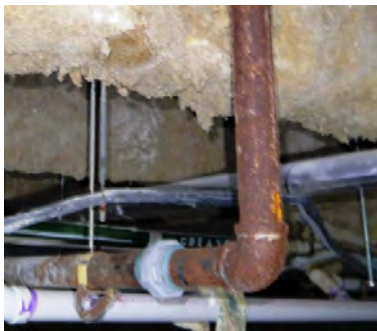
Rusted Pipe

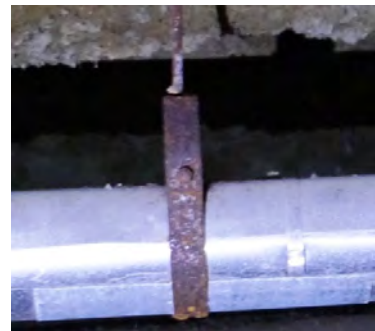
Rusted pipe hanger

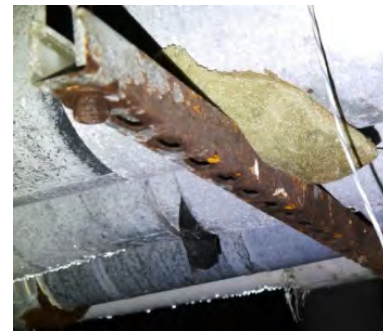
Rusted pipe support

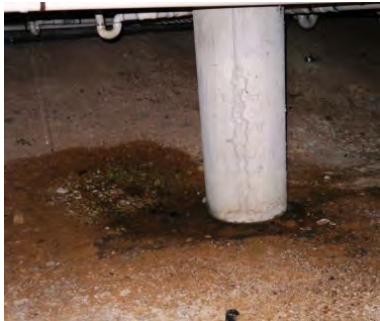
Leaking pipe	Rusted pipes & supports	Rusted pipe hanger

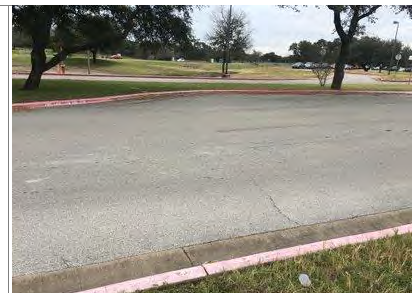
Settling at exit

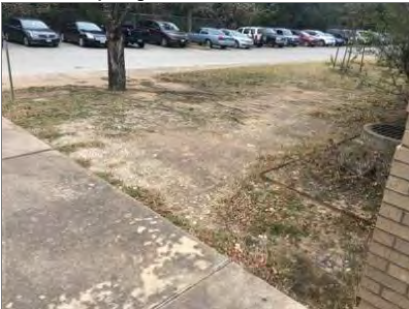
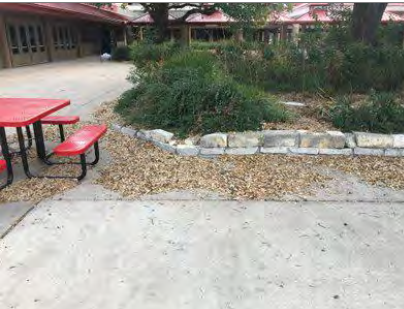
Landscaping

Worn grass	Overgrown vegetation (main courtyard)
