Crockett High School Site Summary

Address	5601 Manchaca Road Austin, TX 78745
Number of Permanent Campus Facilities	2
Original Year of Construction	1969
Total Campus Building Area (combined)	336,603 SF

Main School Building – BLDG-008A

Theater Building – BLDG-008B

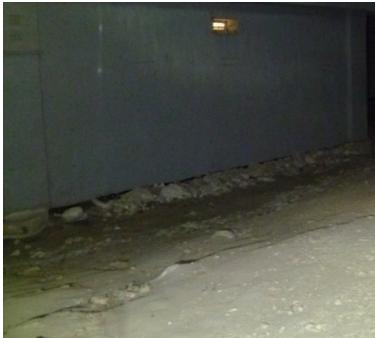
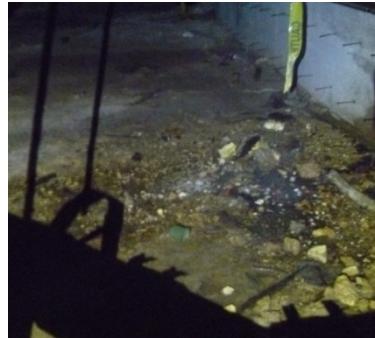
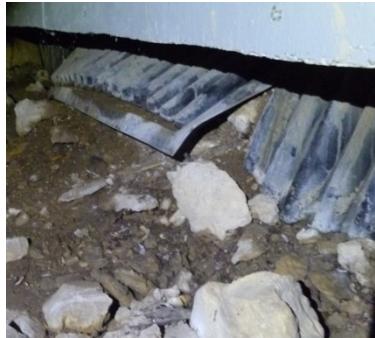
Damp soil	Saturated soil below leaking pipe	Soil infiltration due to failed soil retainers

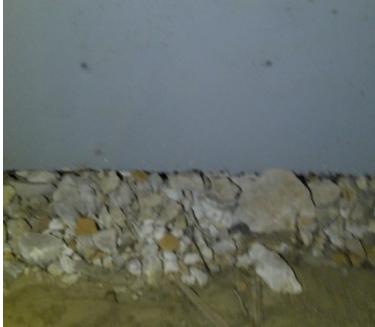
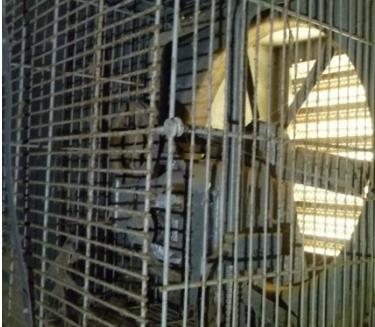
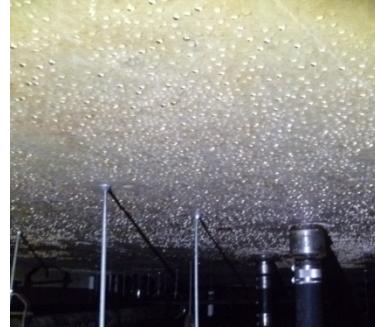
Violated void space below perimeter beam	Ventilation fan not operational	Condensation on underside of slab

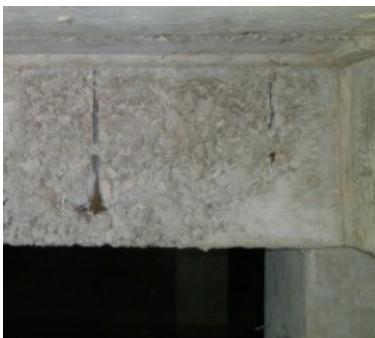
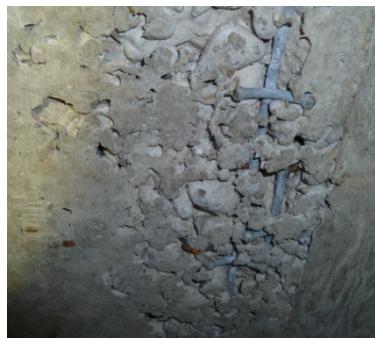
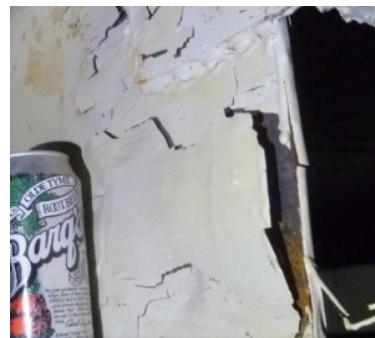
Poor concrete consolidation in floor beam, exposed/corroded beam reinf	Poor concrete consolidation in slab, exposed wire reinf	Rust and paint chipping on steel beam

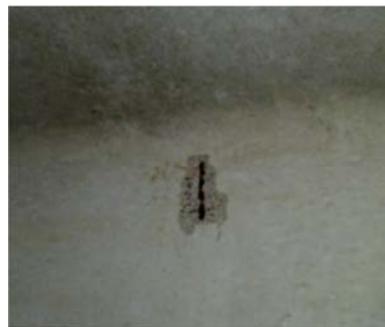
Exposed rebar in slab channel

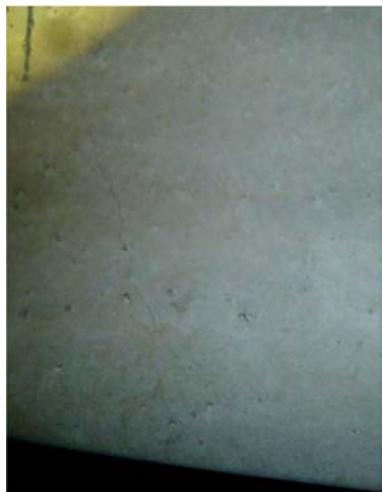
Small cracks in slab channel

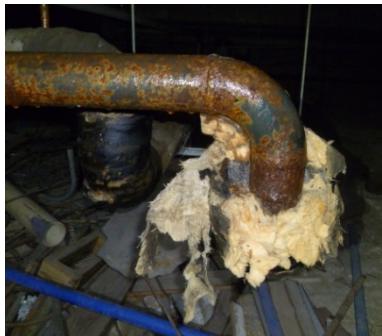
Rusted pipe and degraded insulation

1. Repair leaking pipe.
2. Clean and protect rusted cast iron pipes from further corrosion.
3. Replace heavily corroded hangers.
4. Replace moldy, degraded, and missing pipe insulation.

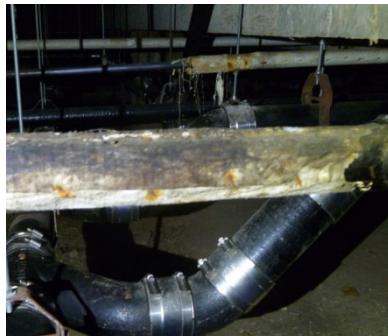
Moldy pipe insulation

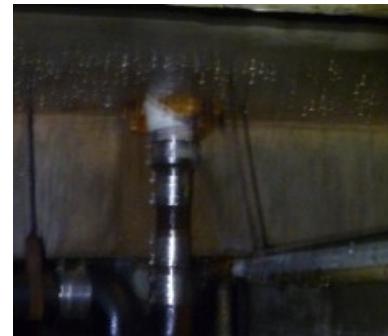
Heavy pipe leak

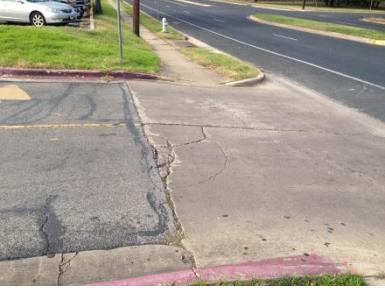
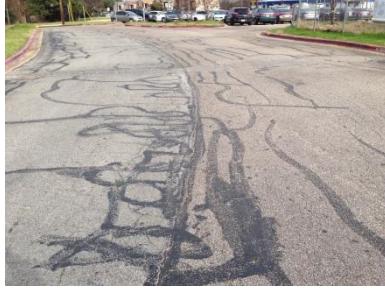
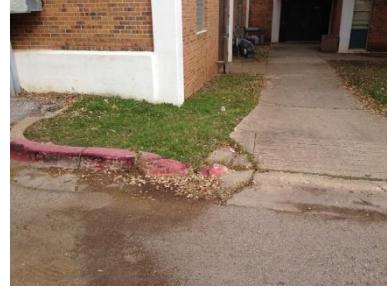
Broken and scraped concrete at Bus drop off entrance/exit, R1	Cracking at bus drop off road, R1	Broken Curb R2

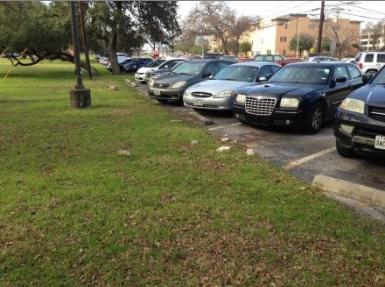
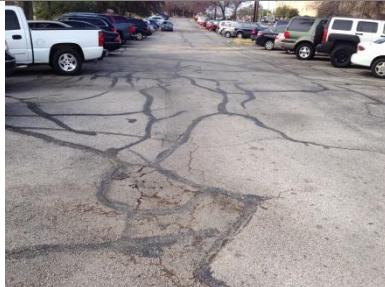
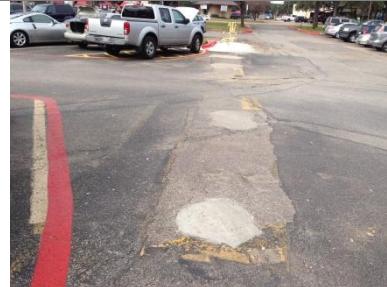
Broken curb stops Staff\Student Parking, P1	Pot hole and cracking Staff\Student Parking, P1	Staff\Student Parking ,P2 Patches where gate was removed

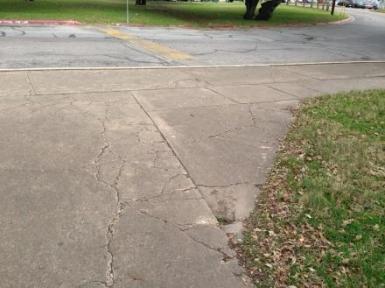
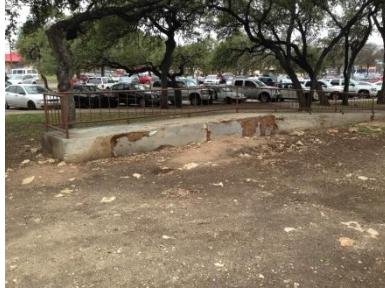
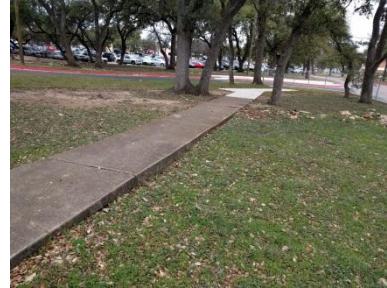
Cracked Sidewalk at athletic building	Remove sidewalk at Construction Construction Technology Center	Backfill Sidewalk (Typical)

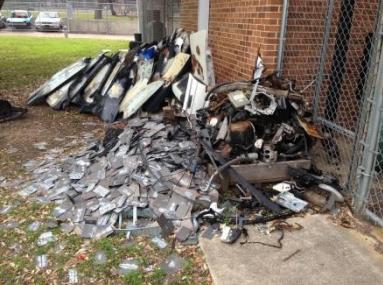
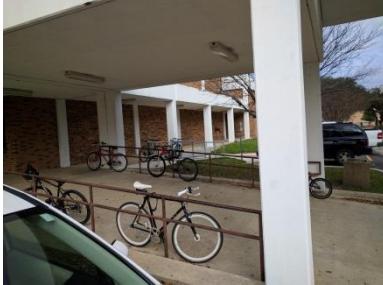
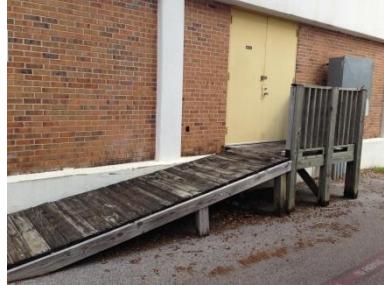
Car parts and welding samples	Bike rack needed	Rotting ramp and decking

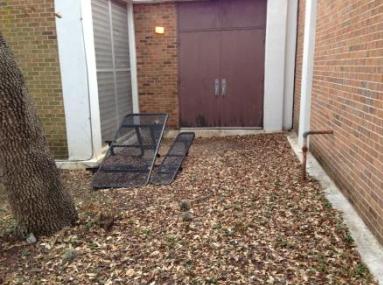
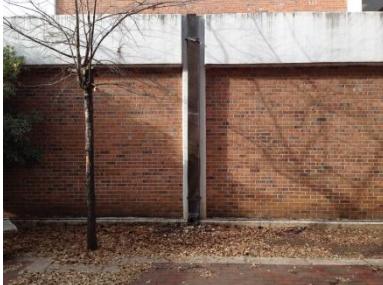
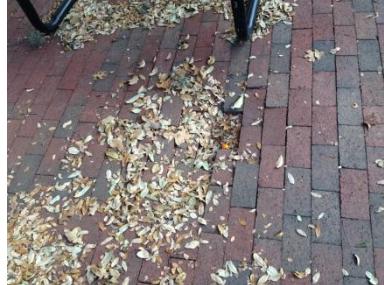
Center Court Yard (CY2) Broken picnic Table	Center courtyard (CY2) Broken Downspout	Center courtyard (CY2) depression in brick pavers

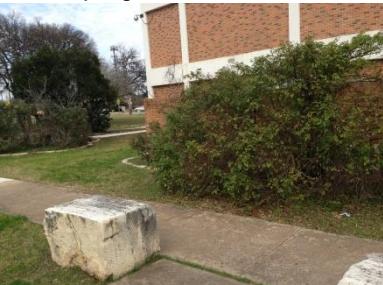
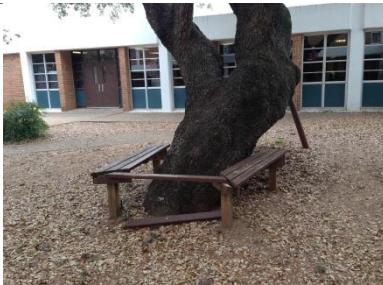
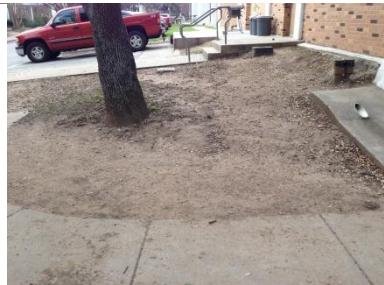
Overgrown landscaping	Broken bench and tree branch support	No grass near performing arts center

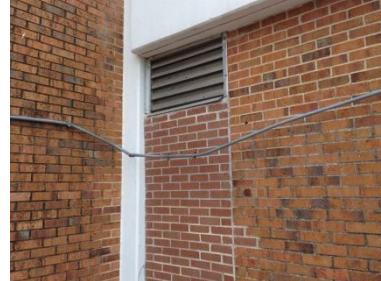
Inlet and sanitary manhole with erosion and infiltration	Hole from removed light	Loose conduit

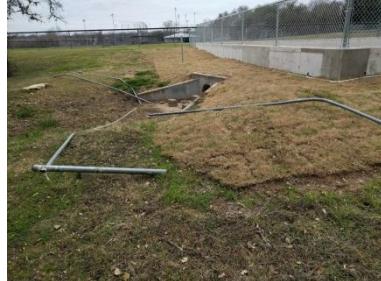
Clogged outfall structure grate	Outfall structure bent and loose	Outfall structure with demolished fence.

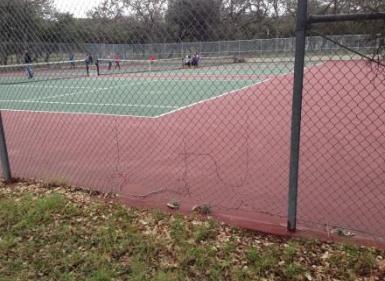
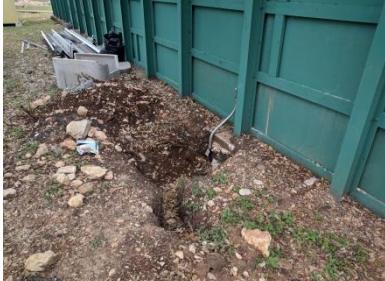
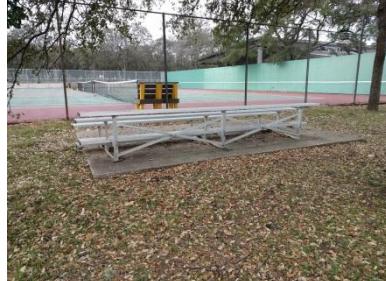
Fence patch at tennis court	Open utility construction needs backfill	Bleachers and rusting chain link fence at tennis court

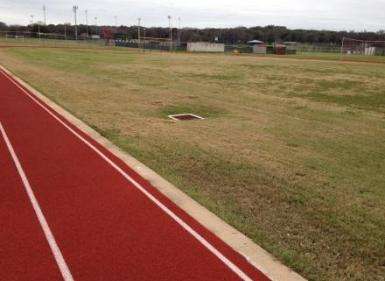
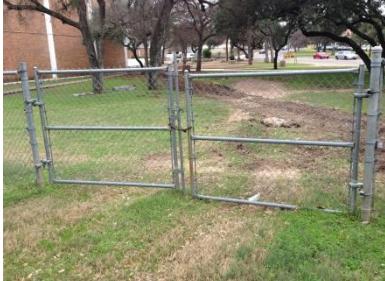
Inlet on football field and track, field slope is steep on west side.	Gate does not close properly

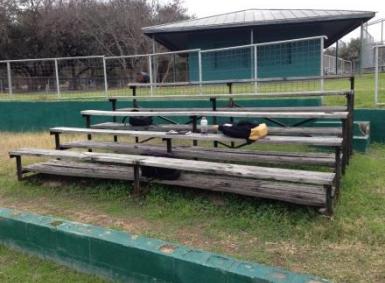
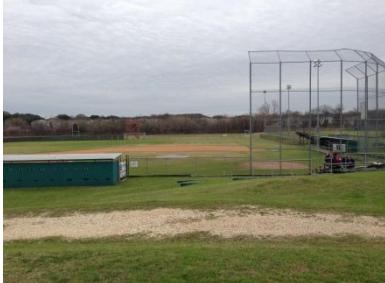
Rotting Bleachers on dirt. Retaining wall with no cap	Gravel road needs regrading or paving at baseball field
