Eastside Memorial High School Site Summary

Main School Building – BLDG-019A

Theater Building – BLDG-019B

Site/Civil Assessment

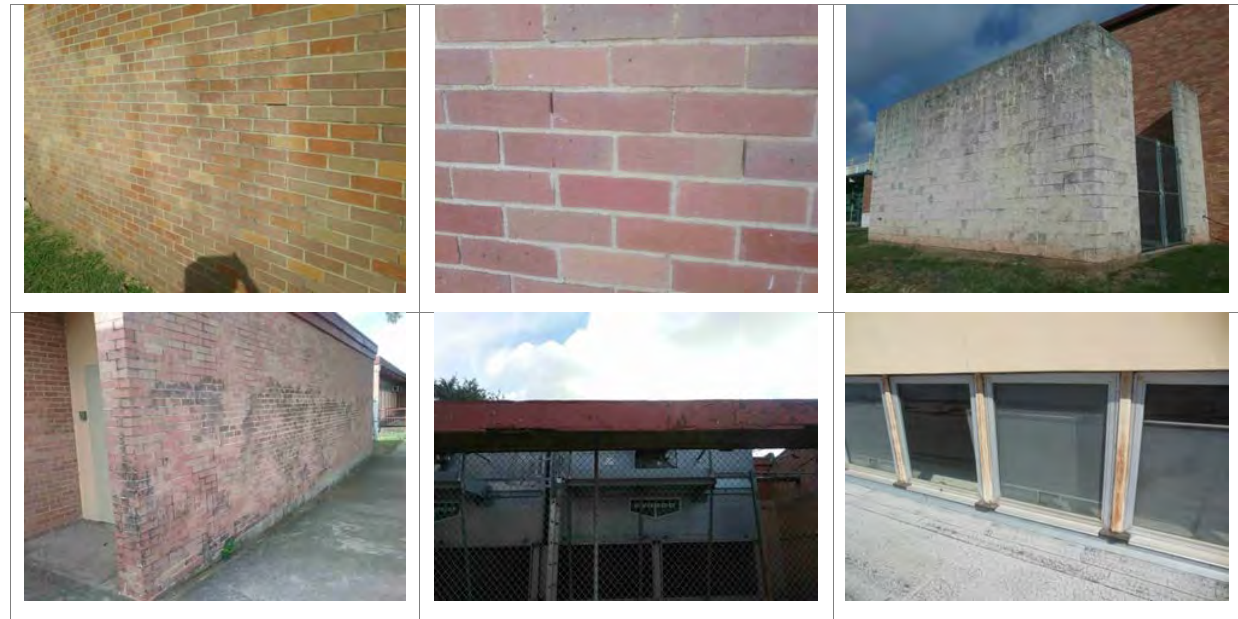
System	Subsystem	Condition and Deficiency Overview	System Condition Rating
Exterior	Exterior Walls	<p>The exterior of the building consists of a combination of exterior cladding materials such as brick, prefinished metal panels, painted steel, EIFS (exterior insulated finish system), and ceramic tile accent walls.</p> <p>The exterior walls that were observed were in average condition. There were areas around the perimeter of the building especially at the bottom of the walls near the gymnasium area where the brick face shell has been removed. This was most likely due to overly aggressive graffiti removal techniques which left the exterior wall more susceptible to moisture migration. In addition, there were also select areas such as on the south elevation and the west elevation just outside of the AISD (Austin Independent School District) print shop where the pointing mortar was deteriorated. There were also isolated areas with organic growth on the masonry surface such as on the west elevation at the 100-wing, various locations in the courtyards where overflow roof scuppers were located and on the split faced block on the south elevation where there was an mechanical equipment enclosure screen wall. There was an area on the west side of the building where there is a mechanical enclosure where the concrete is spalling above the line of the fence which poses a safety hazard. Chipped paint at some painted steel areas adjacent to windows on the roof level was observed. Other finishes</p>	Average

System	Subsystem	Condition and Deficiency Overview	System Condition Rating
		<p>such as prefinished metal wall panels, EIFS, and ceramic tile accent walls were in good condition.</p> <p>The facility occupants reported that there are gaps between the floors and exterior walls which allow water infiltration. In addition, rodents, ants and roaches are present throughout the building. Rodents nest in the front office closet. The facility occupants also noted that there is a crack in the exterior wall at the principal's office.</p>	
	Exterior Windows	<p>The exterior windows consist of single-pane glazing units with prefinished aluminum frames.</p> <p>There were many localized areas where the window panes were cracked. It was observed that the window glazing sealant is cracked and is deteriorated on the windows throughout the facility. The window sealant was cracked and deteriorated in the clearstory windows in roof area 31 above the library. The windows in the 700-wing were etched, yellowed, and difficult to open and the sealant was deteriorated. There was a cracked window in the male faculty restroom and the window was difficult to open. The windows on the west elevation locker rooms are in poor condition; the sealant was cracked, the panes were etched, and there were several cracked panes. The exterior window pane at the kitchen was badly etched. The window sealant was deteriorated, there were two cracked windows that do not open on the west elevation and one severely cracked window on the east elevation of the cafeteria. The windows on the east side of the building, the band/orchestra area and the freshman wing appeared to be in relatively newer condition. However, there was a broken pane at the south elevation near the western most entry doors.</p> <p>The facility occupants reported that the majority of the exterior windows have exceeded their typical design service life. Many of the windows do not seal properly and leak during rain events; the worst area was noted in the 700-wing.</p>	Poor

1. The damaged face brick shell at the locations noted in the report can be protected from moisture migration through the wall with the application of a breathable masonry sealer. In the future the facility should have a graffiti removal procedure in place that utilizes chemical graffiti removal solvents instead of power washing which was suspected as the cause of damage.

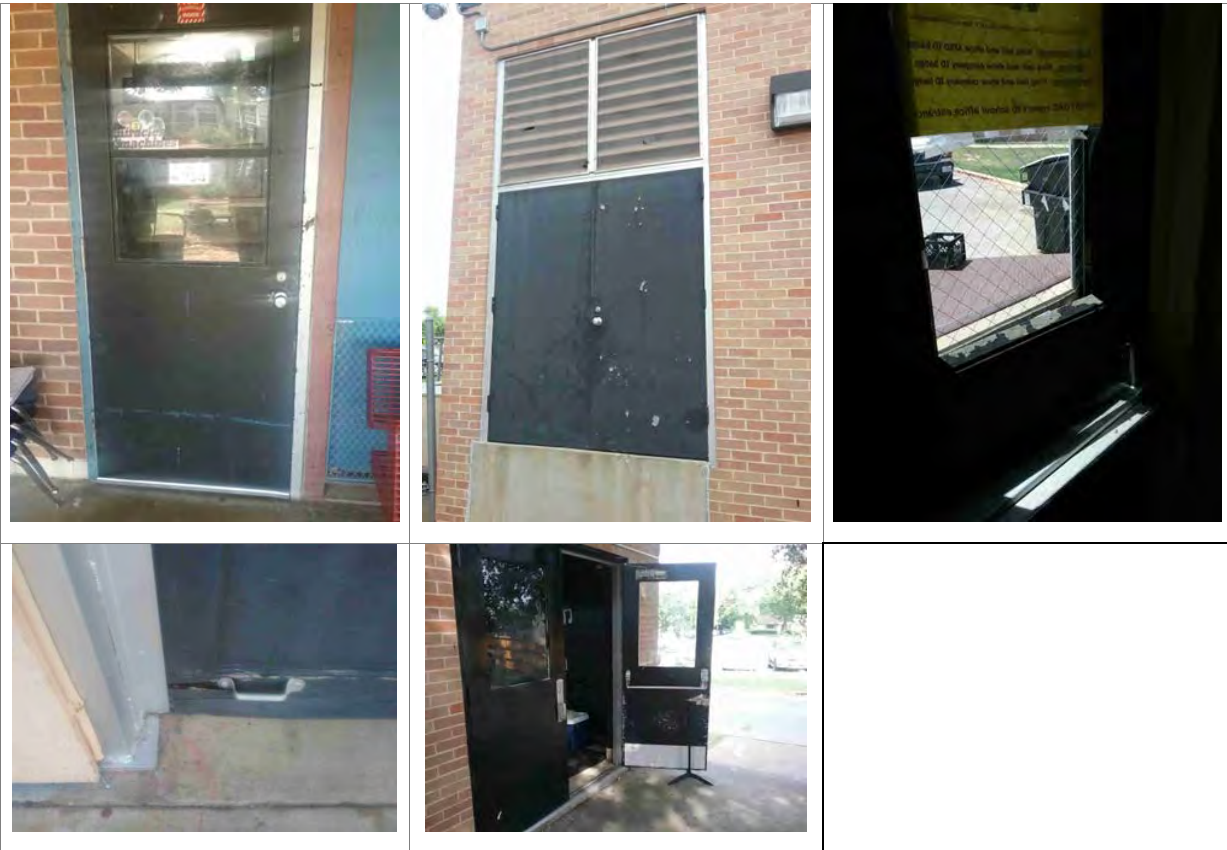
Exterior Doors	<p>There are two main public entryways located at the east side of the building. These doors are painted metal with painted metal frames with vision lights. The remaining exterior service doors around the facility are of the same type. Additionally, there were four 12'x12' manually operated painted wood roll-up doors and one 12'x12'</p>	Average

System	Subsystem	Condition and Deficiency Overview	System Condition Rating
		<p>prefinished aluminum manually operated roll-up door in the auto shop.</p> <p>The exterior doors, frames, hardware and vision lights throughout the facility were observed to be in average condition due to age, high usage, difficult hardware operation, paint scratches, light scratches, dents, and minor rusting. The doors in the 100, 200, 300, 400, and 500 areas were in average condition with minor dents, chipped paint, and etched lights. The 700-wing doors were in poor condition with the same deficiencies. The four 12'x12' painted wood overhead roll-up doors in the auto shop had rotted sills, soiled and chipped paint, the door hardware was bent, and the weather stripping was deteriorated. The 12'x12' prefinished aluminum overhead roll-up door in the auto shop was observed to be in good condition. The band room and mechanical room entry doors were dented, rusted, and the paint was chipped. The exterior door light frame at the kitchen was damaged and in poor condition. The freshman wing prefinished aluminum doors/frames/lights were in good condition.</p> <p>The facility occupants also reported that the majority of the panic door hardware and general door hardware components on the exterior doors (hinges, sills etc.) have exceeded their typical design service life and cause persistent maintenance problems. The ceiling to floor roll-up gates do not function well.</p>

11. Replace all non-functioning ceiling to floor roll-up doors in the corridors and cafeteria with new prefinished aluminum roll-up doors.

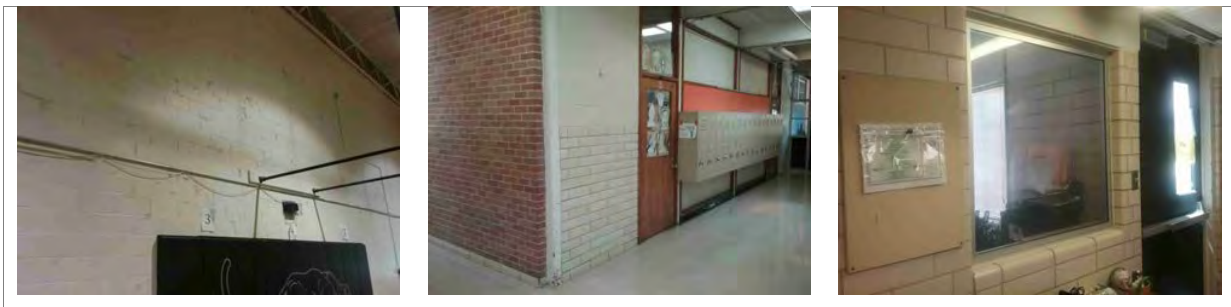
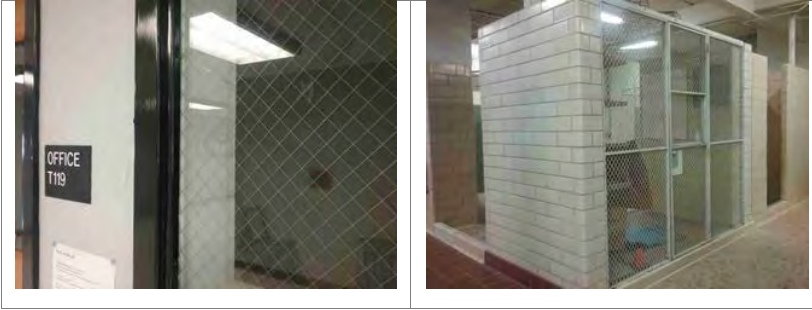
Interior Construction	Interior Walls	<p>The interior partitions original to the building are predominately constructed of painted CMU (concrete masonry unit), glazed block, and brick and painted gypsum board that is painted with glazed tile on the lower portion of the wall. The administration offices and the library had painted gypsum board construction, CMU, or brick walls.</p> <p>The interior partition construction materials appeared to be in average condition.</p> <p>The interior sidelight and window glazing was etched and scratched at various locations such as the cafeteria. There was also a cracked sidelight window in the freshman wing at office T119.</p> <p>The wire mesh partitions in the male and female locker rooms were in average condition with minor chipped paint.</p>	Average
	Interior Doors	<p>The portions of the building original to construction consist of wood doors in wood frames, hollow metal doors in hollow metal frames with and without lights. The kitchen has several metal overhead roll-up doors.</p> <p>The interior doors were observed to be in poor condition given the age of the system and show typical signs of wear and use. The wood doors in the 100, 200, 300, 400, and 500 areas were scratched, gouged, and cracked. The wood doors in the 700-wing have similar deficiencies but were in worse condition. The windows in the doors and transoms throughout were etched. The door hardware was operable but worn. The painted</p>	Poor

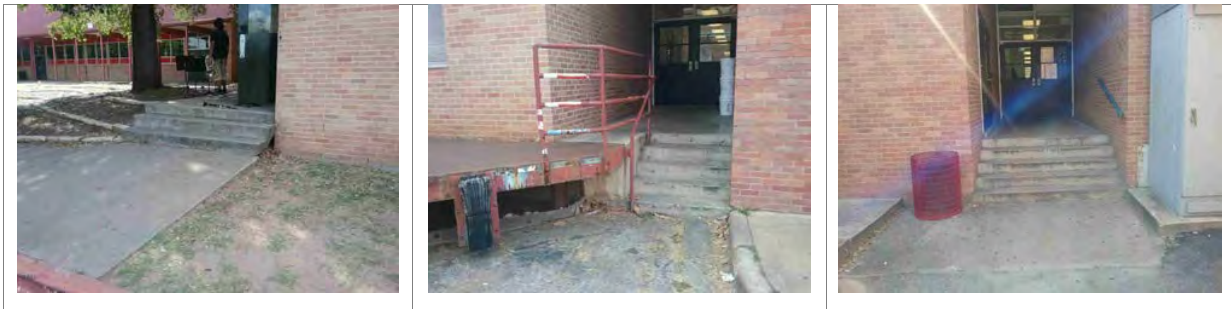
Stairs	Exterior Stairs	<p>The exterior stairs are comprised of poured concrete.</p> <p>The stairs were observed to be in average condition. There were three exterior stairs that lack proper handrails. Lack of handrails is a safety hazard.</p>	Average
	Interior Stairs	<p>There are four sets of interior wood stairs in the gymnasium leading to the former stage area.</p> <p>One set of stairs at the former backstage area had a broken wood stair tread which poses a safety hazard. The freshman wing has two concrete filled metal pan stairways that were in good condition.</p>	Average
Interior Finishes	Interior Wall Finishes	<p>The interior partitions original to the building are predominately constructed of painted CMU, glazed block, brick and painted gypsum board with glazed block on the lower portion of the wall. There are new ceramic tile wall finishes in the male and female restrooms in the 200-, 300- and 400-wings. There is painted CMU and exposed brick in the band rooms with acoustical wall panels mounted to the walls which are in good condition. The freshman wing finishes are made up of painted CMU, gypsum board and glazed block which are all in good condition.</p> <p>The interior wall finishes appeared to be in average condition as instances of minor cracking and chipping were observed throughout all wall surfaces with portions of the 700-wing being in the worst condition. In the small</p>	Average

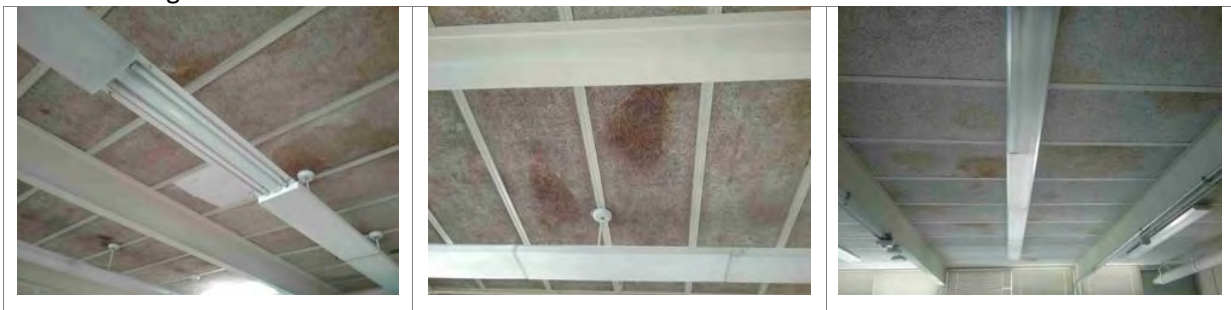
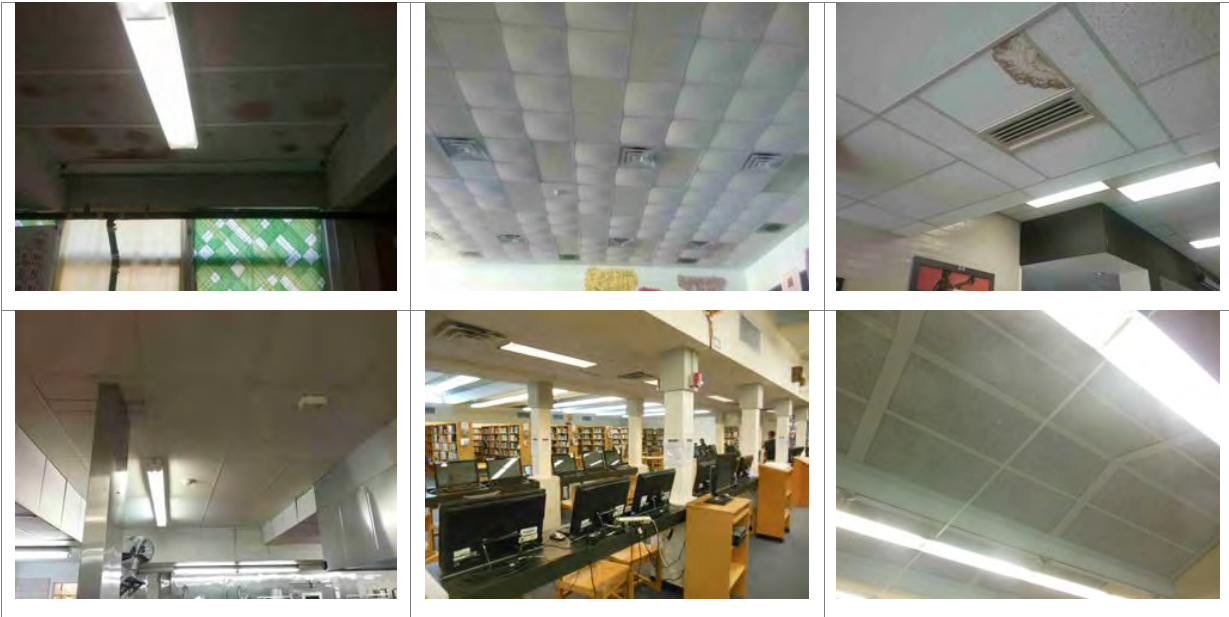
Interior Ceiling Finishes	<p>The interior ceiling finishes around the facility are comprised of 2x4 wheat board and 2x4 and 12x12 ACT (acoustical ceiling tile).</p> <p>The 2x4 tectum board ceilings in the 100, 200, 300, and 400 area corridors, classrooms, restrooms, and health clinic were in average condition some soiled with minor water stains. In the 700 area there were water stained, aged and bowed ceiling tiles particularly in classrooms 702, 704, 708, room 207 (the roof above this area was being repaired) and room 410.</p> <p>The large and small gymnasium, male and female locker/shower ceiling finishes were comprised of 2x4</p>	Average

System	Subsystem	Condition and Deficiency Overview	System Condition Rating
		<p>tectum board and painted structural steel which were in average condition.</p> <p>The 2x4 ACT in the administration, main office, and the 500 area classrooms were in average condition.</p> <p>The 2x4 ACT in the kitchen and cafeteria had some water damaged ceiling tiles.</p> <p>The 2x2 ACT in the library had minor water damaged tiles. The ceiling tiles in the band/orchestra room was severely bowed and in poor condition.</p> <p>The freshman wing 2x4 ACT was in good condition.</p> <p>The facility occupants noted that the ceiling was open near the cafeteria serving lines.</p>	
Conveying	<p>The Freshman Academy section of the building is equipped with a hydraulic passenger elevator to service two levels. The hydraulic pump was located in a mechanical room, ELVMEC1, adjacent to the elevator shaft and accessed from outside. The elevator was noted as having a maximum weight capacity of 2,100-pounds. This elevator was installed in 2005 and appeared to be in excellent condition. No current inspection certificate was observed, and access to the car was not achieved. A maintenance and inspection log entry for 02DEC15 was observed in the hydraulic pump room.</p>		Excellent

1. Repair damaged ceiling tiles. Monitor and repair roof leaks as needed on all buildings to prevent further damage.

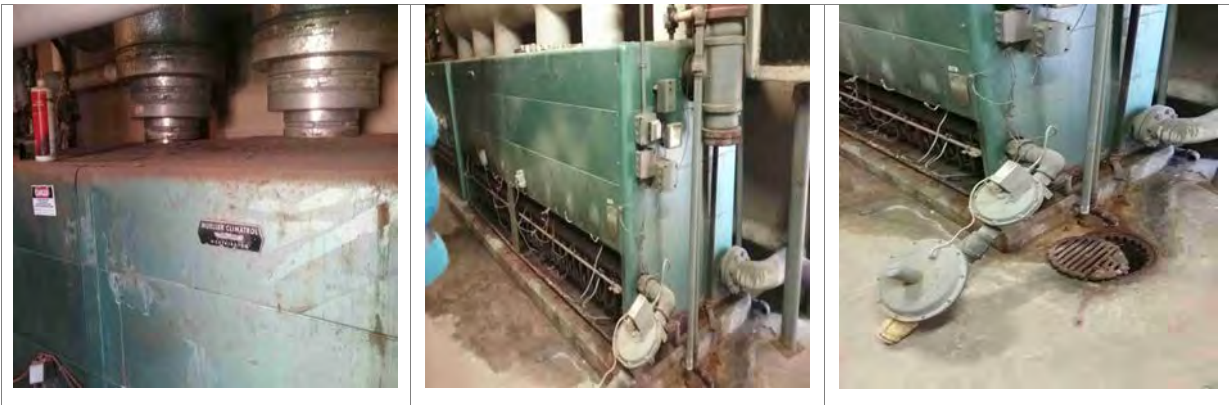
System	Subsystem	Condition and Deficiency Overview	System Condition Rating
	Domestic Water Distribution	<p>There are multiple gas and EWHs (electric water heaters) throughout the building to feed specific locations. These water heaters are located in the designated mechanical/electrical rooms associated with the building, and cafeteria area. These water heaters are estimated to be of 500- to 1,200-gallon capacity. The science labs in the T-Wing have small instantaneous water heaters installed below the sinks.</p> <p>The main mechanical room of the building has two 200-TON chillers and two 300-TON cooling towers on the exterior shell. The room also has series of hot water pumps and cold water pumps associated with the chillers and cooling towers.</p> <p>The large water heaters, which have an estimated capacity of 1,200-gallons, in the electric room outside the cafeteria, kitchen, and mechanical room 100 were observed to be in poor condition. These water heaters appeared to be past the typical design service life. The water heaters with an estimated capacity of 600-gallons in mechanical room 400 and T140 were observed to be in good condition with no identified or reported deficiencies. The plumbing distribution equipment was observed to be in average condition based on the deficiencies of the water heaters mentioned above. Damaged insulation and corroded piping was also observed in some of the spaces.</p> <p>The chillers and cooling towers in the main mechanical room were observed to be functioning well and in good condition with typical deficiencies like damaged insulation and corroded piping. Chilled water pump, CHWP-2 was observed to be leaking in the main mechanical room. It was leaking, mostly due to package leaking.</p> <p>The mechanical room in the basement of the gymnasium was inaccessible at the time of the assessment.</p>	Average

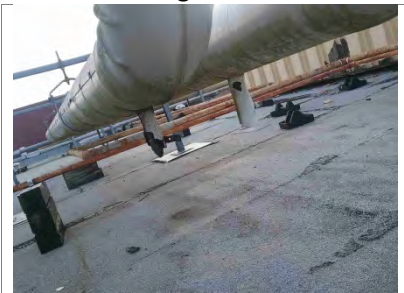
Other Plumbing	<p>The roof drains are equipped with metal grate covers to prevent debris from entering the drainage system, but the covers were observed to be corroded. The domestic water and gas pipelines throughout the building were rusted. It was reported that the science classroom floor drains do not collect water properly.</p>	Poor

1. Continue preventative maintenance on aged plumbing fixtures and/or planning for replacement in the future as fixtures continue to age at all associated campus facilities.
2. Repair or replace any damaged or missing piping insulation as needed at all facilities.
3. Clean and flush out all of the roof and interior floor drainage piping at all facilities, particularly on the eastern roof section of the Main School Building that was observed with standing water. Additionally, repainting or addressing the corrosion on the metal grates/covers for the drains to mitigate further deterioration and build-up around the drains.
4. The domestic water and gas pipelines throughout the campus should be replaced.

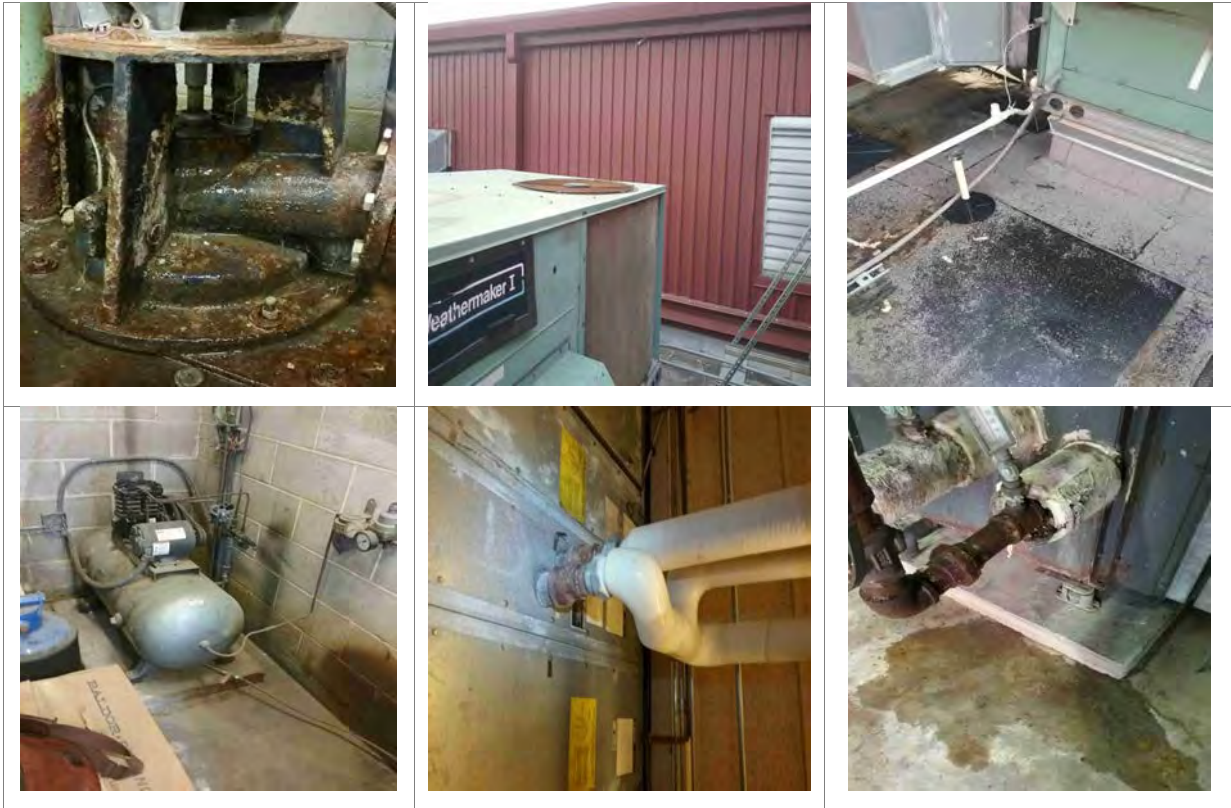
Mechanical/HVAC System Deficiency Examples

System	Subsystem	Condition and Deficiency Overview	System Condition Rating
Mechanical/ HVAC		<p>The major mechanical equipment consists of FCUs (fan coil units) located in classrooms and labs, split-system air condensers and AHUs (air handling units) located primarily in larger mechanical spaces inside the school. Package units are located on the roof or around the exterior perimeter of the facility. These serve the HVAC (heating, ventilating, and air conditioning) system along with some additional equipment at the neighboring campus facilities.</p> <p>The AHUs are located throughout the interior of the facility and range from an estimated 1,050 CFM (cubic feet per minute) to 25,800 CFM in capacity. These AHUs serve different zone locations throughout the facility. Typically, the AHUs are equipped with preventative maintenance logs attached to the housing enclosure or nearby for reference.</p> <p>The facility contains many package units, mostly located on the roof and two located around the exterior perimeter of the facility. These package units range from an estimated 2-TON to 12-TON capacity.</p> <p>Multiple ERUs (energy recovery units) are installed in the penthouses on the roof of the building. One ERU is installed on the roof of the T-wing which served the entire wing. The unit mixes outside air with the air returned by HVAC units to maintain a standard temperature in the wing.</p> <p>Supplemental mechanical equipment for the HVAC system also includes EFs (exhaust fans), VAV (variable air volume) terminals, and FCUs. Roof top EFs were installed 2006 or 2015 and were observed to be in good condition. Roof top EFs ranged between 300 CFM to 1500 CFM capacity. The roof top EFs over the kitchen are much larger. A make-up-air unit was also observed over the kitchen space. The VAV terminals and FCUs were observed to be in good condition with no reported or observed deficiencies.</p> <p>The AHUs and RTUs (roof top units) were observed to be in average condition with the most typical deficiency being corrosion on the housing enclosure and the piping associated with the units. Additional deficiencies observed include general aging of the equipment, damaged insulation, excessive noise and vibration, and a few leaks. It was reported that the AHU in room 710 was leaking.</p> <p>Some RTUs and split-systems use R-22 refrigerant, which is an outdated refrigerant that is being phased out of use. Five new RTUs were installed within the last year on the roof and were observed to operate in excellent condition.</p> <p>The ERU on the roof of the T-wing was observed to be in good condition, maintaining a constant temperature throughout the wing. ERUs in the penthouses could not be observed as the penthouses were inaccessible at the time of the assessment.</p> <p>Electrical and mechanical rooms were warm and humid and were insufficiently ventilated.</p> <p>The overall HVAC system of the building was observed to be in average condition based on the previously mentioned deficiencies. It was reported that various parts of the building had inconsistent temperatures, which was most likely due to building renovations which resulted in an unbalanced system.</p>	Average

1. Address any rust or corrosion observed to the equipment, its associated piping, or any other sub-asset in all facilities by cleaning, re-painting, and/or repairing by any other means to prevent further deterioration.

2. Continue to replace the original AHUs and equipment that have reached the end of the design service life.
3. Repair or replace any damaged or missing piping insulation as needed at all facilities.

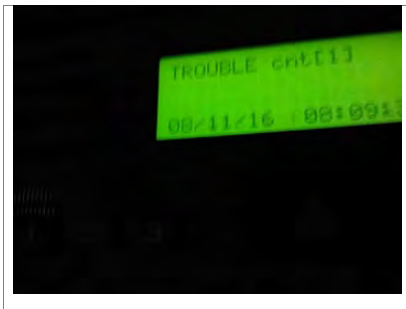
System	Subsystem	Condition and Deficiency Overview	System Condition Rating
Fire Protection	Fire Alarm	<p>The building is equipped with a fire alarm system that consists of alarm and signaling devices such as horn and strobe combination devices, pull stations, and detectors.</p> <p>The fire alarm system is controlled by a Honeywell Silent Knight control panel. The fire alarm system was observed to be in good condition. However, the fire alarm control panels displayed a "TROUBLE" indication. The nature and cause of the problem was not determined.</p>	Good
	Fire Protection/Suppression	<p>The majority of the building does not have an automatic fire suppression system. There is an automatic sprinkler system for fire suppression located above the stage in the theater. The building is protected by portable fire extinguishers placed throughout the facility. The kitchen area is provided with Badger Range Guard wet chemical fire suppression.</p> <p>There was no evidence of inspections or testing of the kitchen hood suppression system.</p> <p>Although the fire extinguishers are up to date on inspections, fire extinguishers are located in the mechanical rooms, but many are not mounted to by brackets to the walls. There are fire extinguishers sitting on the floors, behind equipment and storage, and on mechanical equipment.</p>	N/A

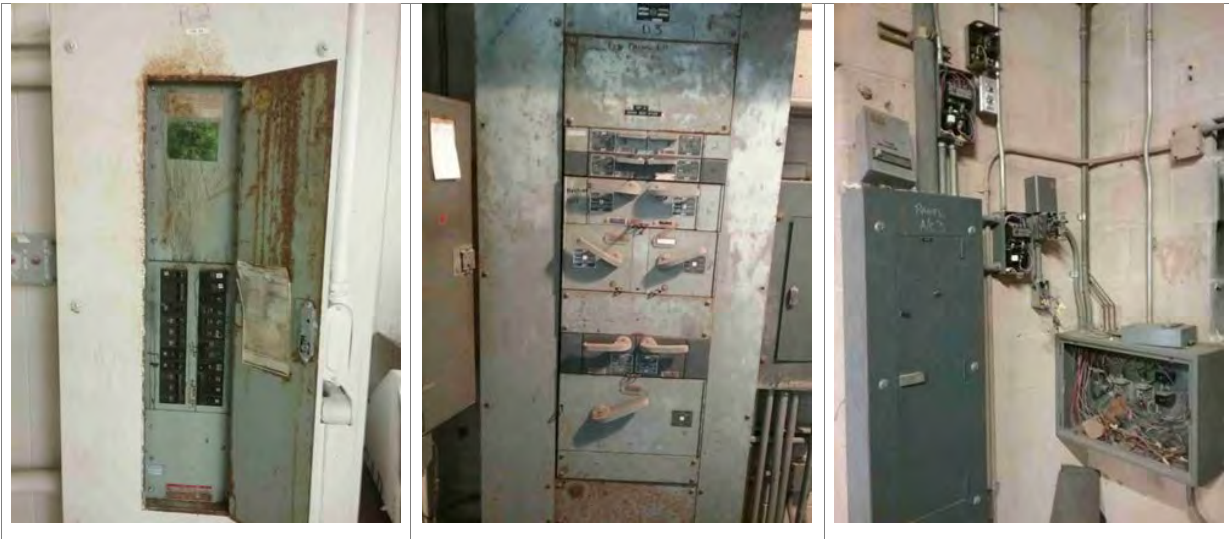
Electrical Distribution

System	Subsystem	Condition and Deficiency Overview	System Condition Rating
		<p>for the school district's print shop. This switchboard's nameplate was not readable and therefore, the rating is unknown.</p> <p>An 800-amp, 400-amp, 480Y/277 volt distribution panelboards are located in a corridor outside room GVBCOFC.</p> <p>A 480Y/277 volt, 800-amp distribution center was located in the library.</p> <p>208Y/120 volt 3-phase distribution panels were located in dedicated mechanical rooms, electrical rooms, and closets. This equipment was fed by step-down transformers in the building. They also provided over-current protection for branch circuits and for sub-panels located throughout the building.</p> <p>The building was equipped with a TVSS (transient voltage suppression system) located in the mechanical room MECHKIT.</p> <p>It was specifically reported that room 504 frequently trips circuit breakers that supply it. Room 705 (computer lab) does not have adequate supply; and the print shop and auto shop specifically have original panels for which spare parts cannot be obtained and need to be replaced.</p> <p>While much of the electrical distribution equipment was observed to be in poor condition, a large fraction of the equipment was original and in poor condition with assets exhibiting corrosion and were well beyond their typical useful life.</p> <p>There were numerous receptacle and junction boxes with missing covers and exposed wiring. A number of original panelboards had been re-purposed as junction boxes, tying in the original branch circuits to newer panelboards. This condition could be considered a life safety hazard.</p>

1. Immediately provide missing cover plates for all exposed junction boxes and sensor covers, as these instances should be considered life safety hazards.

2. Repair or replace all electrical distribution equipment that have exceeded their typical design life, or are affected by corrosion or rust. Remove any floor receptacles as they are being phased out of use district-wide.

3. Replace transformers that have exceeded their typical design life.
4. Replace re-purposed panelboard cavities with properly sized steel junction boxes. Replace all wiring that has exceeded its EUL.

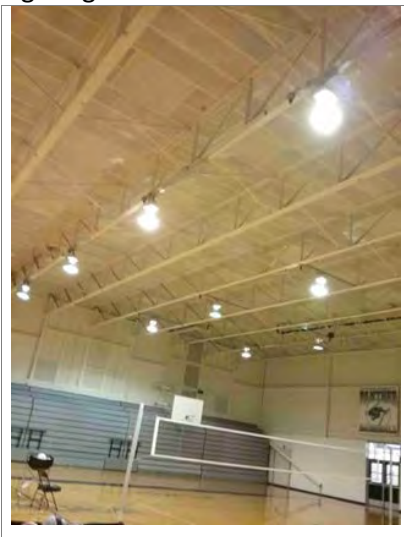
Lighting	<p>Interior lighting primarily consists of recessed and suspended T-12 and T-8 fluorescent fixtures.</p> <p>Exterior lighting consists primarily of flood light fixtures, surface-mount soffit fixtures and wall-mounted metal halide fixtures. It was reported that these fixtures are being replaced by LED (light-emitting diode) units they fail.</p> <p>Emergency wall packs and illuminated exit signs were observed throughout the building.</p> <p>It was reported that the high bay metal halide lighting</p>	Good

System	Subsystem	Condition and Deficiency Overview	System Condition Rating
		<p>fixtures in the gymnasium were slow to fully illuminate, and that they are experiencing frequent maintenance problems.</p> <p>Fluorescent tubes were missing or not working in a number of fixtures. .</p> <p>It was reported that the exterior lighting in the back parking lot and in a number of breezeways, which connect building wings, was not adequate.</p>	
	Communications & Security	<p>The building is equipped with electronic key pass entry, interior and exterior security cameras and motion sensors throughout the building. The security equipment appeared to be in good condition.</p> <p>The building is equipped with telecommunications systems.</p> <p>Overall, the buildings communication and security system is in good condition. It was reported that additional surveillance cameras were needed in the corridors, and on the exterior.</p>	Good

5. Replace all outdated luminaires with LED luminaires with dimming capabilities.
6. Replace all existing exit signs with LED fixtures and add more exit signs where required for all buildings.

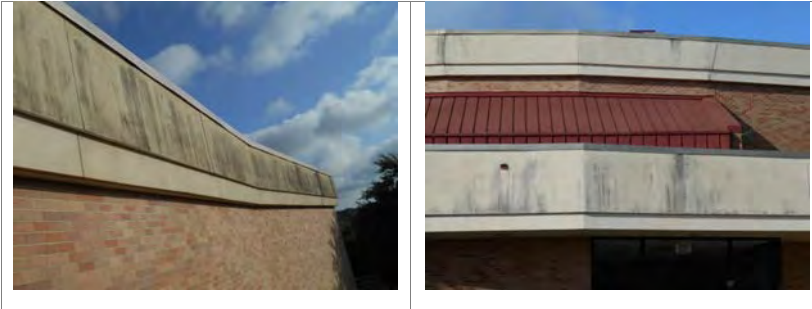
System	Subsystem	Condition and Deficiency Overview	System Condition Rating
Exterior	Exterior Walls	<p>The exterior walls of the building are constructed of brick with a stucco soffit at the perimeter of each roof level. There is a metal ladder attached to the brick façade at the south east elevation of the building that provides access to a portion of the south roof.</p> <p>The brick and mortar joints were observed to be in good condition on all façades of the building. Minor dirt build-up was observed on the brick at the higher sections of the façade walls. The stucco soffit was observed from grade level and appeared to be stained and dirty at various locations.</p>	Good
	Exterior Windows	<p>The only exterior windows in the building are located at the main entry on the north elevation of the building. The windows are single pane glazing in an aluminum storefront framing system.</p> <p>The exterior windows were observed to be in average condition. The framing elements of the system were dented in several areas and showing minor signs of corrosion.</p>	Average

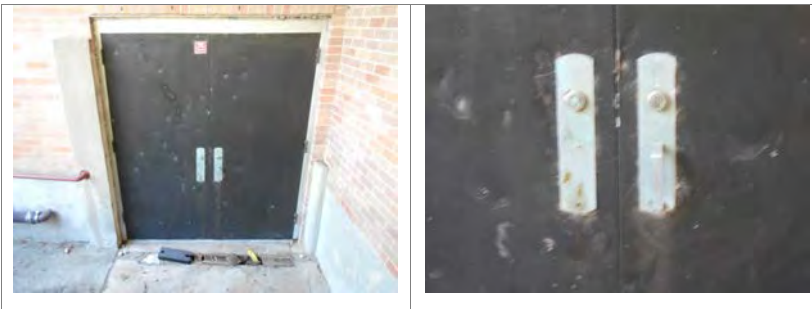
Exterior Doors	<p>The main entry to the building is located on the north elevation. The main entry doors are fully glazed in an aluminum storefront framing system. The exterior service doors are metal with metal frames. There is one manually operated metal roll-up door located at the rear of the building on the south elevation.</p> <p>The exterior doors were observed to be in average condition. The service doors were dented, missing</p>	Average

System	Subsystem	Condition and Deficiency Overview	System Condition Rating
		various pieces of door hardware at some locations, and showing general age due to exposure to the elements.	
Roofing	<p>The roofing material covering the building is constructed of two different systems: low slope built-up roofing and steep slope standing seam metal roofing. The standing seam metal roofing was observed from grade level only and was not accessed during the assessment. The low slope built-up roofing section at the south end of the building was the only assessable area for observation. The remaining built-up roof areas were not accessible and not able to be viewed from grade level. Water is largely removed from the roof surface via interior roof drains.</p> <p>The portion of built-up roof that was accessed was observed to be in poor condition and nearing or at the end of its typical design service life. Several areas of the gravel ballast were worn away exposing the asphalt and roofing felt material. The flashing was observed to be corroded. Many of the roof drains were missing debris cages.</p>		Poor

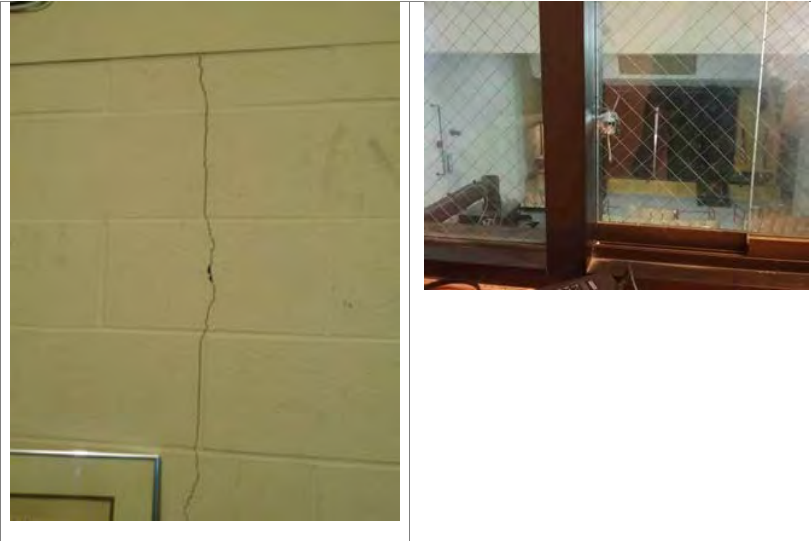
Interior Construction	Interior Walls	<p>The majority of the interior walls are constructed of CMU. There are two small open mezzanine levels located at the rear of the theater stage area. The mezzanines are constructed of concrete and steel. Interior windows are found at the elevated projection room at the rear of the theater. These windows are aluminum framed with single pane glazing.</p> <p>The interior walls were observed to be in average condition. Cracked CMU, possibly caused by building settlement, was observed in the projection room. Cracked and damaged glazing was observed in one of the projection room windows.</p>	Average
	Interior Doors	<p>The interior doors throughout the building are wood with metal frames. An interior manually operated metal roll-up door is located between the stage area and the back-of-house receiving area. The roll-up door was fixed in the open or up position and not viewed at the time of assessment.</p> <p>The interior doors were observed to be in average condition showing scratches, gouges, and minor damage on approximately 50 percent of the doors in the building. Some doors have carved graffiti in the main lobby area.</p>	Average

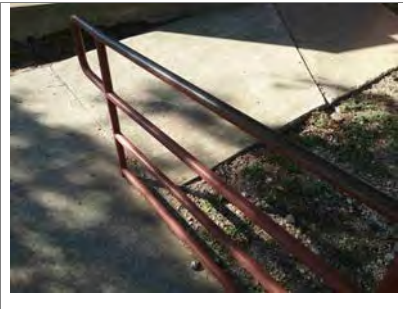
Exterior Stairs

System	Subsystem	Condition and Deficiency Overview	System Condition Rating
		<p>theater at the northwest elevation of the building. There is a concrete stair and metal tube handrail at the south east elevation of the building providing egress from the theater.</p> <p>The concrete ramps and stairs were observed to be in good condition with only minor deficiencies noted. The paint finish on the metal tube handrails was chipped and peeling in many locations.</p>	
	Interior Stairs	<p>Two sets of interior stairs are located in the theater area providing access to the stage and back-of-house spaces. The stairs appear to be concrete finished with carpet. Each stair has an associated metal tube wall-mounted handrail. There is also an interior stair providing access to the projection room at the rear of the theater. This is a steel framed stair with metal tube handrails where the treads are finished with VCT.</p> <p>The interior stairs and handrails were observed to be in good condition. The paint finish on the metal handrails was worn and chipped.</p>	Good

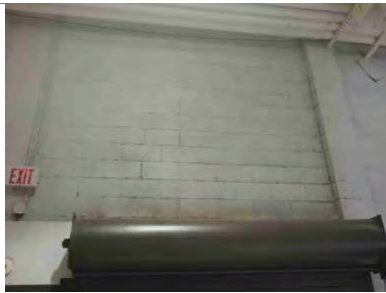
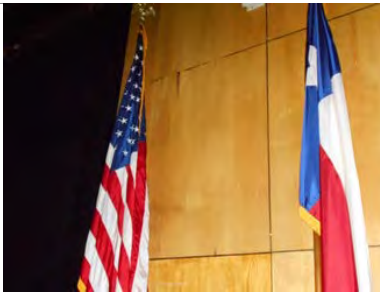
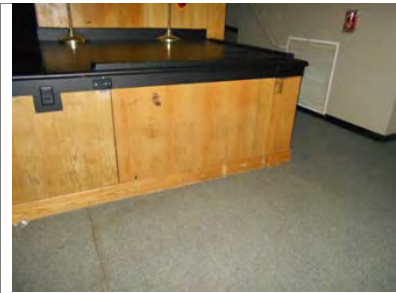
Interior Finishes	Interior Wall Finishes	<p>The CMU walls found within the building are painted. The theater has wood paneling framing the stage area and wood wool acoustical wall panels at the sides and rear of the theater. The main entry lobby has exposed brick walls. The restroom walls are finished with glazed tile.</p> <p>The interior wall finishes were observed to be in average condition due to age and wear. The painted CMU, especially in the theater support spaces behind the stage, were smudged and chipped in various areas. Excessive dirt build-up was observed above the roll-up door leading to the exterior. The wood paneling framing the stage in the theater was observed to be damaged, warped, and chipped in various areas.</p>	Average
	Interior Floor Finishes	<p>The theater support spaces and mezzanines have a sealed concrete floor. The stage has a concrete base with a layer of painted plywood on the surface. There is VCT found in the dressing rooms, at the front entry lobby, and in the projection room. The main theater area has a combination of carpet and sealed concrete floor at the seating area. The restrooms are finished with ceramic tile.</p> <p>The interior floor finishes were observed to be in average condition. The sealant on the concrete floors appeared to be aged and in need of a fresh coat of</p>	Average

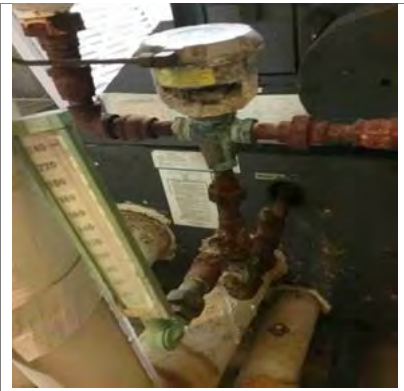
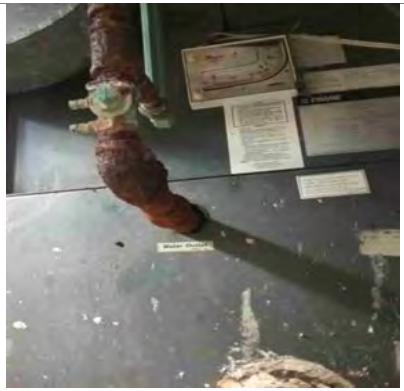
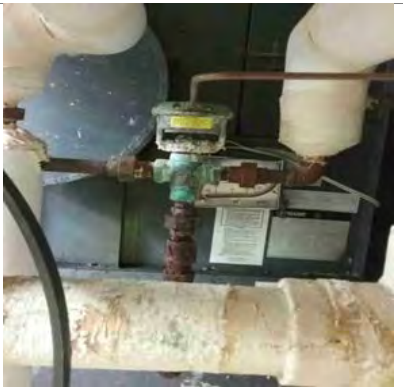
Mechanical/HVAC System Deficiency Examples

System	Subsystem	Condition and Deficiency Overview	System Condition Rating
		The HVAC systems were in average condition. Staff did not report any complaints with the building's HVAC system. The electrical room was warm and was equipped with a mechanical ventilation system that appeared to be inoperative. The AHUs as well as the water pumps are aged and approaching the end of their typical design service life. Water outlet pipelines connected to the air handlers was rusted.	
Fire Protection	Fire Alarm	<p>The building was equipped with a fire alarm system that consists of alarm and signaling devices such as horn and strobe combination devices, pull stations, and smoke detectors.</p> <p>The fire alarm system was controlled by a Honeywell Silent Knight control panel. The fire alarm system was observed to be in good condition.</p>	Good
	Fire Protection/Suppression	<p>The building has a wet pipe fire sprinkler system. Dry chemical portable fire extinguishers are located throughout the building.</p> <p>The fire protection system was observed to be in good condition and is regularly inspected by a fire marshal. The observed fire extinguishers have up-to-date inspection tags.</p>	Good

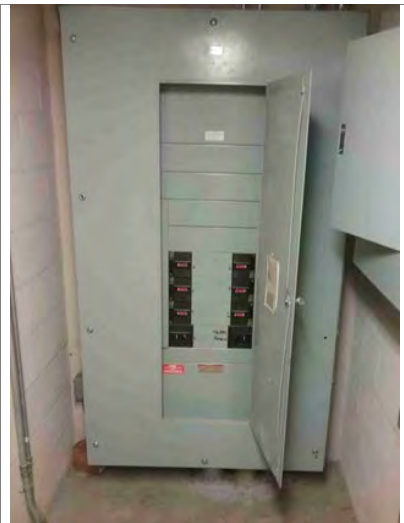
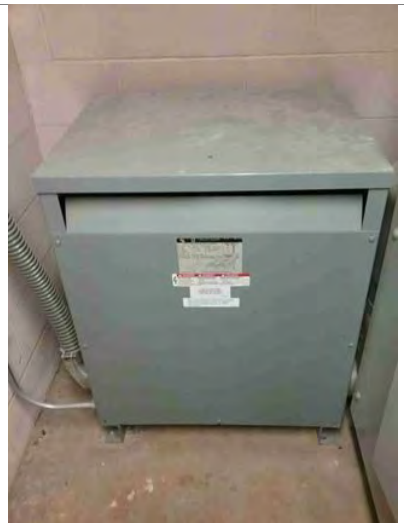
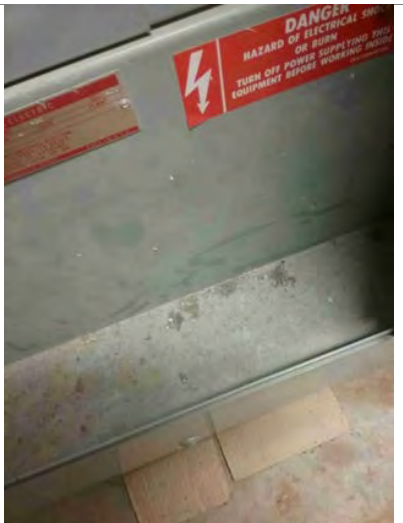
Electrical	Electrical Distribution	<p>The main distribution center for this building is located on the second floor room THEELEC. The 480Y/277-volt, 400-amp, 3-phase main panelboard, supplies electricity to various branch circuits and to a dry step-down transformer. This transformer supplies 208Y/120 volt, 3-phase power to a second distribution panelboard.</p> <p>The equipment appeared to be in average condition; however, a great deal of dust appears to have accumulated.</p>	Average
	Lighting	<p>Interior lighting within the buildings appeared to be primarily from surface mounted, recessed, and suspended T-12 and T-8 fluorescent Fixtures.</p> <p>Emergency wall packs and illuminated exit signs were throughout the building.</p> <p>Exterior lighting consisted primarily of flood light fixtures, surface-mounted soffit fixtures, and wall-mounted metal halide fixtures. It was reported that as older units fail, LED units are replacing these fixtures.</p> <p>The backstage was equipped with high bay metal halide lighting fixtures. Recessed fixtures illuminated the auditorium.</p> <p>The lighting appeared to be in good condition.</p>	Good

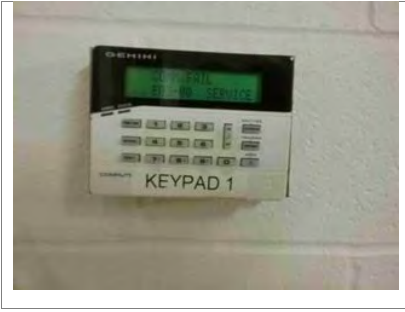
System	Subsystem	Condition and Deficiency Overview	System Condition Rating
	Communications & Security	<p>The building was equipped with electronic key pass entry and exterior security cameras. The security equipment appeared to be in good condition.</p> <p>The buildings were equipped with telecommunications systems.</p> <p>The security keypad indicated a "COMM" failure. The nature and cause of the problem was not determined.</p>	Average

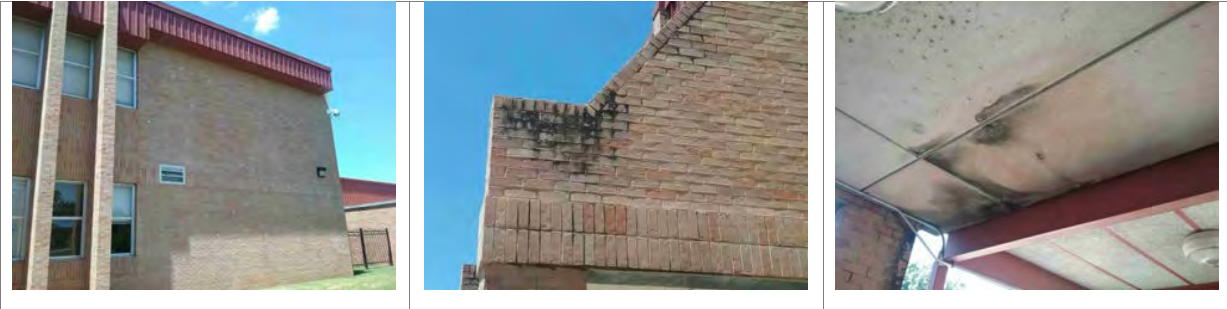
System	Subsystem	Condition and Deficiency Overview	System Condition Rating
Exterior	Exterior Walls	<p>The building is a two-story structure. The exterior walls of the building are brick with a metal panel soffit at the roof edge. There are aluminum louvers of varying sizes present on all façades.</p> <p>The exterior walls were observed to be in good condition with a few minor deficiencies observed. Built-up dirt and what appeared to be paint ball marks were observed on the brick façade. The underside of the exterior entry canopy was observed to be stained and water damaged from a possible leak from the canopy above.</p>	Good
	Exterior Windows	<p>The exterior windows around the facility are aluminum framed with single pane glazing. These windows appear to be the operable type. The windows at the entry doors are single pane glazing in hollow metal frames.</p> <p>The exterior windows were observed to be somewhat aged, but in good condition with no deficiencies noted.</p>	Good

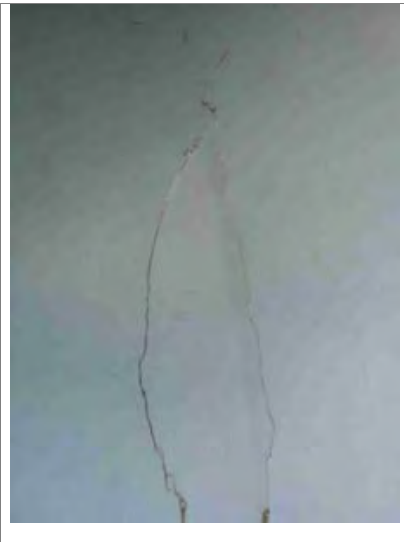
Interior Construction	Interior Walls	<p>The interior walls found in the building are constructed of gypsum board and metal studs. There are interior windows found in the main corridors providing sight into the classrooms. The interior windows have hollow metal frames with single pane glazing.</p> <p>The interior walls and windows were observed to be in good condition. One deficiency was observed in the gypsum board construction at the roof hatch. There was a crack in the gypsum board caused by possible water infiltration at the perimeter of the hatch.</p>	Good
	Interior Doors	<p>The interior doors found in the building are wood with glazing lights and hollow metal frames.</p> <p>The doors were observed to be in good condition showing minor signs of wear. Only a few doors had loose hardware and were difficult to open/close completely.</p>	Good
	Interior Specialties	System not present.	N/A
Stairs	Exterior Stairs	System not present.	N/A

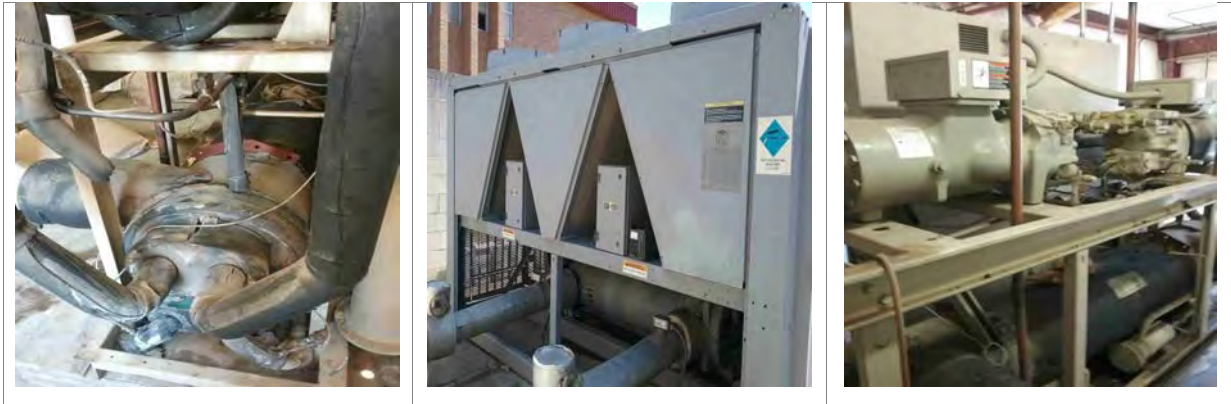
Mechanical/HVAC System Deficiency Examples

System	Subsystem	Condition and Deficiency Overview	System Condition Rating
	Interior Stairs	System not present.	N/A
Interior Finishes	Interior Wall Finishes	System not present.	N/A
	Interior Floor Finishes	System not present.	N/A
	Interior Ceiling Finishes	System not present.	N/A
Conveying	System not present.		N/A
Plumbing	Plumbing Fixtures	System not present.	N/A
	Domestic Water Distribution	System not present.	N/A
	Other Plumbing	System not present.	N/A
Mechanical/ HVAC	<p>The building has a rotary chiller and a large air condenser on the exterior, which serves the paint shop area. The penthouse in the building has a small reciprocating chiller, which most likely is acting as a split-system compressor for the paint shop area.</p> <p>The overall condition of the HVAC systems associated with the building was in good condition with general wear and tear damages on insulation of pipes.</p>		Good
Fire Protection	Fire Alarm	System not present.	N/A

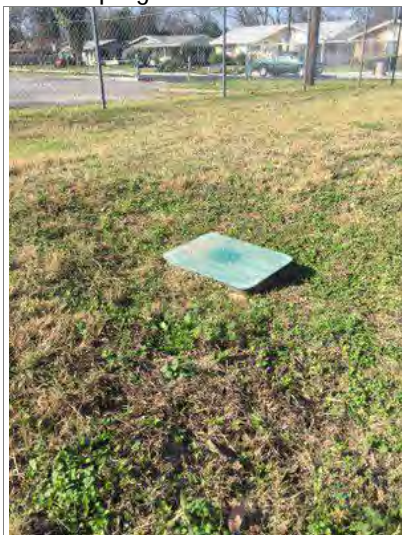
Irrigation box backfill

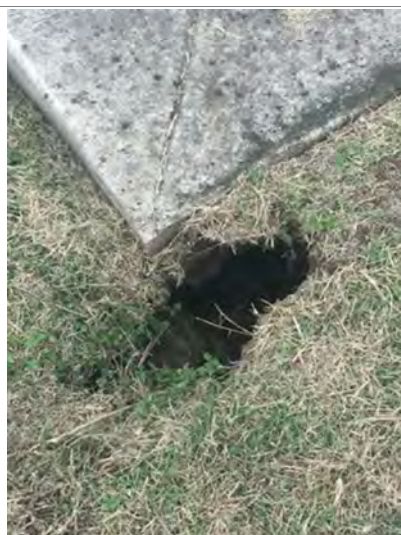
Erosion/hole around inlet

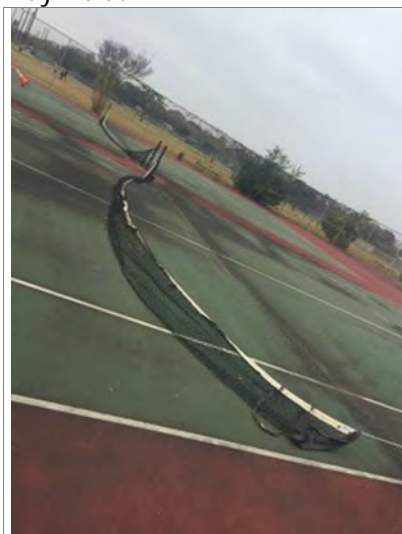
Tennis net collapsed

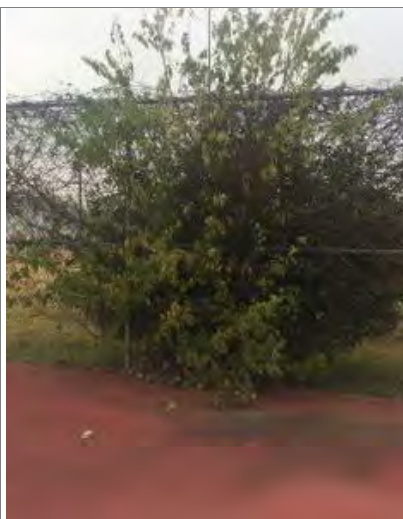
Overgrown vegetation (tennis)

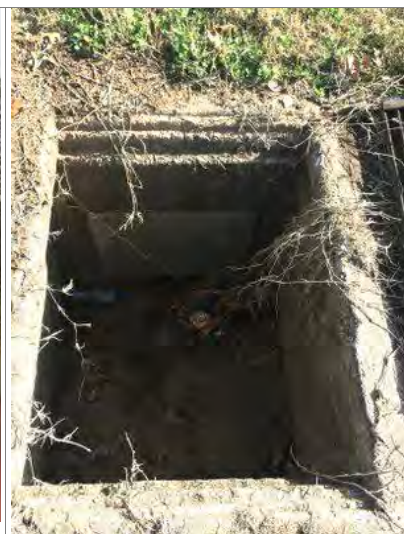
Inlet missing cover (track)

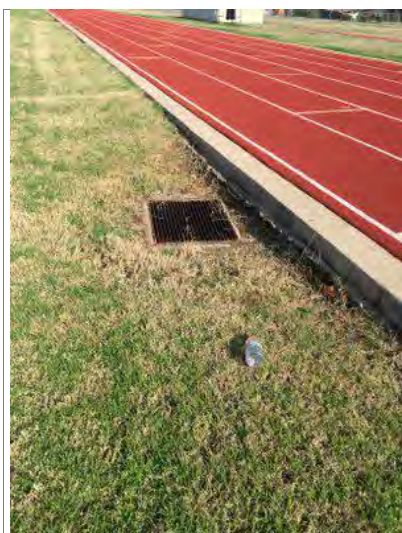
Drop off to inlet from track

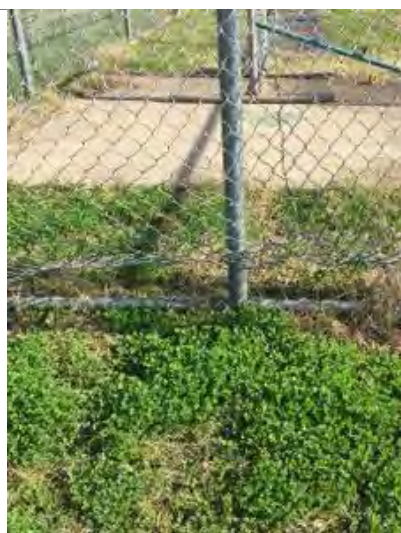
Softball fence broken

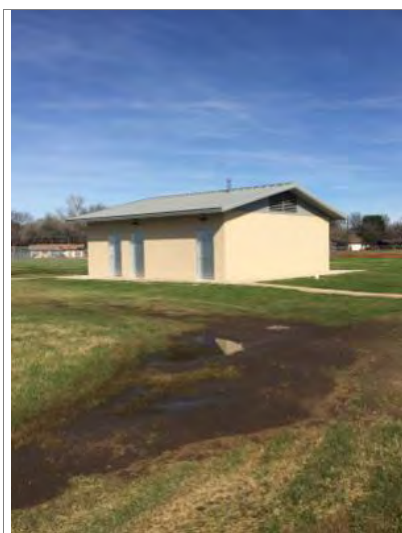
Tire tracks creating ponding
