## Garza Independence High School Site Summary

<b>Address</b>	1600 Chicon Street Austin Texas 78702
<b>Number of Permanent Campus Facilities</b>	5
<b>Original Year of Construction</b>	1939
<b>Total Campus Building Area (combined)</b>	46,233 SF

## Main School Building – BLDG-015A

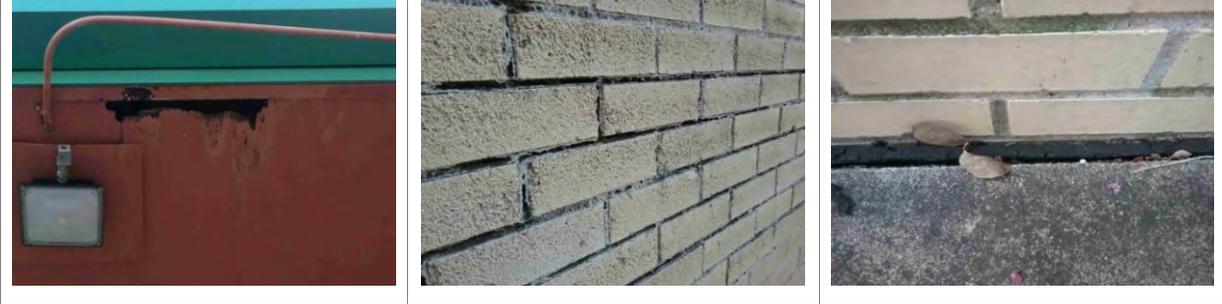
System	Subsystem	Condition and Deficiency Overview	System Condition Rating
Exterior	Exterior Walls	<p>The exterior of the building consists of a brick façade that was built in 1939. The building is two stories with two basement rooms.</p> <p>The exterior of the building appeared to be in average condition with some of the brick mortar starting to deteriorate at the rear entrance. The expansion joints where the brick wall meets the sidewalks were observed to be deteriorated and pulling away from the sidewalk edge. A large hole was observed in the plywood soffit at the loading dock. Insects and other pests could possibly enter the building at this location.</p>	Average
	Exterior Windows	<p>The windows are aluminum framed units with single-pane glazing inset into the brick façade and are not original to the building.</p> <p>The exterior windows were observed to be in good condition. There was a gap observed between the bottom of the window frames and the concrete sills. This condition was observed in the majority of the windows.</p>	Good

1. Apply caulking and sealant to the base of the window frames at the concrete sills to preserve the integrity of the window assembly.
2. Investigate the extent of the corroded exterior exit stair at east end of gymnasium.
3. Patch and repair the plywood soffit at the kitchen entrance.
4. Repoint the mortar on the brick façade wall where damaged and missing.

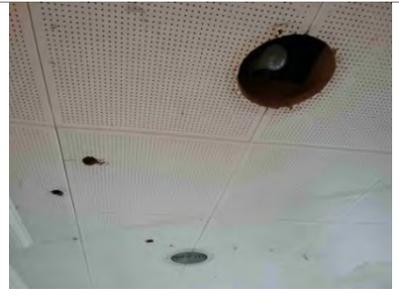
System	Subsystem	Condition and Deficiency Overview	System Condition Rating
		<p>classrooms. The remaining 5% is vinyl stick-on flooring found in the gymnasium that resembles wood.</p> <p>The flooring was observed to be in average condition. The original wood floor was buckling in many places; room 105 in particular. The science labs have a shared common area, and the VCT tile was observed to be missing due to a wall repair. Tiles were missing in the cafeteria and gymnasium restrooms.</p>	
	Interior Ceiling Finishes	<p>About 85% of the interior ceilings are acoustical tile; 5% are 2-foot-square perforated tiles in the cafeteria; 5% are 1-foot-square perforated tiles in the weight room; and 5% is open corrugated metal deck on bar joists in the weight room. The ceiling appeared to be in average condition.</p> <p>The perforated stick-on ceiling tile in the cafeteria stage area, appeared to be very outdated and in poor condition. The tile was observed to be ripped, stained and yellowed.</p>	Average

1. Replace the perforated ceiling tile in the cafeteria stage area. It was old, yellow, and ripped.
2. Retile the floor area between the science labs with new vinyl tile.
3. Patch ceramic floor tile in the restrooms where toilet partitions were removed.
4. Repair buckled wood floor in room 105, as it is a trip hazard.

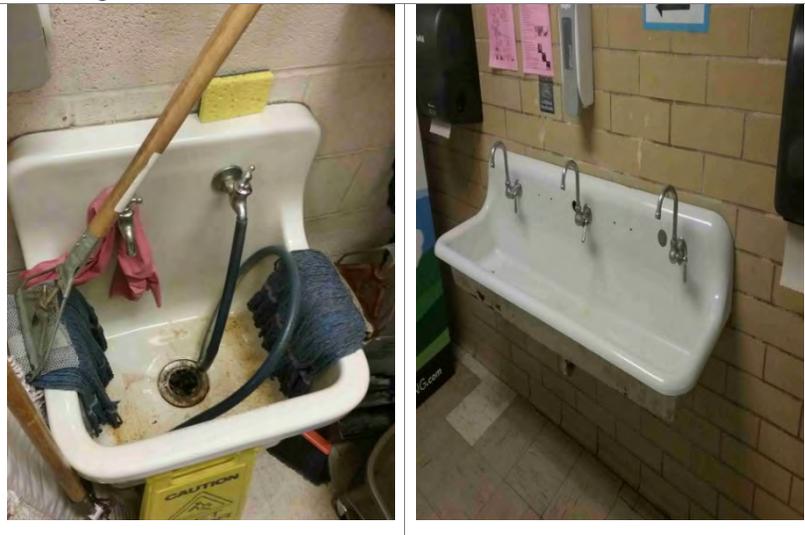
Plumbing Fixtures

System	Subsystem	Condition and Deficiency Overview	System Condition Rating
		<p>outdated porcelain plumbing fixtures were observed. The fixtures were as follows: One outdated porcelain trough style wash basin outside of cafeteria and one outdated porcelain mop sink in the janitorial closet next to room 205.</p>	
	<p>Domestic Water Distribution</p>	<p>The majority of the plumbing fixtures observed in this facility are not serviced by any domestic hot water distribution equipment. The plumbing fixtures in the commercial kitchen and gymnasium area are serviced by vertical gas or electric water heaters.</p> <p>The vertical gas water heater near the kitchen (100-gallon capacity) was installed in 1996 and has reached the end of its design service life but was observed to be functioning with no reported deficiencies. The vertical electric water heater near the gymnasium was observed to be in good condition. The associated plumbing distribution piping for this system appeared to be in good condition.</p>	<p>Good</p>

1. Replace outdated porcelain plumbing fixtures.

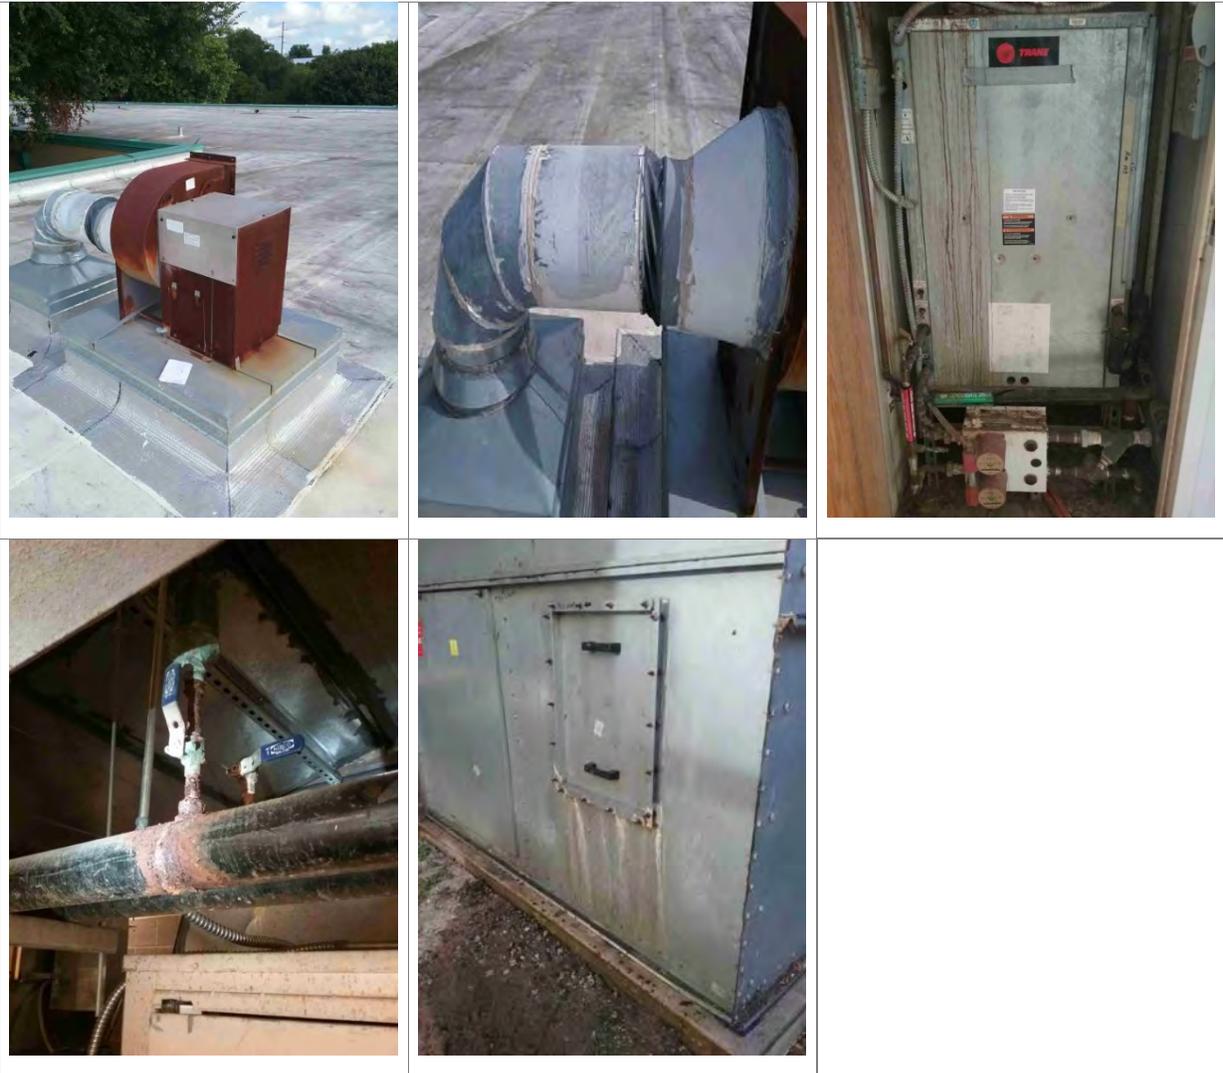
System	Subsystem	Condition and Deficiency Overview	System Condition Rating
		damaged. Also, the large WSHP 23 located on the far west side of corridor 1 had excessive corrosion on its heat sink return piping. Lastly, the packaged fluid cooler system had a noticeable leak on the west side of the enclosure, near what appeared to be a maintenance hatch for the return water basin.	
<b>Fire Protection</b>	Fire Alarm	<p>The building contains a fire alarm system by Silent Knight consisting of detectors, pull stations, and horn/strobe combinations.</p> <p>The equipment appeared to be in good condition. The main panel was not located but was assumed to be in the MDF (main distribution frame) room, which was not accessible.</p>	Good
	Fire Protection/ Suppression	<p>The building is not equipped with a fire sprinkler/suppression system; however, it is protected by portable fire extinguishers that are stationed throughout the building.</p> <p>All portable fire extinguishers observed were inspected within the last year and appeared to be in good condition.</p>	N/A

1. Address any rust or corrosion observed on the equipment, its associated piping, or any other sub-asset by cleaning, repainting, or repairing to prevent further deterioration.
2. Plan for and track equipment that uses R-22 refrigerant. The refrigerant is being phased out of manufacturing and construction use in the near future, and thus will make all equipment obsolete.
3. Conduct preventive maintenance checks and services for WSHPs in rooms 103 and 106.
4. Conduct preventive maintenance checks and services for packaged fluid cooler tower system.

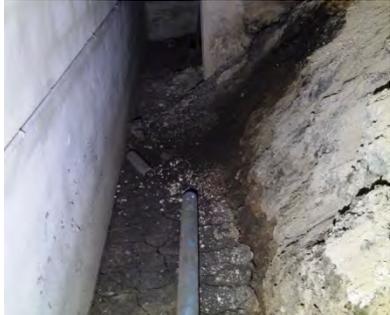
<p>Damp soil at perimeter of southeast wing</p>	<p>Damp soil under cafeteria wing</p>

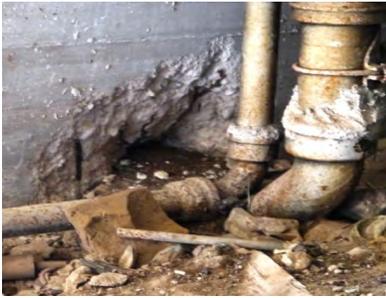
<p>Spall at bottom of perimeter beam</p>

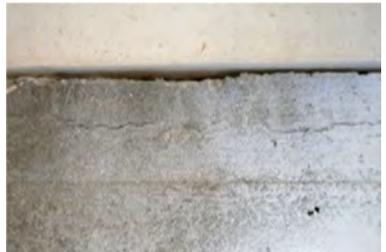
<p>Minor cracking at top of interior beam in southwest crawl space</p>

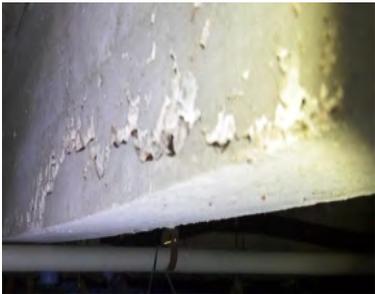
<p>Honeycombing on interior beam in southeast crawl space</p>

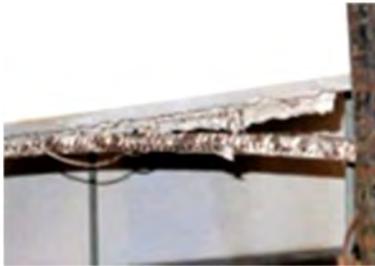
<p>Spalling, exposed/corroded detached longitudinal reinforcement at bottom of precast pan joist</p>

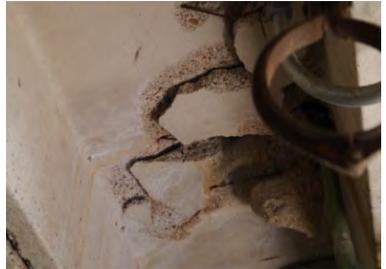
<p>Large spall and exposed reinforcing at underside of pan joist slab</p>

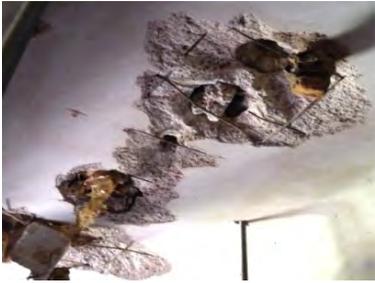
<p>Spalling and exposed reinforcing on pan joist slab at pipe penetrations</p>

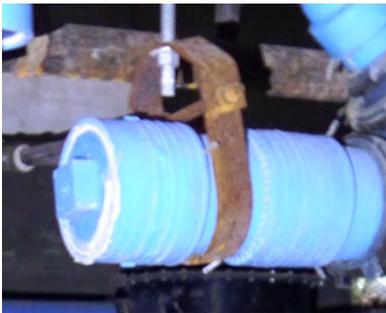
<p>Rusted pipe hangers</p>

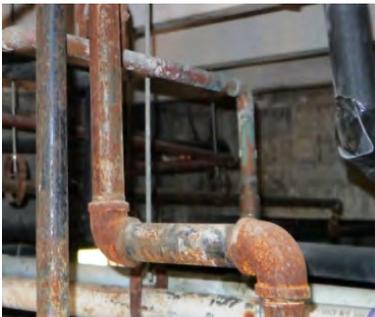
<p>Rusted pipes</p>

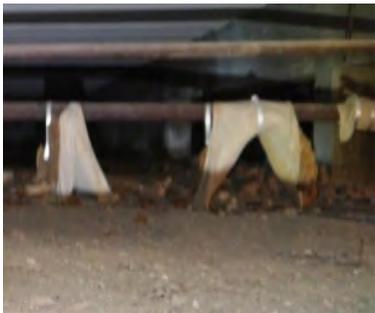
<p>Degraded/falling pipe insulation</p>
--	---	---

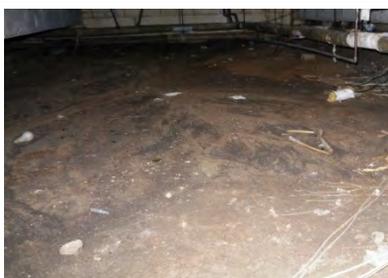
Damp soil throughout crawl space

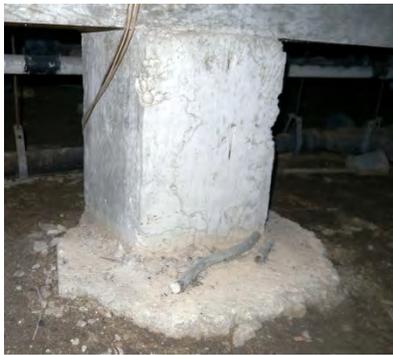
Honeycombing and mushrooming on column

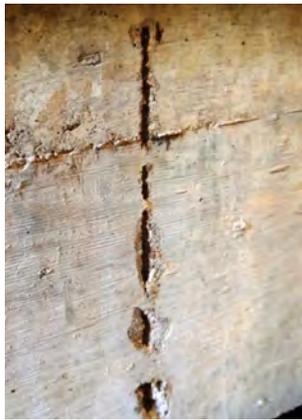
Exposed/rusting slab reinforcement at access hatch opening

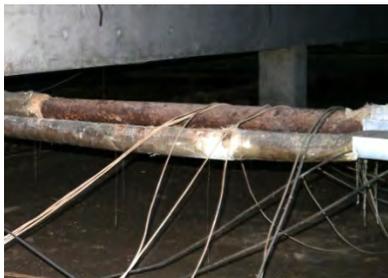
Missing pipe insulation and rusted pipes

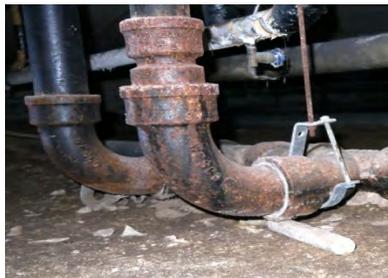
Rusted cast iron pipes & hangers

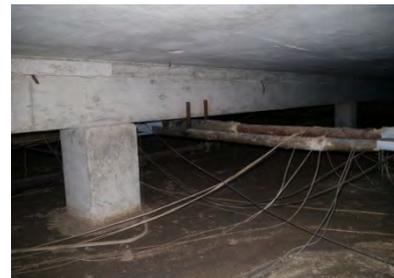
Wiring in the crawl space is draped across the ground

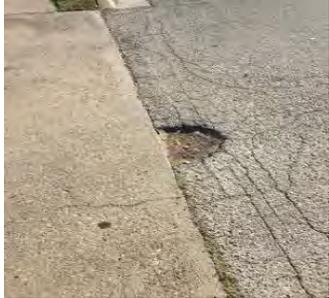
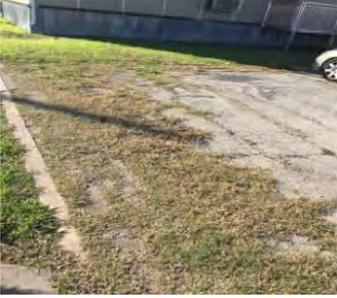
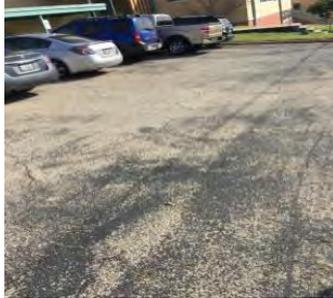
Parking Lots

Pothole in Visitor Parking Lot A	Pavement Fail in Staff Parking Lot B	Cracking and old seal coat in Staff Parking Lot C2

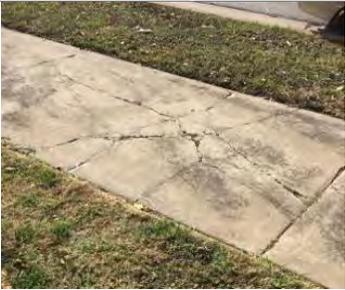
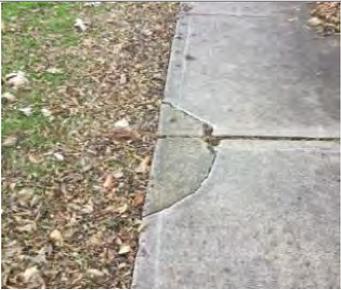
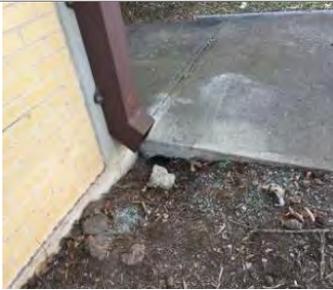
Pedestrian Paving

Broken sidewalk	Broken sidewalk	Sidewalk erosion

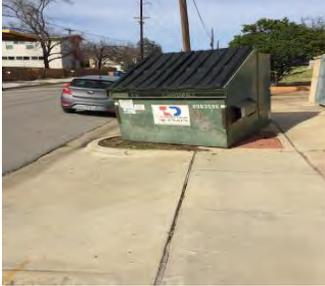
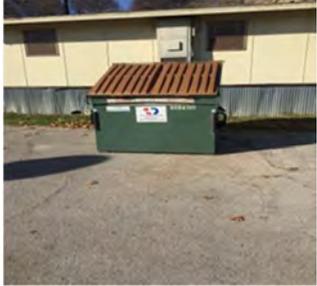
Site Development

Dumpster sits on walkway	Dumpster without concrete pad or approach	Rain Barrel with no overflow to underdrain

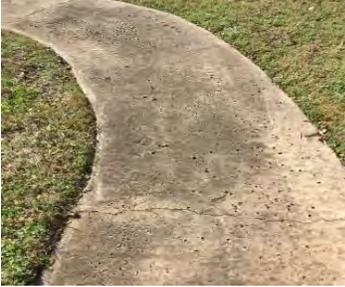
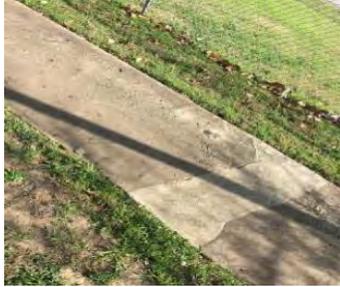
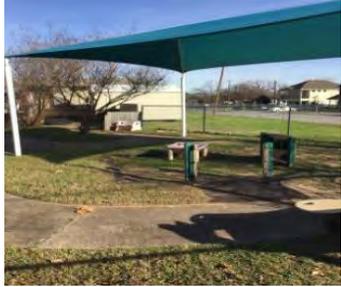
#### Playscapes

<p>Bug holes and cracks on walkway</p>	<p>Cracked walkway</p>	<p>Poor drainage in southern most playscape</p>

1. Repair walkway.
2. Regrade for proper drainage.
