Johnson High School (LBJ) & Liberal Arts and Science Academy (LASA) Site Summary

Main School Building – BLDG-014A

Theater Building – BLDG-014B

Site/Civil Assessment

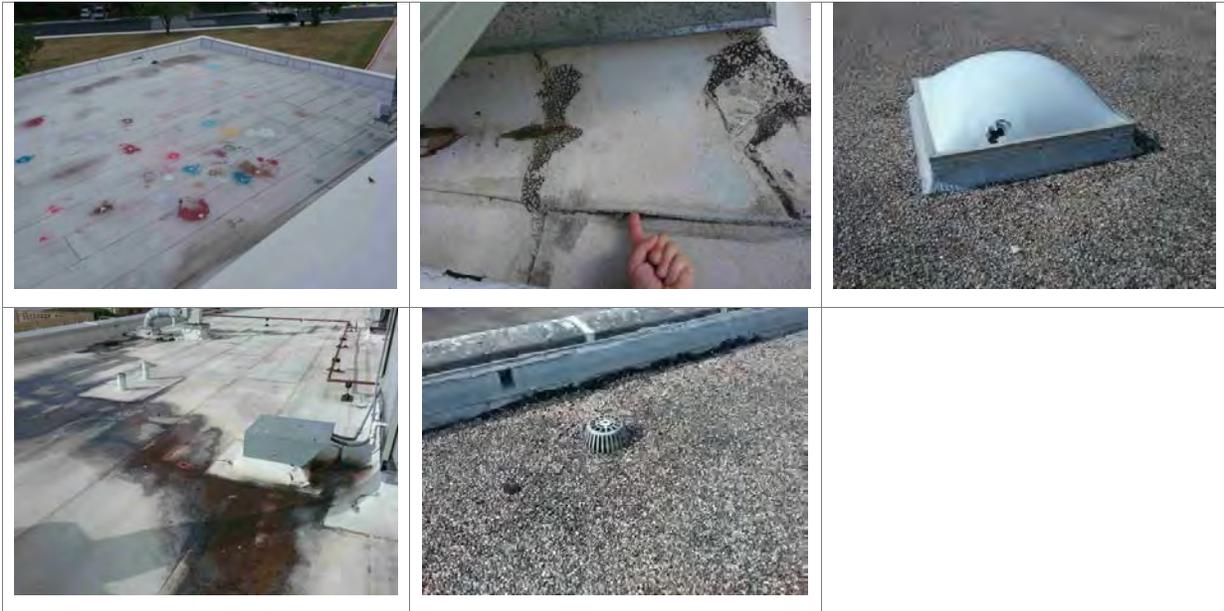
Roofing Deficiency Examples

Roofing		<p>The roof material is a mixture of built-up and modified bitumen. These roofing systems are in poor condition due to age, lack or repair or incomplete repairs. Recommendations for the specific sections are contained in the asset portion of the assessment. Issues observed included blisters, ponding, spray paint, and other types of damage or aging. Two areas need to be re-roofed in their entirety. Condensate lines in areas appeared to drain onto the roof.</p>	Poor
Interior Construction	Interior Walls	<p>Interior partitions are typically gypsum board over metal studs. The corridors are covered with transite panels. In one section of a remodeled area, it appears that a panelized system was used that includes vinyl wall covering. In the kitchen and locker rooms area, masonry walls are present. Wood construction is used in the male locker room. On the second floor, it appears that the accordion type walls are present.</p>	Average

1. Replace all gravel coated built up roofing.
2. Replace the roofing over the locker rooms and athletic areas.
3. Repair or replace damaged skylights.
4. Monitor built up roofing section above classrooms.
5. Route condensate lines to a code compliant location rather than draining onto the roof.

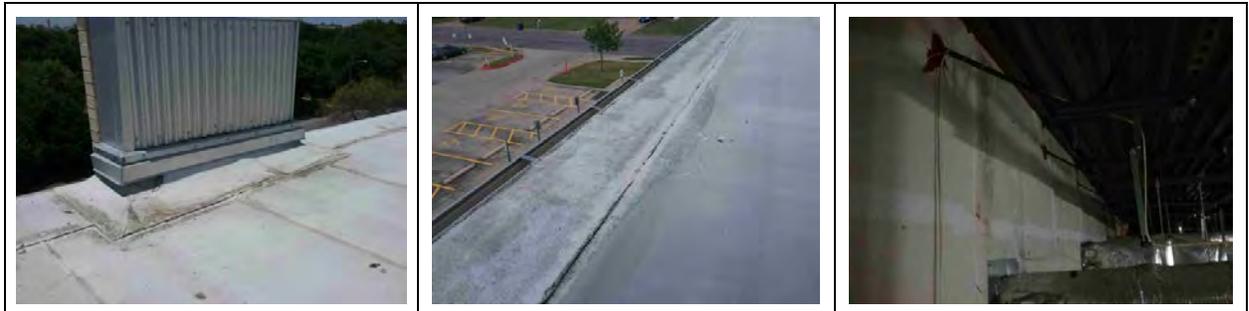
Roofing Deficiency Examples

Roofing	The roof is modified bitumen system. The roofing system is in average condition. It showed aging at the parapet and roof		Average

System	Subsystem	Condition and Deficiency Overview	System Condition Rating
		system joints. There appeared to be evidence of water penetration in the mechanical mezzanine area. Uppermost roof accessibility is via a three-story ladder with no lighting to be found. It was deemed inaccessible.	
Interior Construction	Interior Walls	The interior walls are gypsum board with acoustic treatments in the main hall. The interior walls are in good condition. No deficiencies were noted.	Good
	Interior Doors	In the public areas, the doors are solid core wood veneer in hollow metal frames while the remainder are hollow metal doors in similar frames. The interior doors are in average condition. A double door located between the stage and classroom area did not close. A single door between the classroom and stage appeared to have a broken handset and is blocked open. Both non-functioning units are rated doors in a rated partition.	Average

1. Repair roofing where aged.
2. Seal leaks.
3. Investigate water infiltration at mechanical mezzanine and in classroom area.

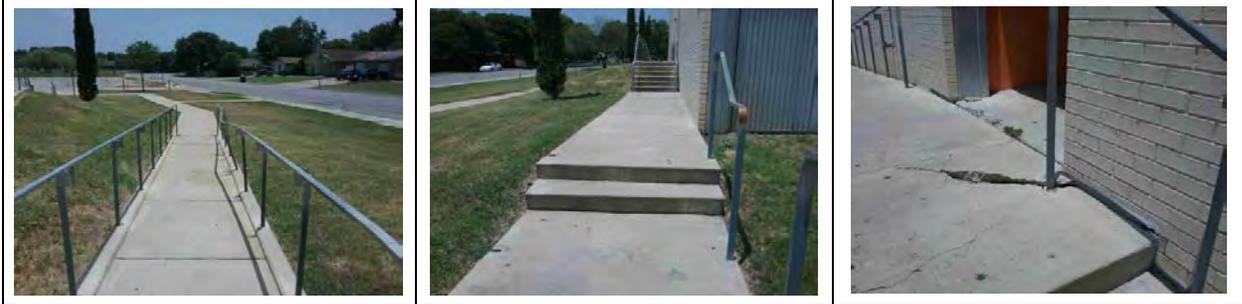
Interior Specialties	System not present.	N/A
Stairs	Exterior Stairs	Exterior stairs are either concrete with metal railings or galvanized metal stringer and treads with metal railings. The exterior stairs are in poor condition. Signs of rust in these areas indicated failure of the coating system. In one location, the handrail was missing and in another, the railing was bent. Settlement of the building relative to the sidewalk caused damage that exposed rebar and cracks that were trip hazards at adjacent landings.	Poor
	Interior Stairs	Due to lack of lighting, interior stairs were unreviewable. Exiting paths off the stage to the exterior exits are being used for storage and present a life safety hazard. Vestibules between the auditorium and exterior doors were also used as storage effectively reducing the exiting capacity by half.	Poor
Interior Finishes	Interior Wall Finishes	Interior wall surfaces include a variety of materials but are typically gypsum board construction with paint systems, ceramic tile, wooden trim and acoustic panels applied. The wall finishes are in good condition. Painted surfaces have taken abuse in the lobby and service areas. Door jams on single doors had paint degradation along with the lobby.	Good

1. Repair exterior stairs to cover rebar, seal cracks, and eliminate trip hazards.
2. Remove all stored materials from stairs.

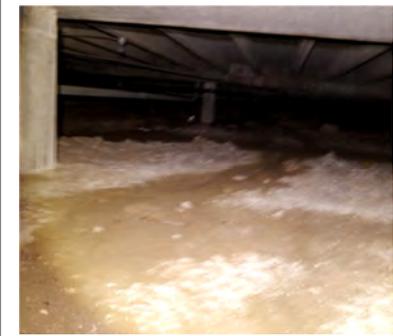
Damp soils in crawl space

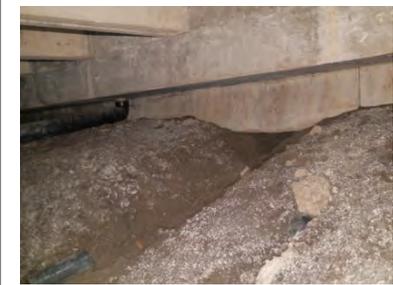
Water infiltration & soil erosion below soil retainers

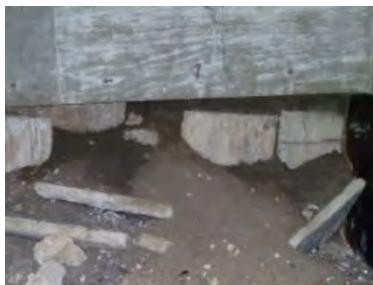
Broken/caved/undermined/settled concrete soil retainers

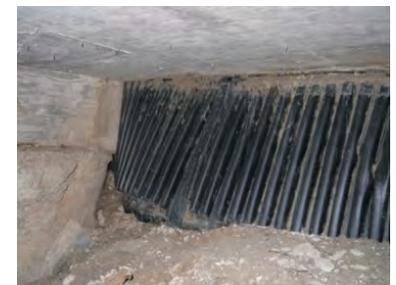
Bulging/slipping plastic soil retainers

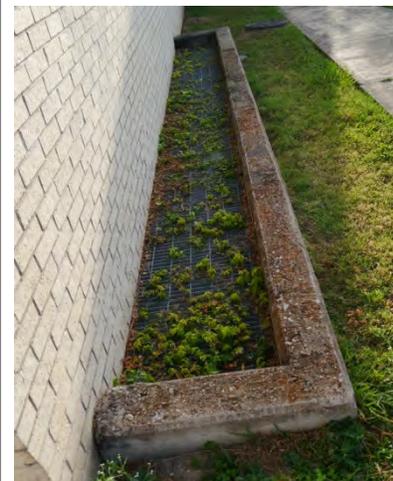
Foliage growing in areaway well

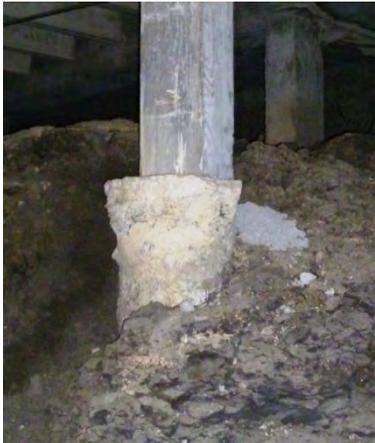
Top of pier exposed due to soil erosion

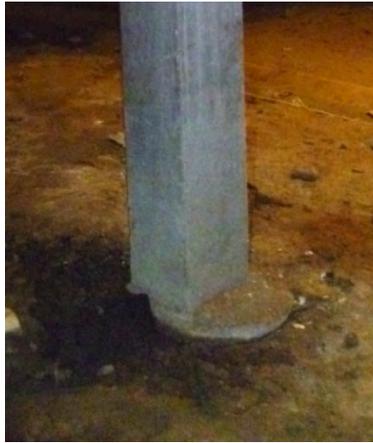
Column not centered over pier

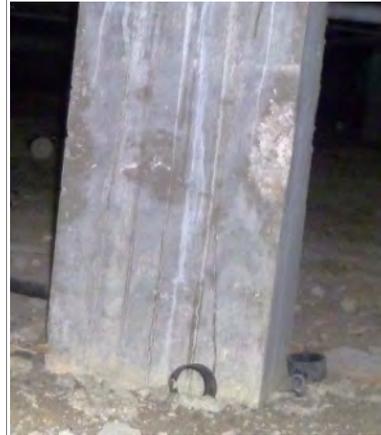
Spalling/honeycombing interior column

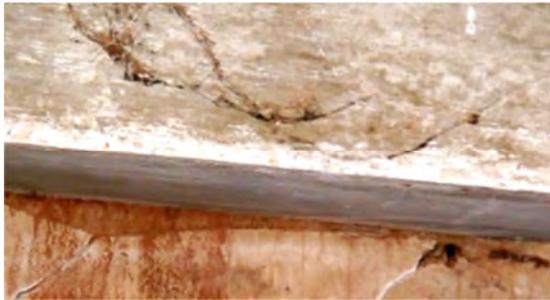
Small perimeter beam cracks

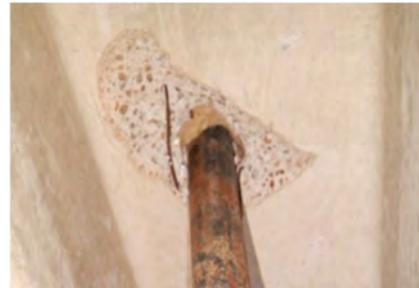
Spalling, exposed/corroded reinforcement in precast deck at pipe penetration

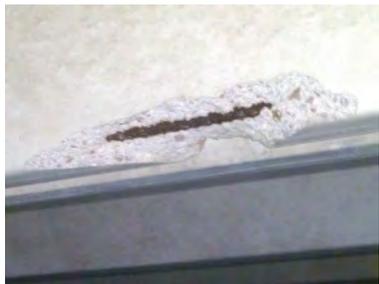
Spalling, exposed/corroded reinforcement at bottom of joist

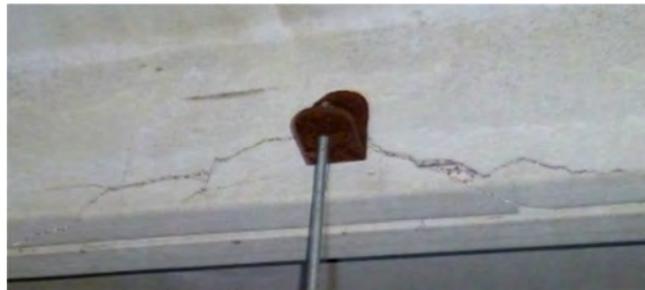
Cracking in precast channel at hanger anchor

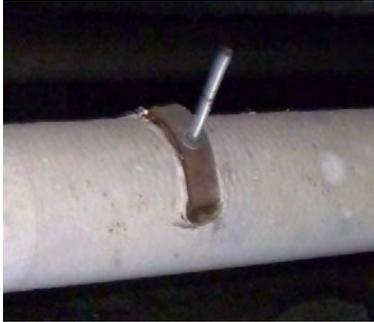
<p>Broken hanger (Fine Arts Wing)</p>

1. Replace failed hanger rods
2. Clean rust from pipes and paint to protect from further corrosion
3. Repair/replace fallen insulation

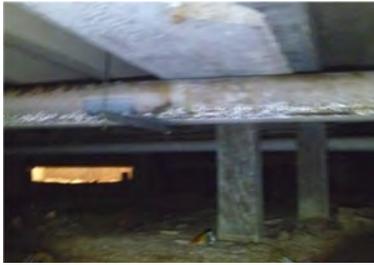
<p>Moldy/degraded pipe insulation</p>

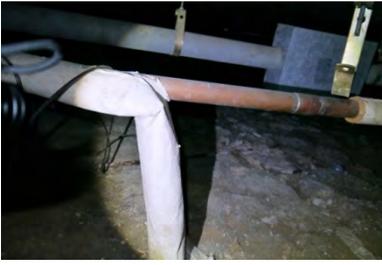
<p>Old insulation falling off (Fine Arts Wing)</p>

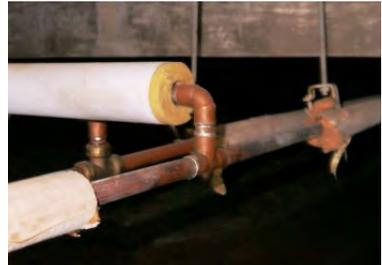
<p>No insulation at joints (Fine Arts Wing)</p>

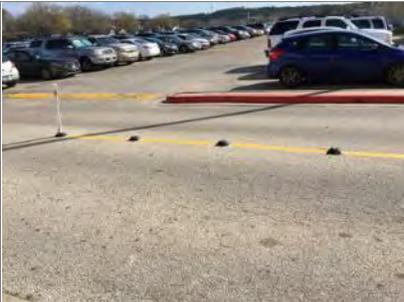
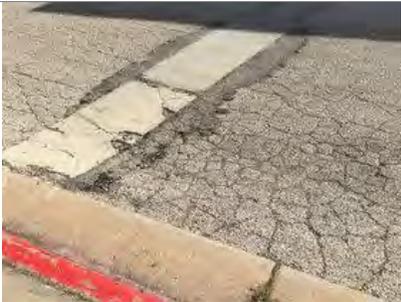
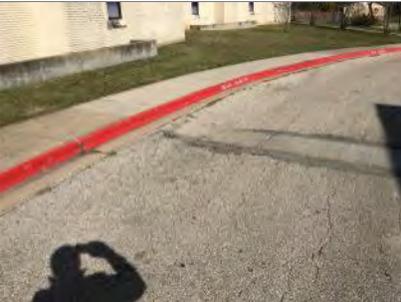
Roadways

Flexible posts missing in R1	Alligator cracking and patch in R2	Alligator cracking and patch in R2

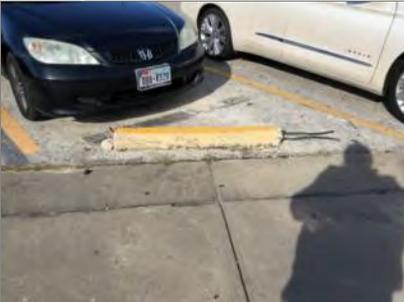
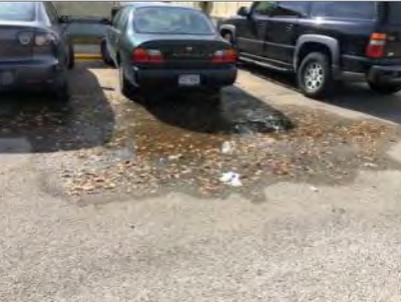
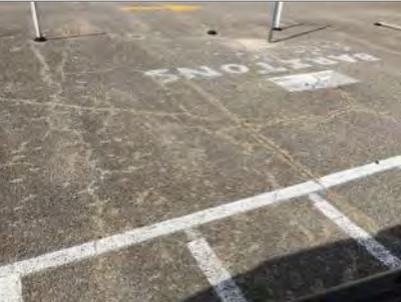
Parking Lots

P1 broken curb stop	P2 area flooding	P2 raveling lot

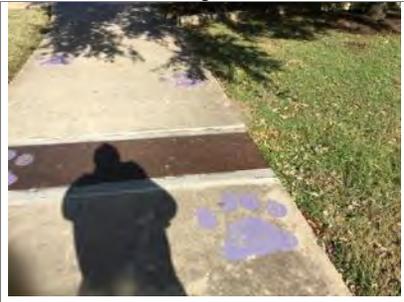
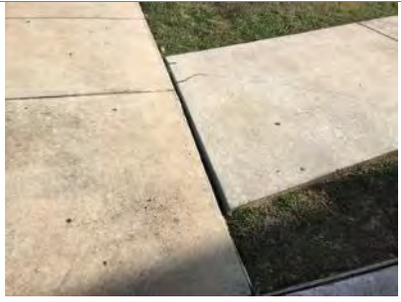
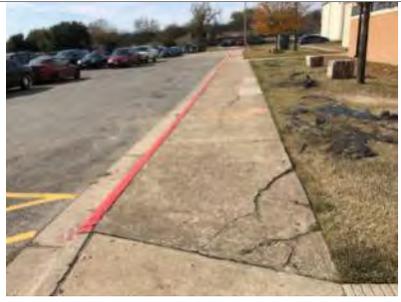
Pedestrian Paving

Metal plate not level in front of school	Uneven sidewalk east of bus drop off	Cracking sidewalk north west of P3 lot

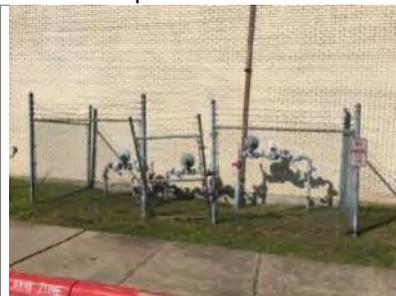
Broken fence

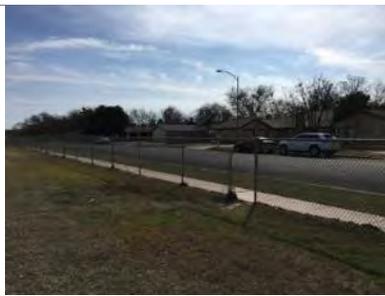
Missing piece in fence.

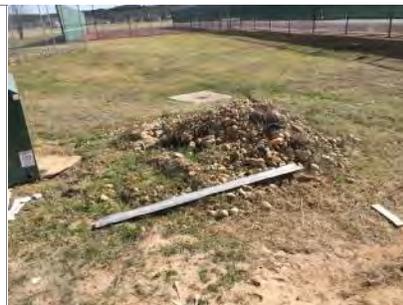
Debris pile

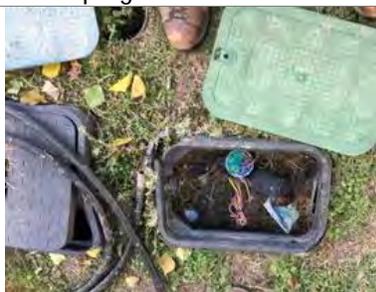
Irrigation box missing cover

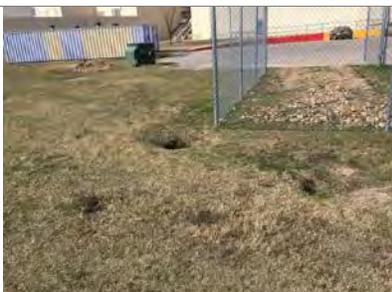
Holes in ground

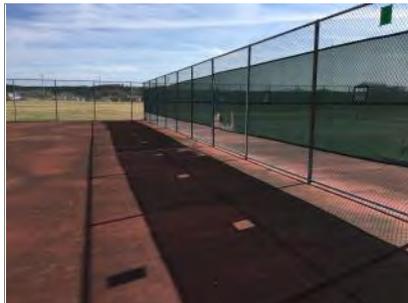
Worn and cracked tennis court surface

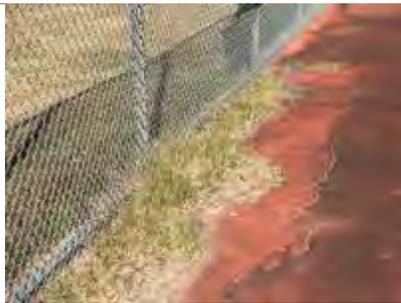
Cracking and grass on tennis court

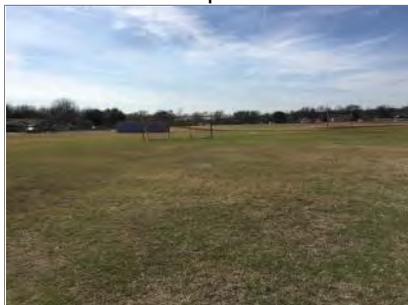
Low spots throughout field

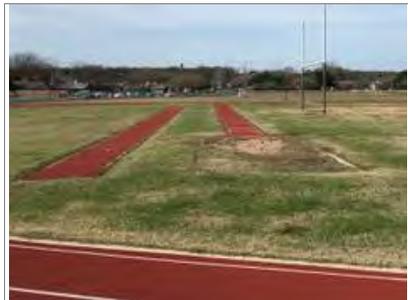
Sandpits need to be cleared of debris

1. Fill and clean up sandpits.
