McCallum High School Site Summary

Address	5600 Sunshine Drive Austin, TX 78756
Number of Permanent Campus Facilities	8
Original Year of Construction	1953
Total Campus Building Area (combined)	265,022 SF

Main School Building – BLDG-005A

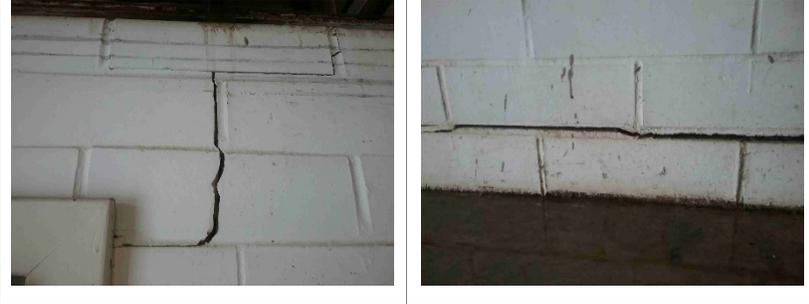
Interior Walls

System	Subsystem	Condition and Deficiency Overview	System Condition Rating
		because significant cracks were observed both between the bricks and through the bricks.	
	Interior Doors	There is one interior door in the building leading to the restroom. The door is wood in a wood frame. The door was observed to be in poor condition with excessive water damage at the base. Some wood was also observed to be chipped from the door.	Average
	Interior Specialties	System not present.	N/A
Stairs	Exterior Stairs	System not present.	N/A
	Interior Stairs	There is one set of concrete stairs in the interior of the building providing access from ground level to the sunken finish floor of the building. The stairs were observed to be in good condition with no visible damage.	Good
Interior Finishes	Interior Wall Finishes	The interior of the building is painted. The interior finish was observed to be in average condition. Chipped paint was observed. Many cobwebs were observed.	Average

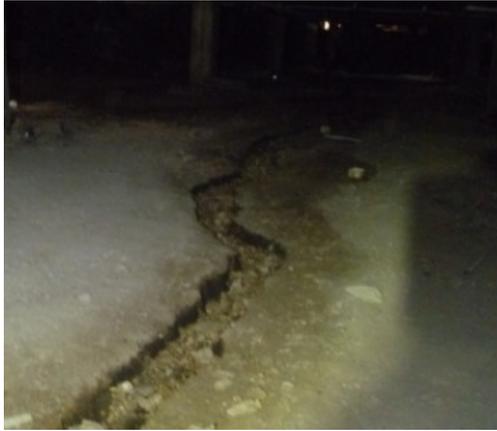
Ditch cut by storm water

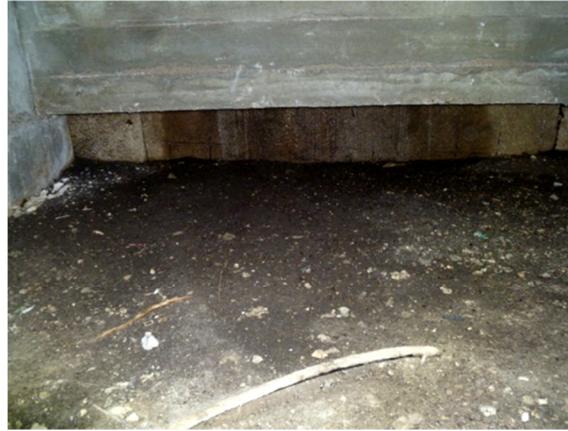
Water infiltrating crawl space from outside perimeter of building

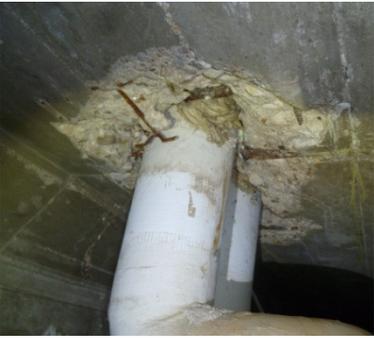
<p>Spalled deck concrete and exposed/rusted reinforcing at pipe penetration through slab</p>

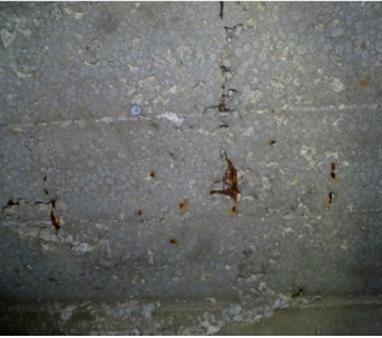
<p>Mild honeycombing and exposed reinforcement on slab underside</p>	
---	---	--

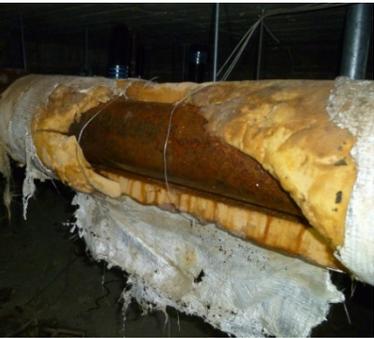
<p>Failed pipe insulation</p>

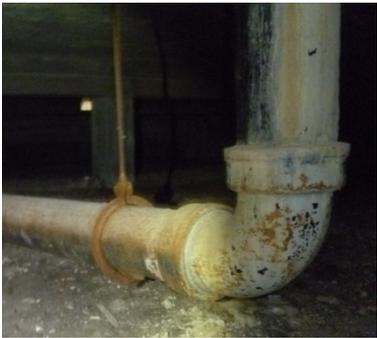
<p>Rusted pipe support hanger</p>
--	---	---

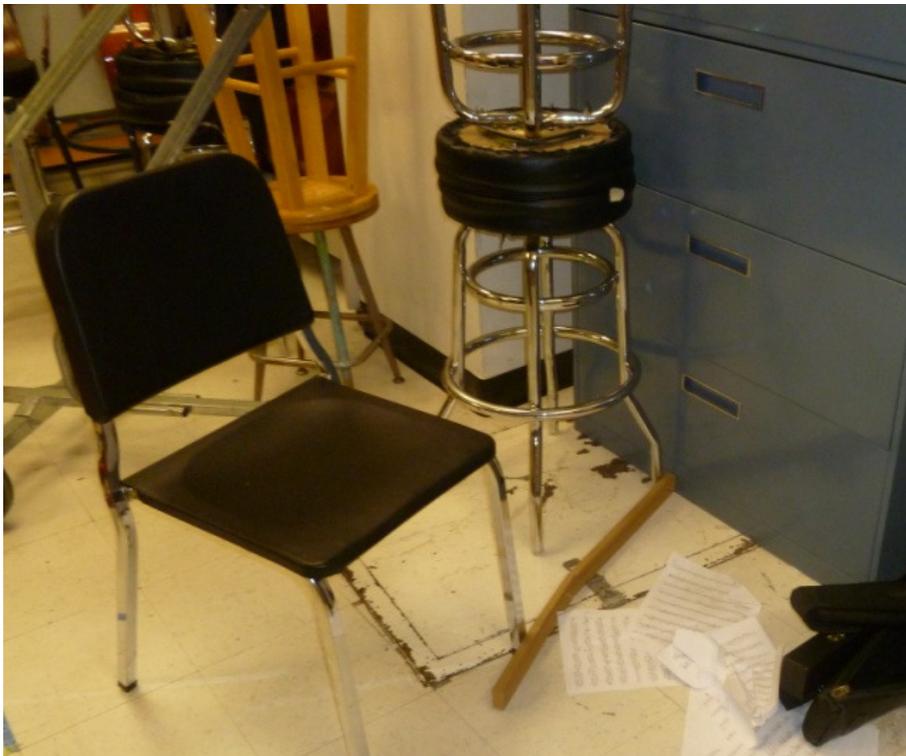
The crawl space for Building C was inaccessible as the floor hatch was blocked by a file cabinet as seen in the photo below.

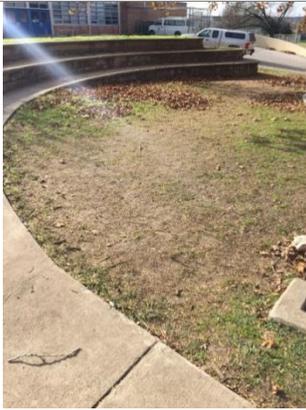
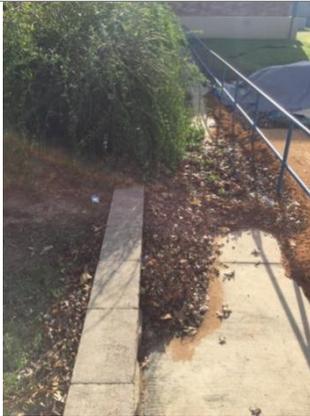
Courtyard/Landscaping

Overgrown vine in the interior courtyard	Grass worn in performance area	Sidewalk overgrown by primrose jasmine

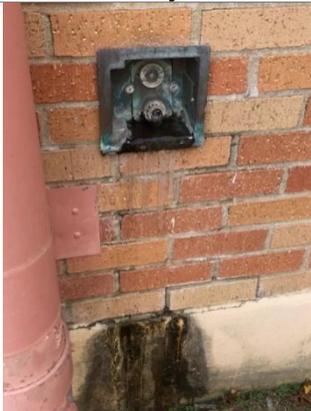
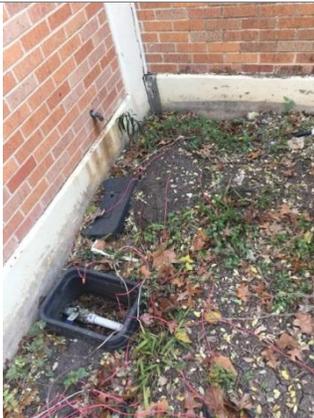
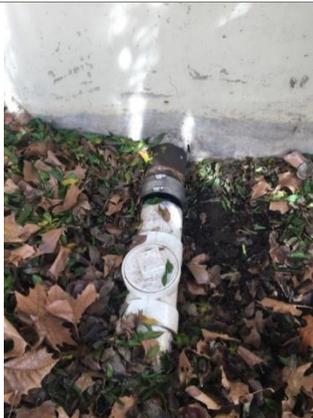
Water and Sanitary Sewer Utilities

Leaking faucet	Courtyard irrigation controls exposed	Disconnected sanitary cleanout

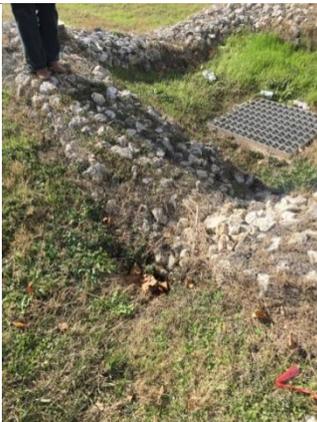
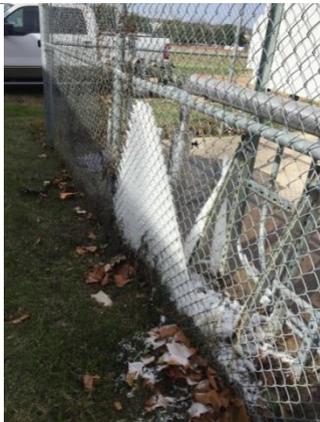
Storm Sewer and Other Site Utilities

Storm sewer infiltration	Broken electrical conduit for perimeter light	HVAC valve releasing water onto fence.

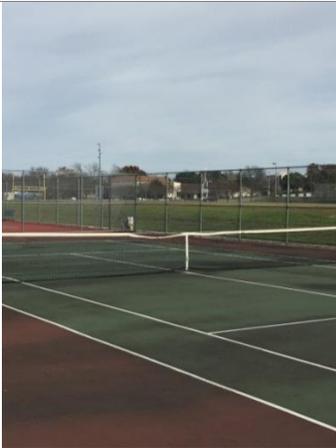
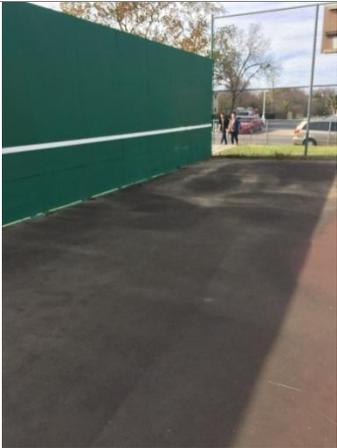
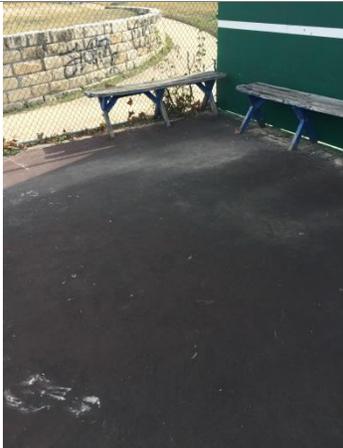
Tennis

Damaged net on tennis court	Ponding water on tennis court	Ponding water on tennis court

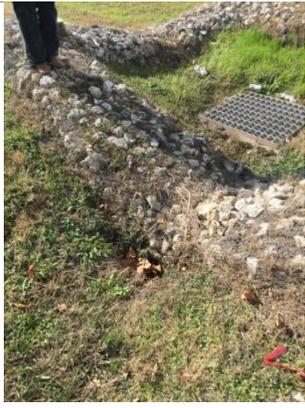
Soccer/Multi-Purpose Field

<p>Storm drain with infiltration at soccer field</p>

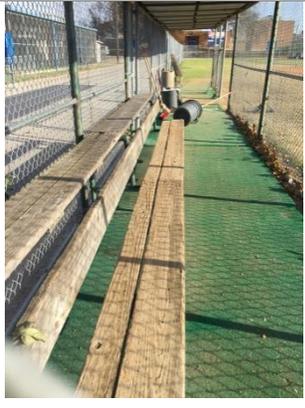
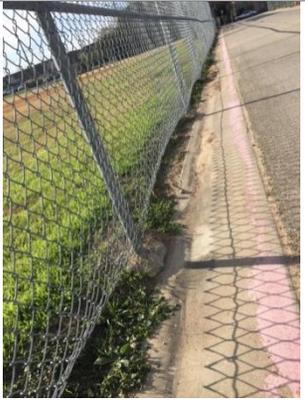
Baseball Field

<p>Deteriorating dugout bench seats</p>	<p>Loose fencing at baseball field</p>

1. Replace wooden benches
2. Repair fencing
3. Add parking at storage building
