Reagan Early College High School Site Summary

Address	7104 Berkman Drive Austin, TX 78752
Number of Permanent Campus Facilities	9
Original Year of Construction	1965
Total Campus Building Area (combined)	253,072 SF

Administration Building – BLDG-006A

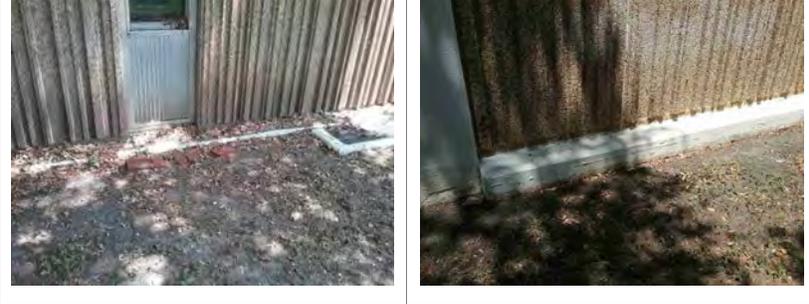
System	Subsystem	Condition and Deficiency Overview	System Condition Rating
Exterior	Exterior Walls	The exterior of the building consists of painted reinforced concrete beams and columns with prefabricated concrete panels coated with aggregate. The exterior walls were observed to be in good condition, with isolated areas in need of cleaning due to organic growth and debris accumulation. Additionally, isolated areas of the foundation needed recoating and joint sealants maintained.	Good
	Exterior Windows	The exterior windows consist of single-pane glazing units with aluminum frames. The exterior windows were in average condition for their extended age. Facility staff reported no leaks.	Average
	Exterior Doors	The building has two main entrances and two additional emergency exits. All are metal doors in metal frames. The main entrance doors are partially glazed. The remaining service doors around the facility are metal. The exterior doors were in average condition due to age, high usage, and minor rusting. They were well-coated to protect from typical weathering.	Average

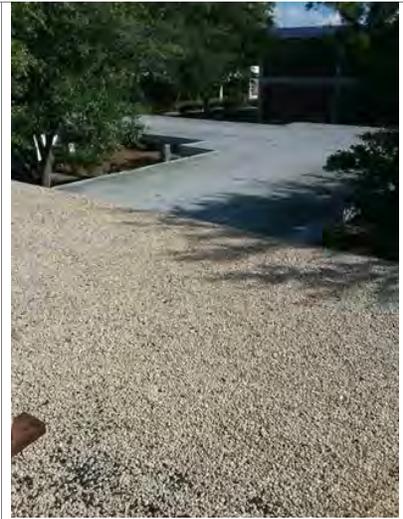
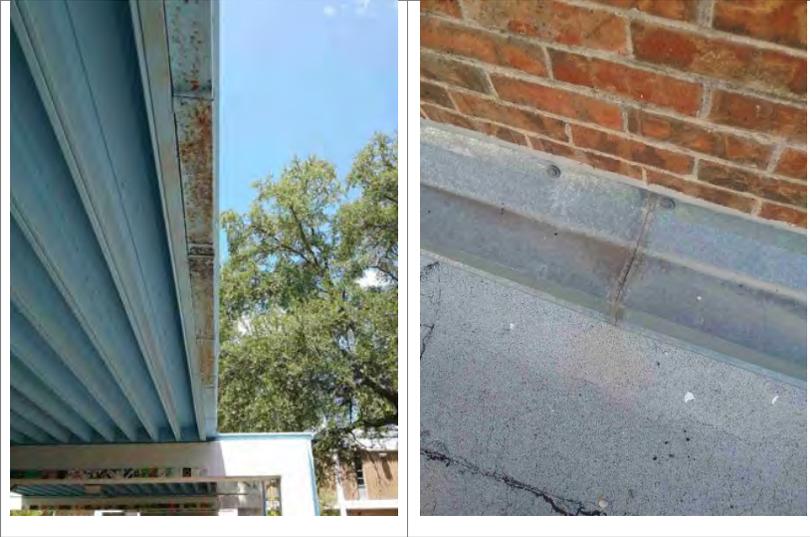
Roofing	The roof material covering the building is constructed of various materials. The main portion of the building is covered with built-up asphalt and granular topping while modified bitumen is found on the entrance and covered walkway canopies. The covered walkway canopies are constructed of concrete columns, beams and metal framing. The front canopy of the main entrance is constructed of concrete and has a roof covering of built-up asphalt with a granular topping. The roofing systems covering the building were observed to be in poor condition.		Poor

System	Subsystem	Condition and Deficiency Overview	System Condition Rating
		<p>The following deficient conditions were observed on the main building roof surface: evidence of ponding water, cracked asphalt scuppers, cracked sealant, debris build-up, and bald spots resulting in the exposure of the asphalt membrane. The roof trim and metal flashing materials were observed to be in average condition. It should be noted that there were no reported active leaks in occupied spaces within the building at the time of the assessment.</p> <p>The following deficient conditions were observed on the walkway canopy roof surfaces: evidence of ponding water, blisters, spider cracking, and cracked sealant. The trim and metal flashing was observed to be cracked and aged. The gutter and downspout system serving the walkway canopies was observed to be insufficient as wide-spread corrosion and peeling paint was observed on the canopy's metal framing system. It also appeared that water frequently cascaded out of the gutter system onto the pedestrian sidewalks located below the canopies. It was also observed that the top of the concrete beam system supporting the canopy structure was spalling in several areas due to exposure to the elements. Julie Vetter, AISD Construction Management, reported that the concrete beam system that supports the canopy has more wide spread issues. All walkway canopies appear to have structural integrity issues. Gaps can be seen from the exterior and within the courtyard stairs area. Two concrete beam systems have already been replaced due to these issues.</p>

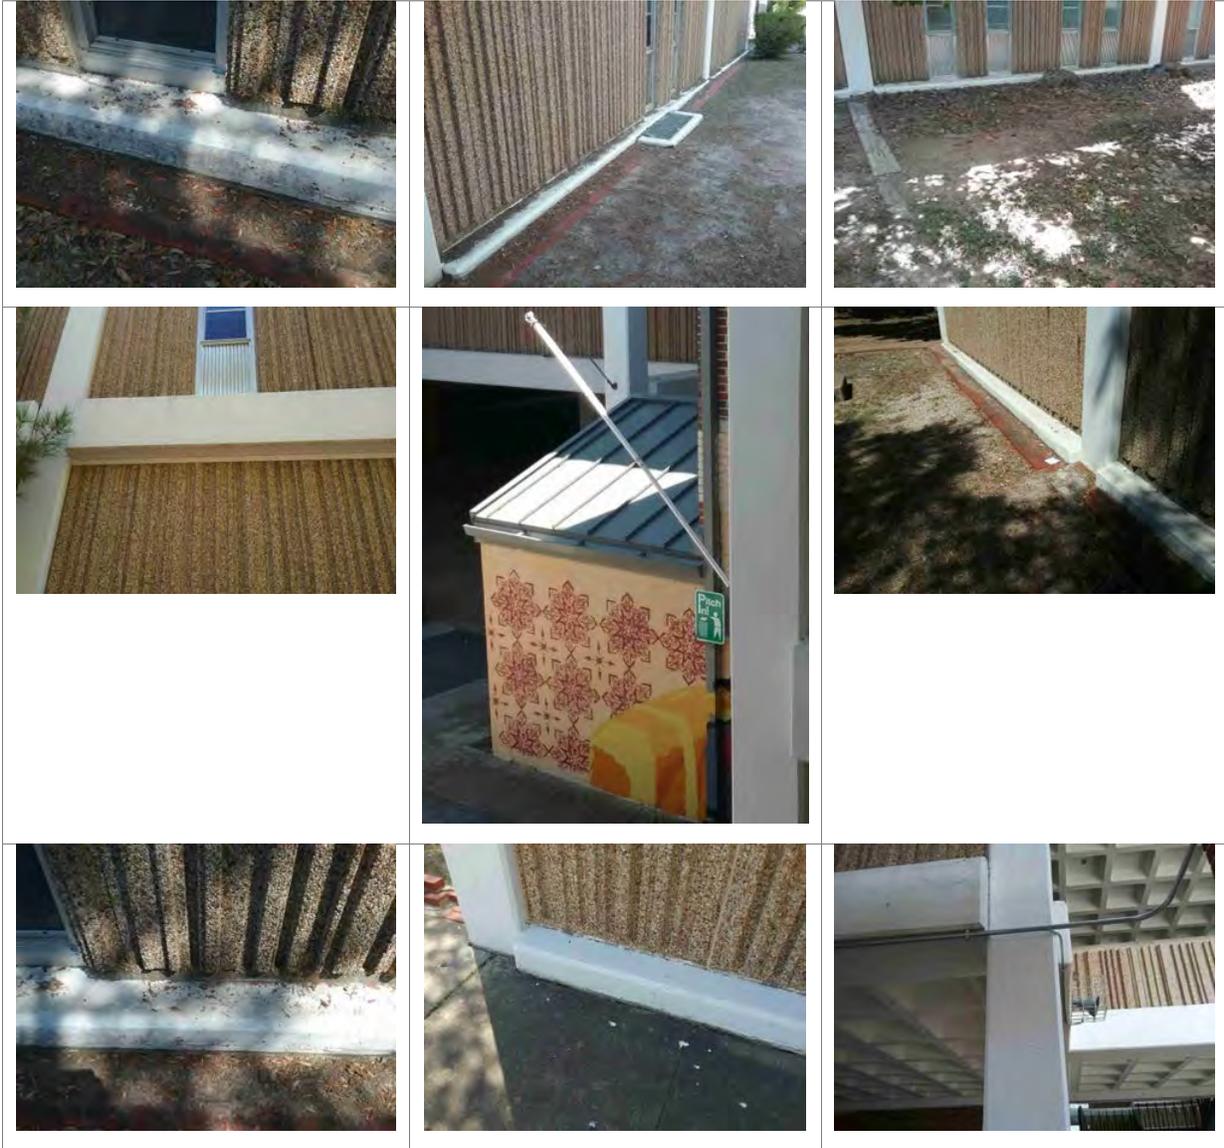
Exterior Walls

System	Subsystem	Condition and Deficiency Overview	System Condition Rating
		<p>Occasional minor rust spots were present on 5% of the external aggregate-coated concrete wall panels. The joints of the exterior wall with the foundation were dirty and degraded throughout the building, as were the joints of the building to sidewalks.</p> <p>The reinforced concrete beams of the balcony near the elevator were cracking horizontally near their top and their interface with other beams and columns.</p> <p>The makeshift brick apron adjacent to the foundation on the northwest below adjacent to roof B-02 appeared problematic as it was likely permeable since the brick joints were not sealed and it had settled and drained towards the foundation.</p>	
	Exterior Windows	<p>The exterior windows consist of single-pane glazing units with aluminum frames and vertical sliders spring-loaded with four sections of glass</p> <p>The units were in average condition given their service age. No leaks were reported by facility staff. Sealant was degraded from 50% of the windows on their inside and throughout their outside. The lower painted aluminum panels of 50% of the windows were faded. Room 235 has a missing window latch so it would not stay shut due to the window's spring loading. In 15% of the windows, glass panels had been replaced with acrylic, of which about 30% was heavily worn and scratched. 60% of window blinds were missing or broken. The windows were rated average as they have exceeded their expected design service life, broken and missing blinds, and acrylic panel fading. Some damage existed in windows adjacent to the entry way doors that may be attributable to possible structural issues similar to those in Building H New Mall or other causes.</p>	Average

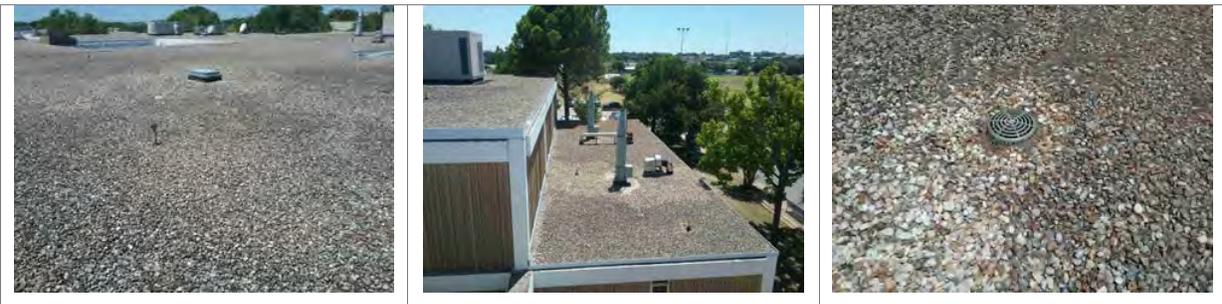
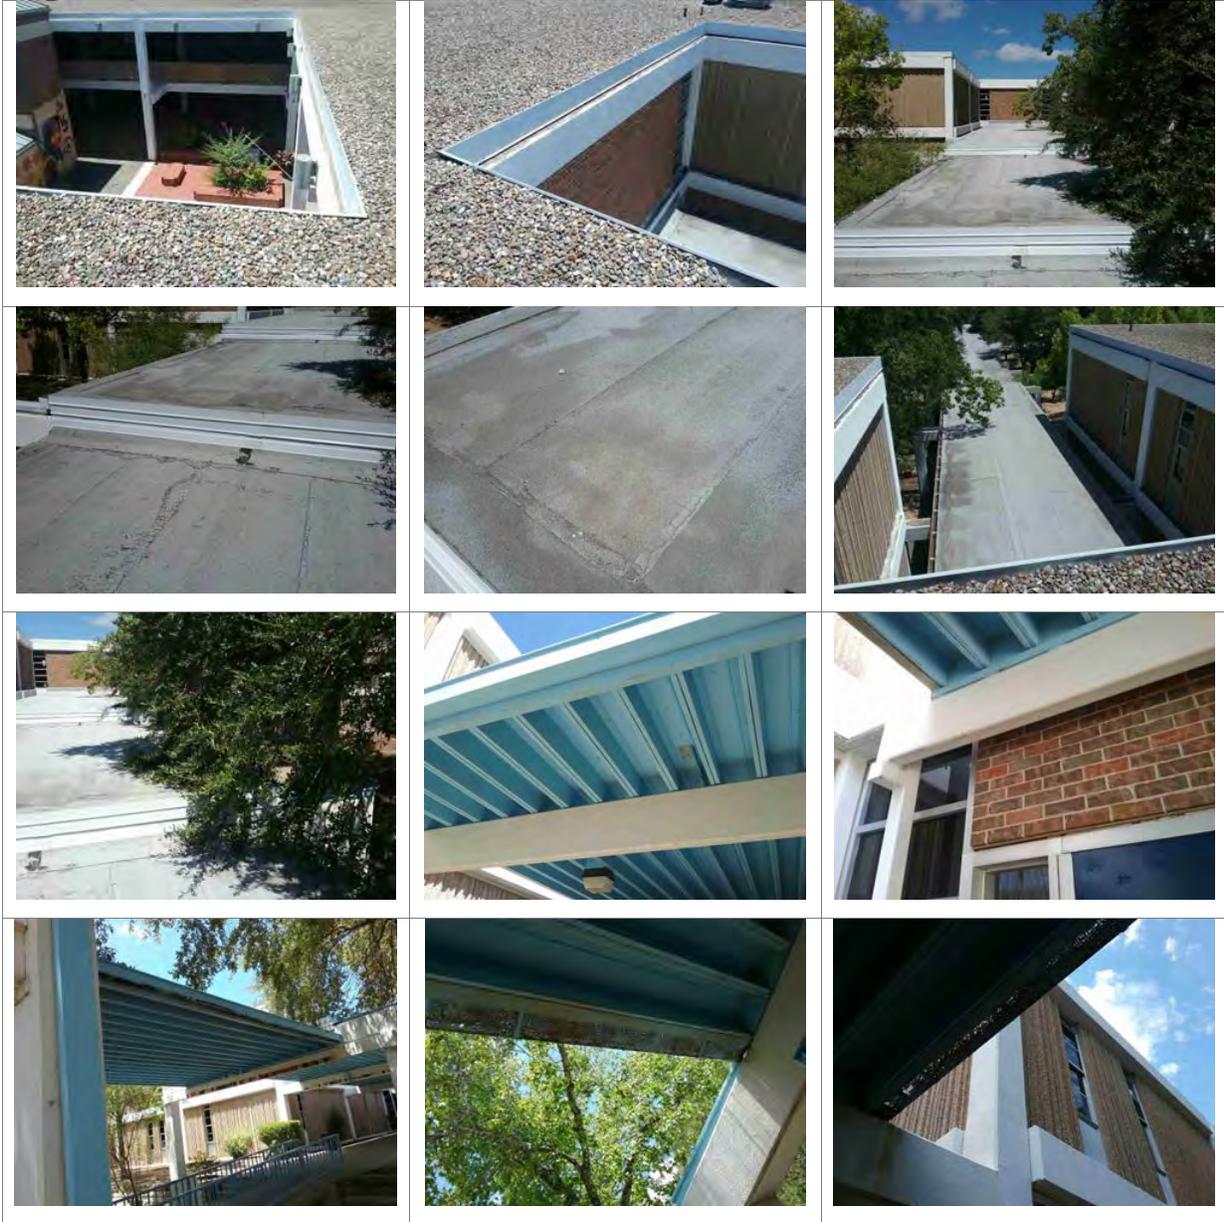
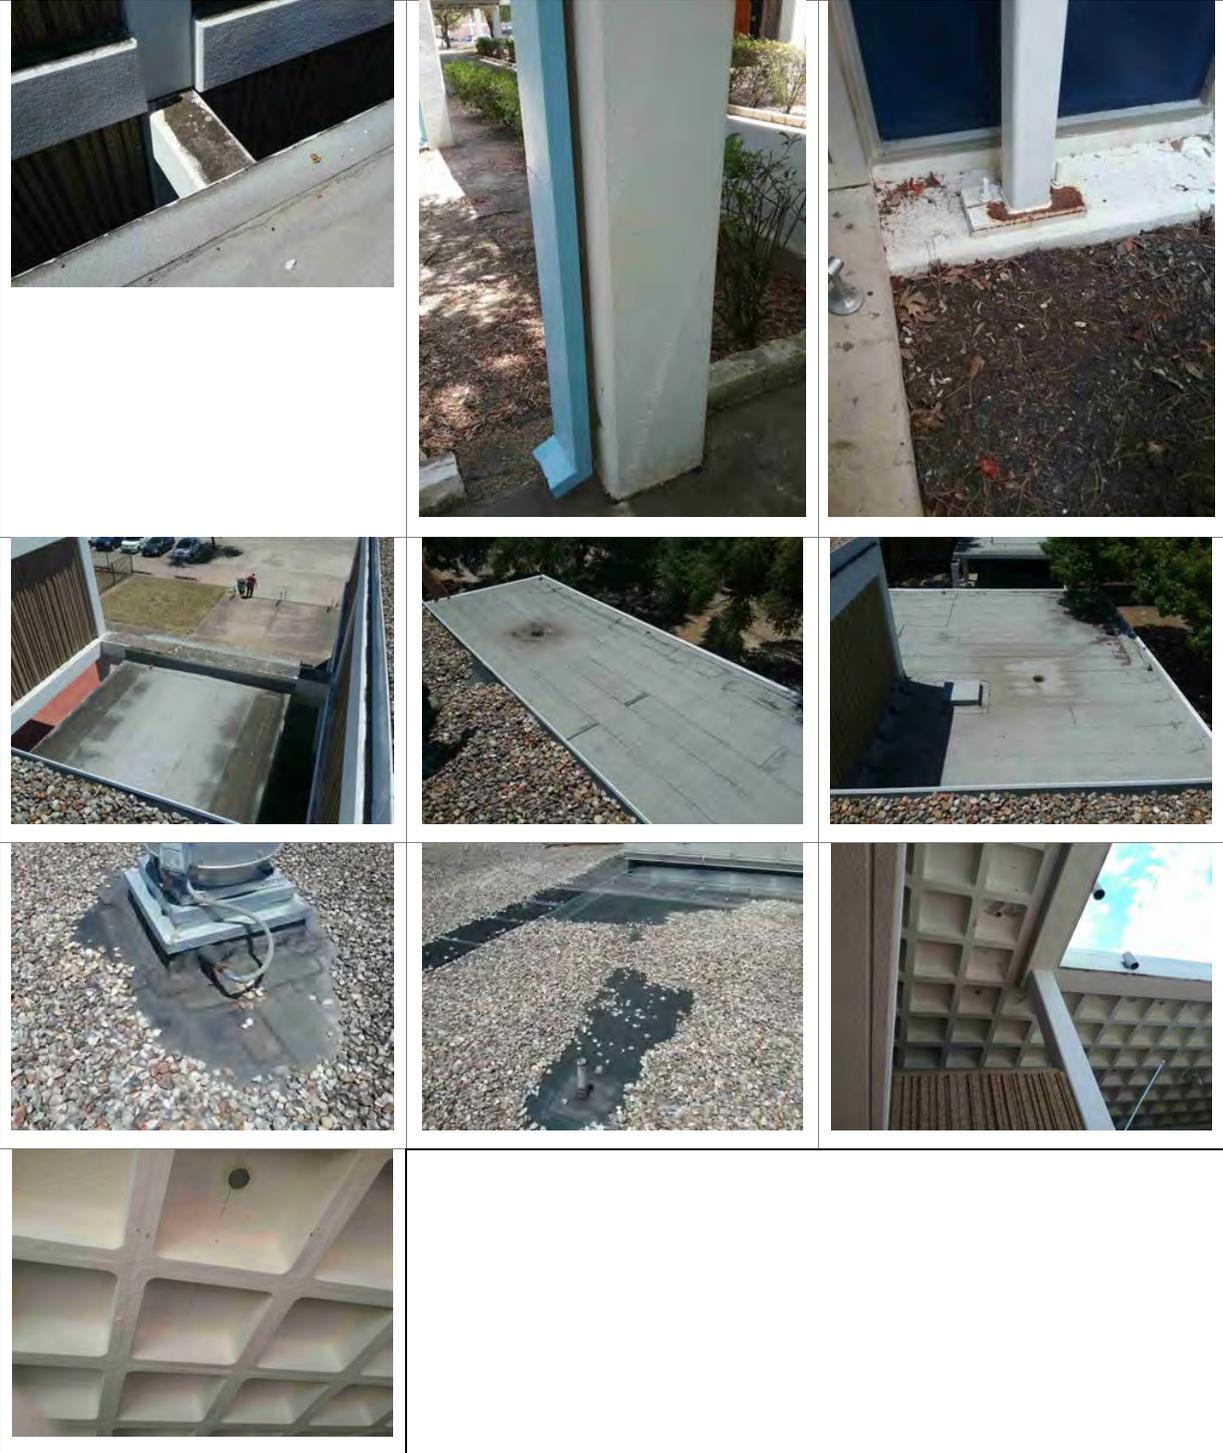
System	Subsystem	Condition and Deficiency Overview	System Condition Rating
<p>Roofing</p>		<p>The roof material covering the building varies between a single-ply membrane with a gravel topping on the main portion of the building and modified bitumen on the entrance and covered walkway canopies. The covered walkway canopies are constructed of concrete columns, beams and a metal framing system.</p> <p>The roofing systems covering the building were observed to be in poor condition.</p> <p>The following deficient conditions were observed on the main building roof surface: evidence of wide-spread ponding water, cracked scuppers, exposed areas of membrane material, cracked sealant at roof penetrations, and uneven distribution of the gravel topping across the roof surface. Most materials were observed to be aged. Gravel and debris was present in the gutter system in various locations. It should be noted that there were no reported active leaks in occupied spaces within the building at the time of the assessment.</p> <p>The following deficient conditions were observed on the canopy roof surface: evidence of ponding water, blistering, spider cracking, and cracked sealant. The canopy flashing and trim joints were cracked, rusted, and weathered. Tree branches overhung onto the roof surface and deposited debris on portions of walkway and entrance canopies. The gutter and downspout system serving the walkway canopies was observed to be deteriorated and insufficient as wide-spread corrosion and peeling paint was observed on the canopy's metal framing system. It also appeared that water frequently cascaded out of the gutter system onto the pedestrian sidewalks located below the canopies. The bottom portion of the gutter channel was observed to be deteriorated. It was also observed that the top of the concrete beam system supporting the canopy structure was spalling in several areas due to exposure to the elements. The steel framing structure was observed to be corroded in various areas as the finish paint was blistered and peeling. Facility staff report evidence of active leaks present within the band hall.</p>	<p>Poor</p>

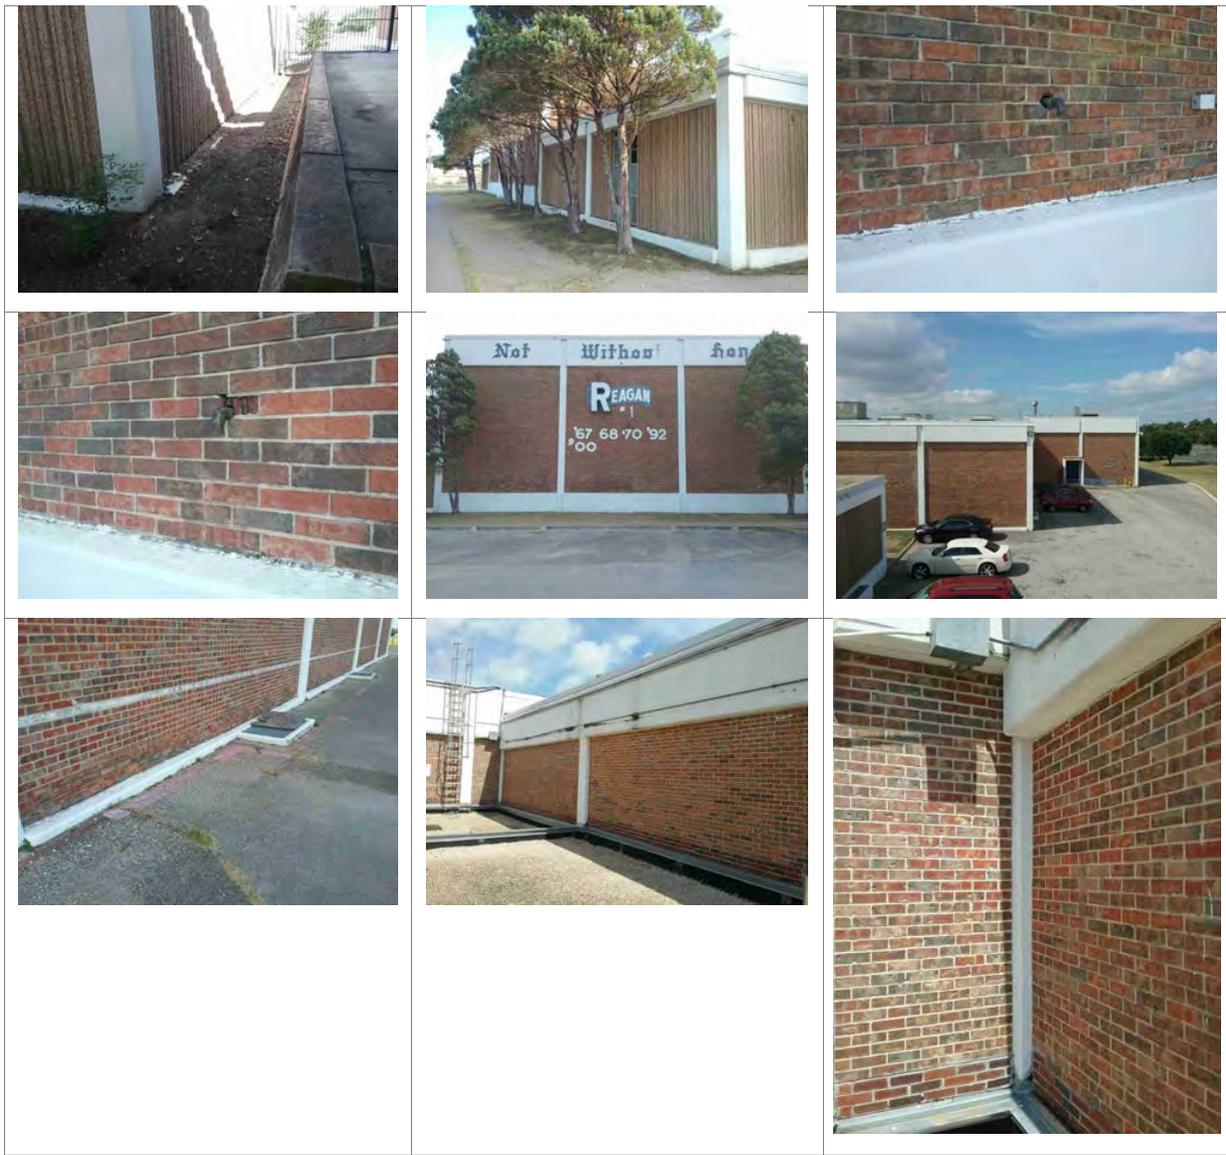
System	Subsystem	Condition and Deficiency Overview	System Condition Rating
Exterior	Exterior Walls	<p>The exterior of the building consists of painted reinforced concrete beams and columns with brick veneer panels for the gymnasiums or prefabricated concrete panels coated with aggregate for the one story portions of the building.</p> <p>The exterior walls were observed to be in average condition. The north wall of the trainer room had debris covering most of its foundation beam, likely due to the concentrated drainage directed in the narrow corridor between it and the abutment wall of the sidewalk for the north neighboring standalone [former] Band Hall [now dance studio]. Debris had also accumulated on the foundation beam of the south wall. Isolated instances of conduits penetrating the wall that were unsealed or adjacent to cracked or degraded bricks were also present. The brick veneer was weathered, but not excessively for its age or to affect its performance. Some instances of weathered coating and cracked, degraded joint sealant and/or mortar existed on the foundation beams on the west and near the southeast corner. Walls with electrical conduit attached to them had rust stains or had weathered near the conduit. The flashing and trim on the upper beam of the south wall of the small gymnasium was rusting heavily in an area,</p>	Average

System	Subsystem	Condition and Deficiency Overview	System Condition Rating
		<p>likely due to water penetration. The lettering material of the school name, motto, and championship years on the south wall was heavily weathered and a couple of letters had fallen off or had pieces broken off and had peeling paint. An excessive quantity of ants was observed in the vertical joint of the second story walls under roofs C-02 and C-04 adjacent to C-10. The external louvers throughout had cracked, shrunk, or missing sealant in the joints of their frames to the walls; about 10% had blades ajar, dented, or a very few that were missing, and about 10% of screens were dented and bent; about 70% of their lintels were corroded and were weathered; the louvers under roof C-09 above the former dance room had weathered and bent screens. The northwest wall of the small gymnasium and north wall of the auxiliary gymnasium appeared to have parking lot drainage running towards them, as indicated by debris build-up, organic matter, and moisture, and subsequent accelerated weathering of both the brick veneer and joint sealant of the walls. Beams on the southeastern exterior had deteriorated paint. The south and southwestern walls had dirt and damaged grout.</p>

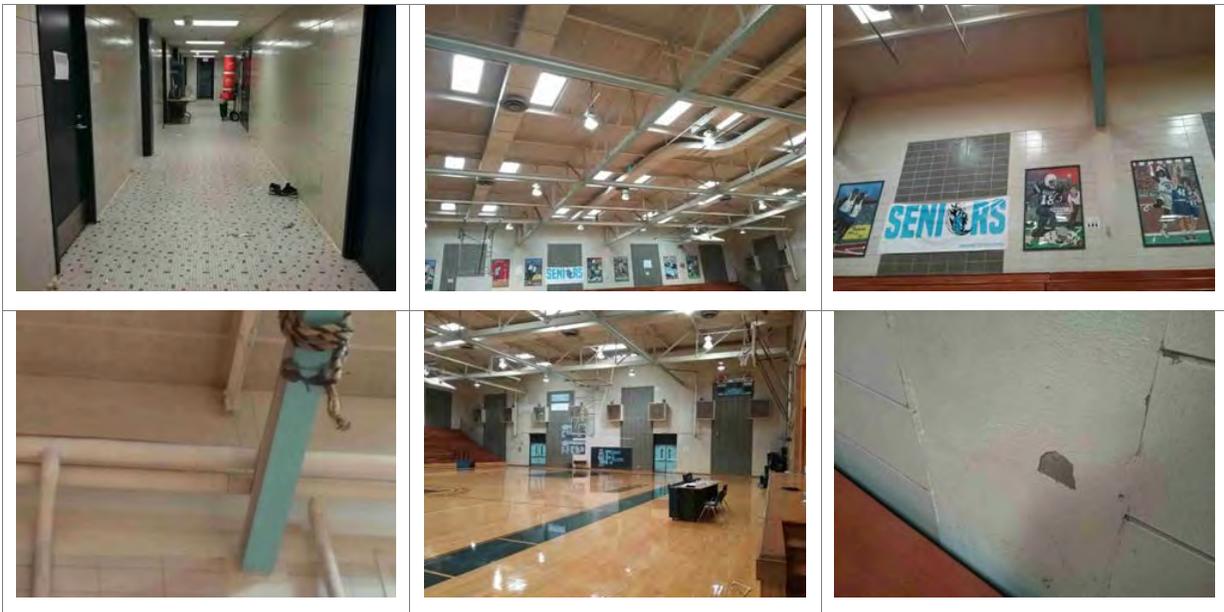
Interior Walls

<p>Interior Construction</p>	<p>Interior Walls</p>	<p>Interior walls are primarily CMU.</p> <p>The tiled corridor for the locker rooms and equipment storage rooms was humid and smells very musty, perhaps because of the doors being closed on either end of the corridor and inactive or inadequate ventilation.</p> <p>Cracking was observed in the walls of all three gymnasiums. In the large gymnasium, the north wall had cracks from the ceiling/roof within about six inches each of the roof's girders connected at their top bolt to the wall down to the top of the glaze/tiled CMU portion of the wall below at its intersection with the column to which the girder connected; a similar such crack was present in the middle of the wall although no girder was present. The west wall had fewer such and less progressed cracks near where some of the roof's beams connected to its columns from the ceiling/roof down to where the glazed/tiled CMU intersected the columns to which the beams connected. The east wall had similar such cracks, but less progressed. The large gymnasium's columns had about 25% visible sporadic</p>	<p>Average</p>

System	Subsystem	Condition and Deficiency Overview	System Condition Rating
		<p>horizontal cracking spanning the width of many of its columns; more cracks could have existed under the paint of the columns; the top of the southwest corner wall had symmetrical cracks on its intersecting walls.</p> <p>The small gymnasium also had similar cracking, though less severe to that of the large gymnasium where its girders connected to its walls and similar degrees of horizontal cracking in its painted columns.</p> <p>The auxiliary gymnasium's west wall had approximately three instances of cracking regularly along the same CMU joint mortar spanning the entire height of the wall. The cracks were wider at their top, narrowing to their bottom. The southeast corner also had a crack at the intersection of its walls, also wider on top and narrowing towards its bottom. The east wall had cracking along both vertical joints of a 'column' of CMUs from the top of the wall to the bottom, which were more distinguishable at the bottom of the column than the top, and possibly attributable to or indicative by the cracked CMU block at the bottom of this 'column' of CMUs.</p>

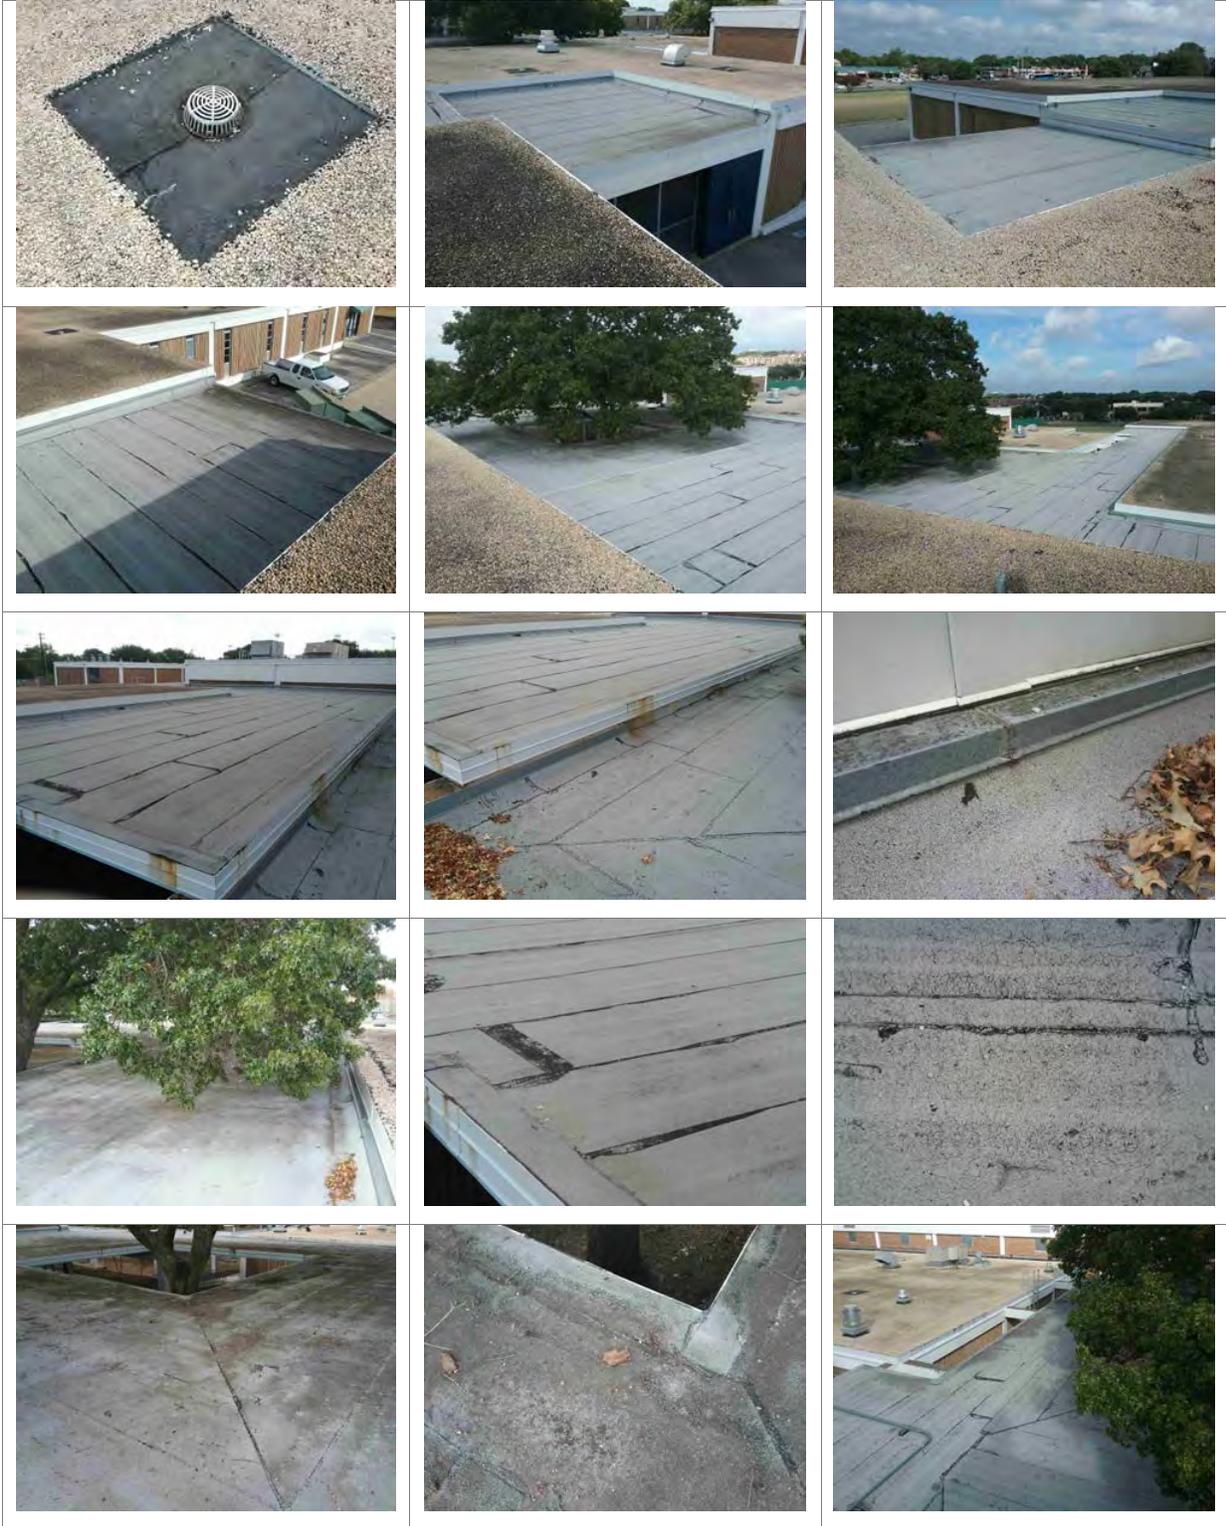
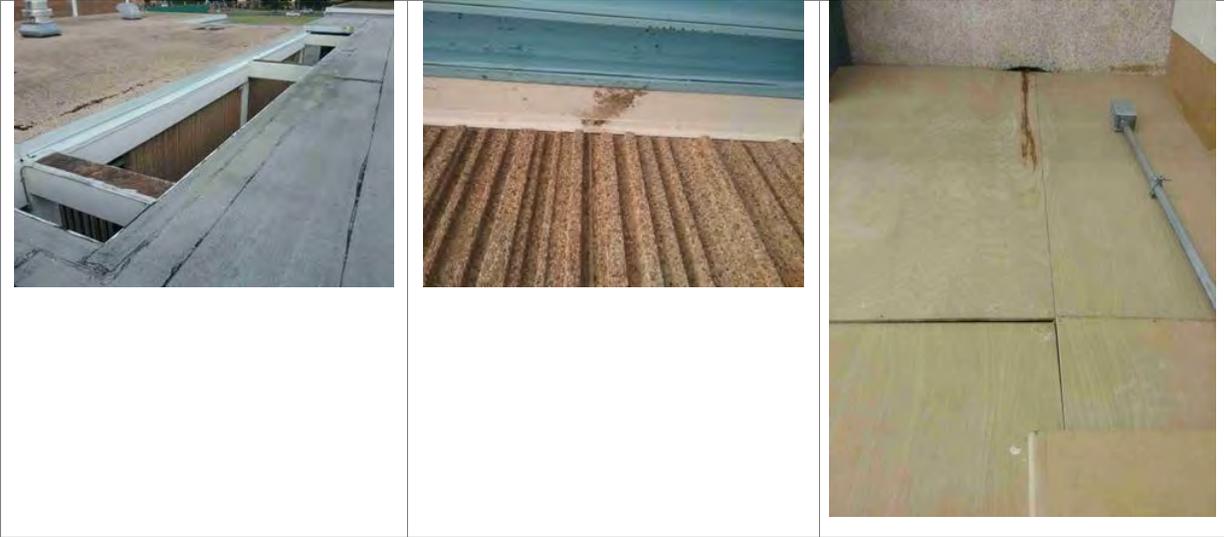
Roofing	The roof material covering the building varies between built-up asphalt with a granular topping on the main portion of the building and modified bitumen on the entrance and covered walkway canopies. The covered walkway canopies are constructed of concrete columns, beams and steel and aluminum framing. The roofing systems covering the building were observed to be in poor condition. Active or historical leaks were observed in the building and on the bottom side of the covered walkway canopies. The following deficient conditions were observed on the main building roof surface: evidence of ponding water, cracked asphalt scuppers, cracked sealant, debris build-up, and bald spots resulting in the exposure of the asphalt membrane. The roof trim and metal flashing materials		Poor

System	Subsystem	Condition and Deficiency Overview	System Condition Rating
		<p>were observed to be in average condition.</p> <p>The following deficient conditions were observed on the walkway canopy roof surfaces: evidence of ponding water, blisters, spider cracking, and cracked sealant. The trim and metal flashing was observed to be cracked and aged. Gutters and downspouts on the canopies were not present. It was also observed that the top of the concrete beam system supporting the canopy structure was spalling in several areas due to exposure to the elements. Tree branches overhung above the covered walkway canopies contributing greatly to debris and water accumulation and subsequent accelerated weathering.</p>	
Interior Construction	Interior Walls	Interior walls are predominantly painted gypsum board on wooden or aluminum framing, finished wood paneling, painted CMU, or painted vented CMU. Some minor water damage to the drywall adjacent to the door entering the locker room was observed.	Good

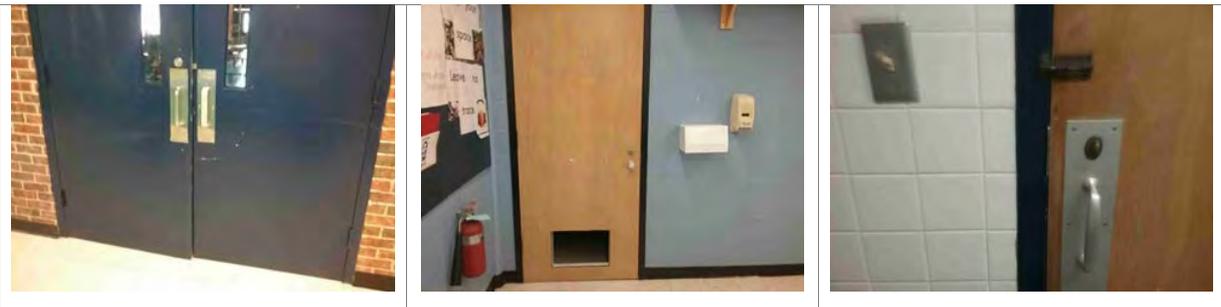
Interior Doors

<p>Interior Doors</p>	<p>Due to age of the building several interior remodels have taken place which has led to a large variety of interior doors, the condition assigned was average. Some doors were dated while other doors are newer. Doors were a mix of metal and wood while door frames were metal. Some doors have vision glass with security mesh while other doors have louvers on the bottom or both.</p> <p>The doors were observed to be in overall average condition. Deficiencies observed included wear and tear on the door finishes which has led to scuff marks, scratches, dents and signs of wear for heavily used doors. Some doors were observed to have missing louvers or mesh installed over the position of the louver rather than actual louvers. The hardware on the doors was observed to also be in average condition due to loose hardware, failed locking mechanisms requiring secondary locks on doors, and locks that stuck.</p>	<p>Average</p>
