Travis High School Site Summary

Address	1211 E Oltorf Street Austin, TX 78704
Number of Permanent Campus Facilities	6
Original Year of Construction	1953
Total Campus Building Area (combined)	285,468 SF

Main School Building – BLDG-007A

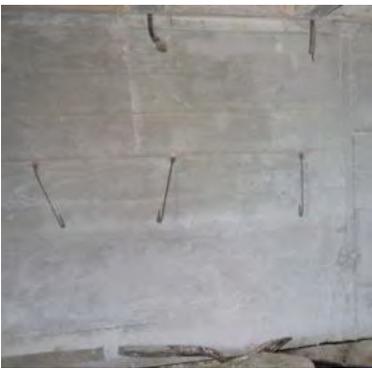
Exposed Structure

<p>Formwork ties for walls left in place</p>

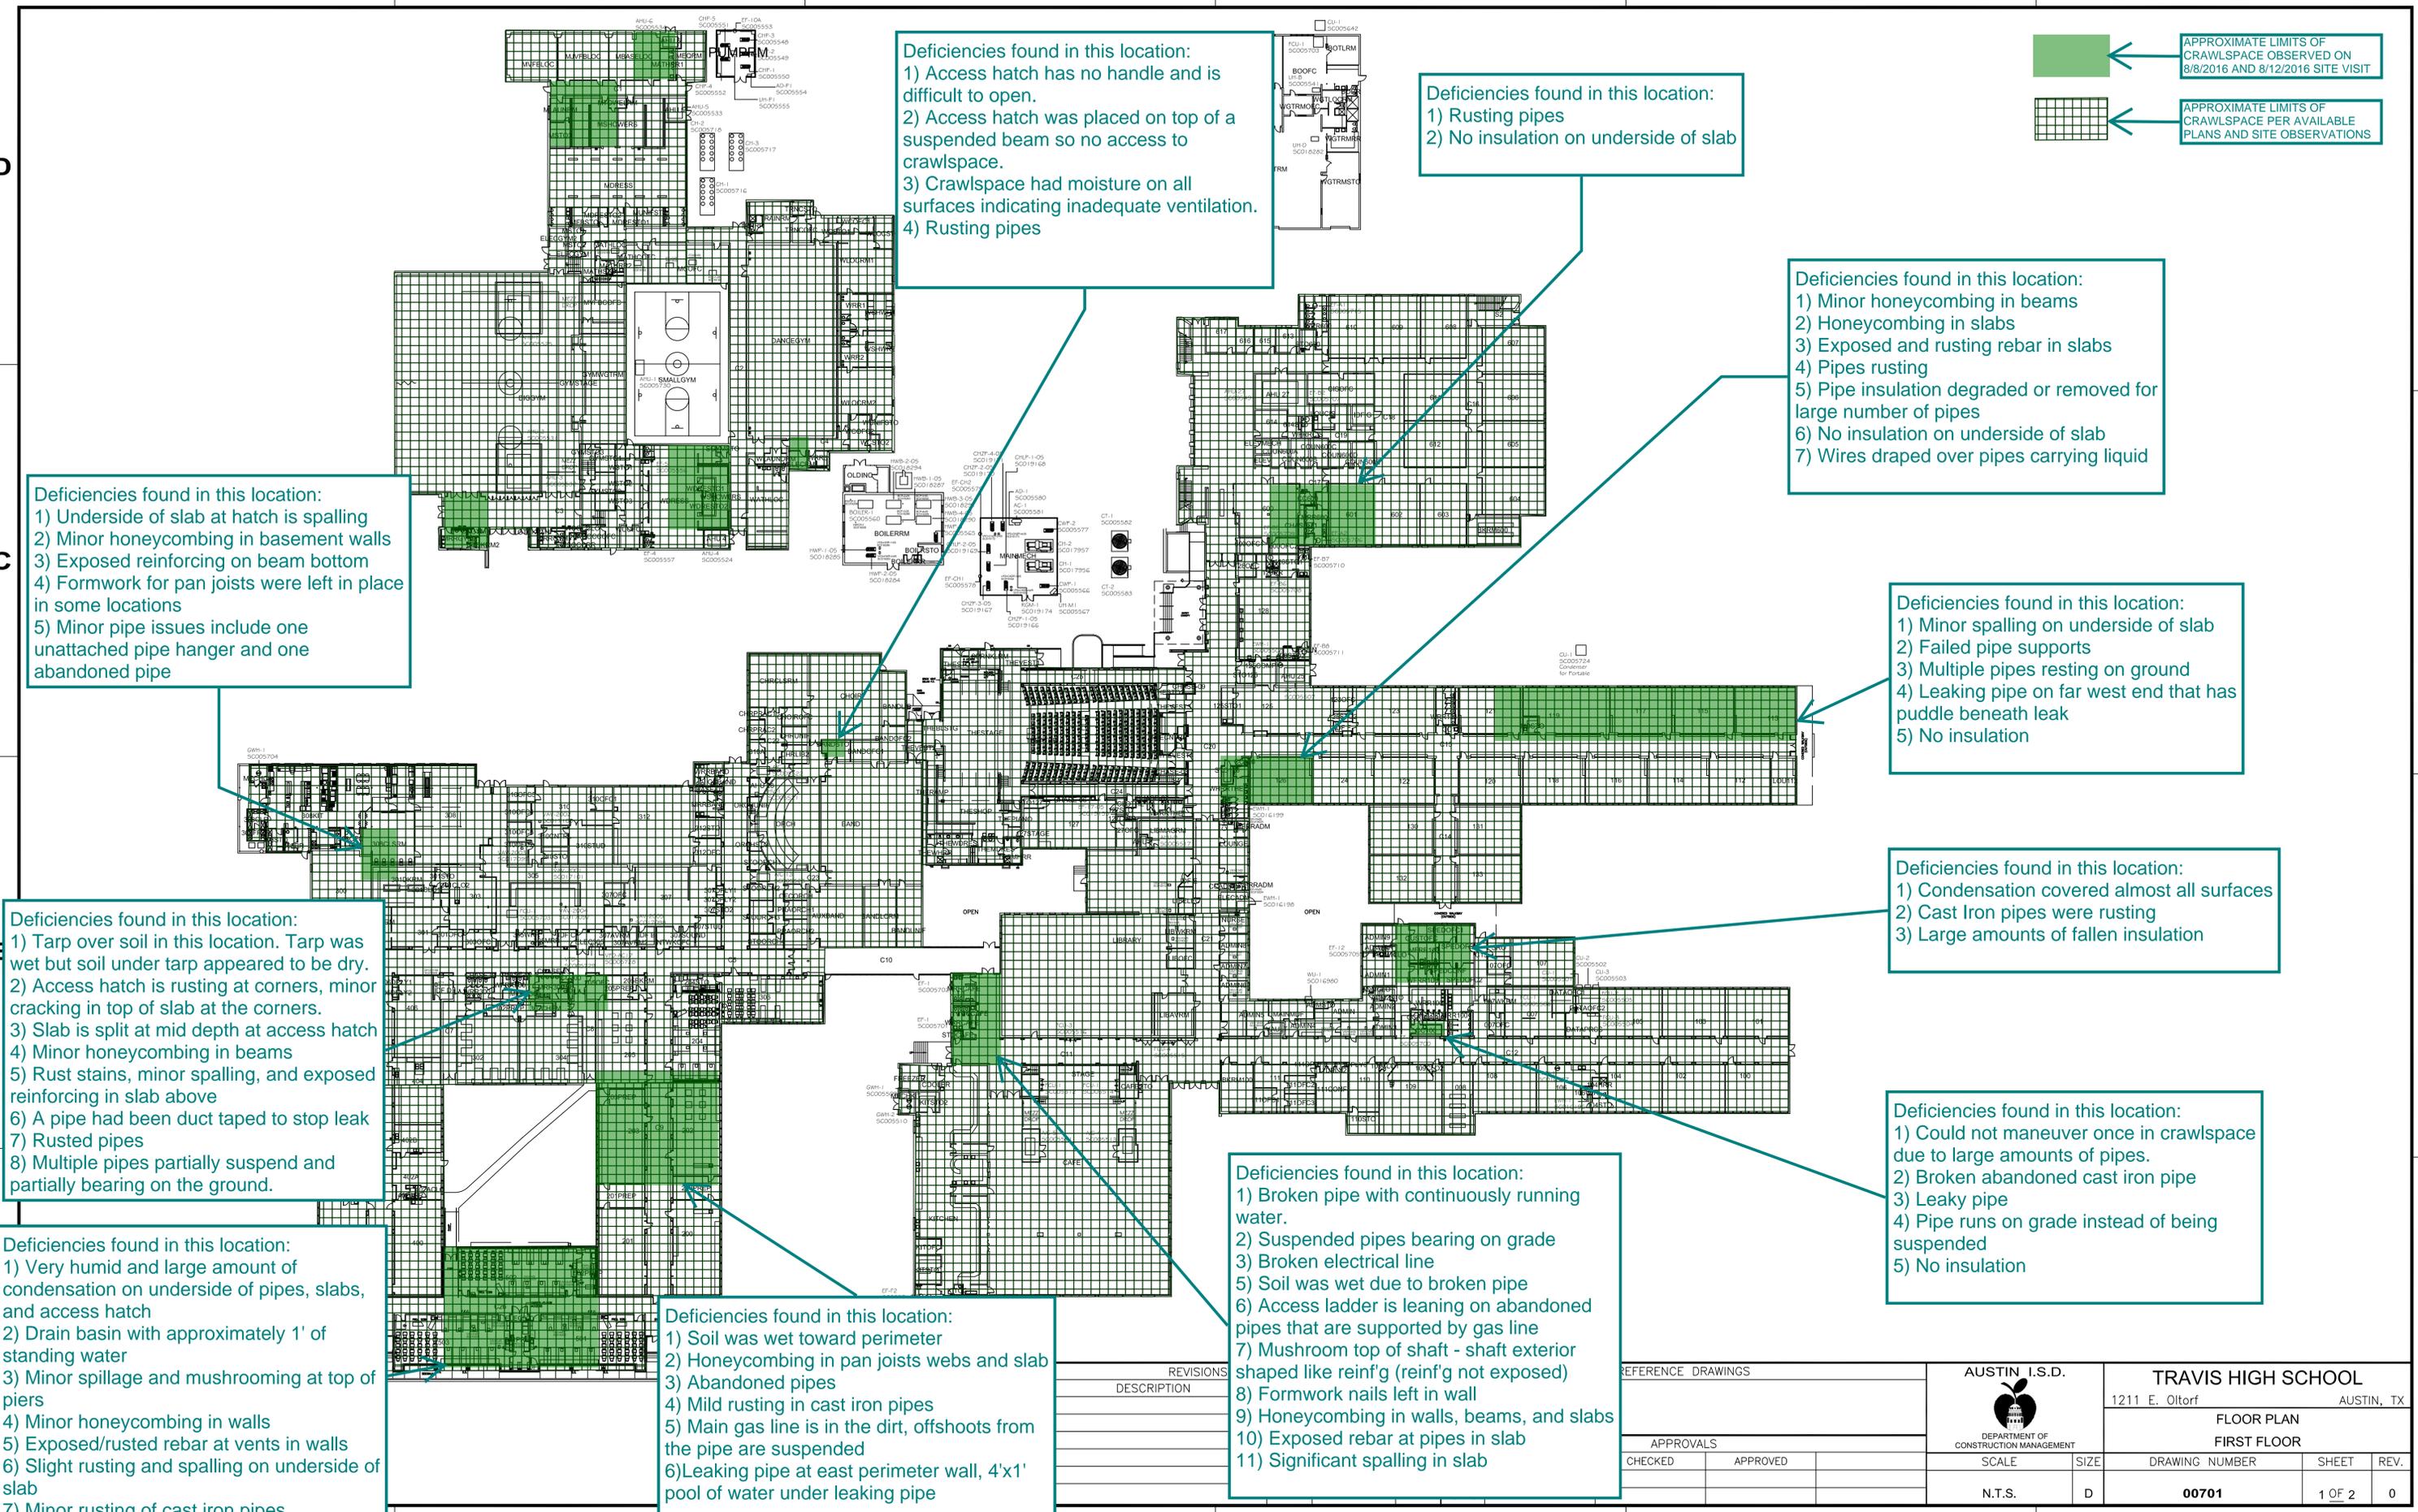
Deficiencies found in this location:

- 1) Access hatch has no handle and is difficult to open.
- 2) Access hatch was placed on top of a suspended beam so no access to crawlspace.
- 3) Crawlspace had moisture on all surfaces indicating inadequate ventilation.
- 4) Rusting pipes

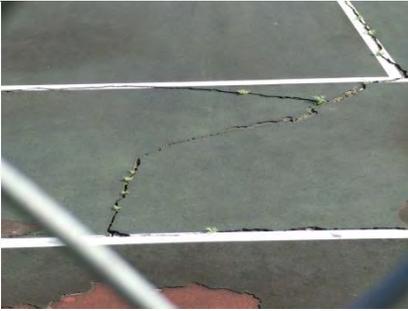
Dark patches with cracks	Tennis court cracks

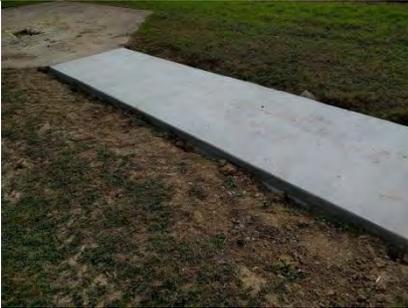
Track

Pole vault drop-off	Pole vault drop-off

1. Add fill topsoil material to account for pole vault track drop-off
