Bedichek Middle School Site Summary

Address	6800 Bill Hughes Road Austin, Texas 78745
Number of Permanent Campus Facilities	3
Original Year of Construction	1972
Total Campus Building Area (combined)	133,942 SF

Introduction

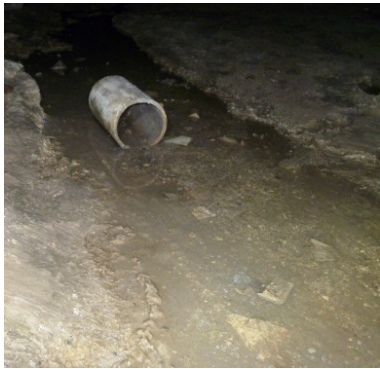
<p>Standing water</p>

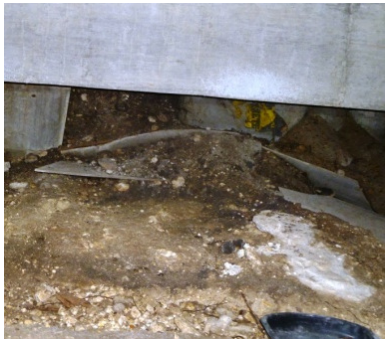
<p>Failed retainers, soil intrusion below perimeter beam</p>
---	--	--

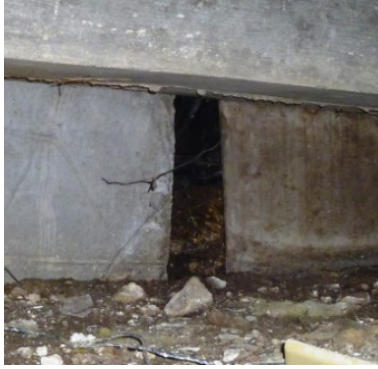
Gap between soil retainers

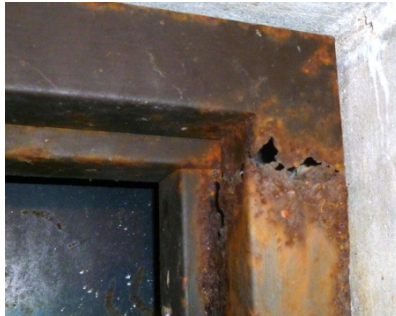
Corroded access hatch frame

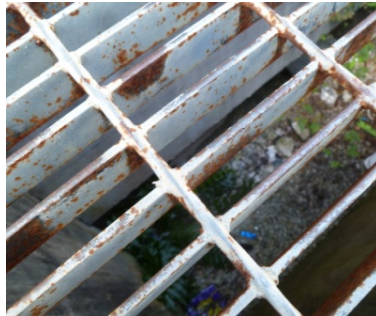
Mild corrosion on areaway grate

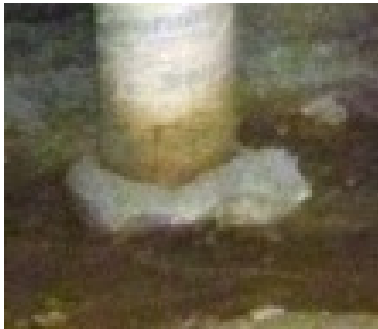
Mushrooming concrete at top of pier

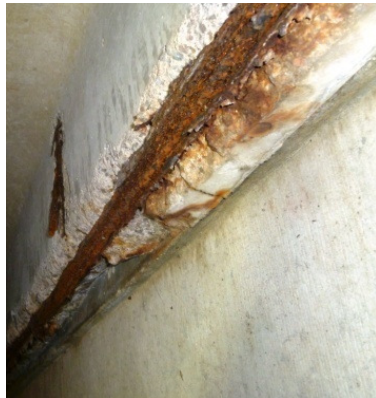
Severe longitudinal spalling and rebar corrosion at bottom of precast joists

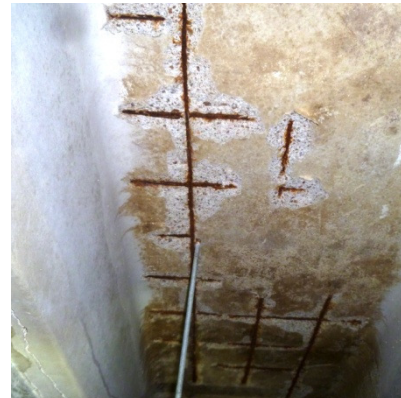
Exposed/corroded reinforcement at precast deck soffit

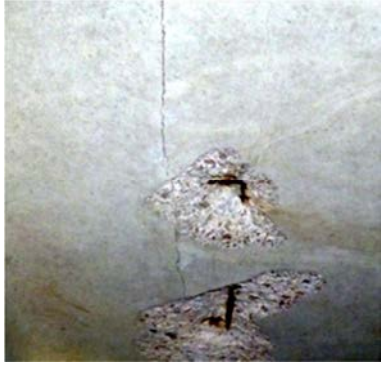
Longitudinal crack, spalling, rusting rebar
in precast deck soffit

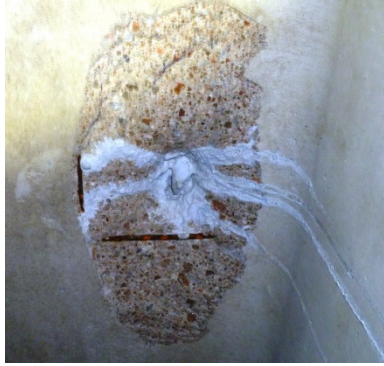
Spalling on underside precast deck

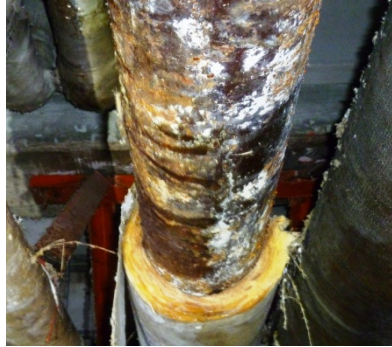
Corroded cast iron pipe

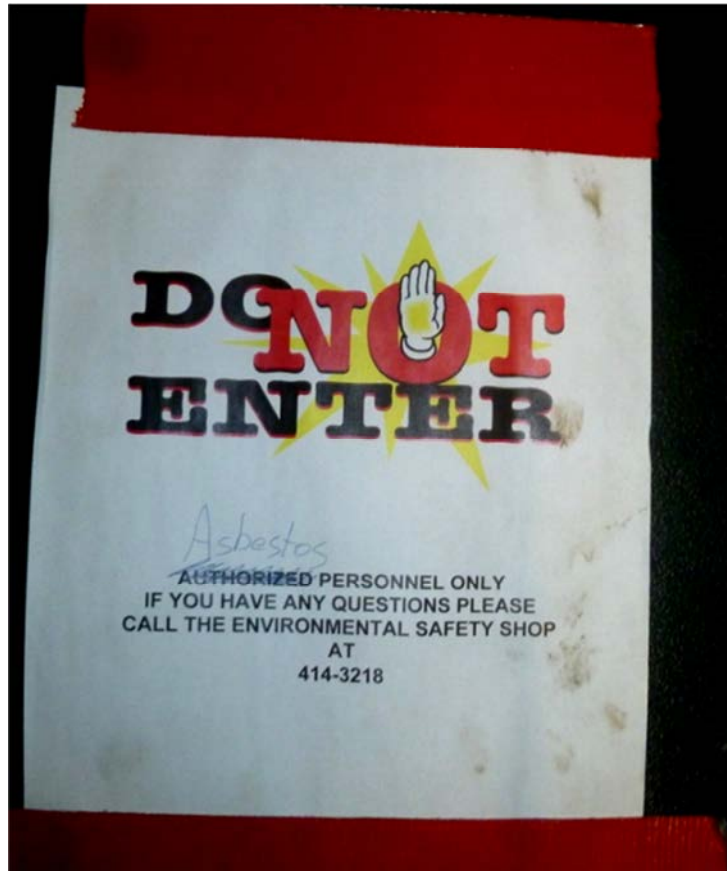
NOTES CONCERNING CRAWL SPACE OBSERVATIONS: Building B crawl space was not observed because an asbestos hazard sign was posted at the crawl space entrance.

Asbestos hazard sign

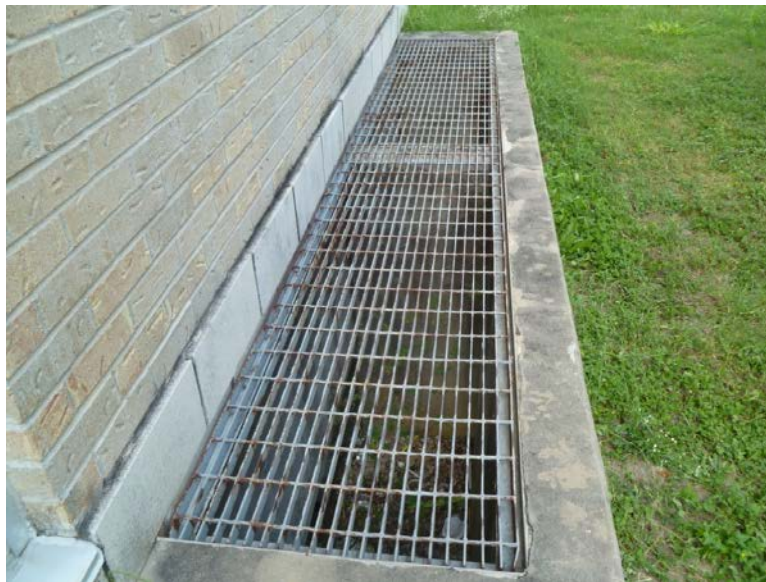
NOTES CONCERNING CRAWL SPACE OBSERVATIONS: Building C crawl space was not observed due to a deep drop down into the crawl space. Without a ladder in the areaway it is not safe to try to jump down to the crawl space.

Deep drop in access areaway

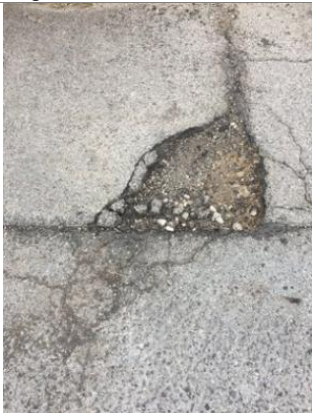
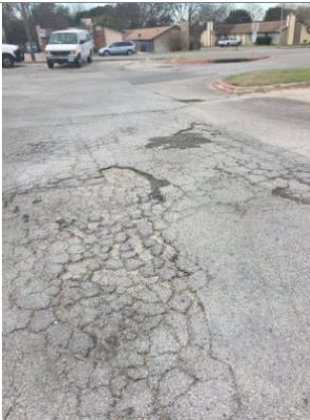
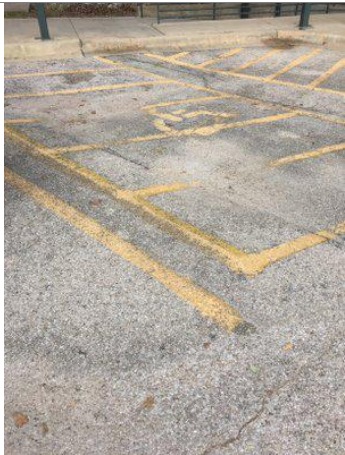
Pothole	Severe alligator cracking	Cracking and raveling

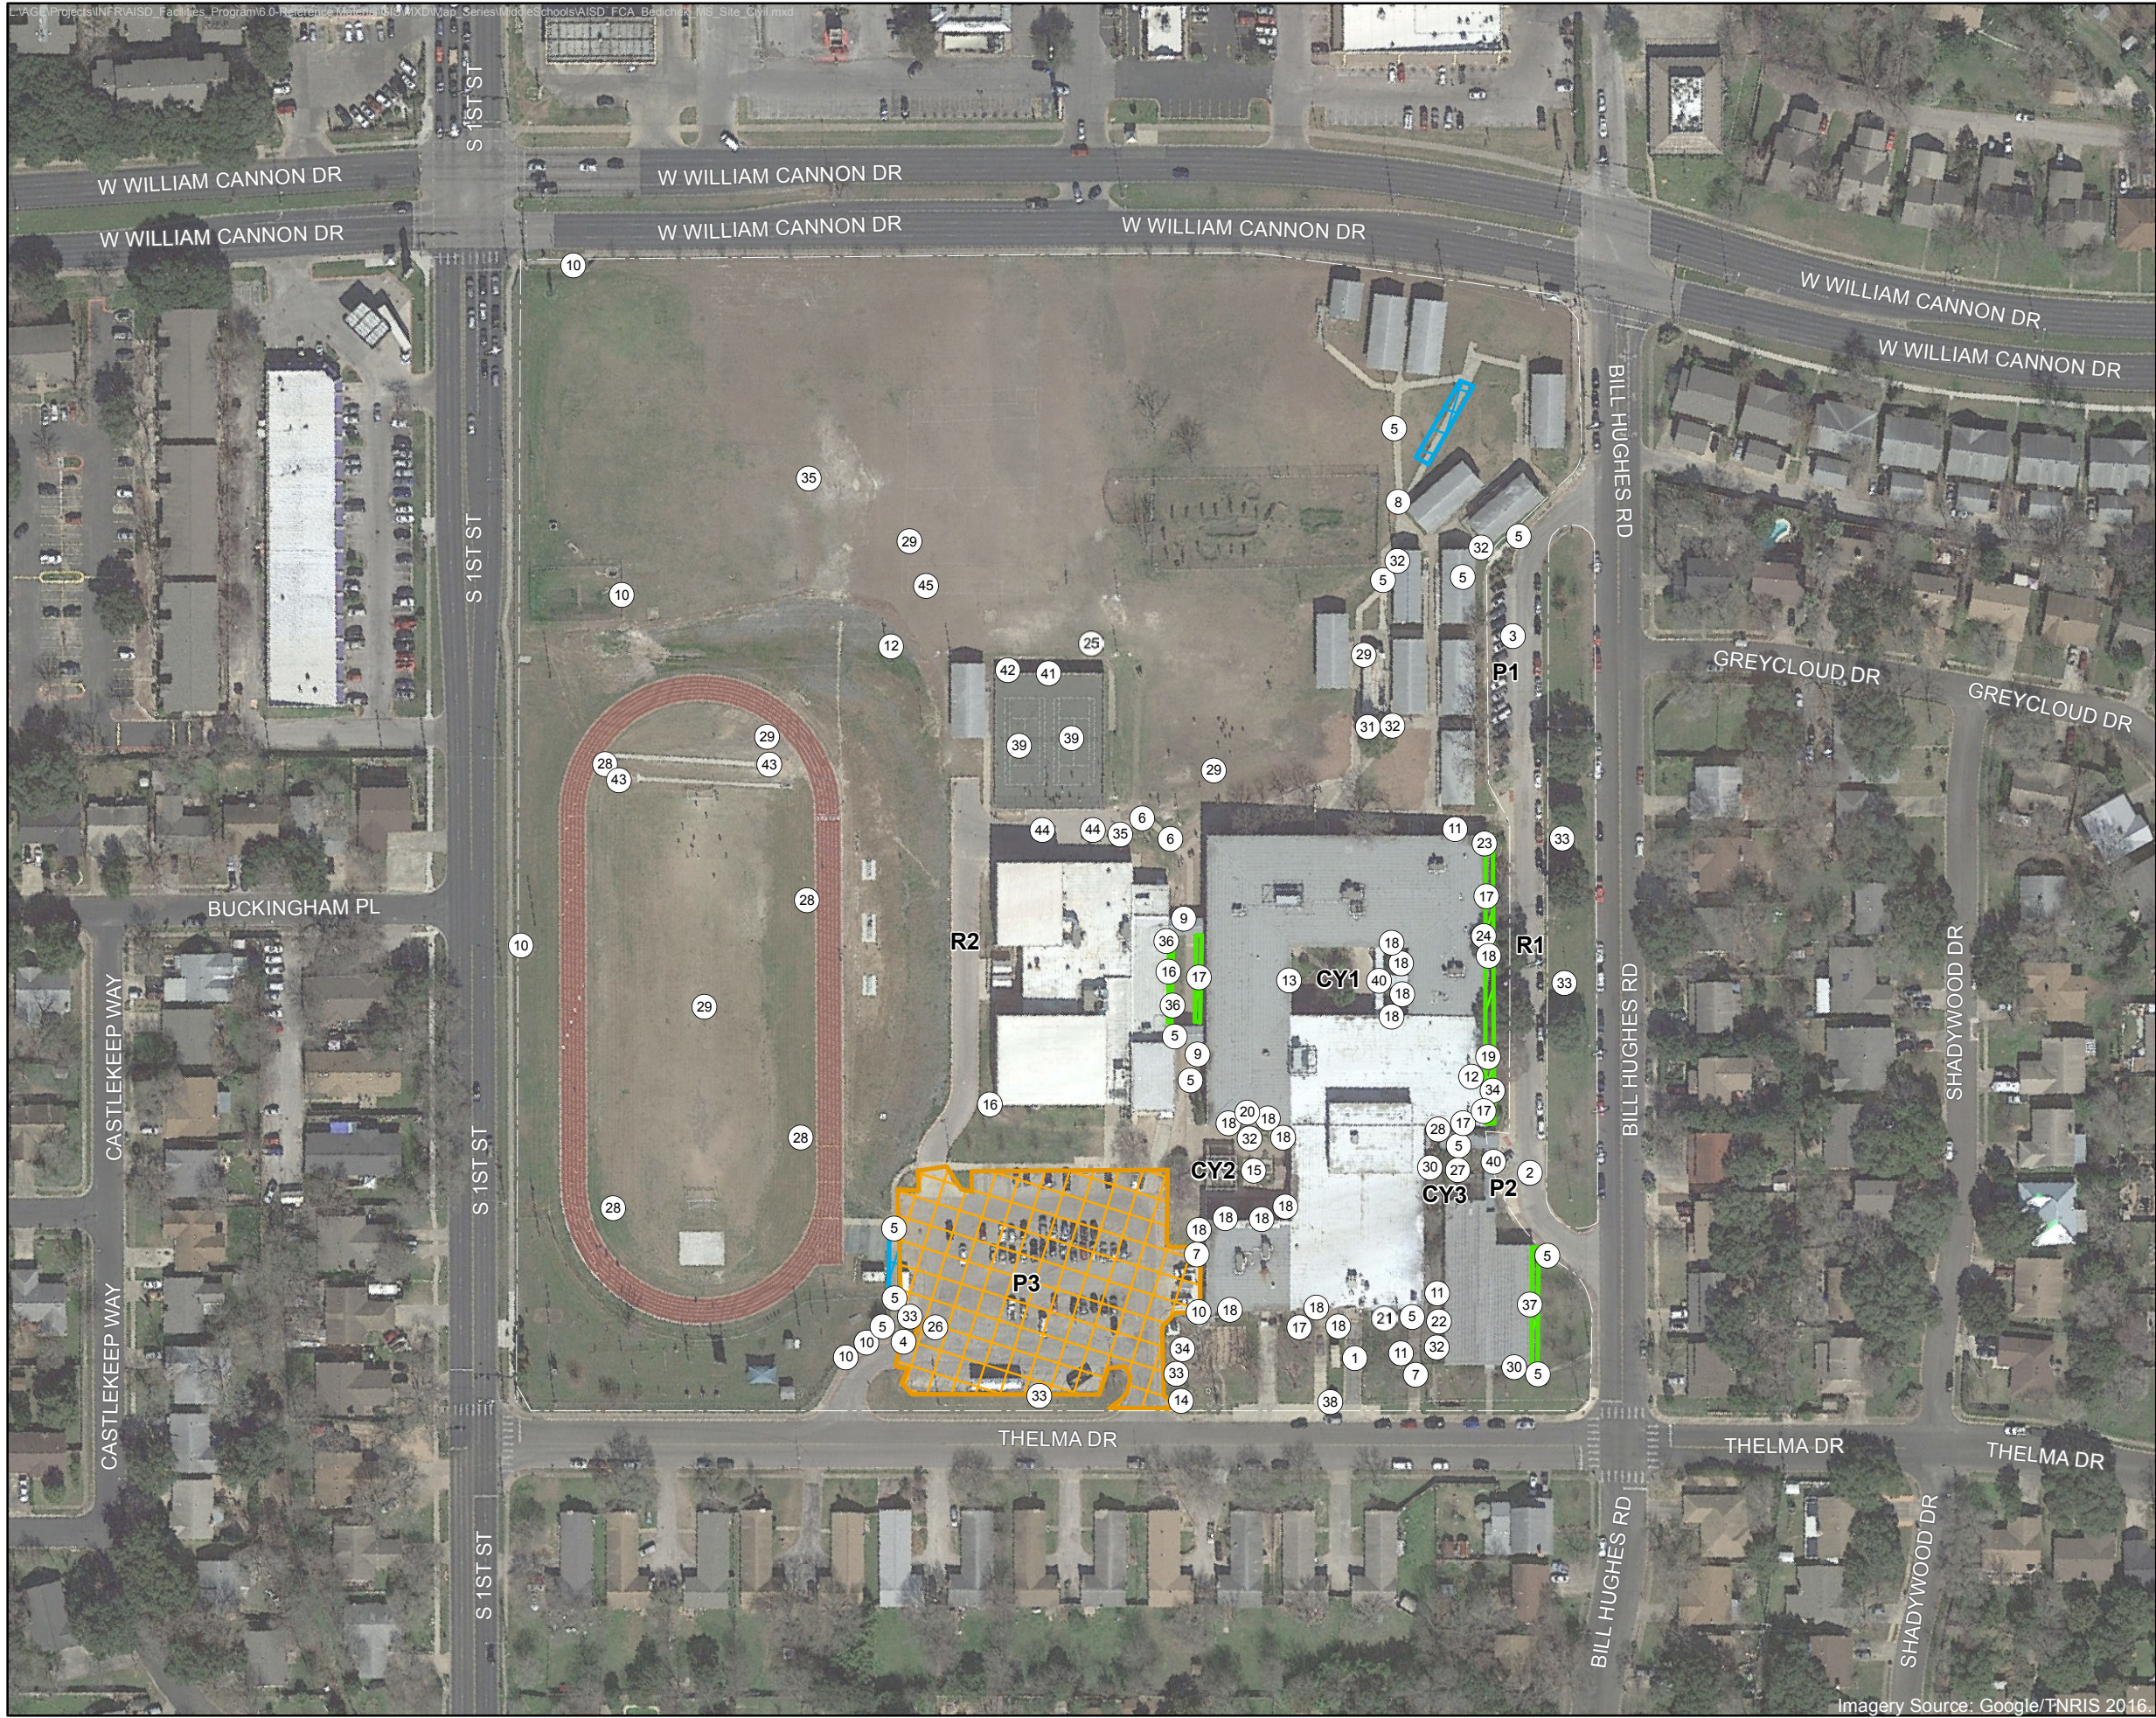
- Legend**
- ① Recommended Improvements
 - Drainage Improvement
 - Pavement Improvement
 - Sidewalk Improvement
- NOTES:**
- PAVEMENT DISTORTION IN THIS AREA.

- THERE ARE LONGITUDINAL CRACKS IN THIS AREA.
 - THERE IS ALLIGATOR CRACKING IN THIS AREA.
 - DAMAGED CURBS.
 - THE SIDEWALK IS BROKEN/HEAVING/SUNKEN IN.
