## Burnet Middle School Site Summary

## Main School Building – BLDG-046A

## Mechanical Building – BLDG-046B

## Site/Civil Assessment

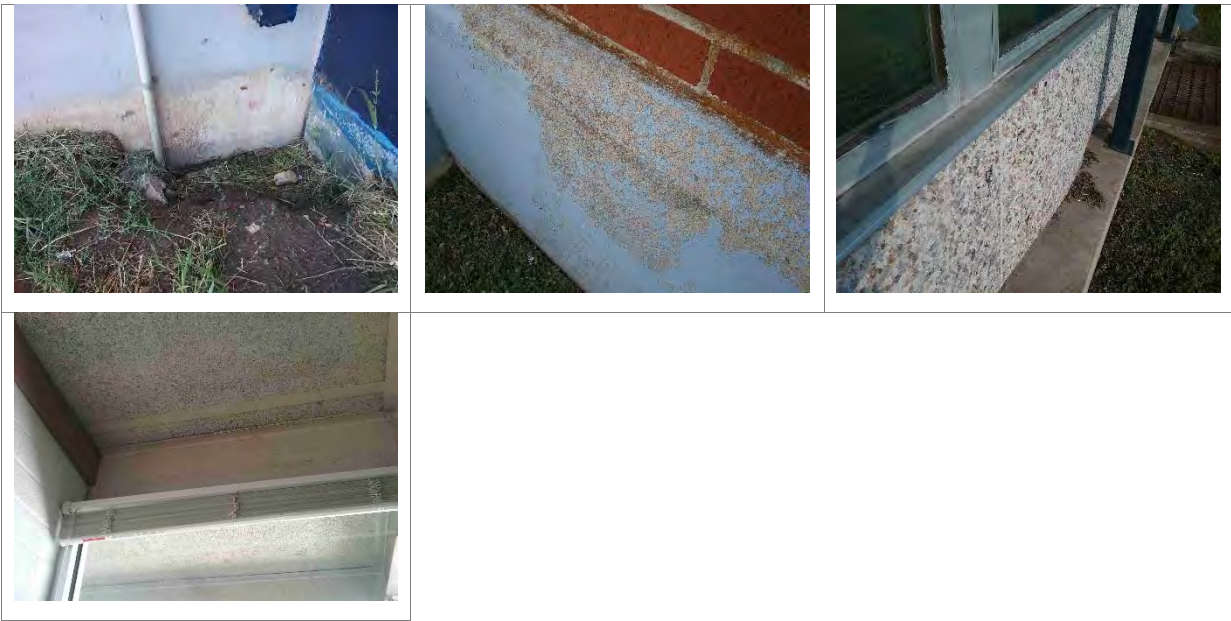
**Exterior Walls**

System	Subsystem	Condition and Deficiency Overview	System Condition Rating
Exterior	Exterior Walls	<p>The exterior walls of the building are constructed with concrete masonry unit (CMU) cores faced in brick with gravel inlay accents. The building consists of many wings organized around greenspace or courtyards, and only one wing of classrooms is a two-story. The rest, and majority, of the building is one story.</p> <p>The walls were observed to be in generally good condition, free of water discoloration and well kept. A few deficiencies were noted during the assessment, most of which require only light maintenance. Pockets of sunken soil were observed at a few downspouts.</p> <p>Most of the painted portions of the foundation wall were observed to be chipped. More notably, a buckled portion of the gravel infill was observed beneath a classroom window. It was also observed that the exterior girders for the building were exposed and not insulated. This was typical of many roof beams and girders. This resulted in a thermal bridge from exterior to interior and affects the efficiency of the HVAC (heating, ventilating, and air conditioning) system. It is not a life safety issue, nor is an urgent fix, but the technique is simply not common practice today and may result in some HVAC inefficiencies.</p>	Good

1. Fill eroded soil and provide splash blocks at the exit of the downspouts to avoid further erosion.
2. Repaint foundation wall.
3. Investigate buckled gravel wall for cause of deficiency and remedy.
4. Insulate exposed structure at exterior envelope.
5. Reseal windows with dry, cracked sealant, which is an estimated 25 percent of all windows.
6. Clean debris from windows, inside and out.
7. Replace broken, missing, or mismatched panes with vision glazing matching the surrounding panes.
8. Investigate organic growth on the lintel outside the copy room to determine course of action.
9. Touch up small areas of scratched doors with paint to match existing paint.
10. Replace rusted door and frame leading to the small gym area.
11. Replace sliding cafeteria door/window system with aluminum frame system with laminated glass.
12. Insulate roof girders exposed to external weather elements

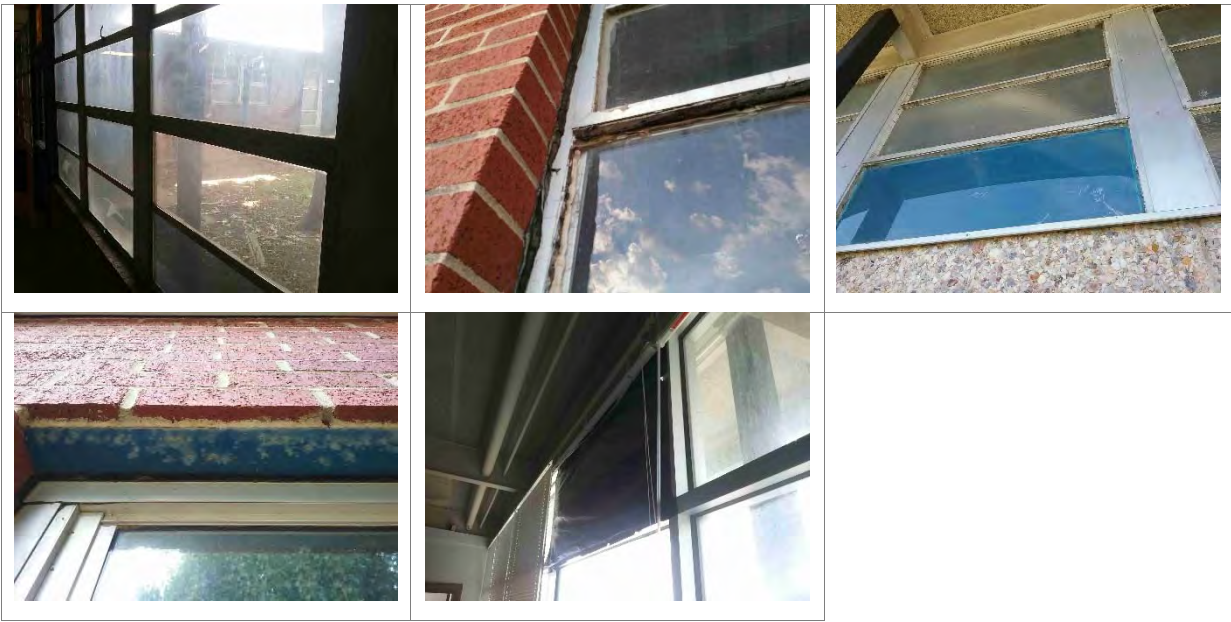
**Exterior Windows**

System	Subsystem	Condition and Deficiency Overview	System Condition Rating
	Exterior Windows	<p>The exterior windows are a mixture of original and updated horizontal bands, in metal and aluminum frames respectively. Both window systems have single pane glazing, with either textured or smooth glazing. The roof eave projects over the face of the windows is about 4'-0" in most areas of the building.</p> <p>The window system was observed to be generally in average condition, and the majority of corridor windows appeared excessively dirty. The sealant of the older metal frame windows was observed to be dry and failing, constituting about 25 percent of all windows and including the kitchen windows. About a dozen panes were observed to be either missing and replaced with another material, or broken and taped.</p> <p>Organic growth was observed on the lintel outside the copy room, and a black tarp was observed to be taped over a window in room 300.</p>	Average

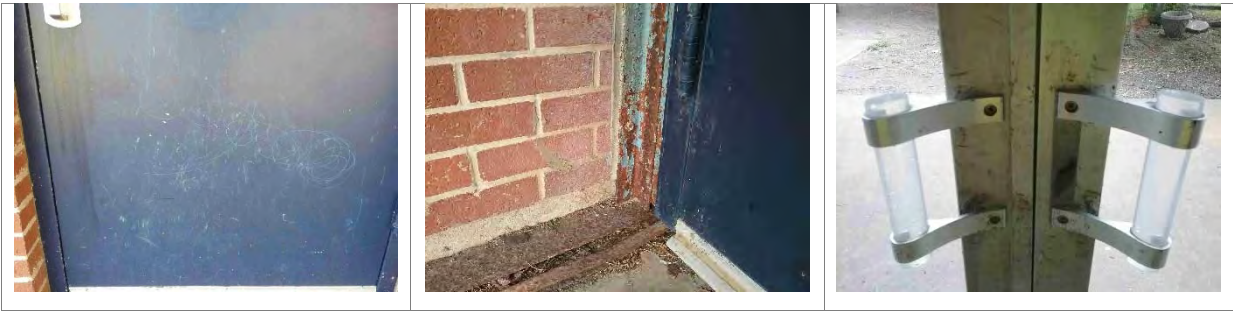
Exterior Doors	<p>The exterior doors of the building are painted metal in metal frames. Most doors are half glazed and are set in a storefront system. The doors leading from the cafeteria to the courtyard are unique from all other doors in the building. They are 8'-0" tall glazed sliding doors, set in a full height metal frame storefront system. The glazing in the door systems throughout the building is single pane. The exterior doors have modern hardware and seem to have been installed in the past five years.</p> <p>The doors appeared to be in good condition, only lightly used and overall weatherproof. A few spots were observed to need touch-up paint. The exterior door near the small gym was observed to have rust on the frame. The cafeteria sliding doors appeared more worn than the rest of the exterior doors, with scratches and excessive dirt on the frame.</p>	Good
Roofing	<p>The roof covering the building consists of either built-up asphalt with a granular topping, modified bitumen, or a single ply membrane, all constructed at different times. There are 30 skylights over the gyms. There is also an extensive covered walkway on the campus with a corrugated metal roof.</p> <p>The roof as a whole was observed to be in average condition as minor repairs may be required and the system appeared mostly watertight. Ponding was observed in many places throughout all roof types, especially near the gutters. The modified bitumen roof appeared to be in good condition though the membrane is showing its age. The seams appeared well welded, but hairline cracks from sun exposure were observed to pepper the surface. The eaves of the</p>		Average

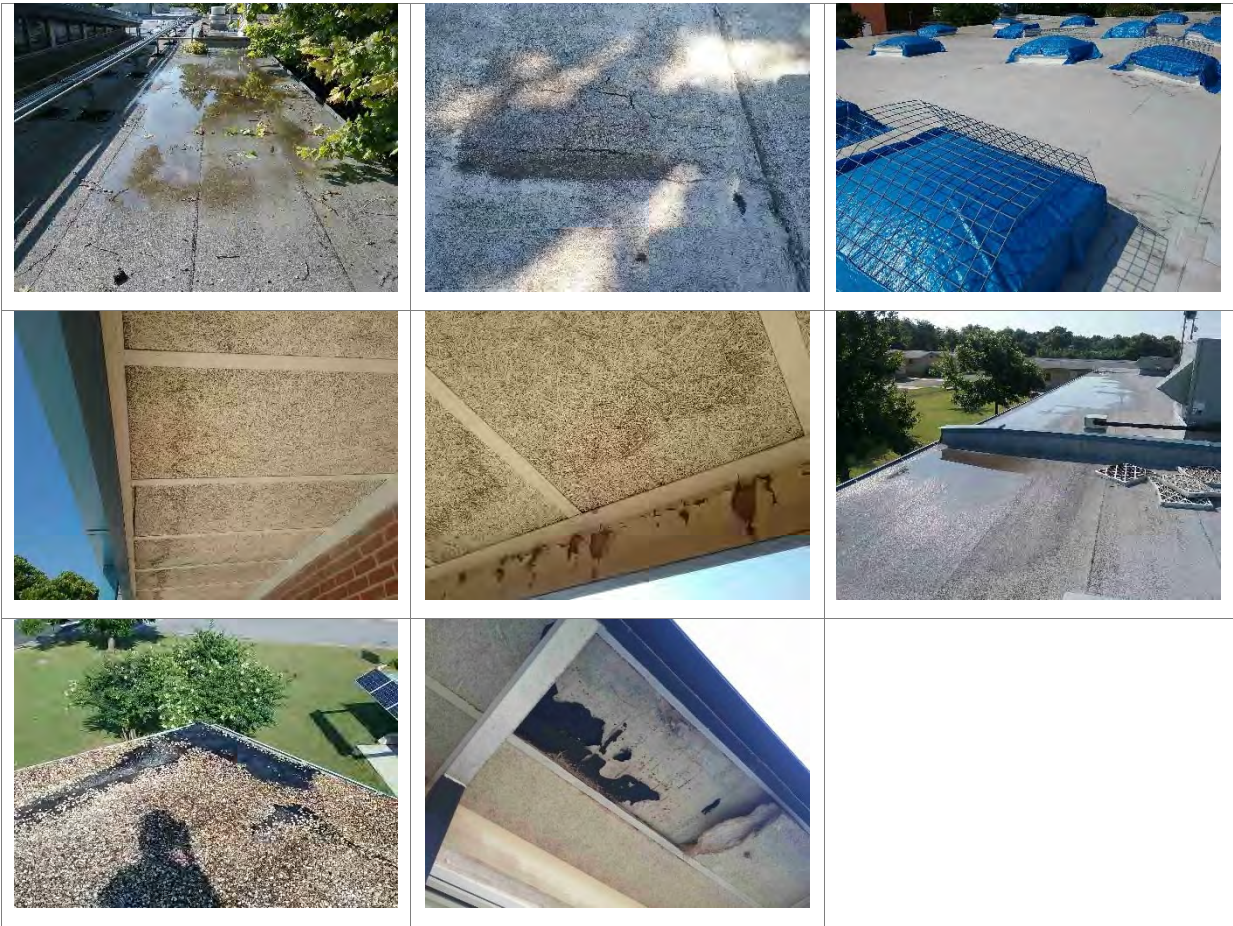
Roofing Deficiency Examples

System	Subsystem	Condition and Deficiency Overview	System Condition Rating
		<p>double height roof, finished with wood wool panels, also appeared to be in good condition.</p> <p>The single ply membrane above the roof appeared to be in nearly new condition. Ripples of dirt were observed to have gathered at the seams and especially near the gutters, but the layers of membrane appeared to be adhered together well. Over the large gym area, 23 skylights were observed to be covered in tarp due to reported leaks. Under the eave of the large gym, a line of water-damaged wood wool was observed. In the same location, the finish on the steel fascia was observed to be peeling significantly. The line of the membrane overlap at the gutter was observed to be located just above the damaged wood wool eave.</p> <p>Ponding was observed at the edge of the built-up roof above the 200-wing and spots of displaced gravel were observed. Underneath the ponding areas, the wood wool paneling of the roof eave was observed to be deteriorating as well.</p>

1. Further investigate reported skylight leaks over the gym. Replacement or reinstallation may be required.
2. Investigate all roof areas observed with standing water in order to re-slope to proper drainage points.
3. Replace gravel where disturbed.
4. Repair or replace all damaged eave panels. Monitor and repair roof leaks as needed to prevent further damage.

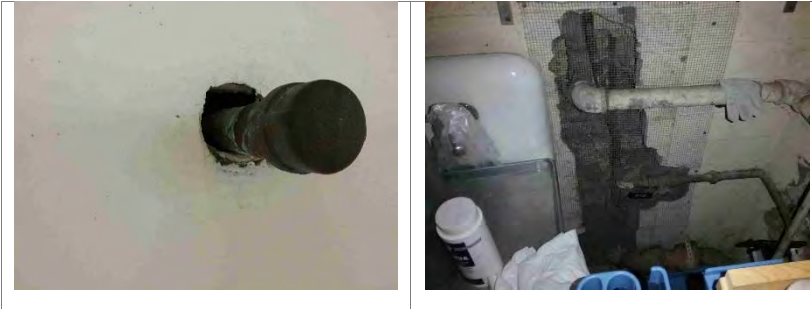
#### Interior Walls

<b>Interior Construction</b>	Interior Walls	<p>The interior partitions are predominately constructed of CMU, glazed masonry units, and brick. Wooden air grilles exist at the base of the classroom partitions adjacent to the main corridors.</p> <p>The interior partitions appeared to be in good condition as no cracking or chipping was observed. Some partitions lack sealant at piping penetrations. In the 100-wing, a partition in the janitorial closet by the female restroom is severely deteriorated with exposed piping beyond.</p>	Good
	Interior Doors	<p>The majority of classroom doors are wooden doors with half glazing of acrylic and knob hardware.</p> <p>It was observed that the wooden doors and finishes throughout the building were faded, and the bases of the doors were showing wear and tear. The acrylic on most classroom doors was observed to be surface scratched, with a few broken panes in total.</p>	Average

1. Repair damaged walls and properly seal around penetrations.
2. Further investigate cause of flooding in room 16. Roof repair or wall repair may be required.
3. Repair chipped concrete in gym corridors.
4. Recondition the surface of faded and worn doors. Consider replacing if reconditioning not possible or not cost effective.

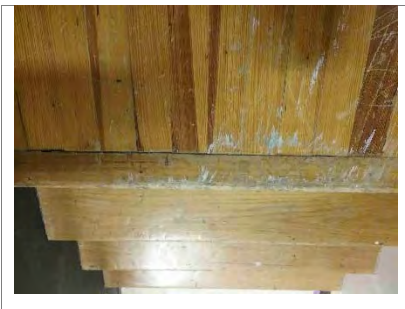
#### Interior Stairs

System	Subsystem	Condition and Deficiency Overview	System Condition Rating
	Interior Stairs	<p>There is one main interior stair system in the building connecting the 100- and 200-wings. It is 90 inches wide with a metal and wood handrail. There is a stair and ramp system in the gym area corridor finished in rubber. There is also smaller wooden stairs in the gym and cafeteria, allowing access to the two stages in the building. Those stairs are 24 inches wide and appear original to the building.</p> <p>The main stair appeared to be in good condition while some of the stage stairs located in the cafeteria appeared to be in average condition. The wood of the stage stairs appeared worn and aged.</p>	Good
Interior Finishes	Interior Wall Finishes	<p>Many of the interior walls of the building are finished with brick, glazed masonry, wood paneling, or paint. The portion of the building serving as the music hall has furred-out partitions of painted gypsum board. The kitchen walls are unfinished beyond the glazed masonry units with which they are constructed.</p> <p>Generally, the wall finishes appeared to be in average condition due to the visible aging of the materials. Most of the wood paneling appeared to be faded from time, and the edges of the wood were observed to be worn or damaged. The age of the materials gave the impression of dinginess in the classrooms. A few spots of discoloration on a gypsum board partition were also observed. A small portion was observed to be roughly patched. A portion of the 400-wing was observed to be missing a fascia.</p>	Average

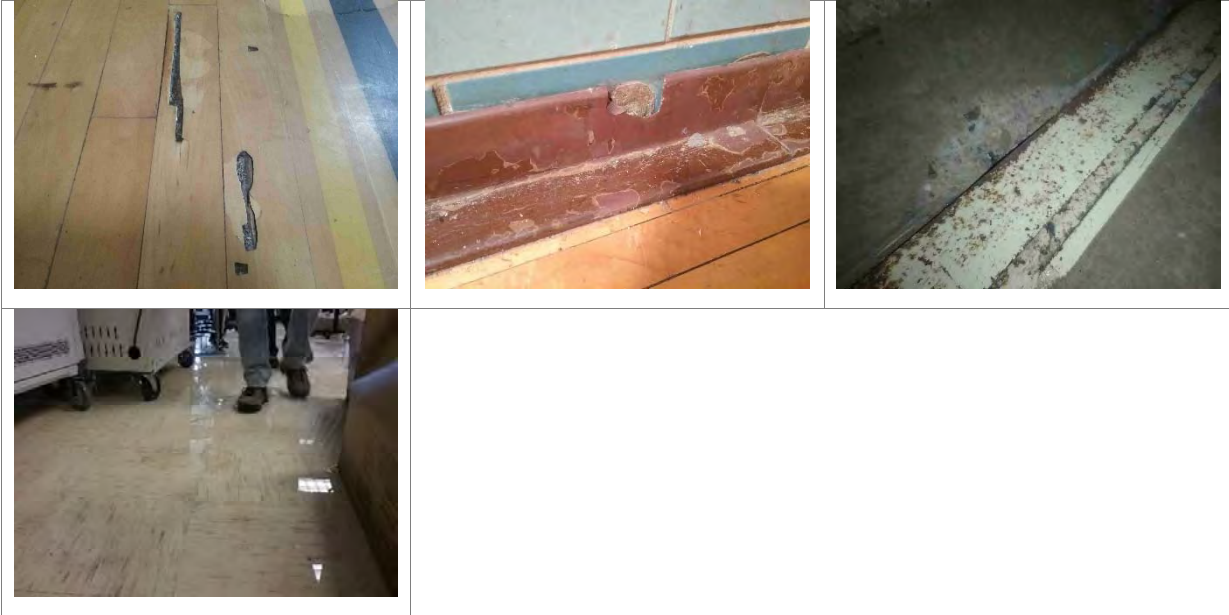
#### Interior Floor Finishes

Interior Floor Finishes	<p>The majority of the building floor is finished in vinyl composition tile (VCT) with rubber base. The gym floors are finished with athletic wood flooring and the administration wing with carpet. The kitchen floor and base is finished in quarry tile.</p> <p>The linoleum and carpet floors were generally in good condition, though a few deficiencies were observed. The carpet in computer room 403 smelled of mildew, and the room was humid. The wood flooring in the small gym was observed to be worn and chipped in places. The wall base of the same room was observed to be discolored and damaged. The concrete floors of the corridors flanking the small gym appeared damaged, missing chunks of concrete.</p> <p>In room 16, a major deficiency was observed. On June 29, 2016, the day after a heavy rain event, the floor of</p>	Good

System	Subsystem	Condition and Deficiency Overview	System Condition Rating
		room 16 was observed to be flooded with a half-inch deep layer of water. The walls and ceiling finishes were found to be dry, and the source of the water could not be determined. It was reported in the interview that the problem had previously been fixed.	
	Interior Ceiling Finishes	<p>The interior ceiling of the building is comprised of lay-in acoustical ceiling tile (ACT) and wood wool panels, including the student restrooms. The kitchen ceiling is comprised of lay-in gypsum board panels.</p> <p>Though the ceilings were generally observed to be well maintained, some missing or damaged tiles were observed throughout the building. Where the ceiling was penetrated by piping or conduit, poor sealing was observed to be common. Water damage was specifically observed to affect a few ceiling tiles in the administration wing, cafeteria corridor and janitorial closets. Some ceiling tiles throughout the building were observed to be bowing or sitting in warped tees, amounting to about 5 percent of the total ceiling system. The ceiling in room 105 was observed to have been cut around a pee trap for the sanitary line, leaving the sanitary line exposed in the classroom. This condition was also observed in the adjacent corridor. In the kitchen, black spots on the ceiling above the dishwashing station were observed, possibly evidence of biological matter. One area near the fire suppression hood was observed to be poorly sealed around penetrations. The ceiling between the gym and music wing is aged more than any other area.</p>	Good

1. Repair chipped portions of small gym floor.
2. Replace damaged rubber base.
3. Investigate source of mildew smell in computer lab. Consider replacing carpet with flooring to match the rest of the school.
4. Replace damaged ceiling tiles and replace discolored tees.
5. Replace acrylic door lites with laminated glass.
6. Repair damaged wood doors, stairs, and panels.
7. Investigate discolored wall in music wing for organic growth or water damage.

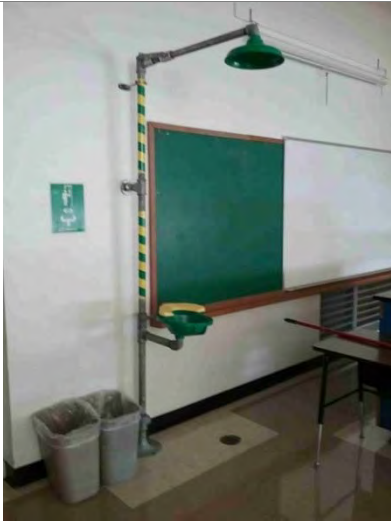
#### Plumbing Fixtures

System	Subsystem	Condition and Deficiency Overview	System Condition Rating
		<p>restroom plumbing fixtures are typically aged but still operational and in good condition.</p> <p>It was reported by facility staff that ten service sinks located in the janitorial closets (i.e., mop sinks) should be upgraded, but no deficiencies were identified. In addition, it was reported by facility staff that the 400-wing male restroom was backing up and flooding, however such conditions were not observed.</p> <p>The building also includes other specialty locations with plumbing fixtures, including a kitchen for the school cafeteria, culinary classrooms with a full-scale kitchen, and home economics classrooms. These plumbing fixtures were observed to be in good condition. Staff interviews indicated there are no shut-off valves to the individual wings of the building, which was confirmed.</p> <p>The eyewash/safety shower stations in rooms 205 and 207 appeared to not be fully functional, as they were missing actuator handles or leaked.</p> <p>Staff interviews indicated problems with piping and floor drains in the kitchen; no drainage issues were observed, however the kitchen was not in use.</p>

1. At the 400-wing male restroom where backups were noted by staff, subsequent to basic flush valve operation and cleaning via drain auger or similar device, investigate the sanitary plumbing with a small “push” camera system for potential blockages or breaks.
2. Repair leaks and missing actuator handles for the eye wash stations in rooms 205 and 207.
3. Consider protecting (i.e., through use of bollards) exposed domestic water pipe entries located at the building exterior, and re-coating corroded pipes.
4. Repair damaged roof leader piping, and provide proper overburden at the exterior of room MU4 and the 100-wing.

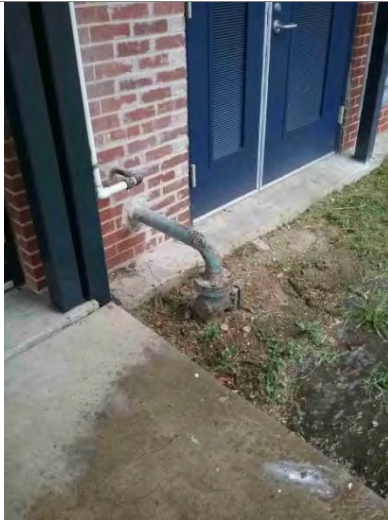
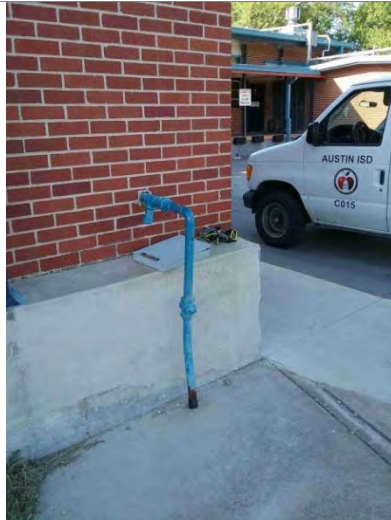
#### Domestic Water Distribution

<b>Plumbing (Continued)</b>	Domestic Water Distribution	<p>Plumbing fixtures in the cafeteria kitchen are serviced by a 75-gallon, 227 MBH gas water heater (GWH), which was found to be in good condition with an estimated ten years of remaining service life. No other plumbing fixtures in the building are believed to be serviced with hot water.</p> <p>Domestic water service piping, where observed (i.e., outdoor ground-to exterior entries) was in fair condition. A corroded pipe entry was observed entering mechanical room AHU-13 (air handling unit-13), and there was a bent, unprotected entry near the loading dock.</p> <p>The plumbing distribution equipment was observed to be in average condition based upon the deficiencies mentioned above.</p>	Average

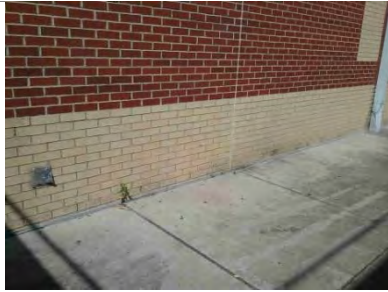
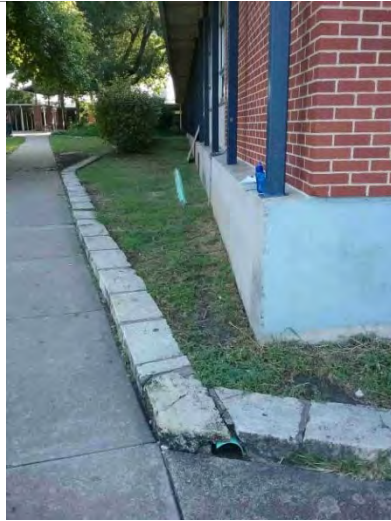
System	Subsystem	Condition and Deficiency Overview	System Condition Rating
	Other Plumbing	Most roof drains appear to be in place and free of debris. Gutters and downspouts generally appear to be in good condition, but there is a dented roof leader and wall vent on the north exterior of room MU4, and, adjacent west of the 100-wing, a buried 6-inch PVC (polyvinyl chloride) roof leader discharge main was exposed, with its outlet cracked and filled with dirt.  Natural gas piping and appurtenances at the building exterior appeared in good functional condition.	Average
Mechanical/ HVAC	The major mechanical equipment consists of packaged modular AHUs located primarily on the roof, with several located in indoor mechanical spaces and mezzanine areas. Package units were found located on the roof top or around the exterior perimeter of the facility. These serve the HVAC system. It should be noted that several HVAC units located in mezzanine areas between floors (i.e., above drop ceilings) were not verified or assessed. In addition, equipment located inside MDF (main distribution frame) rooms is not accessible due to security constraints.  Twenty AHUs, ranging in capacity from an estimated 4,000 CFM (cubic feet per minute) to 10,000 CFM, are located on the roof. Seven other verified AHUs are located throughout the interior of the facility and range from an estimated 4,000 CFM to 12,000 CFM in capacity. Aside from three older, average-condition outside air/heat recovery units on the roof, AHUs at the building were observed to be in good to excellent condition, with most exhibiting smooth sounding operation, a lack of leaks or corrosion, and a manufacture date of 2015.		Good

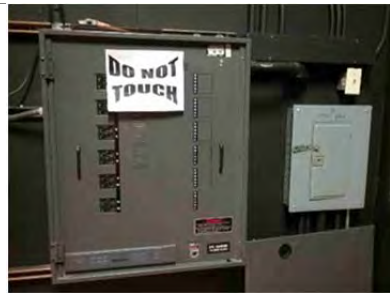
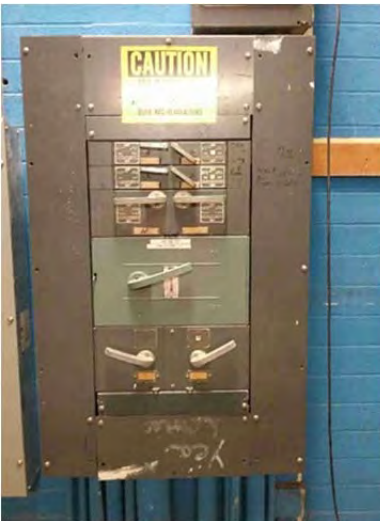
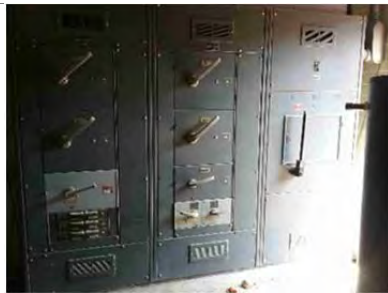
### Electrical Distribution

System	Subsystem	Condition and Deficiency Overview	System Condition Rating
		The facility staff reported that many classrooms are on shared circuits and are under capacity. The distribution transformers in the building were observed to be all hot to touch and generating a lot of humming noise and vibration, which indicated they are either at capacity or possibly overloaded. Facility staff also reported that the kitchen steam table causes frequent breaker trips.	
	Lighting	<p>The building's exterior lighting consists mostly of building mounted HID (high-intensity discharge) floodlights and some LED (light-emitting diode) luminaires that are located under the canopies. The interior lighting consists of primarily T8 fluorescent luminaires. The cafeteria stage lights are by Strand Lighting and appeared to be in good condition. The gym has HID low bay fixtures, which appears to be in good condition.</p> <p>The lighting for the building was observed to be in average-condition. Many interior and exterior luminaires appeared to be aged past their design life. Observed deficiencies include broken lenses, inconsistent color temperatures, and non-functional fixtures. An exposed light switch was observed in the female restroom, which is a safety hazard. There are exit signs present in the building; however during our visit, the power went out and none of the exit lights and emergency egress lights worked. During the power outage, it was observed that there is inadequate emergency egress lighting throughout the school, especially in the corridor areas and in the administration front office area. There are some 2x4 fixtures with integral batteries in the corridors, but these appeared to not provide adequate egress illumination.</p> <p>It was observed there does not appear to be any occupancy sensor/automatic off lighting controls at the facility.</p>	Poor

1. Replace all panelboards and switchboards from the original construction as they are severely aged past typical design life. Remove existing panelboards that are located in corridors and provide new panelboards. Intercept and extend existing loads to new panelboards.
2. Increase size of existing distribution step-down transformers to accommodate classroom 120V electrical loads.
3. Provide additional electrical receptacles where needed, particularly in classrooms at the main school.
4. Verify the condition of telecommunications system/equipment in the main school, as it was inaccessible. Add additional data drops in classroom as requested by the facility staff.
5. Provide main circuit breaker at each electrical service to enable safe working conditions for staff/contractors for doing preventative maintenance/adding loads for the equipment.

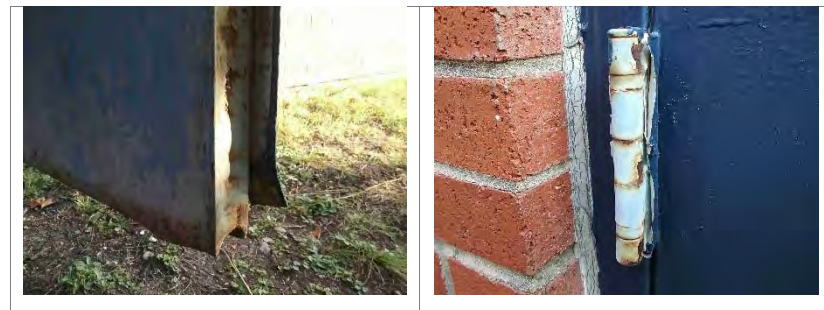
#### Exterior Doors

System	Subsystem	Condition and Deficiency Overview	System Condition Rating
Exterior	Exterior Walls	The exterior walls are constructed with CMU block with a brick wythe on the exterior. The wall is solid on the first level and transitions to slit brick at the top level to allow air flow to the cooling towers.  The exterior face of the wall appeared to be in good condition, even though the building was built in 1970.	Good
	Exterior Windows	System not present.	N/A
	Exterior Doors	There is one pair of metal double doors leading into the ground level of the building. They are 4-foot-wide leafs of painted metal. There is also one manual metal overhead rolling door measuring 9 x 10 feet.  A few signs of rust and scuffs were observed on the double doors, but the interior of the door was observed to be rusted, faded, and scratched. The hinges were also observed to be slightly rusted. The overhead rolling door appeared to be in excellent condition.	Average

1. Clean and recoat metal double doors to prevent rusting and corrosion on them.

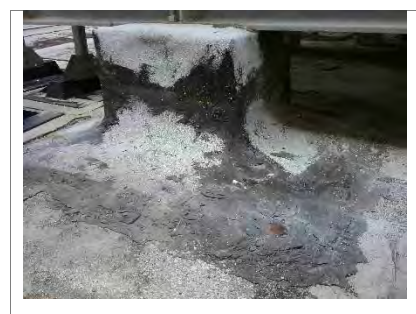
### **Roofing Deficiency Examples**

Roofing	The roofing is composed of asphalt sheeting with no aggregate covering.  The roofing appeared to be in average condition. The asphalt was observed to be cracking and messily adhered together.		Average

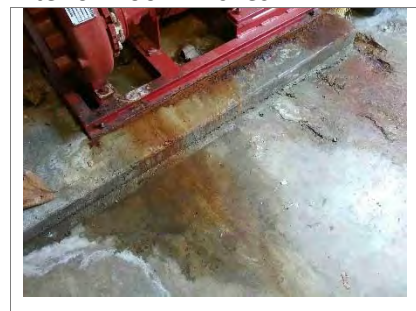
#### Interior Floor Finishes

System	Subsystem	Condition and Deficiency Overview	System Condition Rating
<b>Interior Construction</b>	Interior Walls	There is one interior partition in the building, constructed retroactively. It is constructed of wood studs with unfinished plywood sheathing.  The partition appeared to be in good condition.	Good
	Interior Doors	Subsystem not present.	N/A
	Interior Specialties	Subsystem not present.	N/A
<b>Stairs</b>	Exterior Stairs	Subsystem not present.	N/A
	Interior Stairs	Subsystem not present.	N/A
<b>Interior Finishes</b>	Interior Wall Finishes	Subsystem not present.	N/A
	Interior Floor Finishes	The floor is unfinished concrete slab on grade with concrete curbs for the equipment.  A few spots of corrosion from water and bleeding rust stains were observed on the floor surface. The integrity of the floor appeared to be unhindered by the damage, though cosmetically it was poor.	Average
	Interior Ceiling Finishes	Subsystem not present.	N/A

1. Clean and repair stained and damaged areas of the concrete floor.

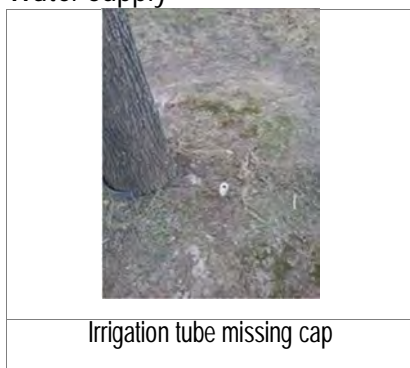
### Water Supply

System	Subsystem	Condition and Deficiency Overview	System Condition Rating
Site Utilities	Water Supply	<p>The water supply system is in average condition. On the east side of campus, the irrigation caps are missing for several of the trees. This will cause a pressure issue, and the landscaping will not get the irrigation it needs to survive. On the north east side of campus, toward the front entrance, there is an exposed pipe along the building wall.</p> <p>Water Supply Deficiencies:</p> <ul style="list-style-type: none"> <li>Missing irrigation caps</li> <li>Exposed pipe.</li> </ul>	Average
	Sanitary Sewer	<p>The portion of the sanitary sewer system that was observed is in average condition. No fiberglass sanitary sewer inspection box was found. There is a manhole on the east side of campus that needs a cover.</p> <p>Sanitary Sewer Deficiencies:</p> <ul style="list-style-type: none"> <li>No fiberglass sanitary sewer inspection box was found.</li> <li>There is a manhole on the east side of campus that needs a cover.</li> </ul>	Average

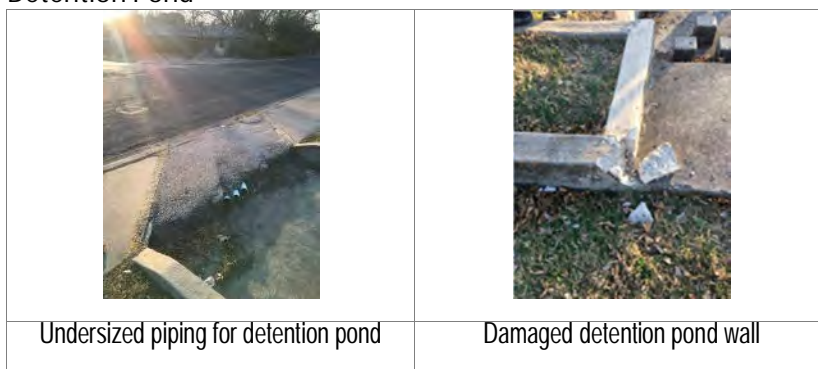
### Detention Pond

Storm Sewer	<p>There is an underground drainage system that collects storm water via area inlets or curb inlets. The underground drainage system is in average condition.</p>	Average
	Detention Pond	<p>The detention pond is located on the south side of campus and releases into Doris Drive. The pond is very shallow and, based on staff comments not large enough for the capacity of water entering it. The pond discharge has been limited to three small pipes. The campus has serious drainage damage and issues and further study is warranted to solve the problem.</p> <p>Detention Pond Deficiencies:</p> <ul style="list-style-type: none"> <li>Flooding upstream from the pond.</li> </ul>	Poor
	Other Site Mechanical Utilities	<p>Exterior lighting is provided for the track and football field. There is no lighting for the parking lots or areas around the portables.</p> <p>The electrical pole toward the back side of the open grass area, on the east side of the campus, has a missing U-strap, causing the electrical box to sway in the wind. Another box pole in the same area is missing the cover, exposing the wires.</p> <p>Other Site Mechanical Utilities</p> <ul style="list-style-type: none"> <li>The electrical connections require maintenance.</li> </ul>	Average

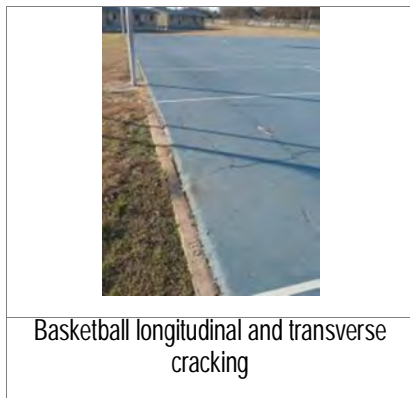
### Basketball Courts

System	Subsystem	Condition and Deficiency Overview	System Condition Rating
Playfields	Basketball Courts	<p>The basketball courts are in poor condition. There are severe cracks throughout the surface and need resurfacing. The nets for the goals are either nonexistent or in poor condition. The coach reported this is because the community often steals the basketball nets.</p> <p>Basketball Court Deficiencies:</p> <ul style="list-style-type: none"> <li>Entire court needs resurfacing</li> </ul>	Poor
	Tennis Courts	The tennis courts were resurfaced two years ago and are in good condition.	Good
	Soccer/Multi-Purpose Field	<p>The soccer/multi-purpose field is a grass field. The grass appears to be well kept. There are low spots and dips in the center of the field from over compaction due to use. Irrigation tubes are reported to stick out around the field. There is an exposed irrigation box that needs a cover around the perimeter of the field. The soccer/multi-purpose field is in average condition.</p> <p>Soccer Field/Multi-Purpose Field Deficiencies:</p> <ul style="list-style-type: none"> <li>Dips in the field</li> <li>Irrigation box needs cover</li> <li>Irrigation tubes are reported to stick out around the field.</li> </ul>	Average

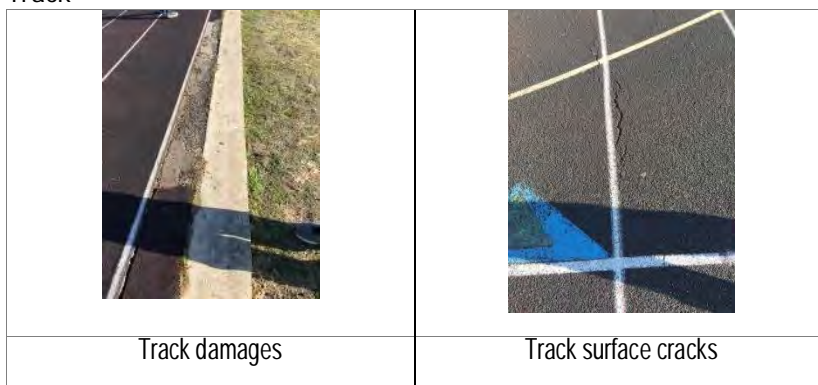
### Track

Baseball/Softball Field	System not present.	N/A
	Bleacher Seating	System not present.	N/A
	Track	The track is in poor condition. The track is a rubber material.	Poor

System	Subsystem	Condition and Deficiency Overview	System Condition Rating
		<p>The edges of the track are falling off and have major cracks around the entire perimeter. The interior portions of the track have minor cracking and repair patching throughout.</p> <p>Track Deficiencies:</p> <ul style="list-style-type: none"> <li>• Perimeter of track severely damaged</li> <li>• Interior of track shows minor cracking and repair patching</li> </ul>	
	Green Space	<p>The green spaces are in average condition. Some areas need revegetation to minimize erosion.</p> <p>Green Space Deficiencies:</p> <ul style="list-style-type: none"> <li>• Drainage damage</li> </ul>	Average
	Football Field	Part of soccer/multi-purpose field.	N/A
	Playscapes	System not present.	N/A

1. Repair perimeter of track.
2. Repair/Resurface track.
