Covington Middle School Site Summary

Address	3700 Convict Hill Road Austin, TX 78749
Number of Permanent Campus Facilities	3
Original Year of Construction	1986
Total Campus Building Area (combined)	173,867 SF

Introduction

Main School Building – BLDG-057A

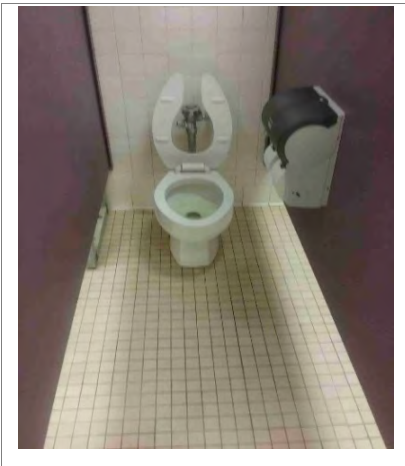
System	Subsystem	Condition and Deficiency Overview	System Condition Rating
Plumbing	Plumbing Fixtures	<p>This building has male and female public restrooms along with separate public male and female restrooms in the administration area. The public restrooms for the students are on the first and second floors. The urinals are wall-hung, vitreous china. The toilets are also vitreous china, and the faucets are manual. The toilets and urinals have manual flush valves.</p> <p>The plumbing fixtures were in poor condition. There were many toilets and urinals that did not flush well, specifically in BRR114. The toilets in the male and female public restrooms on the first floor had low water pressure. The toilet furthest from the public male restroom entrance on the first floor did not flush properly. The water for the open area faucet took an extended period of time to become warm during the assessment. The kitchen fixtures also did not have hot water.</p>	Poor

1. Repair the toilet in BRR114.
2. Address water pressure issues in the public male and female restrooms on the first floor.
3. Repair male and female locker room sinks per the facility interview notes.
4. Repair/replace plumbing in the two restrooms by the janitorial office and gymnasium per the interview notes.

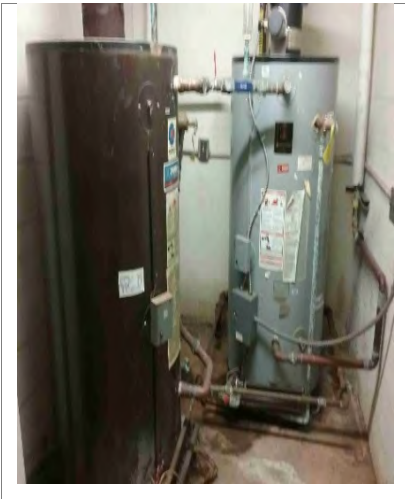
Domestic Water Distribution	<p>There is an electric water heater located near the cafeteria and two gas water heaters in the kitchen area. The public restrooms in this building do not have hot water.</p> <p>The electric water heater just outside of the main building was observed to be in good condition. The water heaters in the main mechanical room were aged and corroded and in poor condition. The water in the teacher's lounge had to run for at least thirty seconds before the water began to become warmer.</p>	Average
	Other Plumbing	<p>There are floor drains located in the mechanical rooms, restrooms, kitchen area, and other locations throughout the building. The floor drains in this building are functional, and it does not have any observed water collection near the fixtures.</p> <p>The floor drain serving the two water heaters in the main mechanical room was old and dirty, but the floor drains throughout the building were observed to be in good condition overall.</p>	Good

1. Continue preventive maintenance on aged plumbing fixtures and plan for replacement in the future as fixtures continue to age in the facilities.
2. Plan to replace water heaters as the typical design service life is 10 to 15 years.
3. Repair the gutters throughout the facility per the facility interview notes.

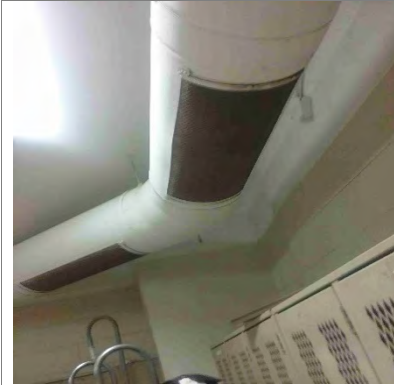
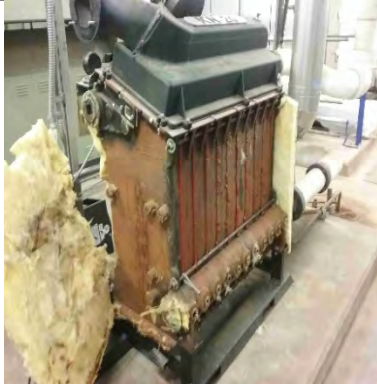
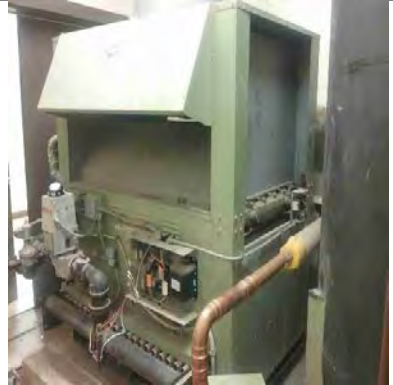
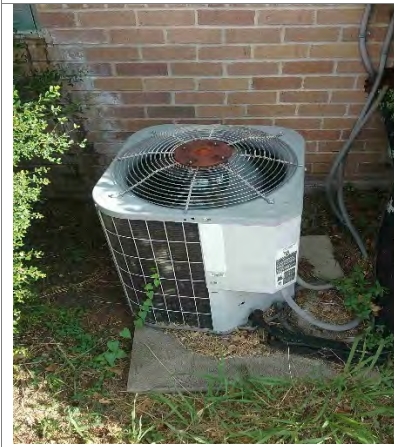
Mechanical/HVAC System Deficiencies

Mechanical/ HVAC	<p>The mechanical equipment primarily consists of water-sourced heat pumps located above the ceiling and in the mezzanine, two cooling towers, and boilers. There is also single condenser unit on the building exterior near the lounge area.</p> <p>The mechanical system was in average condition. The grilles on the duct in the football locker room were corroded and worn. The locker room was observed to be relatively warm as well. It was stated in the interview notes that there was no a/c or heat in the football locker room. The boilers next to the main building mezzanine and gymnasium looked aged and in need of replacement. The boilers</p>		Average

System	Subsystem	Condition and Deficiency Overview	System Condition Rating
		in the main mechanical room were observed to be in average condition. The condenser near the lounge area on the building exterior is aged and corroded.	
Fire Protection	Fire Alarm	<p>The building has a fire alarm system that consists of alarm and signaling devices such as horns/annunciators, strobes, horn/strobe combinations, pull stations, and detectors. The fire alarm system is controlled by a Silent Knight 5820XL control panel.</p> <p>The fire alarm system was in average condition. The fire alarm control panel appeared to be in poor condition, as several recent "failed" inspection tickets were observed posted on the inside of the panel door. However, the fire alarm end devices appeared to be in good condition.</p>	Average
	Fire Protection/Suppression	<p>The building does not have a fire suppression system. The building is protected by portable fire extinguishers placed throughout the facility.</p> <p>All observed portable fire extinguishers had inspection tags dated within the last year.</p>	N/A

1. Replace the condensing unit on the building's exterior.

2. Replace boilers located next to the mezzanine.
3. Replace the boiler serving the gymnasium per the facility interview notes.

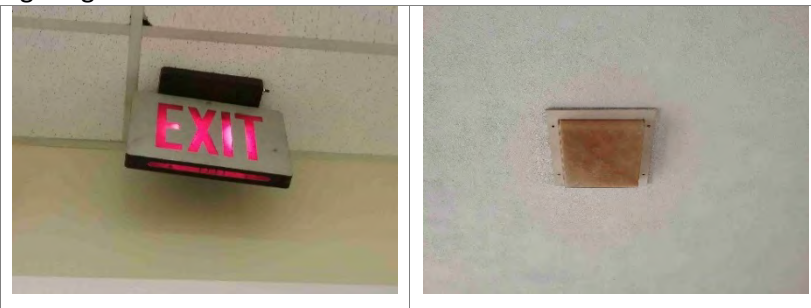
System	Subsystem	Condition and Deficiency Overview	System Condition Rating
		All observed portable fire extinguishers had inspection tags dated within the last year.	
Electrical	Electrical Distribution	The electrical service enters the building at the 277/480-volt 600-amp distribution switchboard 'DP6' located in the electrical room. 'DP6' feeds transformers and branch circuit panelboards located in various electrical rooms throughout the building. The building does not have a lightning protection system. The electrical distribution equipment appeared to be in good condition.	Good
	Lighting	The interior lighting consists of 2x4 fluorescent-lensed fixtures and 2x4 fluorescent parabolic fixtures. The parabolic fixtures are in the classrooms. The emergency lighting appears to be accomplished by emergency battery packs in select 2x4 fixtures. The lighting for the building appeared to be in average condition. About 20% of the interior light fixtures appeared to be aged past their typical design service life. Observed deficiencies included broken lenses, inconsistent color temperatures, and non-functional fixtures. The exit signs and lighting units present in the building appeared to be from the original construction. It was reported that the light fixtures that are in the canopy leading from BLDG-057A to BLDG-057C needed replacement.	Average

1. Replace the light fixtures that are in the canopy leading from BLDG-057A to BLDG-057C with new LED light fixtures.

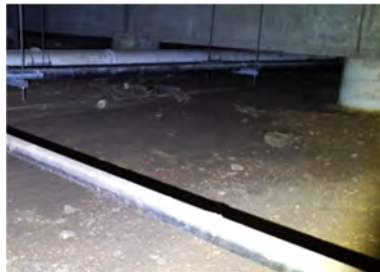
Damp soil around perimeter of building

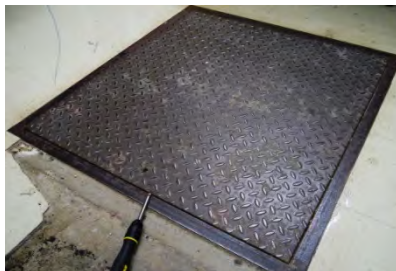
Missing floor hatch handle

1. Remove dirt and debris from the concrete flumes.
2. Improve crawl space ventilation.
3. Replace the missing handle on the floor access hatch in the gym storage room so hatch is operable.

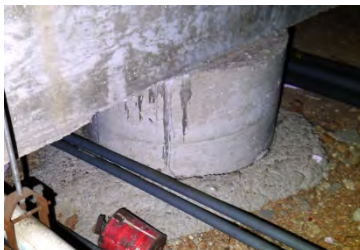
Mushrooming concrete at top of pier

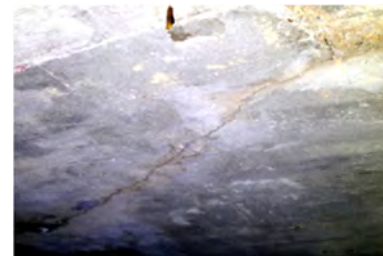
Crack in slab at corner of hatch opening

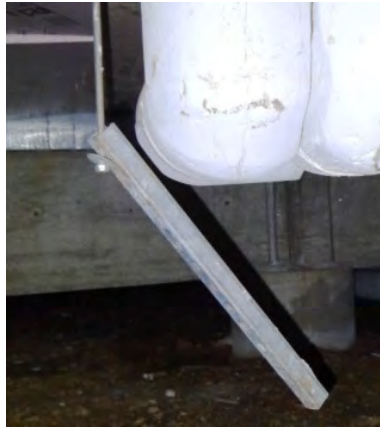
Broken pipe support

1. Replace severely rusted pipes and hangers, clean other rusted areas on pipes & protect from further corrosion
2. Replace broken pipe hangers.
3. Replace fallen rigid board insulation.

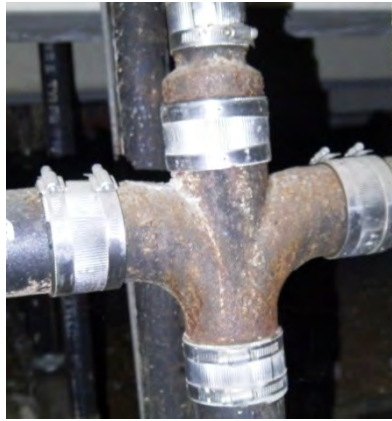
Rusted cast iron pipes

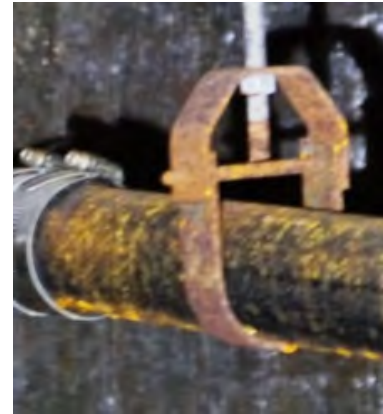
Rusted pipe hangers
