Dobie Middle School Site Summary

Main School Building – BLDG-055A

Stand-Alone Classroom Building – BLDG-055B

Site/Civil Assessment

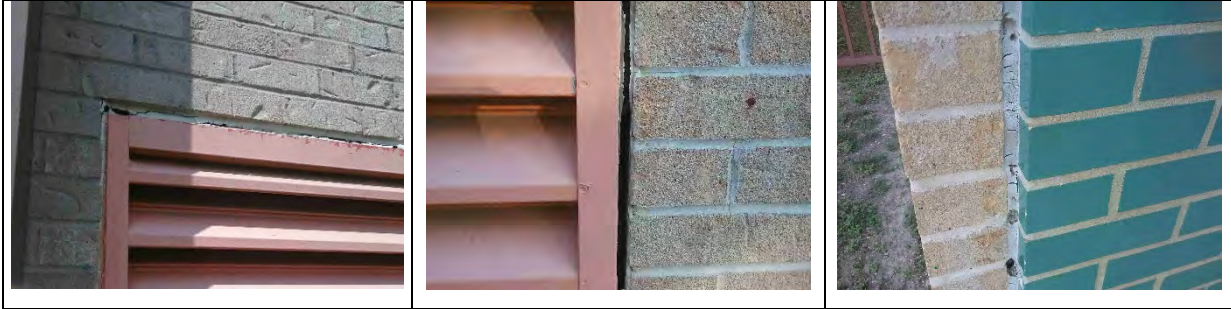
System	Subsystem	Condition and Deficiency Overview	System Condition Rating
Exterior	Exterior Walls	<p>The exterior of the main building is brick veneer. Some walls have a plaster fascia that projects beyond the face of brick. There are brick fin walls that are partially covered with plaster. Glazed brick is integrated in the brick walls at the newer band room addition.</p> <p>The brick façade appeared to be in good condition. Plaster surfaces will need paint in the future but appeared to be in good condition. Sealants around windows and louvers were dry and cracked. Pest intrusion was reported in the kitchen, administration offices and above the ceiling tiles.</p>	Good
	Exterior Windows	<p>The exterior windows are aluminum framed single-glazed units with operable sashes and painted spandrel panels. The window system is original to the building.</p> <p>The windows are still functioning and in average condition relative to their age. The sealant around the windows appeared dry and cracked, and the spandrel panel paint was observed to be peeling.</p>	Average

1. Replace all deteriorated sealant and caulking on the exterior walls, especially at the window frames and louvers.
2. Seal any cracks or penetrations at the exterior walls that would allow pests to enter the building.
3. Repaint exterior window spandrel panels.
4. Replace exterior doors that have corrosion.

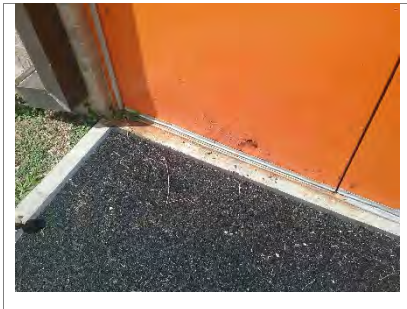
Exterior Doors	<p>The exterior doors are steel with metal frames. Entry doors have side lites and transoms that are single glazed. Some doors to mechanical rooms have louvers.</p> <p>The doors and frames are in average condition and most have been recently painted. One exterior door was observed with significant corrosion and holes near the bottom of the door.</p>	Average

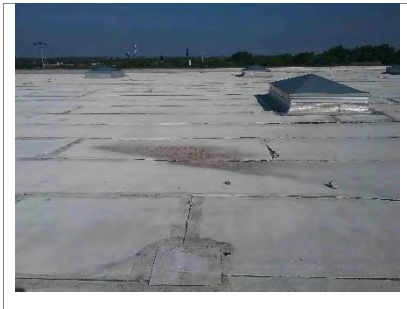
Roofing Deficiency Examples

System	Subsystem	Condition and Deficiency Overview	System Condition Rating
Roofing		<p>The majority of the original portion of the main building roof is built-up with gravel. Subsequent additions to the building, such as the band room and the roof over both gymnasiums, are a modified bitumen. Pre-formed and finished metal roofing is found at the roof edges and serves as part of the parapet and exterior wall fascia.</p> <p>The built-up roof appeared to be aged past its expected service life. No significant ponding was evident, and the roof is reported to drain well. Flashing and counter-flashing appeared to be in good condition. The built-up roof appeared to be functioning average to its age. The modified bitumen roof surfaces are nearing the end of their service life and showing signs of cracking. No significant leaking is reported, and none was observed. It is reported that the roof over the band room leaks during rain events although no evidence was observed.</p>	Average

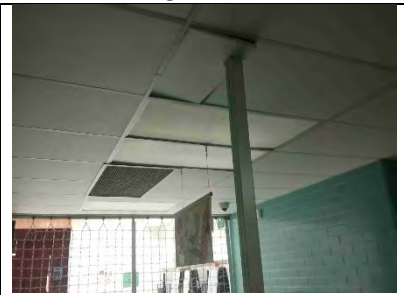
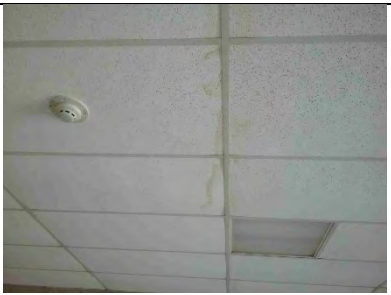
Interior Ceiling Finishes	The majority of the main building's ceiling is suspended lay-in acoustical tile. The locker room and shower areas have painted gypsum board. Gymnasiums have painted exposed steel structure and cement-fiber deck. The band room and theater have acoustical panels attached to walls. Ceilings appeared to be in good condition. A few tiles in the kitchen were falling out of the grid, and there is minimal staining of tiles throughout the building from roof or mechanical equipment leaks.	Good
Conveying	BLDG-055A has an elevator that services handicapped for both floors of the main structure. Although functioning as intended, this elevator showed evident signs of wear and tear. This unit was reported that it may not be ADA compliant.		N/A
Plumbing	Plumbing Fixtures	The building has single- and multi-user restrooms for students and staff located throughout the facility. These restrooms typically contain floor-mounted, vitreous china toilets with manual flush valves along with wall-mounted vitreous china urinals in the male restrooms. It was reported that some of the toilets on the east end of the second floor have downstream clogging issues, but	Average

1. Replace damaged floor tile in room 216.
2. Repair the ceiling grid system and replace the missing ceiling tiles in the kitchen.
3. Continue to maintain athletic flooring and monitor proper environmental conditions in the large gym.

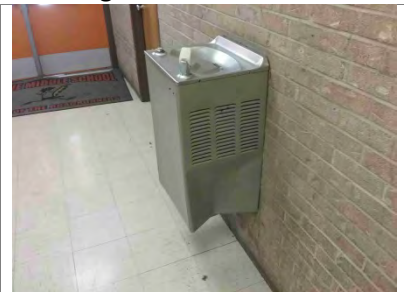
Plumbing Fixtures

System	Subsystem	Condition and Deficiency Overview	System Condition Rating
		<p>this was not observed during the assessment. The facility has multiple styles of sinks, which include counter-mounted stainless steel sinks with manual faucets, counter-mounted vitreous china sinks with manual faucets, wall-mounted vitreous china sinks with manual faucets, and floor-mounted multi-bowl stainless steel sinks that were located throughout the kitchen. Water coolers were located in the corridors throughout the facility, typically near restrooms. The water cooler in COR2 was observed with a large dent in the housing of the unit. Locker rooms contain multi-user stainless steel shower fixtures, all of which appear to be in average condition. Some of the classrooms on the second floor of the building have counter-mounted stainless steel sinks with hot water supplied to them. Apart from the kitchen and the janitorial closets, these were the only fixtures observed with a hot water supply.</p> <p>It was reported that all of the plumbing fixtures are original to the facility and are deteriorating. The plumbing fixtures did appear to be aged, but apart from typical wear and tear, no deficiencies regarding functionality were noted, and the system is rated in average condition.</p>

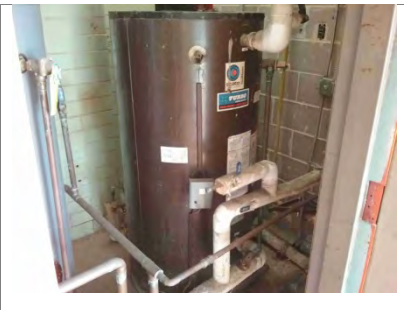
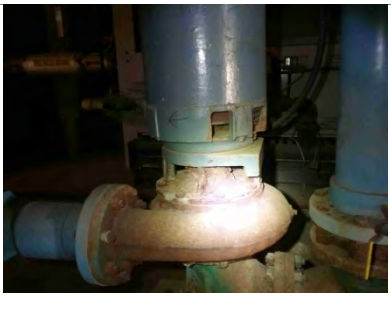
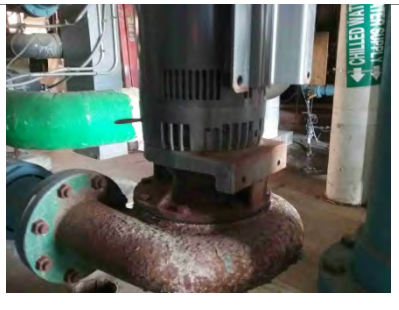
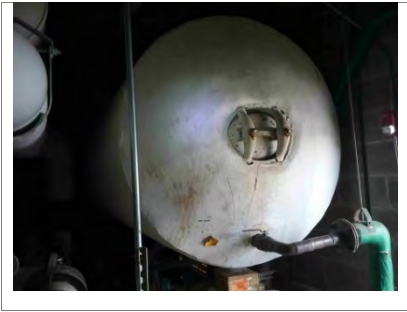
Domestic Water Distribution	<p>Domestic hot water is provided to the kitchen by two 100-gallon GWHs (gas water heaters) located in the MECHKIT room. One of these GWHs was manufactured in 1988 and was observed to be in poor condition nearing the end of its service life with excessive corrosion. It was reported that the kitchen experiences frequent hot water problems, possibly caused by the poor functionality of the water heaters.</p> <p>A 119-gallon EWH (electric water heater) was observed in MATHWKRM. This unit was observed to be in good condition and is believed to serve hot water to some of the second floor classroom sinks. A 30-gallon EWH was located in a closet near BKRM2 and was observed to be in good condition.</p> <p>In the MAINMECH room, the three chilled water pumps all appeared to be in average to good condition showing signs of normal wear and tear. It was reported that the cold water pumps are old and reaching the end of their service life. After the assessment, it was confirmed that these two cold water pumps were in poor condition with severe corrosion and should be replaced in the near future. The hot water pump appeared to be well</p>	Poor

System	Subsystem	Condition and Deficiency Overview	System Condition Rating
		<p>maintained and was in average condition. A large asbestos water storage tank was also observed in the MAINMECH room, which will need to be removed.</p> <p>The domestic water distribution system is in poor condition with all of the deficiencies that were noted. Most of the equipment seemed aged and had significant wear and corrosion.</p>	
	Other Plumbing	<p>The roof had multiple circular cast iron roof drains ranging in size from 8 to 12 inches in diameter. All of the roof drains appeared to be free of debris, with minor wear and tear, and in average condition.</p> <p>It was reported that there are no floor drains for janitorial staff. After the assessment, the number of floor drains appeared to be adequate in restrooms, locker rooms, etc. and were in average condition. The other plumbing is rated in average condition with no serious deficiencies observed.</p>	Average

1. Replace the GWH in the MECHKIT room, which is near the end of its service life and has reported frequent hot water problems in the kitchen.
2. Repair or replace the damaged water cooler in COR2.

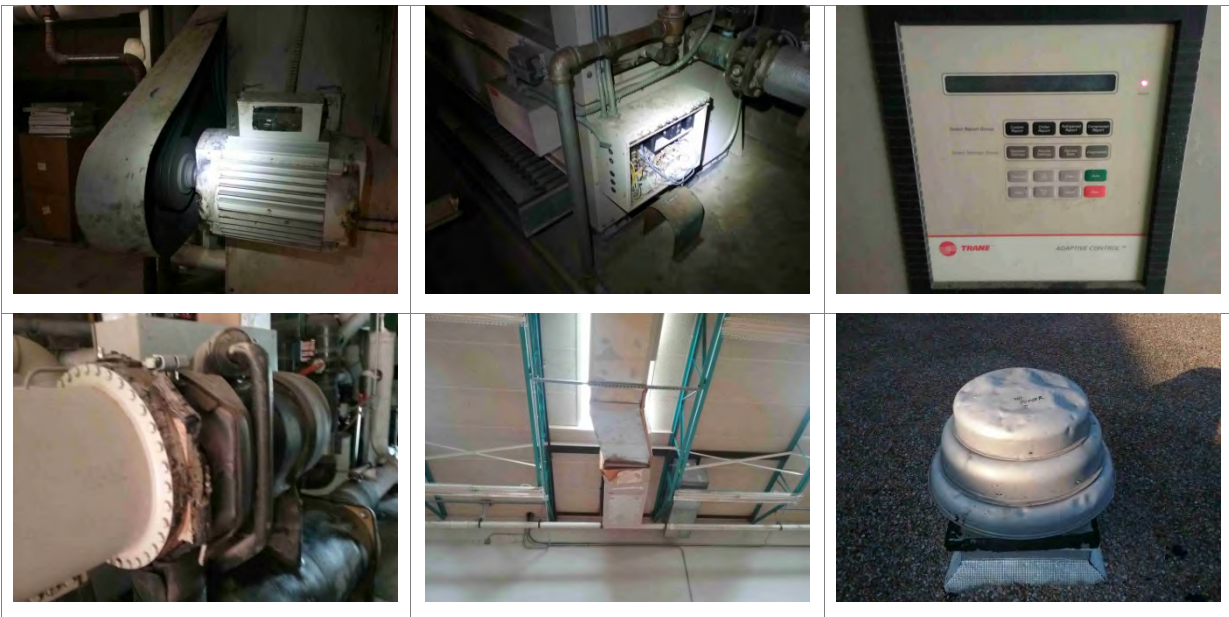
Mechanical/HVAC System Deficiency Examples

Mechanical/ HVAC	<p>The building's HVAC (heating, ventilating, and air conditioning) system is composed of package RTUs (roof top units), split systems, and indoor modular AHUs (air handling units). The RTUs range in size from 6-TON to 20-TON. All of these package units were manufactured in 2005 and 2006 and were observed in average to good condition. It was reported in the interview that there are humidity/moisture problems in the library and gymnasium but the issue was not observed during assessment. Apart from typical wear and tear, the only visible deficiency was that six of the seven RTUs were charged with R22 refrigerant. This refrigerant is being phased out of use in mechanical equipment.</p> <p>The majority of the modular AHUs located throughout the facility had nameplates that were not visible, so size and manufacturer data were not collected. These AHUs have an estimated manufacturing date of 2000 and were observed in average to poor condition. One of the AHUs located in the AHU-11 MECH room appeared to be original to the facility and was in poor condition. This unit has surpassed its service life, and the motor for this unit had exposed moving belts, which create safety concerns.</p> <p>It was reported that the cooling tower located on the roof above the mechanical room is aged and reaching the end of its service life. The cooling tower was observed as having only typical wear and tear but appeared functional and in average condition.</p> <p>In the MAINMECH room, the two gas hot water boilers are reported as being original to the facility and reaching the end of their service life. Further investigation confirms that these units appeared to be aged and in poor condition. One of the boilers, in addition to corrosion, had exposed electrical wiring, which is a safety concern. The two chillers located in the MAINMECH room use R22 refrigerant and appeared to be aged beyond their service life. Both of the units were in poor condition and had excessive noise coming from them. One of the</p>		Poor

System	Subsystem	Condition and Deficiency Overview	System Condition Rating
		<p>chillers was observed to be in alarm mode indicating a possible shut-down. It was reported that the HVAC ductwork was original to the facility and had no known problems. The ductwork appeared to be in average condition with only typical wear and tear. The only ductwork deficiency observed was in the small gymnasium where the ductwork was separated and unsealed.</p> <p>Supplemental mechanical equipment for the HVAC system includes EFs (exhaust fans) and MUAs (modular makeup airs). The EFs on the roof were in average to poor condition with hail damage visible on a significant amount of units. In addition to the hail damage, one of the roof top EFs had no power supplied.</p> <p>The mechanical and HVAC system for the facility is in poor condition with a significant amount of repairs and updating required for the equipment.</p>

1. Consider replacement of aged boilers, chillers, cooling tower, and cold water pumps, which all have significant wear and tear and are near or beyond the end of their service life.
2. Address any problems with the chiller in the MAINMECH room that had an alarm light illuminated.
3. Replace the asbestos-cement water tank that is located in the MAINMECH room.
4. Repair the ductwork in the small gymnasium so that it is sealed and does not have any leaks.
5. Consider investigating the cause of excessive humidity in the reported rooms in the facility.

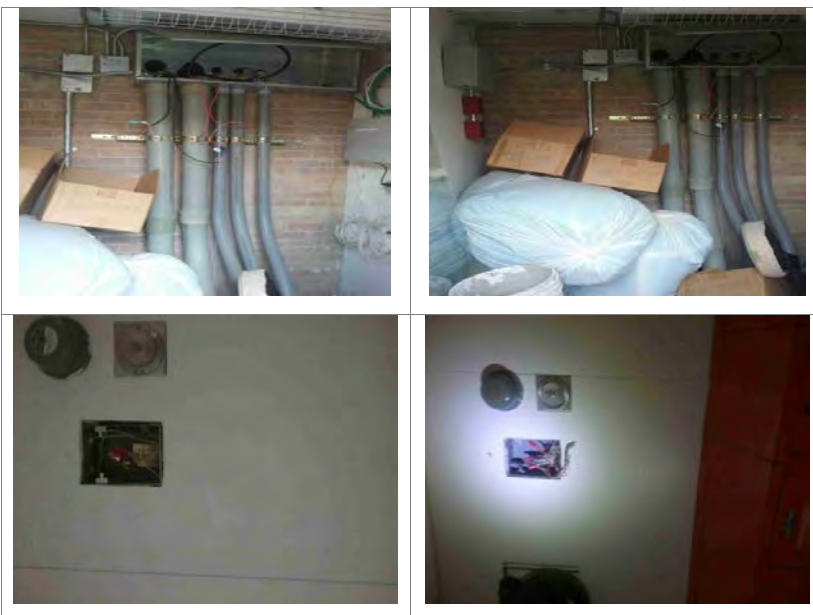
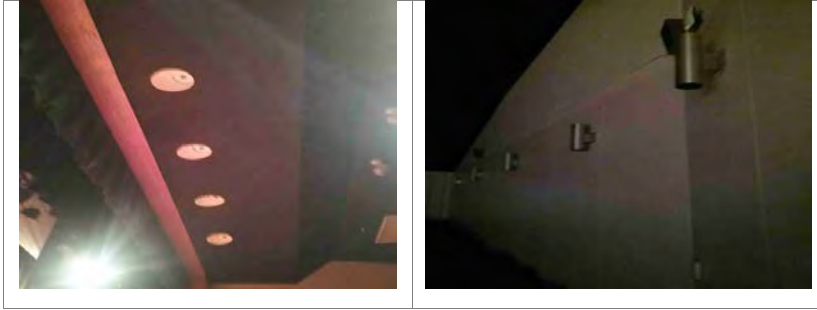
Electrical System Deficiency Examples

Electrical	Electrical Distribution	<p>The electrical service enters the building at 277/480-volt with 2000 max amps 3-phase 4-wire service observed on the main switchboard. Immediately adjacent to this service was a 600 max amp motor control/MMC switchboard also located in the MainMech room that was perceived as supporting mechanical aspects located in this same room. The electrical service includes 800-amp and 600-amp transfer switch panels within this service system. Eight other transformers 75 kVA and below to 30 kVA and greater complete this service for BLDG-055A. This system also includes high-voltage panels that are rated at 480-volt primary that step down to a secondary 208Y/120 located in various rooms throughout BLDG-055A.</p> <p>The assessment confirmed electrical equipment components in rooms designated on the floor plan as</p>	Average

System	Subsystem	Condition and Deficiency Overview	System Condition Rating
		<p>rooms MainMech, MainElec/Boyseqrm, OSST02, AHU10, 117STO/Theatre Room, StageCC, Stgvest2, MechElev, MechKit, Elec3, AHU8 Mech, Elec2elec, AHU4Mech, CC200Wcust, and AHU2mech for both floors of this facility. The electrical equipment and distribution services observed were in good working order with minor items of concern to report with regard to older original equipment in line along with newer equipment supporting the service distribution to this facility. Equipment that was observed as being original to the building's construction was considered average due to its age only, although it was functioning as intended. There was no emergency power supply to report at this facility. A lightning protection system was not present at this facility.</p> <p>The eastern-most corridor of this facility contained wiring boxes that require covers placed over exposed wires.</p>

1. Room OSST02 needs a wire enclosure sealed up and any loose wiring secured immediately.
2. Close and seal electrical boxes where wire is left exposed in the farthest east corridor of this building.
3. Maintain electrical rooms where floor-mounted transformers are located and remove any dust or debris that may be present at these locations.
4. Replace and secure junction box covers throughout BLDG-055A.
5. Remove all unused lighting fixtures or electrical components that may be abandoned along BLDG-055A outer walls.

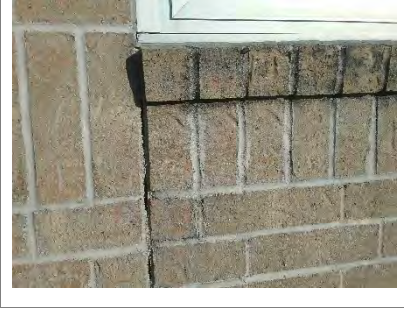
System	Subsystem	Condition and Deficiency Overview	System Condition Rating
Exterior	Exterior Walls	<p>The exterior walls are brick veneer over steel structure. The building may have been constructed in two phases as evidenced by different roof colors, an internal masonry wall, and a joint in the foundation of the building (note: there is a slight difference in finish floor elevations between the two halves of the building).</p> <p>The brick façade was observed to be in good condition. Sealant appeared to be dry and cracked. Due to the stained ceiling tiles at the north side of the internal masonry wall, leaking is suspected along the parapet.</p>	Good
	Exterior Windows	<p>The exterior windows are aluminum frames with single pane glazing and operable sashes.</p> <p>The windows and sealant were observed to be in good condition.</p>	Good
	Exterior Doors	<p>Exterior doors and frames are an aluminum storefront system.</p> <p>The doors and frames were observed to be in good condition, but the doors at both entrances do not function properly. The doors either do not close or do not latch properly.</p>	Good

1. Repair exterior entrance doors so that they operate and close properly.
2. Replace all deteriorated sealant and caulking on the exterior walls

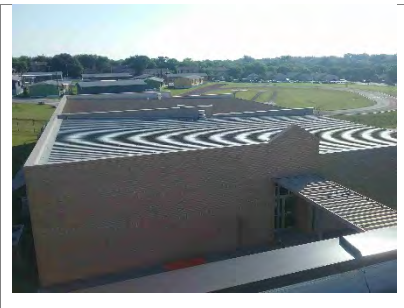
Roofing Deficiency Examples

Roofing	<p>The building roof is a low slope, pre-finished standing seam roof system. The building has parapets at the north and south ends and one internal mid-length of the building. There is a continuous gutter with downspouts along the east side. There is a metal walkway canopy that connects to the main building.</p> <p>The metal roof system appeared to be in good condition as observed from the adjacent building roof level. There are reported leaks and observed staining on walls and ceilings on the interior of the building along the north side of the internal</p>		Good

System	Subsystem	Condition and Deficiency Overview	System Condition Rating
		parapet. Water was observed pooling in a light fixture in room A6. Water may be entering where the roof intersects the parapet wall. The walkway canopy was observed with debris that needs to be removed.	
Interior Construction	Interior Walls	The interior walls are gypsum board over metal framing. There is a solid masonry interior wall that bisects the building and penetrates the roof plane. The interior walls were observed to be in good condition.	Good
	Interior Doors	The interior doors are solid core wood with metal frames. Classroom doors have vision panels. The interior doors and frames appeared to be in good condition and were observed to operate properly.	Good
	Interior Specialties	System not present.	N/A
Stairs	Exterior Stairs	System not present.	N/A
	Interior Stairs	System not present.	N/A
Interior Finishes	Interior Wall Finishes	The interior gypsum board walls and brick walls are painted. Restroom walls have ceramic tile wainscoting on walls. Wall finishes were observed to be in good condition. Minor repainting is needed after the roof/parapet leak is repaired.	Good

1. Determine the source of rainwater entering the building along the internal parapet wall and repair any penetrations to the building envelope.
2. Remove debris from the walkway canopy.

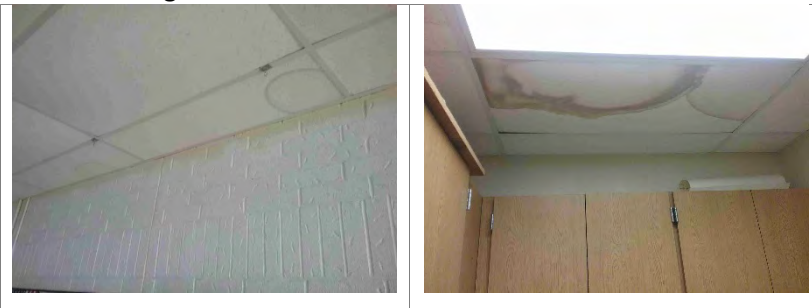
Interior Floor Finishes	The interior floors are vinyl tile with a 4-inch vinyl base. The restrooms have ceramic tile and base. Interior floor finishes appeared to be in good condition.	Good
	Interior Ceiling Finishes	The interior ceilings are suspended lay-in acoustical tile. The ceilings were observed to be in good condition. Staining of tiles is evidence of roof/parapet leaks along the internal brick wall. There is a leak, possibly related to mechanical equipment located above room A10 Storage, resulting in stained ceiling tiles.	Good
Conveying	System not present.		N/A
Plumbing	Plumbing Fixtures	The building has multi-user restrooms for students and staff. The restrooms have counter-mounted vitreous china sinks with manual faucets along with floor-mounted vitreous china toilets with manual flush valves. There are wall-hung vitreous china urinals with manual flush valves located in the male restroom. A multi-station wall-mounted stainless steel drinking water fountain is located in the corridor. Rooms A8 and A10 have counter-mounted single-bowl stainless steel sinks with manual faucets and wall-hung vitreous china sinks with manual faucets.	Average

1. Replace stained ceiling tiles with new ceiling tiles after roof leaks have been resolved.

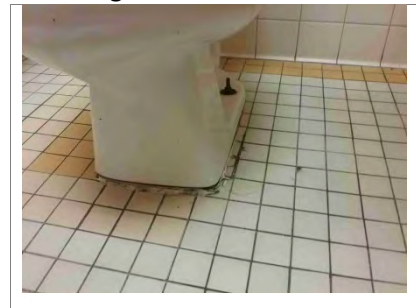
Plumbing Fixtures

System	Subsystem	Condition and Deficiency Overview	System Condition Rating
		The plumbing fixtures show signs of typical wear and tear and are in average condition. The only deficiency with plumbing fixtures was noted on the toilets. Some of the toilets in the building appeared unsealed and may need the flange bolts replaced due to corrosion.	
	Domestic Water Distribution	The only domestic water distribution component observed was the hose bibs on the exterior of the facility. The hose bibs did not appear to have any deficiencies and were in good condition.	Good
	Other Plumbing	The only other plumbing in the building was floor drains and separator grit traps. The floor drains in the restrooms appear free of debris and in average condition. In rooms A8 and A10, there are separator grit traps below the wall-hung sinks which appear to capture solids. These separators appear to be in average condition.	Average

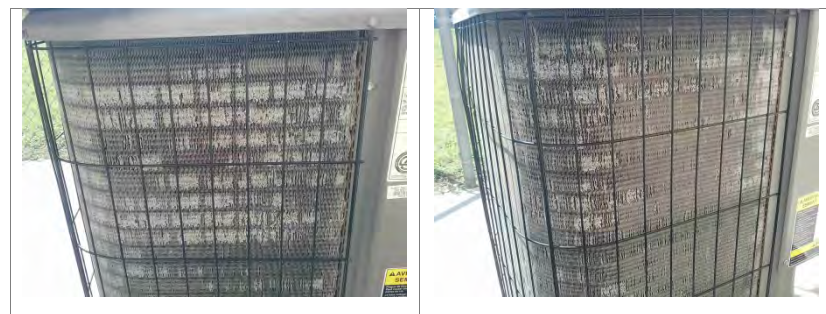
Mechanical/HVAC System Deficiency Examples

Mechanical/ HVAC	<p>The building's HVAC system is composed of air source heat pump split systems and indoor modular AHUs. Along the exterior of the building, there are six condenser units that were manufactured in 2000 and 2006 and have sizes ranging from 3-TON to 20-TON. All of these units were observed to be in average condition with typical wear and tear. The only deficiency noted was the use of R22 refrigerant. This refrigerant is being phased out of use in mechanical equipment.</p> <p>Five heat pumps are also located on the exterior of the building. These units range in size from 2-TON to 3-TON and had an estimated manufacturing year of 2006. The heat pumps were observed in average condition with wear and tear visible on the fan coil. The indoor modular air handlers were not visible during the assessment and may be located in the crawl space above the ceiling tiles. The exhaust fans located on the roof top appeared to be in average condition with no visible deficiencies.</p> <p>The mechanical/HVAC system is in average condition with the deficiencies being typical wear and tear and the use of R22 in condenser units. It was reported that temperature balancing issues occur in this building. These balancing issues were not apparent during the assessment, and the visible components of the HVAC system did not appear to have signs of what may be causing these balancing issues. The problem may be with the AHUs, which were not able to be assessed.</p>		Average

1. Perform routine maintenance on the heat pump fan coils to fix damage and improve their operating capabilities.
2. Inspect the AHUs in the crawlspace above the ceiling tiles. Temperature balancing issues are experienced in this building, and the AHUs may be contributing to the issue.

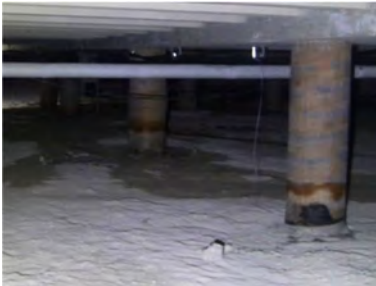
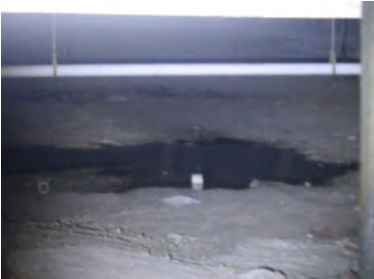
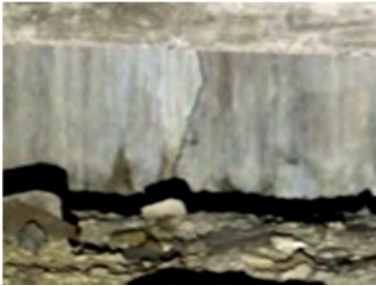
System	Subsystem	Condition and Deficiency Overview	System Condition Rating
Soil, Drainage, Ventilation & Access	Soil Below Building, Site Drainage in Crawl Space	<p>Soil below building was damp along the perimeter and in isolated locations throughout the interior. In two different instances standing water was found. Standing water was observed near the exterior beam of the north-east gym and at the southeast corner of the building. The source of the water infiltration is likely surface water from around outside of building is soaking into the surrounding soils and migrating into the crawl space. The soil was also damp under rusted pipes below the café. Below the MEP room, the soil was sloped for drainage but other areas were mostly flat. The soil under the MEP room becomes damper below the MEP equipment. No drainage system was visible in the crawl space, but drawings show sloping grades and 6" diameter pipes running along north and south sides of the building and discharging to the storm sewer near the NE corner of the original building. The standing water indicates the drainage system or crawl space grading is not working effectively.</p> <p>Erosion was noted in soils around the outside of the building, which has led to low spots adjacent to building perimeter.</p> <p>Soil/Drainage deficiencies:</p> <ul style="list-style-type: none"> • Water infiltration, wet/saturated soils • Standing water found in two parts of the crawlspace • Drainage system or underfloor grading not working effectively • Erosion in soils outside perimeter of building has counteracted site grading, surface water not draining away from building 	Average

Soil Retainers	<p>Concrete soil retainers are present around the entire suspended floor system. In almost all cases the soil retainers were visible with the exception of the west wall.</p> <p>Describe any soil retainer deficiencies.</p> <ul style="list-style-type: none"> • A few cracked soil retainers were observed 	Good
	Areaways/Ventilation	<p>Seven areaways were located around the building. The areaways are too small for physical access and are intended for ventilation only. Observed areaway curb heights appeared sufficient to prevent water infiltration. The areaway in the southeast corner of the school and the areaway on the west side of the big gym both had running fans pulling air to ventilate the crawlspace. However, none of the fans at the other five areaways were working (or they were turned off).</p> <p>Areaway/ventilation deficiencies:</p> <ul style="list-style-type: none"> • Five areaway ventilation fans are not operational • Poor ventilation: condensation present under the access hatch in the south-east corner and under beams and slabs 	Average

Sporadically saturated soil	Standing water in the discreet locations	Cracked soil retainer

1. Restore operation of areaway ventilation fans, investigate need for additional ventilation
2. Re-grade site surrounding building perimeter to fill in eroded areas and slope grade away from building
3. Fix leaking MEP equipment to prevent water from infiltrating the crawl space from above

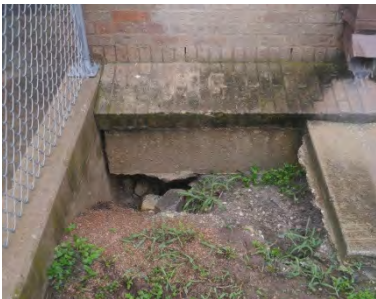
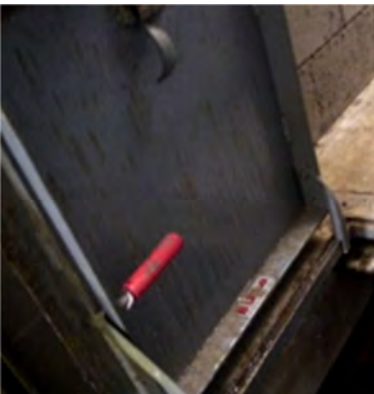
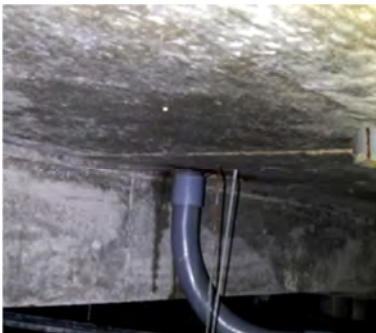
Low spot outside building promoting water infiltration into crawl space	Condensation on underside of access hatch indicates poor ventilation	Moisture on underside of beams and slab indicates poor ventilation

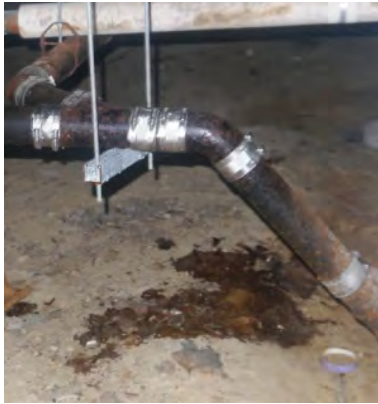
Damp soil under leaking pipes

1. Repair leaking pipe(s)
2. Replace or clean corroded cast iron pipes & protect from further corrosion.
3. Replace or clean heavily corroded hangers/supports.
4. Replace degraded/missing pipe insulation.

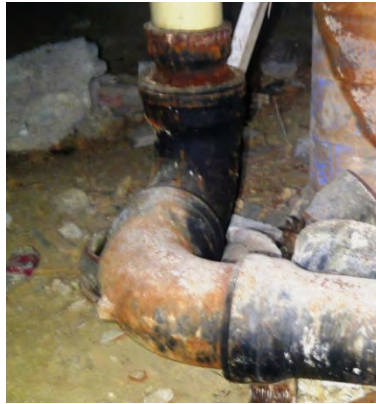
Rusting pipes

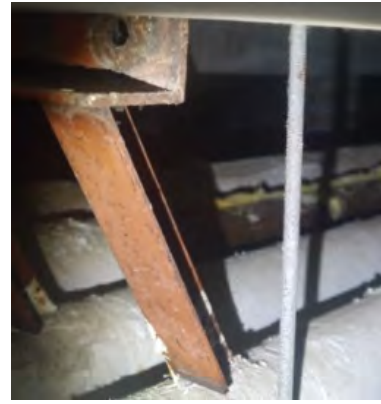
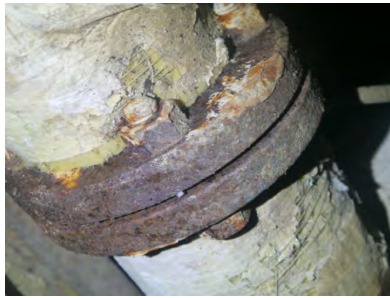
Rusted cast iron pipe connection

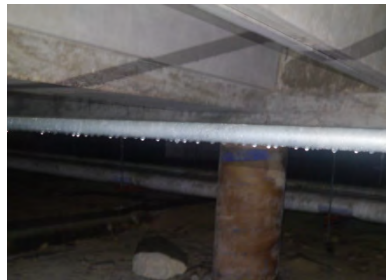
Condensation on pipes

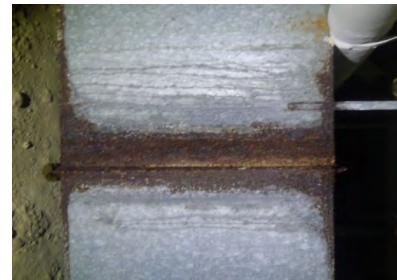
Rusting ductwork
