Fulmore Middle School Site Summary

Address	201 East Mary Street Austin, TX 78704
Number of Permanent Campus Facilities	4
Original Year of Construction	1911, 1980, and 2002
Total Campus Building Area (combined)	159,770 SF

Introduction

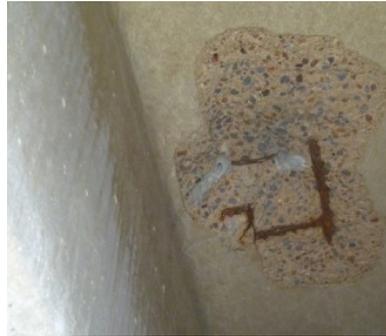
<p>Spalled precast channel slab soffit, corroded slab rebar</p>

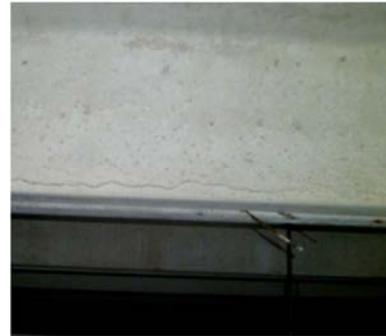
<p>Longitudinal crack along bottom of channel leg</p>

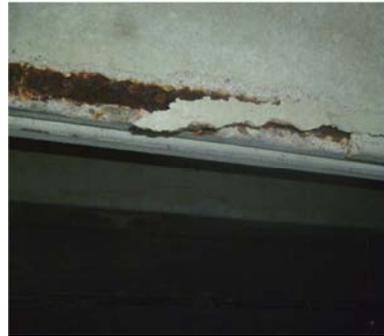
<p>Longitudinal spalling along bottom of channel leg</p>
---	---	--

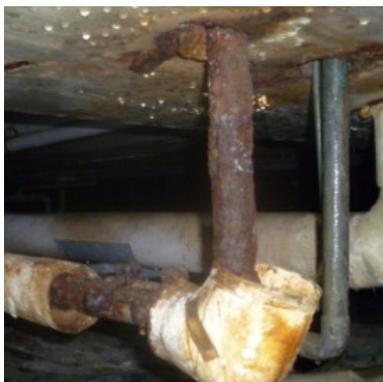
Rusted cast iron pipe

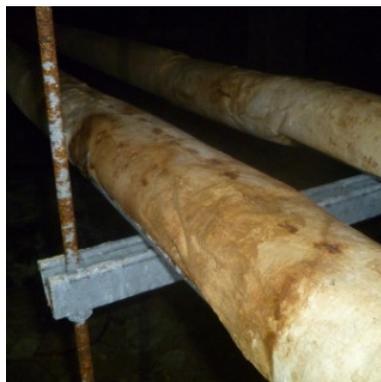
Rusting pipe hangers, degraded/moldy pipe insulation

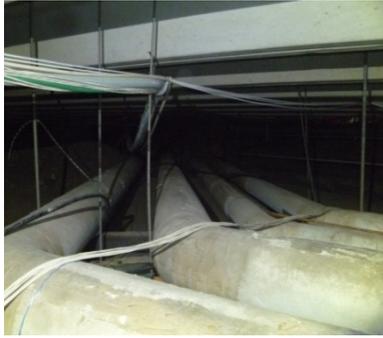
Crawl space to the south of access point blocked by pipes

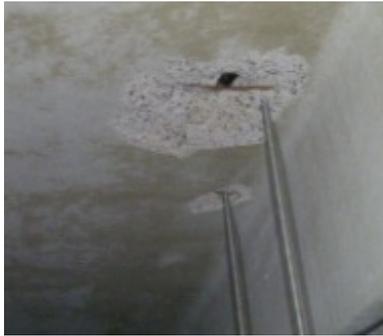
Minor spalls in a precast channel

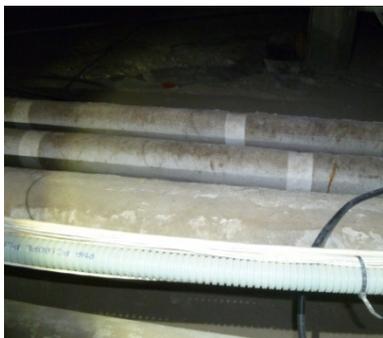
Mold & early signs of pipe insulation degradation

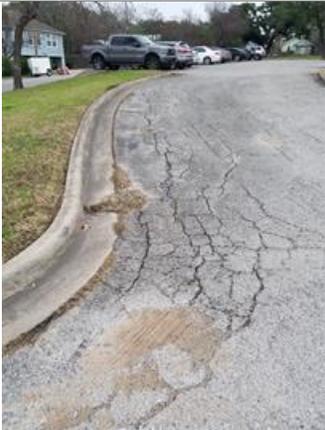
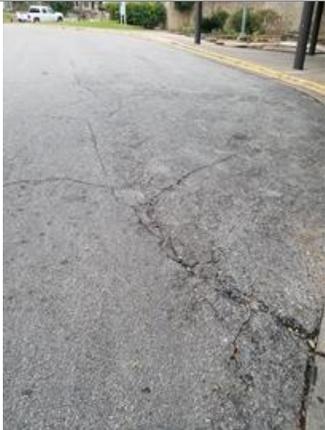
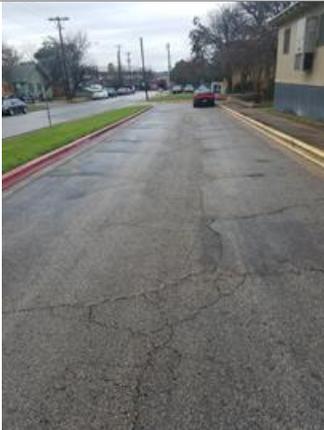
R1 cracking	R1 drop-off cracking	R3 bus drop-off

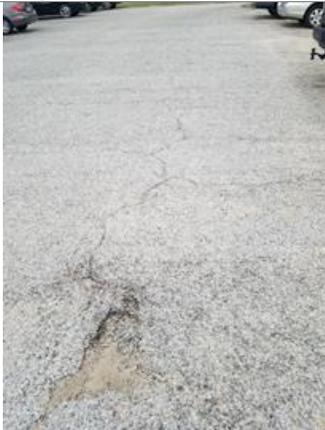
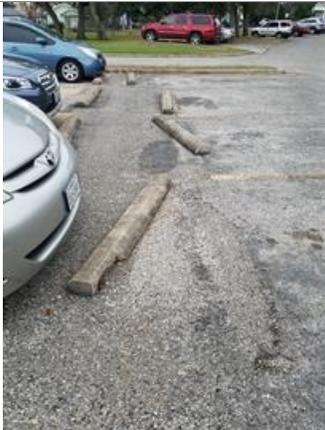
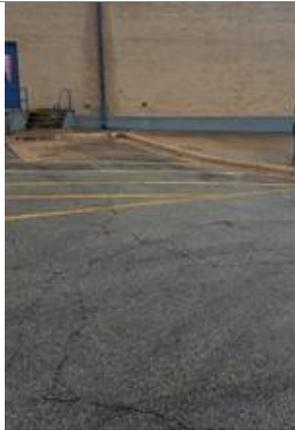
P1 cracking/potholes	P1 broken curb stops	P2 cracking

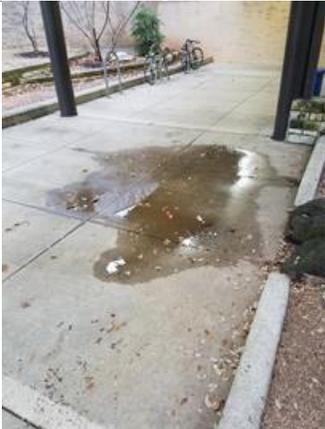
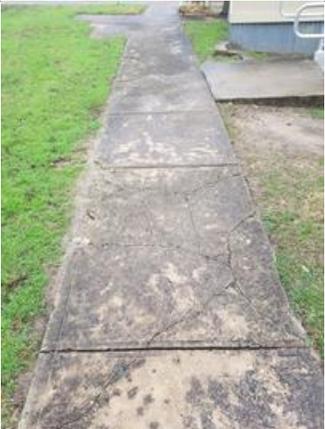
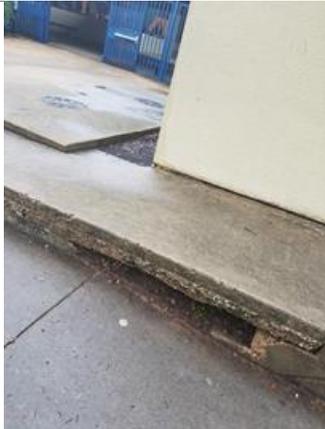
Low spot in concrete near flag pole	Sidewalk cracking near bus drop-off	Erosion under sidewalk near bus drop-off

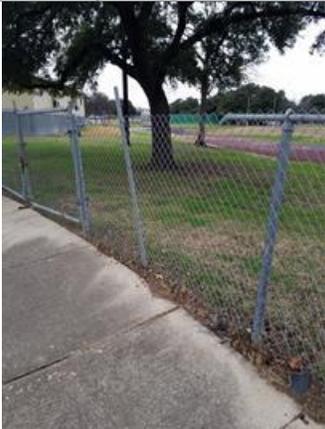
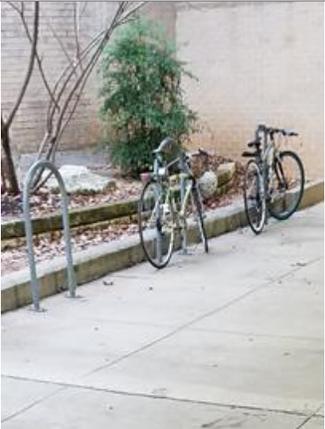
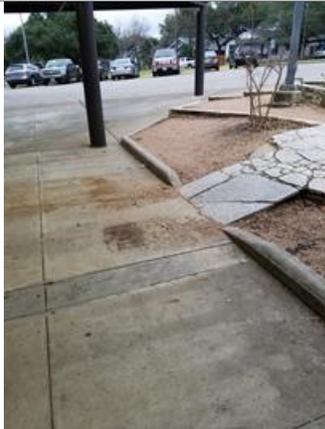
Broken chain link fencing	Bike racks	Broken stone at base of flag pole

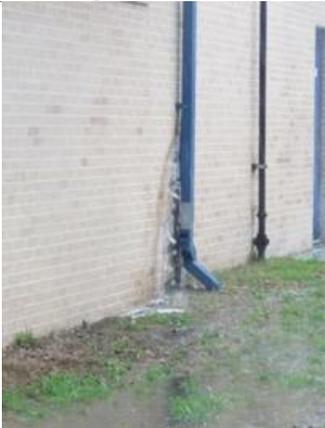
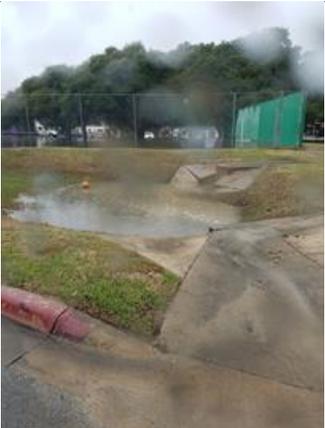
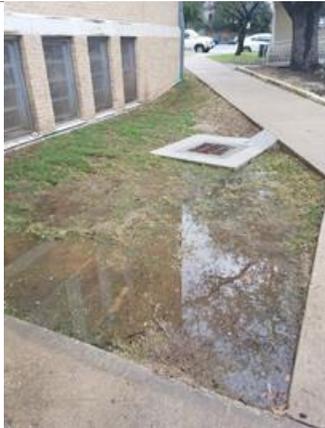
Downspout overflowing	Detention pond	Area around drain flooding

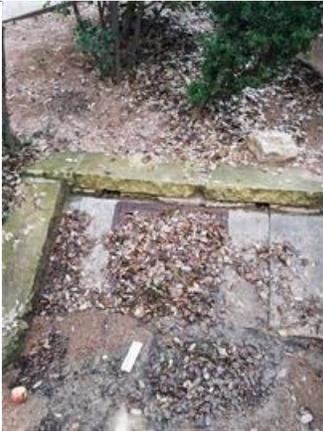
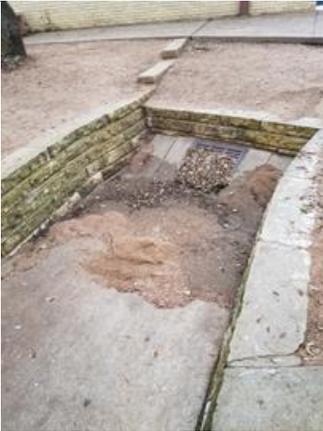
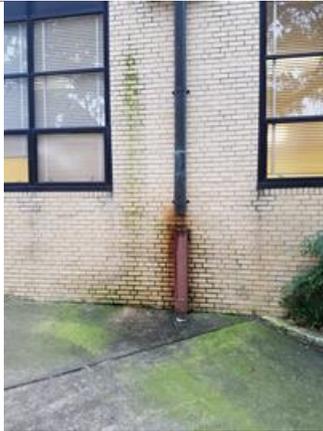
Covered/clogged drain	Covered/clogged drain	Downspout missing lower section

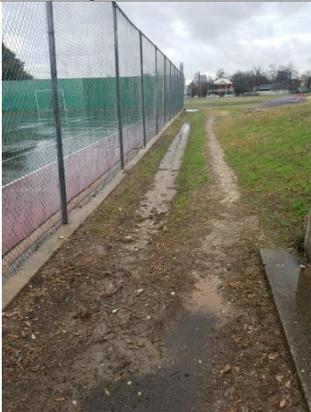
Worn foot path

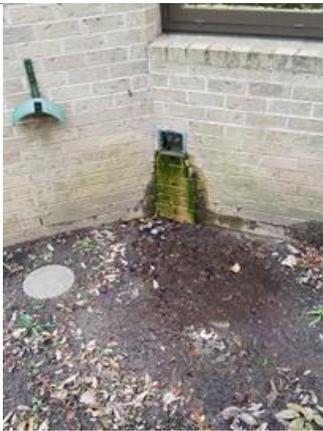
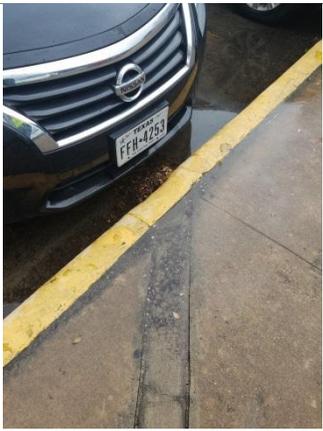
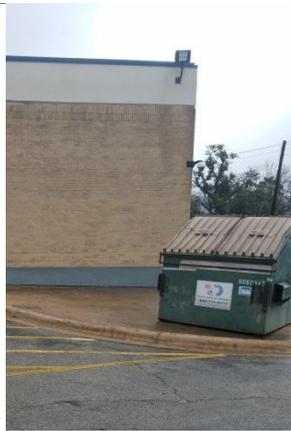
Water faucet leaks	Clogged drain pipe	Missing concrete dumpster pad

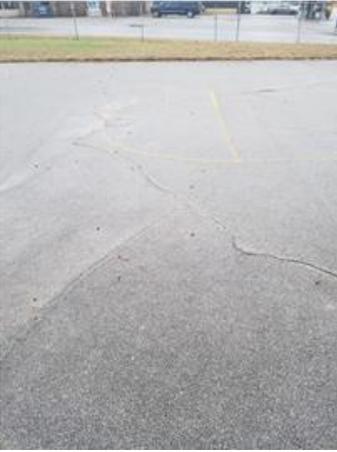
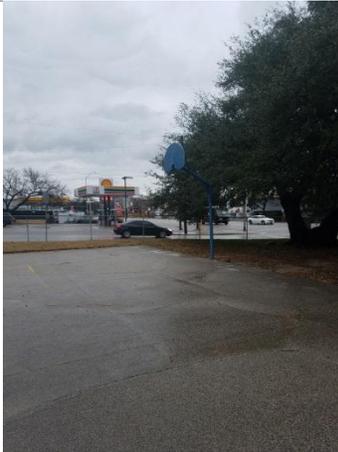
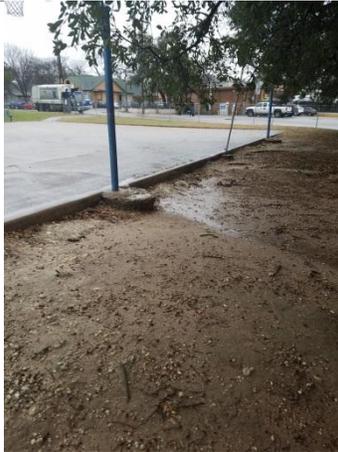
Court surface cracking	Missing basketball rim	Erosion adjacent to BB court

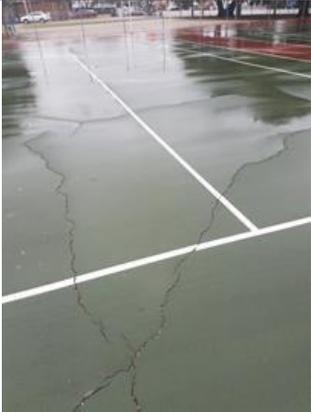
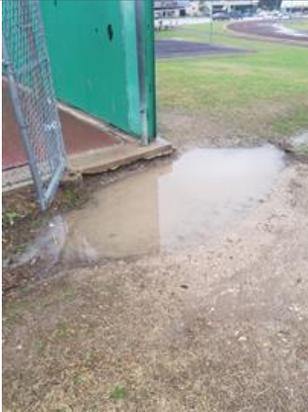
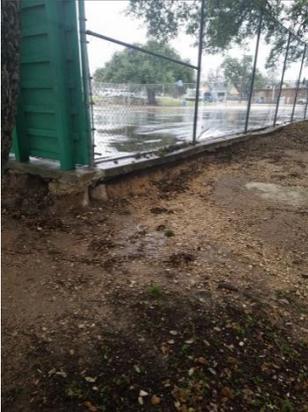
<p>Court surface cracks</p>	<p>Ponding at tennis court entrance</p>	<p>Erosion adjacent to tennis court</p>

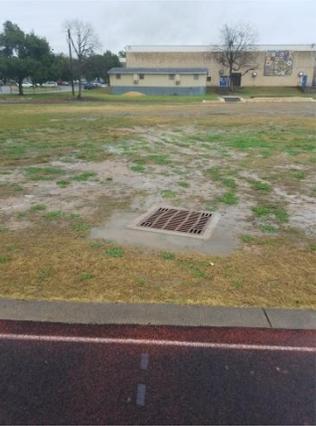
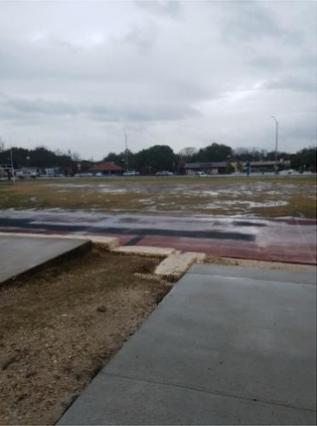
<p>Water ponding on field</p>	<p>Water ponding on field</p>

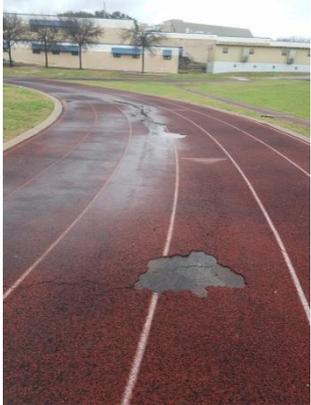
<p>Peeling and missing track sections</p>	<p>Broken tracks sections</p>	<p>Patches and ponding on track</p>

1. Replace the track surface.
2. Repair or replace broken volleyball net.
