Gorzycki Middle School Site Summary

Site/Civil Assessment

Gorzycki MS
7412 W. Slaughter Ln.

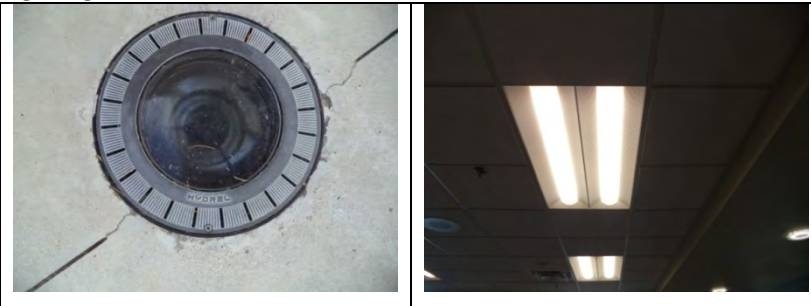
Lighting

System	Subsystem	Condition and Deficiency Overview	System Condition Rating
		<p>voltage control system were also difficult to procure. If a circuit board failed, an entire wing lost power to the classroom lighting. The lead time on procuring parts was unacceptably long. The switching system only had a 7-day cycle on the programmable controls, which meant that all of the lighting in this system was on during the weekends. It was not possible to shut off the lighting system on weekends and holidays, creating high power consumption. It also was reported and observed that the switches in the classrooms which are part of the system did not work consistently.</p> <p>It was reported that the in-ground fixtures were leaking. Staff stated they should be replaced with down-lighting in the curved portion of the main canopy.</p> <p>It was observed and reported that the lighting system was in average condition.</p>

1. Remove in-ground up-lighting and repair the concrete where they are located. Add LED (light-emitting diode) drum lighting in the curved canopy to match existing.
2. Replace the Lithonia Simply 5 systems with new fixtures and controls. This will require a phased approach to be implemented over the course of several years. As units are replaced, the old ones that are still in working order can be used as spare parts to extend the life of fixtures and controls that have not yet been replaced. Make sure new control system works in the classrooms as intended and also allows the lights to be shut off on the weekends.

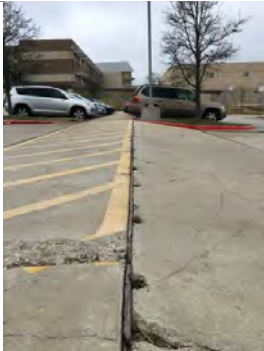
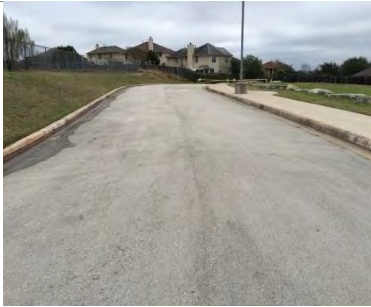
Roadways

Broken Curb, R1	Vehicle scraping, R2	Worn roadway and faded curbs, R3

1. R1, Seal minor curb-side cracks
2. R1, Re-paint curb at main drop-off
3. R2, Repair small broken/ raveling roadway at P3 crosswalk
4. R2, Repair broken/ cracked curbs at P3 crosswalk
5. R2, Repair broken/ cracked storm sewer inlet at P3 crosswalk
6. R2, Re-design tennis crosswalk to avoid vehicle scraping
7. R3, Apply sealcoat to extend life of worn asphalt
8. R3, Repair and re-paint all curb surfaces
9. R4, Apply sealcoat to extend life of worn asphalt
10. R4, Repair broken curb
11. R4, Maintain crosswalk drains

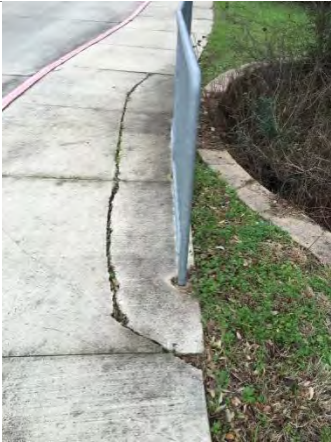
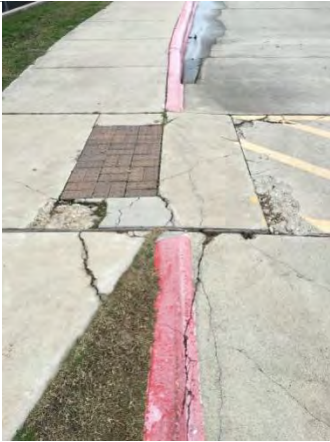
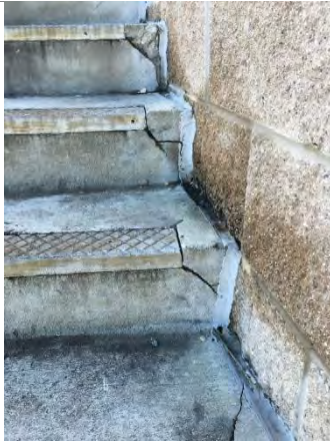
Pedestrian Paving

Heaved hand rail sidewalk section	Broken crosswalk ramp	Broken pedestrian staircase

1. Address water drainage issue at R1 entrance
2. Reconstruct hand rail section of pavement at R2
3. Replace cracked pedestrian pavement
4. Replace cracked crosswalk ramps at P3 crosswalk
5. Add paved sidewalk on east side of school

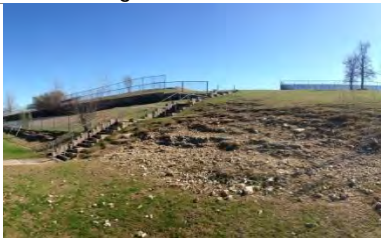
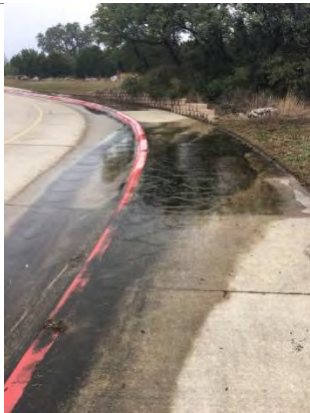
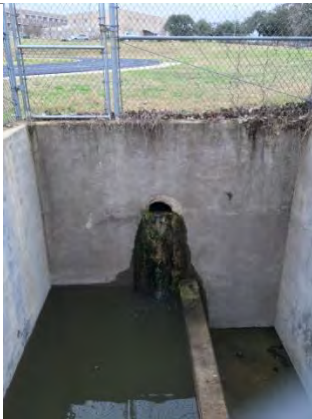
Site Drainage

Natural hill erosion at track	Pedestrian drainage issue, R1	Clogged detention pond outlet

1. Maintain detention pond outlets
2. Assess drainage issue at R1 sidewalk
3. Assess natural hill erosion at track area and adjacent to BB court
4. Maintain crosswalk drains

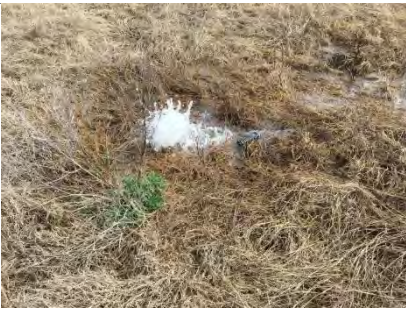
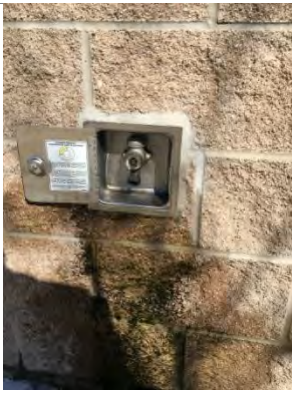
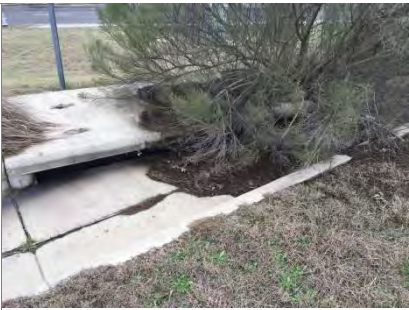
Site Utilities

Broken/ missing irrigation head	Leaking exterior water valve	Overgrown vegetation around storm sewer inlet

1. Replace missing / broken sprinkler heads
2. Repair leaking exterior wall faucets
3. Assess underground utility water leak
4. Add fiberglass grease sampling enclosure

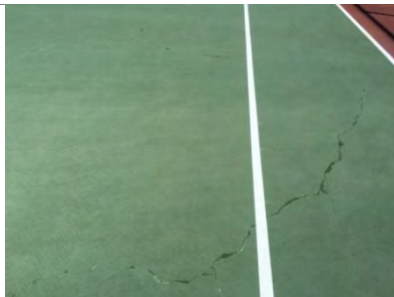
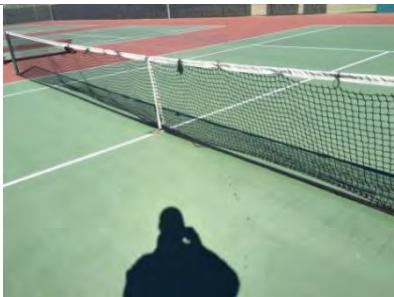
Tennis Courts

Cracked tennis court	Broken tennis netting

1. Seal minor cracks
2. Replace tennis nets
3. Replace missing fence ties

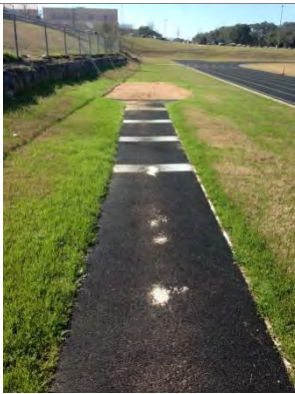
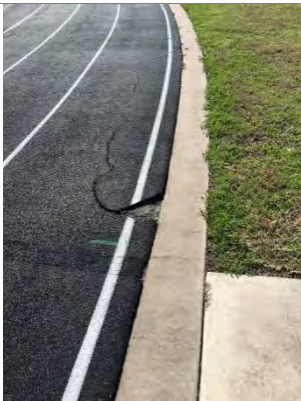
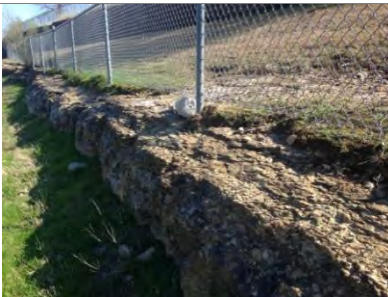
Track

Worn triple jump track	Broken track rubber section	Erosion adjacent to track

1. Repair broken section of track
2. Replace entire surface of triple jump tracks
3. Add concrete pads for bleachers
4. Regrade around drainage inlet to provide positive drainage

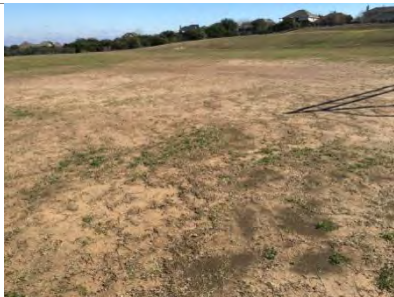
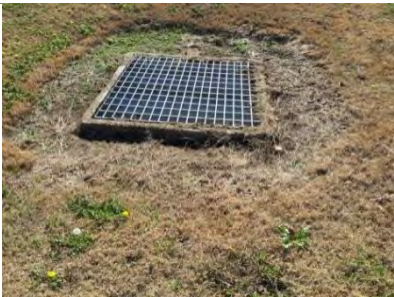
Soccer Field

Soccer field erosion	Erosion around main soccer field inlet

1. Re-sod worn grass area for secondary field
2. Replace soccer nets for secondary soccer field

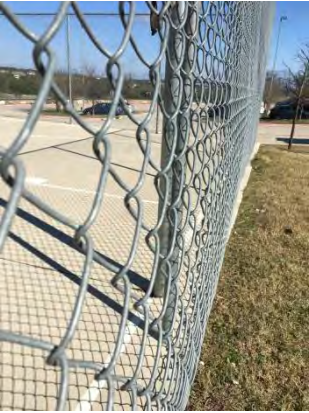
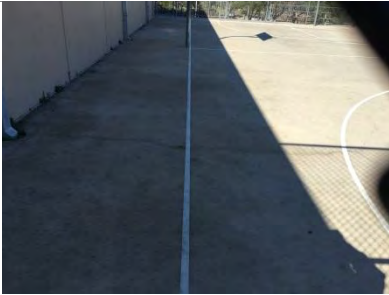
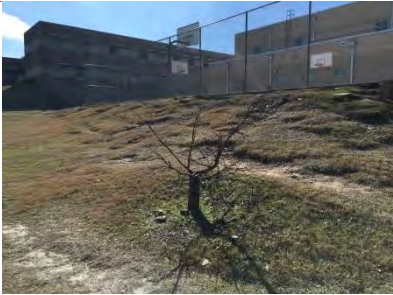
Basketball Court

Damaged / loose fence around court	Cracked court	Erosion adjacent to basketball court

1. Seal minor cracks
2. Replace missing fence ties
3. Assess erosion from court water runoff
