## Kealing Middle School Site Summary

## Administration and Classroom Building – BLDG-044A

## Cafeteria, Gymnasium, and Auditorium Building – BLDG-044B

## Classroom Building – BLDG-044C

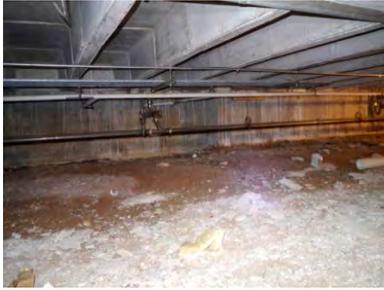
Wet soil along south perimeter wall

1. Investigate water infiltration along south wall and remedy.
2. Determine whether ventilation fans are functional; turn fans on if operational or repair/replace if not.
3. Investigate pipe causing puddle; if leaking repair as needed.

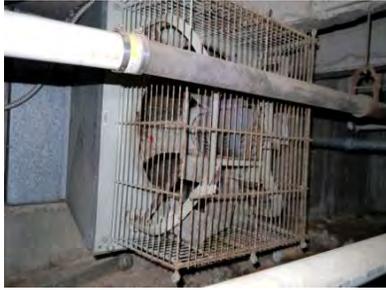
Ventilation fan turned off/not working

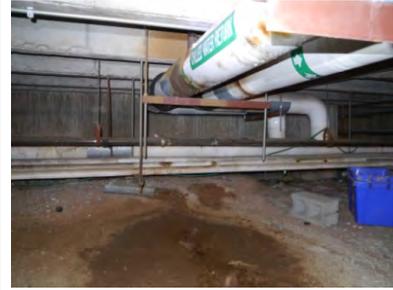
Ponding water from condensation dripping from pipe above

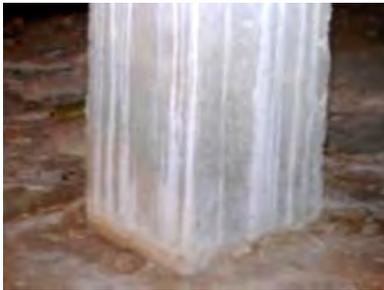
Minor honeycombing/spalling at corners of column

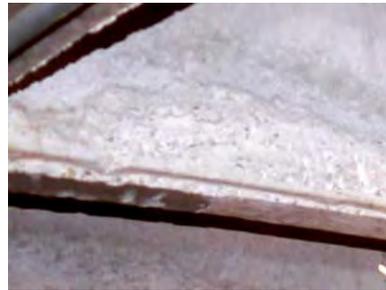
Minor honeycombing on pan joint web

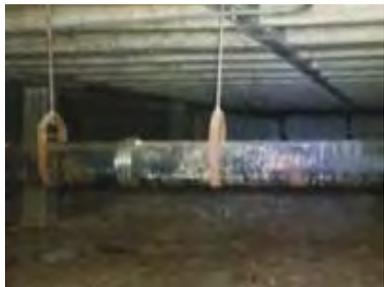
Rusted hangers for suspended pipes

1. Replace rusted pipe hangers as needed.

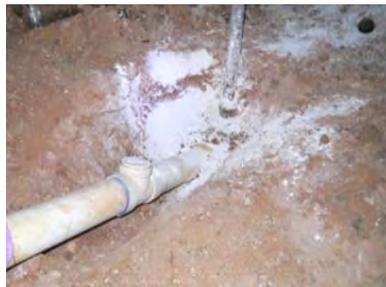
PVC pipe and old cast iron pipe into ground

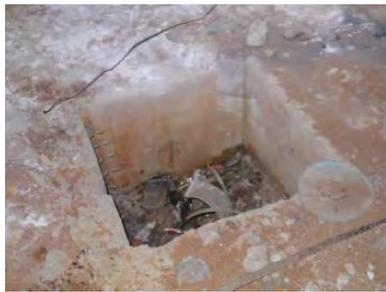
Square hole observed in soil

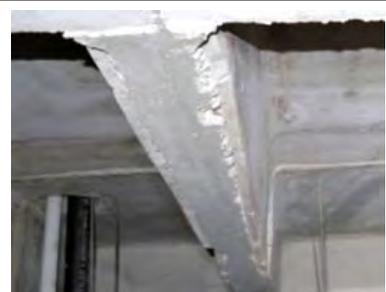
Minor spalling on webs of pan joists

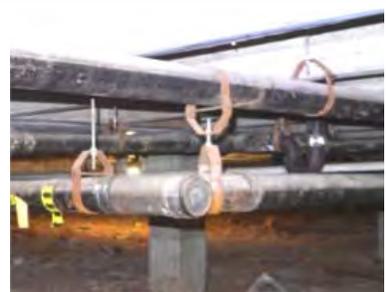
Rusted hangers for suspended pipes

1. Replace rusted pipe hangers as needed and repair/re-suspend pipe on ground.
2. Replace rusted pipe hangers as needed.

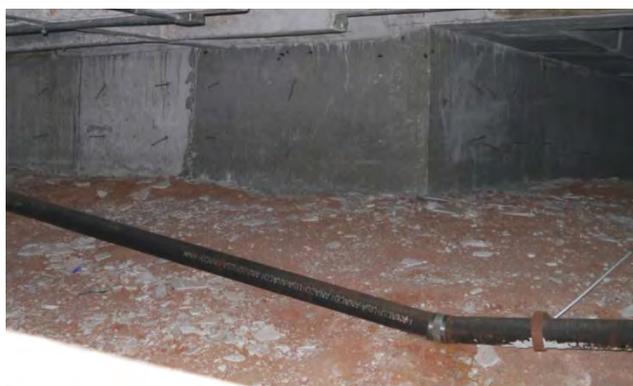
Pipe lying on ground due to broken pipe hanger, pipe is rusted

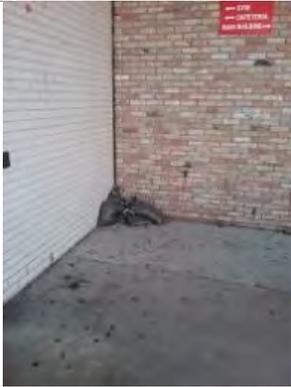
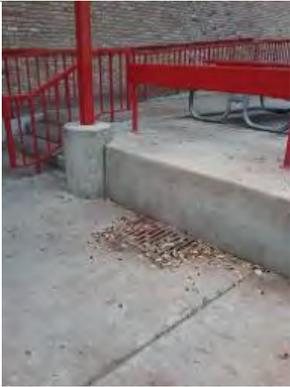
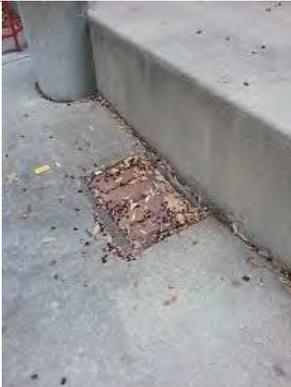
Courtyards

<p>Sandbags used during heavy rain storms</p>	<p>Inlets to be maintained</p>	<p>Maintain inlet, remove debris</p>

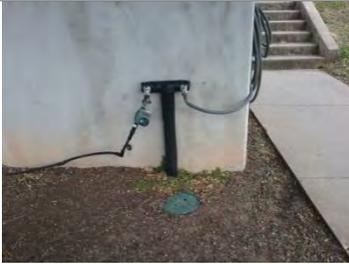
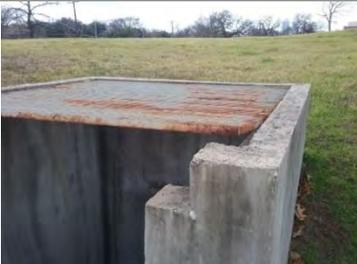
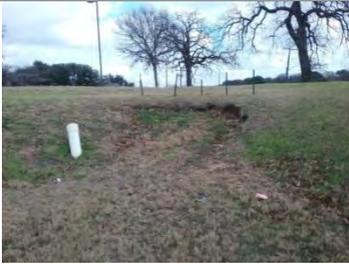
Site Utilities

<p>Garden irrigation</p>	<p>Warped grate on detention pond</p>	<p>Erosion of detention pond</p>

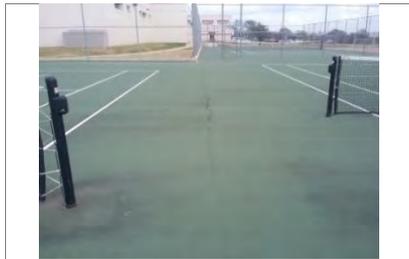
Longitudinal cracking

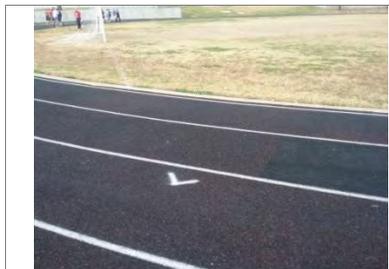
Soccer Field boundary extends onto track

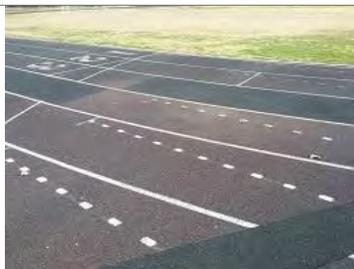
Patches on track

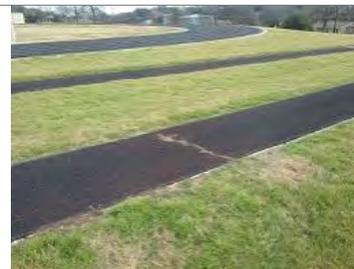
Crack in track

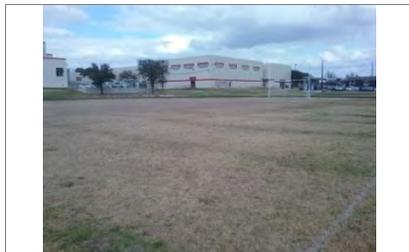
Worn soccer field

1. Replace sod in center of field.
