## Lamar Middle School Site Summary

## Main School Building – BLDG-045A

Building Purpose	Administration Offices, Classrooms, Cafeteria and Gymnasium
Building Area	105,203 SF
Inspection Date	June 14-16, 2016
Inspection Conditions	95° F, sunny
Facility Condition Index

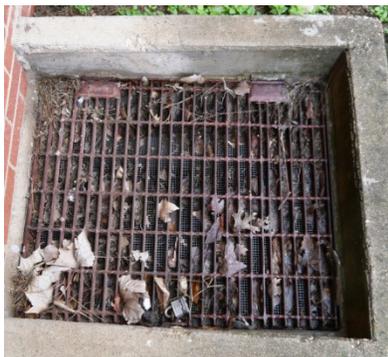
Areaway grate is corroded

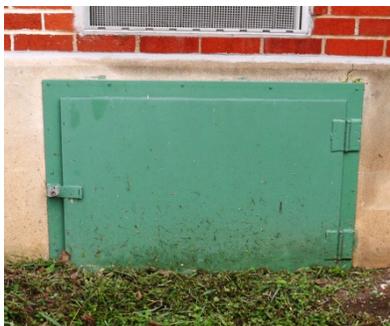
Bottom of hatch door is below grade and inoperable

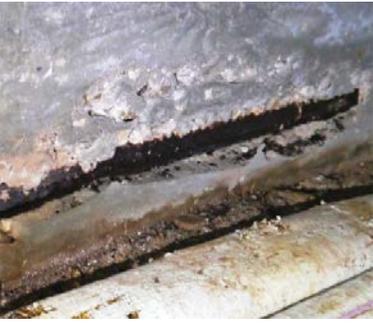
<p>Exposed/corroded reinforcement in perimeter beam</p>

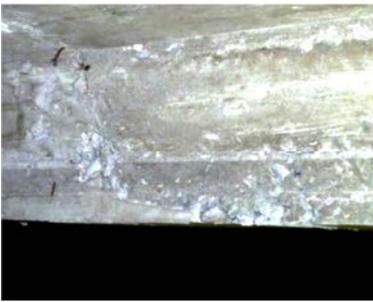
<p>Beam honeycombing</p>

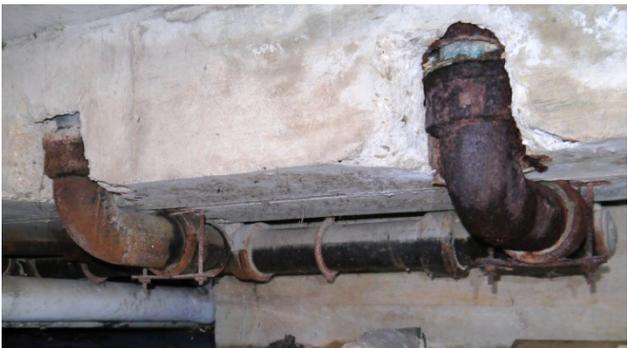
<p>Pipes penetrating beam &amp; rusted</p>

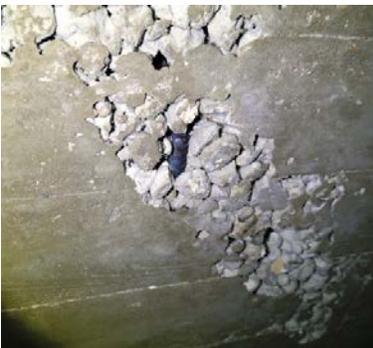
<p>Slab honeycombing</p>

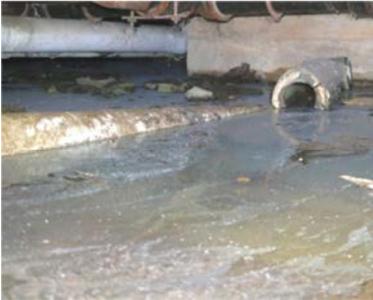
<p>Broken pipe (unclear if pipe is in use)</p>

1. Investigate broken pipe lying on ground of crawl space
2. Replace significantly corroded pipes and hangers
3. Replace degraded/torn pipe insulation

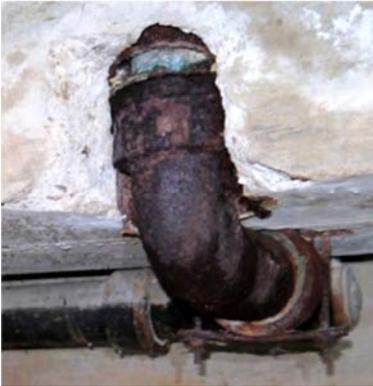
<p>Pipes rusted (some significantly)</p>

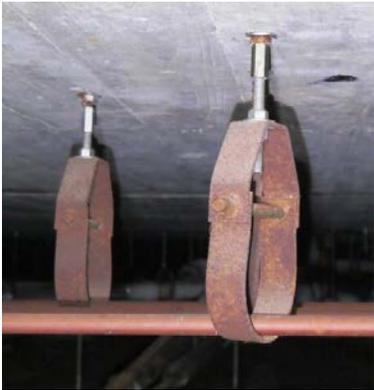
<p>Rusted hangers</p>

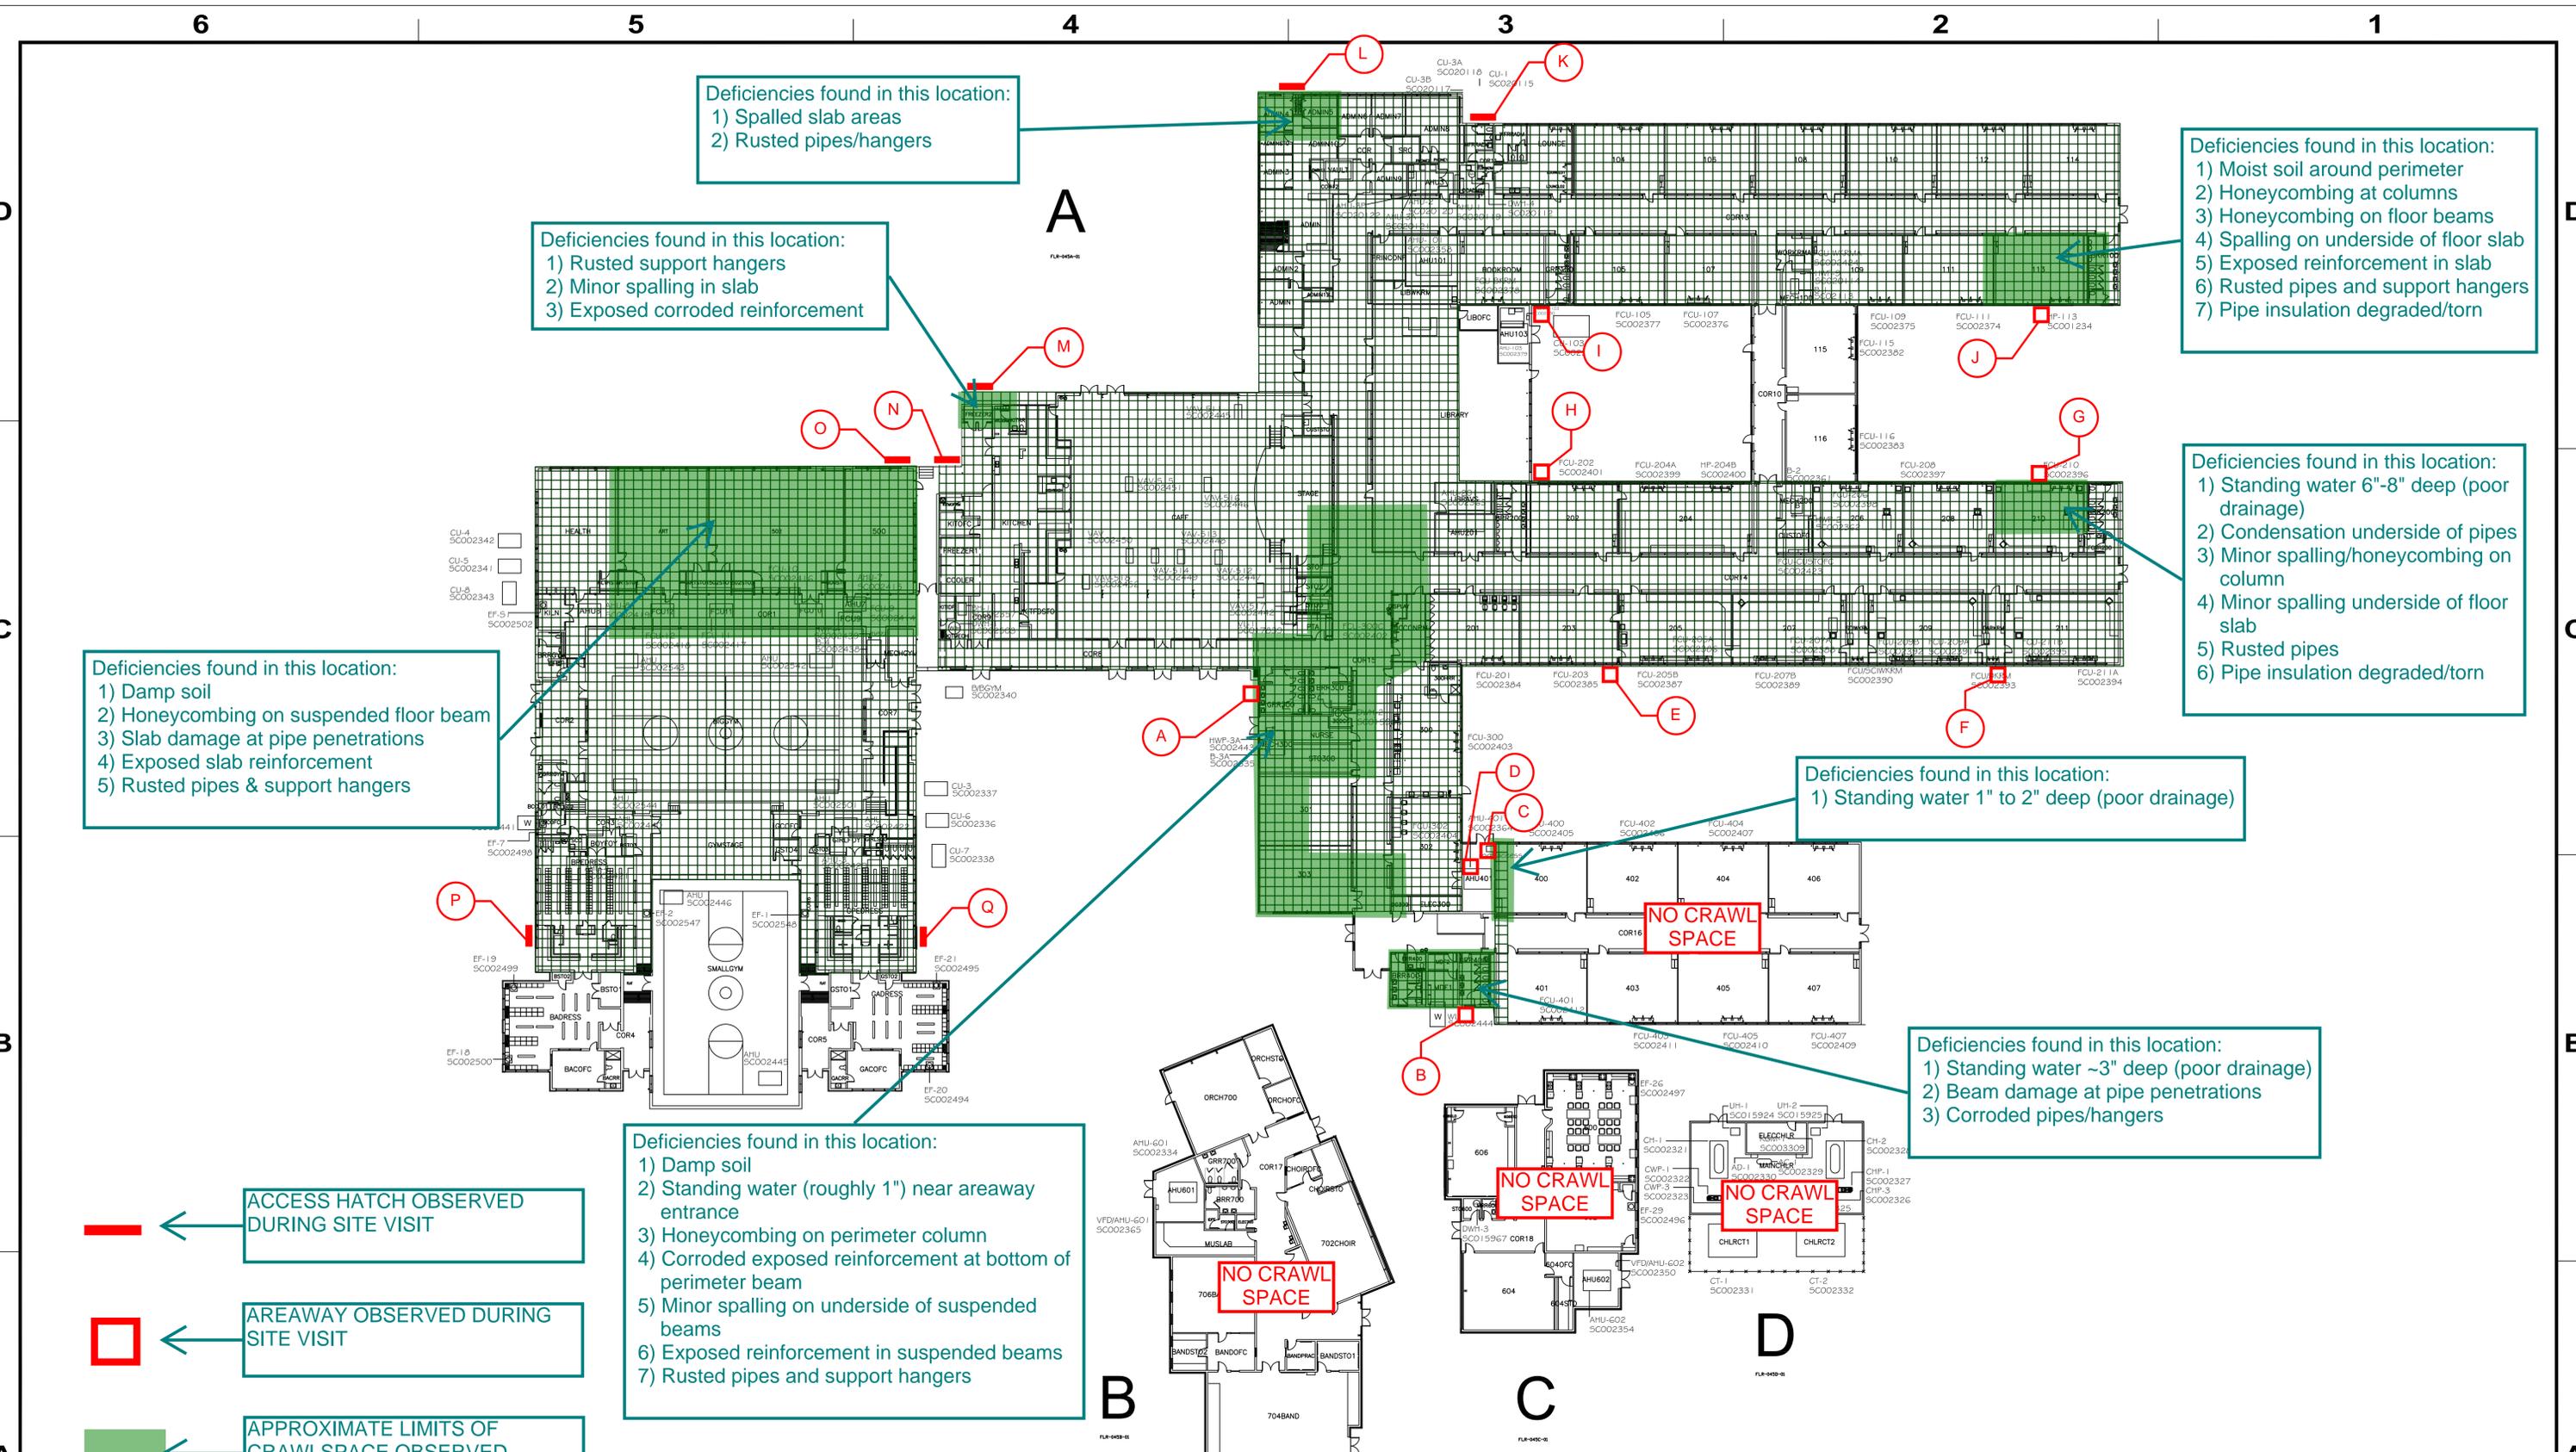
Deficiencies found in this location:  
 1) Spalled slab areas  
 2) Rusted pipes/hangers

Deficiencies found in this location:  
 1) Rusted support hangers  
 2) Minor spalling in slab  
 3) Exposed corroded reinforcement

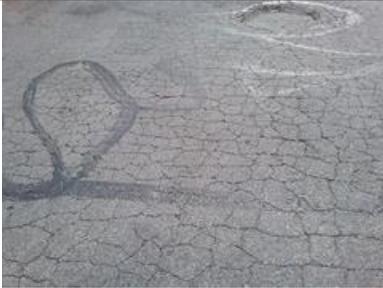
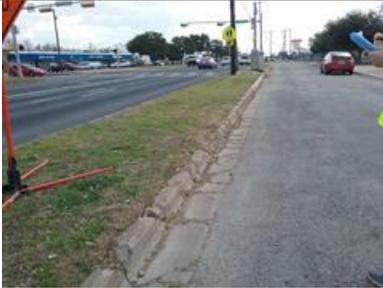
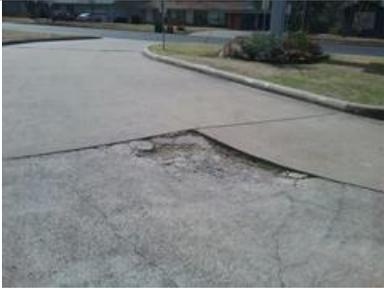
Roadways

Alligator cracking R3	Raveling and failed curb R3	Failing concrete loading dock

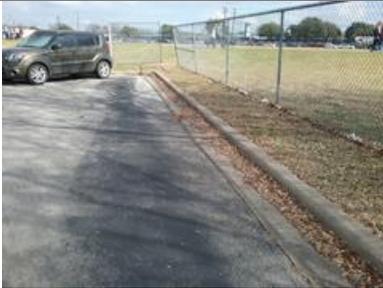
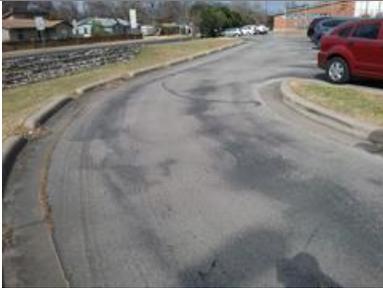
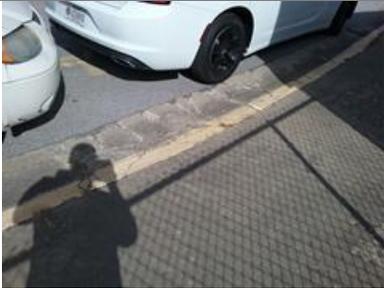
Parking Lots

Raveling/bleeding P1	Curb cuts with silt P1	Failing curb HC parking along R1

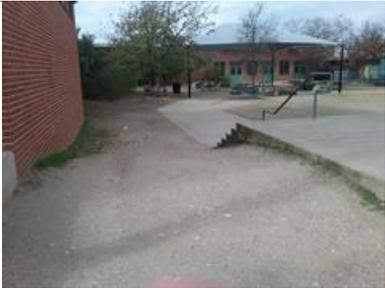
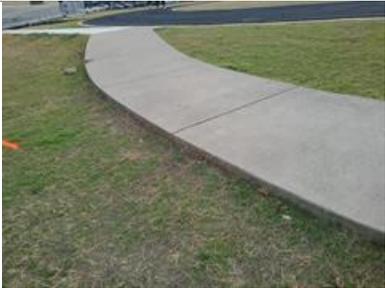
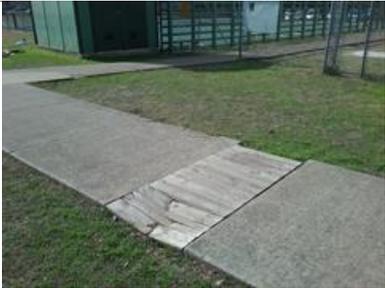
Sidewalk without handrails	Sidewalk without topsoil at edges	Failing wooden sidewalk

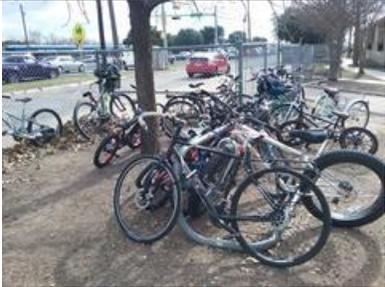
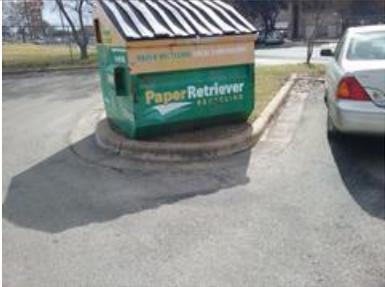
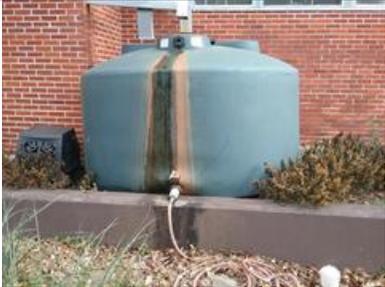
Makeshift bike rack (east side of campus)	Dumpster without pads	Storage tank without overflow

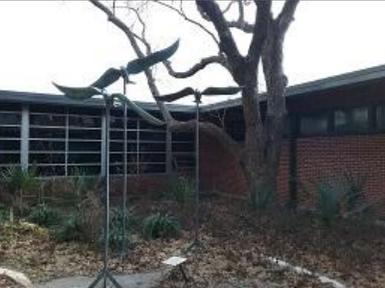
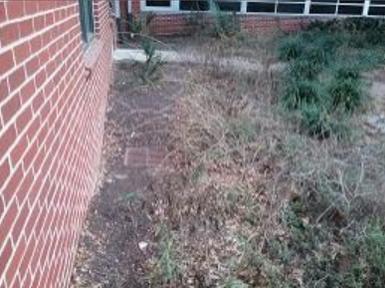
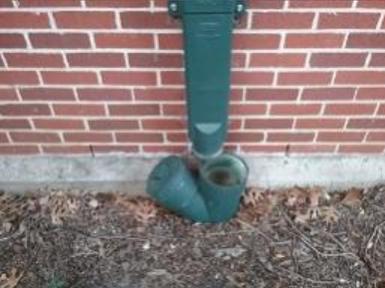
Inadequate lighting	Landscaping neglect	Downspouts damaged, discharge onto soil

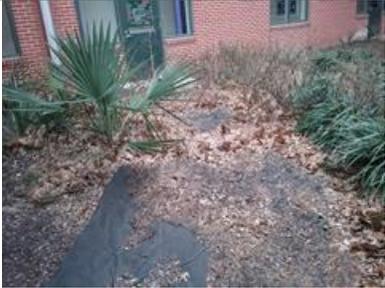
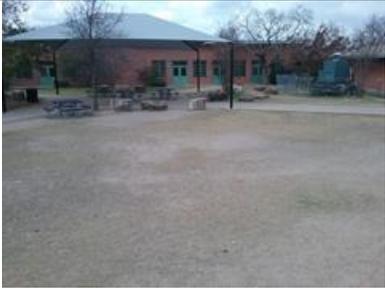
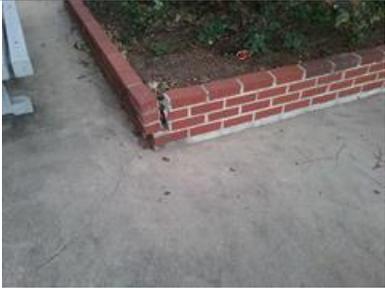
Landscaping

Maintain landscaping in CY2	Worn grass	Broken flowerbed retaining wall

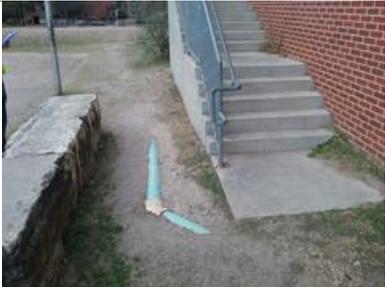
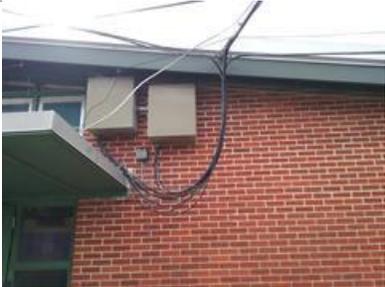
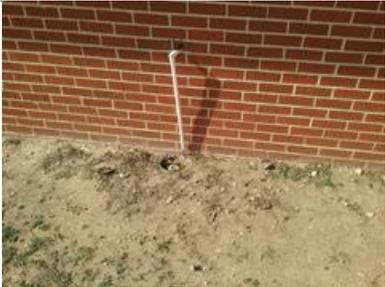
Other Site Mechanical Utilities

Lack of topsoil at underground utility	Loose wiring	Broken conduit with exposed electrical wires
