## Martin Middle School Site Summary

## Main School Building – BLDG-051A

## Building B – BLDG-051B

## Site/Civil Assessment

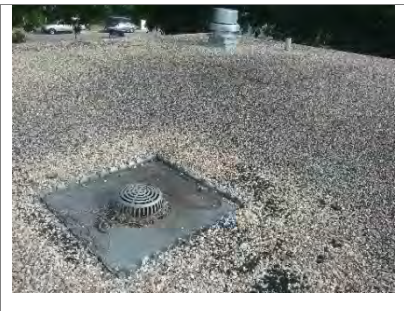
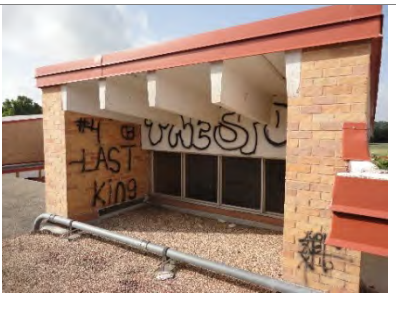
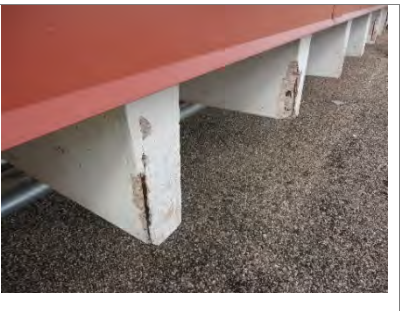
## Roofing Deficiency Examples

System	Subsystem	Condition and Deficiency Overview	System Condition Rating
		<p>the low slope areas appeared to be in good condition. Graffiti was found on the upper roof level over the BRKM stairwell.</p> <p>The roof structure is concrete "T"s and is visible at the upper levels. Some of the "T"s had concrete spalling at the corners with rebar beginning to rust due to exposure to the elements. The standing seam roof does not appear to have been replaced in 2006. There were no visible issues but it appeared aged.</p> <p>The front and side entries have a formed metal barrel vault walkway cover. Both locations appeared to be in good condition. The north walkway cover has netting over the structural members as a bird deterrent, which was torn.</p>	
<b>Interior Construction</b>	Interior Walls	<p>The interior walls are predominantly gypsum board on stud construction, CMU, and brick.</p> <p>The interior walls were observed to be in good condition.</p>	Good

1. Further investigate roof areas on flat areas of blistering adjacent to roof drains.
2. Remove graffiti at roof level over stairwell adjacent to the breakroom.
3. Repair/patch spalling concrete on structural "T"s to prevent further damage.

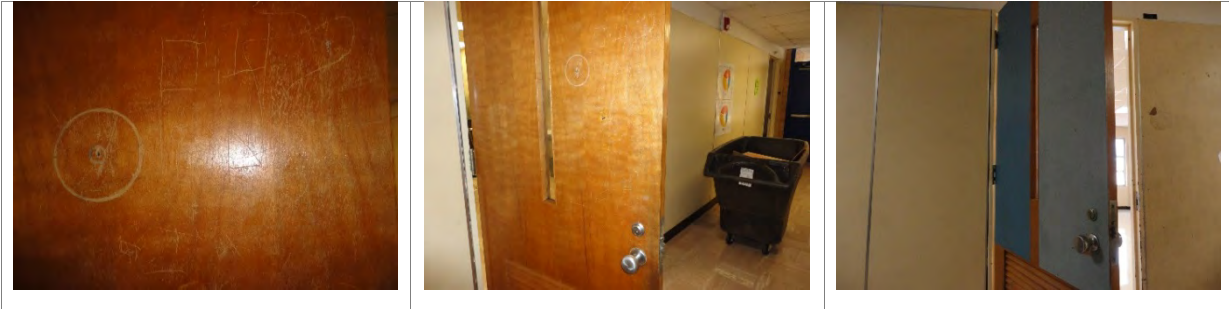
### Interior Doors

Interior Doors	<p>The interior doors are wood with painted metal frames. The restroom and mechanical room doors are painted metal.</p> <p>The wood doors were observed to be in average condition due to age and use. The wood veneer was scratched and marked up on various doors, and the small vision lites were scratched. The metal frames had peeling paint.</p>	Average
	Interior Specialties	<p>There are pre-finished metal lockers on the first and second floors in the corridors.</p> <p>The lockers were observed to be in good condition as they appeared to not be regularly used; all the doors were zip tied shut.</p>	Good
<b>Stairs</b>	Exterior Stairs	<p>There are exterior concrete stairs to the principal's office's exterior door. There are stairs to the second floor in the exterior courtyard area that match the interior stairs in finish. They are concrete with embedded metal anti-slip nosing.</p> <p>The exterior stairs were observed to be in good condition showing signs of routine wear and use.</p>	Good

1. Replace interior wood veneer doors and repaint the hollow metal frames.

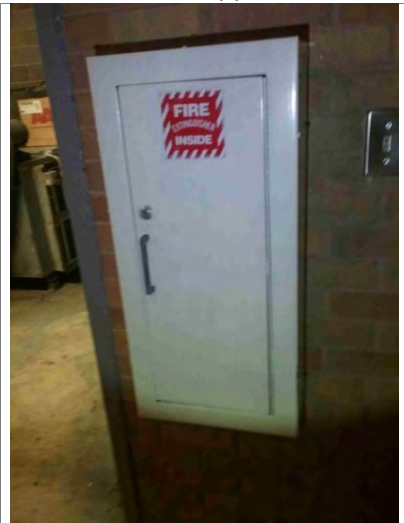
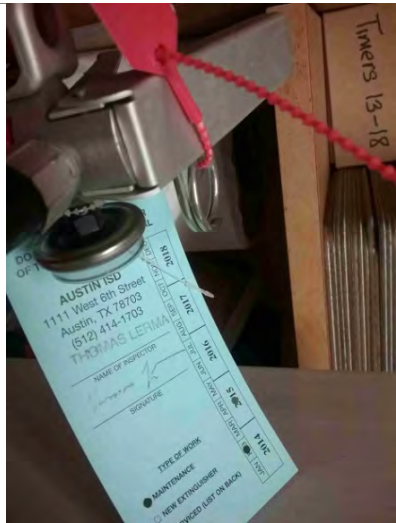
### Fire Protection/Suppression

System	Subsystem	Condition and Deficiency Overview	System Condition Rating
<b>Fire Protection</b>	Fire Alarm	<p>The building has a fire alarm system that consists of alarm and signaling devices such as horns/annunciators, strobes, horn/strobe combinations, pull stations, and detectors. The fire alarm system is controlled by the Silent Knight control panel.</p> <p>The fire alarm system appeared to be in average condition due to some of the fire alarm end devices being aged or worn, especially those located on exterior walls. Facility staff reported fire alarm system faults that need to be investigated.</p>	Average
	Fire Protection/Suppression	<p>The fire suppression system consists of fire extinguishers throughout the building. Visual assessment showed these were in average condition. The fire extinguishers in room 116KIT, CUSTSTO, and the administration area were past due on their annual inspections. Multiple fire extinguisher housings were locked so extinguishers inside could not be visually assessed.</p>	Average

1. Inspect all out of date fire extinguishers, and replace as necessary.
2. Replace worn or dated fire alarm end devices.

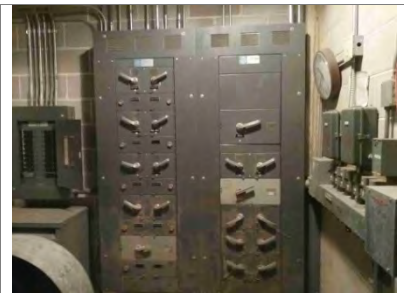
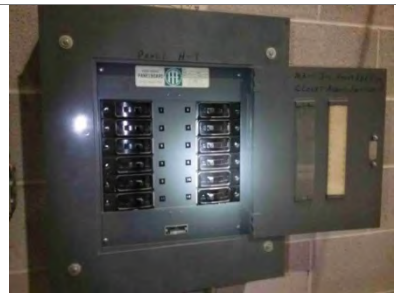
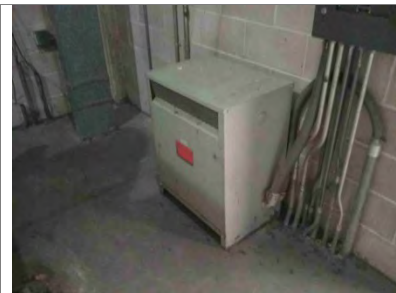
### Electrical Distribution

<b>Electrical</b>	Electrical Distribution	<p>The building's 277/480-volt electrical service is distributed with various panelboards and transformers. The service feeds transformers and high-voltage panelboards located in various rooms throughout the building. The transformers step down the voltage to 120/208-volt secondary, which feeds power to 120/208-volt panelboards and other miscellaneous equipment. The building does not have a lightning protection system.</p> <p>The electrical distribution equipment was observed to be in poor condition. The majority of the electrical distribution equipment, (e.g., panelboards, transformers, electrical shutoff switches, and controllers) are original to the building construction, although some were added in the 1990s and 2000s. The original panelboards were predominantly manufactured by ITE and were obsolete. Along with the obsolete electrical equipment, common deficiencies included missing screws from panelboard covers, missing breaker covers, corrosion, or lack of specification plates on in-wall transformers. A panelboard located in room 113 was found to have open gaps between the front cover and panel housing. Gaps, loose covers, and open breaker slots should be considered life safety hazards. Several roof top safety switches feeding HVAC equipment were found to be worn and corroded.</p>	Poor

1. Investigate the cause of corrosion on panelboards and repair accordingly.
2. Repair the improperly mounted teachers' lounge luminaire.
3. Consider the removal of Token Ring LAN receptacles.
4. Investigate or replaced dated incandescent bulb fixtures on the west side of the building. These lights stay on all the time.

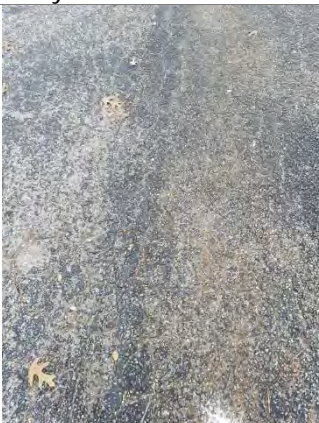
R1 alligator cracking	R1 gravel collects

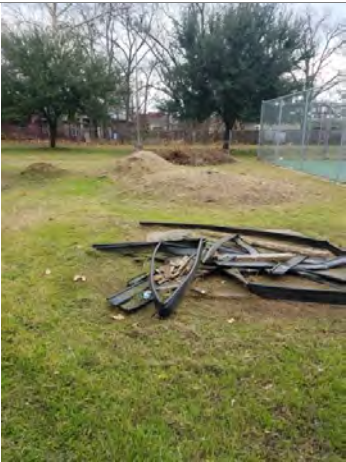
Pile of trash

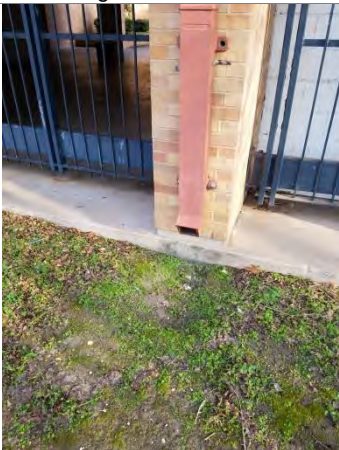
Downspout onto ground	Erosion between sidewalk and building	Broken splash pad
-----------------------	---------------------------------------	-------------------

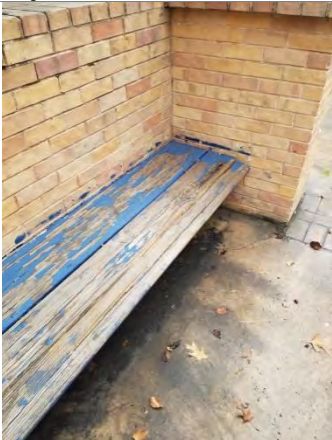
Wooden benches	Brick wall crack	Drain covered

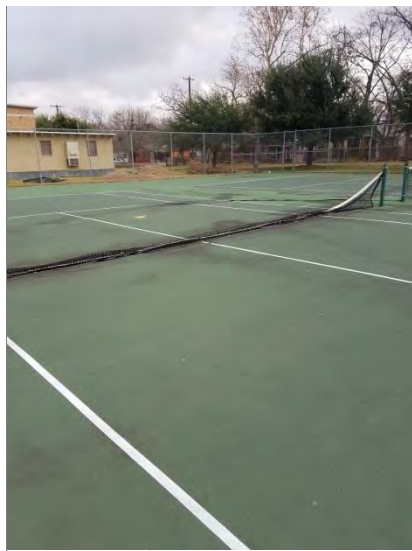
Broken tennis net	Large cracks on court	Water ponding on tennis court

1. Repair fencing
2. Clean out bird nests in lighting
