Means YWLA Site Summary

Address	6401 North Hampton Drive Austin, TX 78723
Number of Permanent Campus Facilities	2
Original Year of Construction	1958
Total Campus Building Area (combined)	132,760 SF

Bertha Sadler Means Young Women's Leadership Academy is located at 6401 North Hampton Drive in Austin, Texas. Originally built in 1958, the campus includes the Main School Building (BLDG-065A) and the Auditorium Building (BLDG-065B) with spaces for the band, orchestra, and choir. At the time of the assessment, it appeared that water infiltration remediation was taking place in both buildings. The buildings are connected by a covered walkway.

Main School Building – BLDG-065A

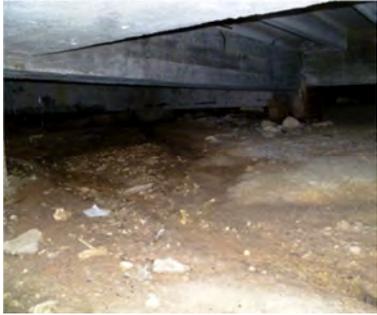
<p>Damp soil</p>

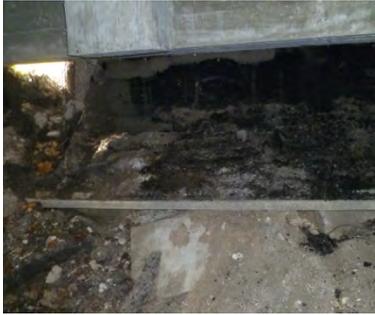
<p>Soil intrusion under perimeter beam due to failed soil retainers</p>

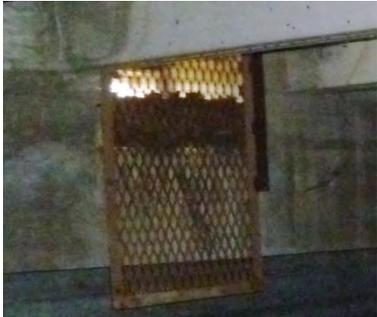
<p>Partially clogged vent</p>

1. Clear clogged areaways & vents
2. Investigate need for additional ventilation
3. Clean hatch frames/doors and protect from further corrosion
4. Fix side hatch doors that are becoming unhinged
5. Replace nonworking locks
6. Replace failed soil retainers; reset intact retainers that have settled below the perimeter beams
7. Re-grade around outside perimeter of building to ensure positive drainage away from foundation

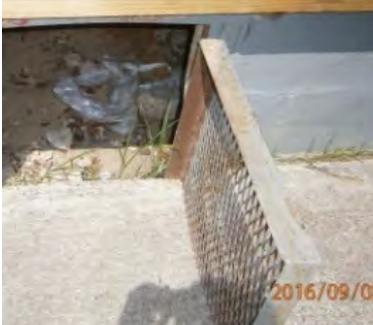
<p>Rusted hatch door & frame</p>

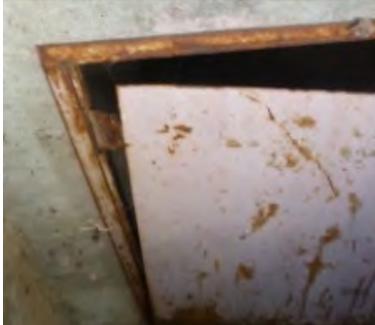
<p>Side hatch door poorly attached</p>

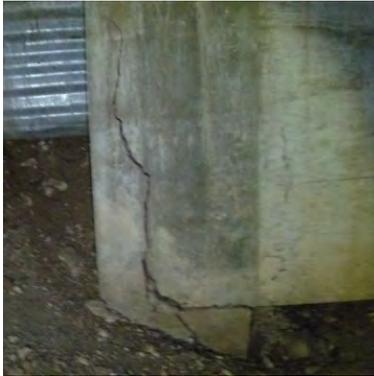
<p>Crack/separation in perimeter beam</p>

1. Clean exposed reinforcement and protect from further corrosion
2. Repair significantly spalled/damaged concrete
3. Investigate need for a structural retrofit of the cracked perimeter beam in the 600 wing, repair crack (repair method to be determined by retrofit engineer)

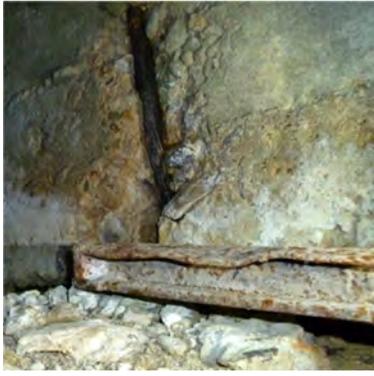
<p>Steel items embedded in beam are corroded</p>

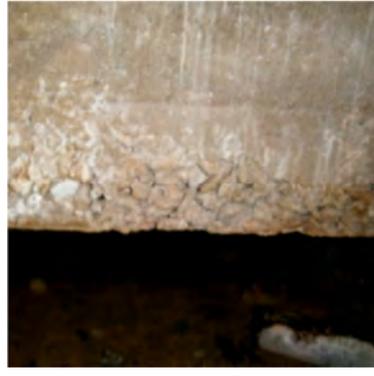
<p>Honeycombing on floor beam</p>

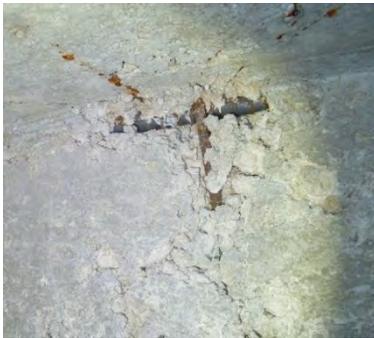
<p>Exposed reinforcement and poor consolidation in perimeter beam</p>

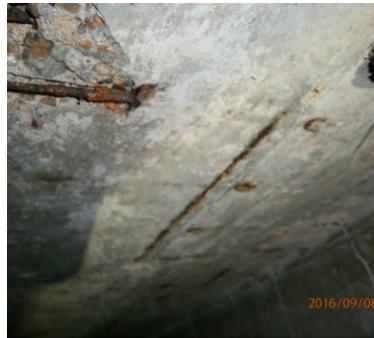
<p>Rusted reinforcement on slab underside</p>

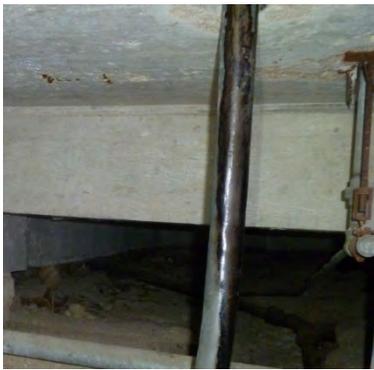
<p>Wet pipe appears to be leaking</p>

1. Repair leaking pipes
2. Repair corroded cast iron pipes & protect from further corrosion or replace
3. Replace heavily corroded hangers/supports
4. Replace degraded, moldy and/or missing pipe insulation
5. If feasible, raise pipes that are in direct contact with soil

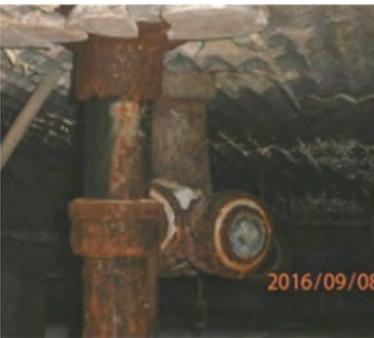
<p>Rusted cast iron pipe</p>

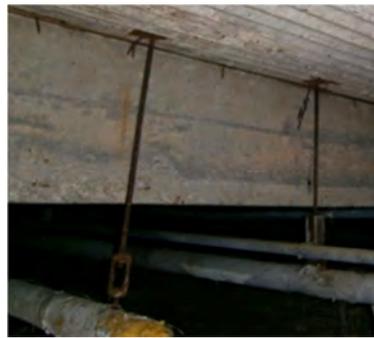
<p>Rusted pipe hangers</p>
---	--	--

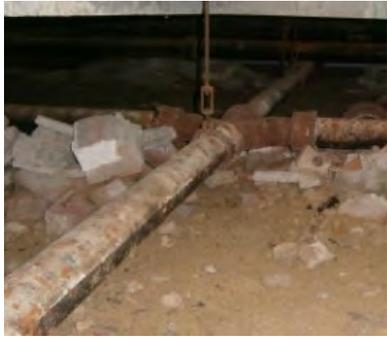
No gap between pipe and soil

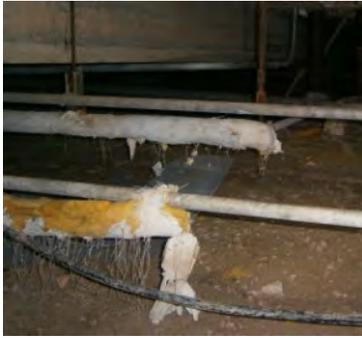
Degraded/missing pipe insulation

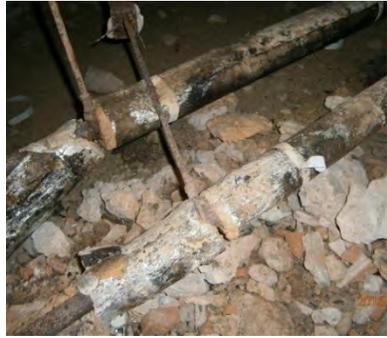
Deteriorated & moldy pipe insulation

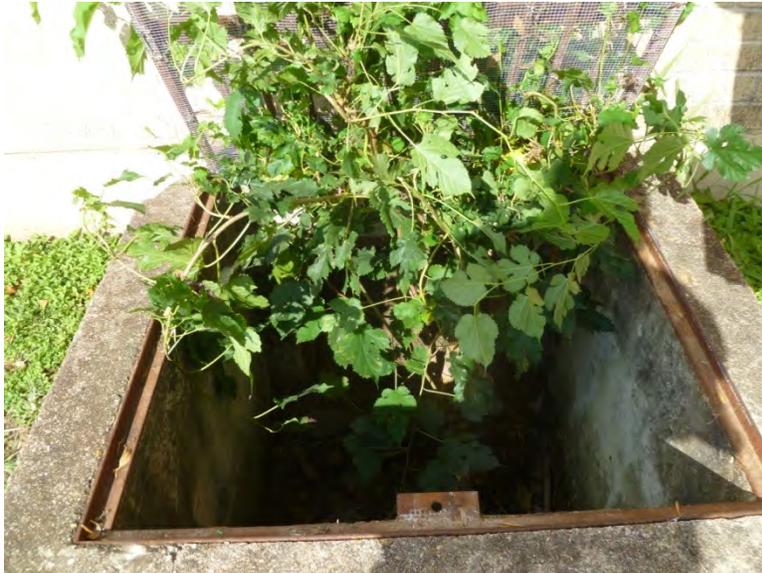
The crawl space below Building "B" could not be accessed as only the areaway access point is clogged with vegetation as seen in the photo below. Soil around the perimeter is sloping towards the building in some areas, possibly due to failed soil retainers.

1. Clear clogged areaway
2. Re-grade around outside perimeter of building to ensure positive drainage away from foundation

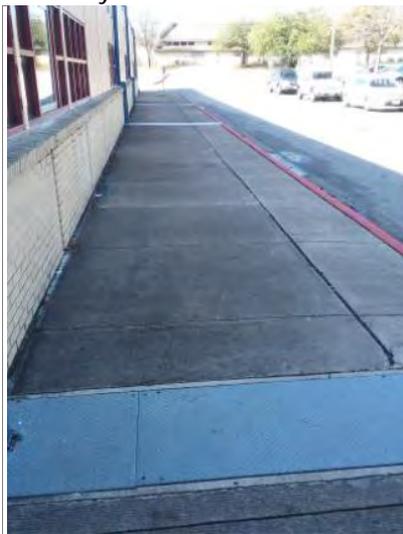
Drainage issues at R1

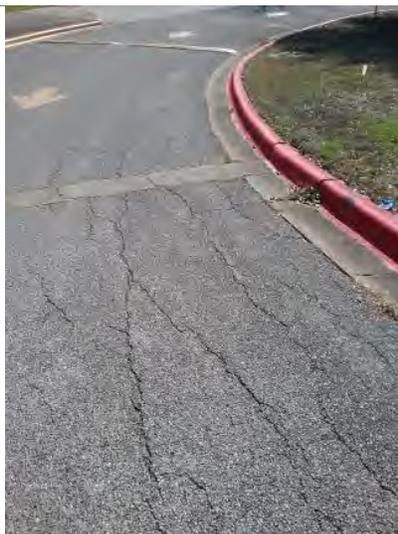
Longitudinal cracking on R2

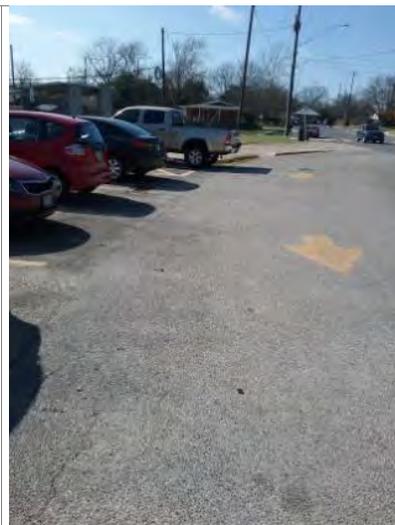
Parking area at R2

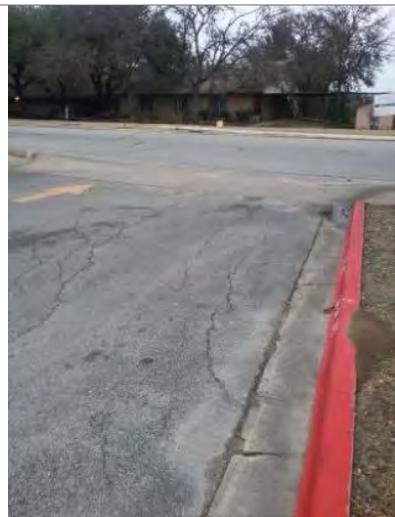
P1: Cracking leading to drive exiting to
Northeast Drive

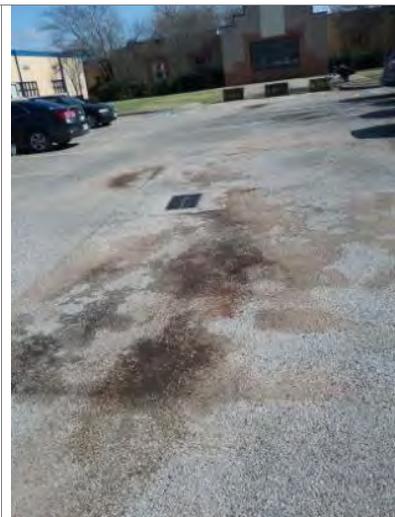
P2: Raveling around drop inlet

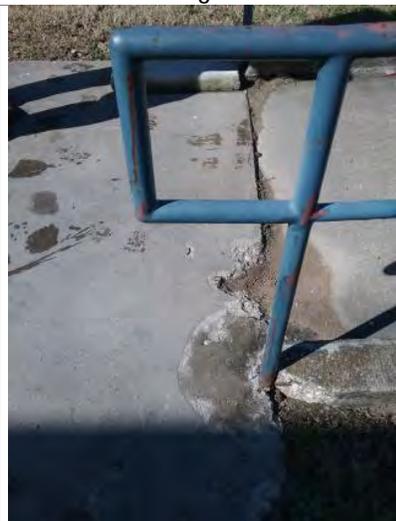
Spalling concrete near stairs at "600" building

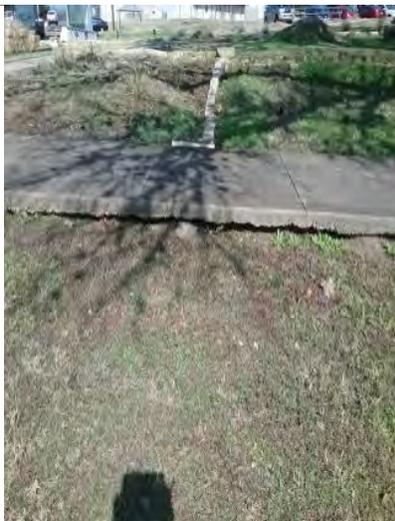
Erosion under sidewalk in garden area

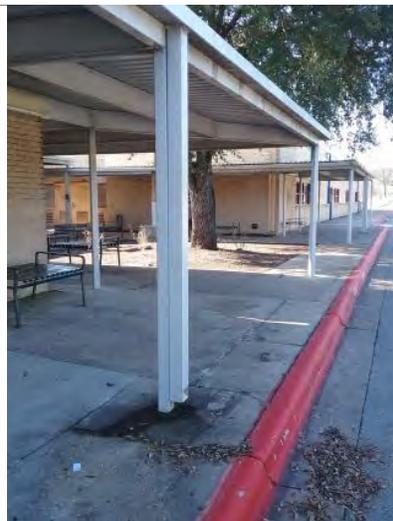
Cracking sidewalk at front entrance of school

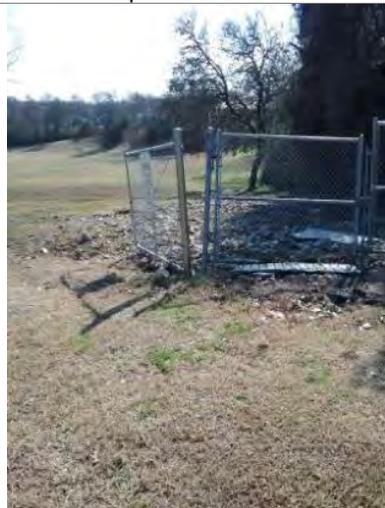
Damaged fence gate

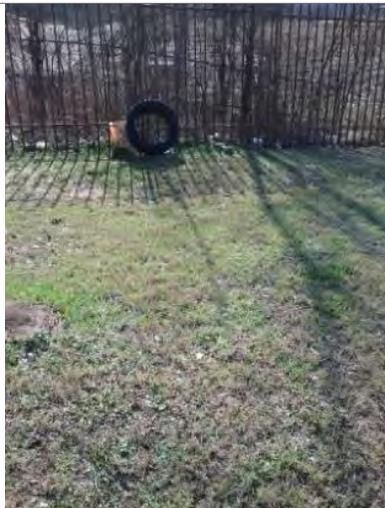
Debris at south perimeter fence

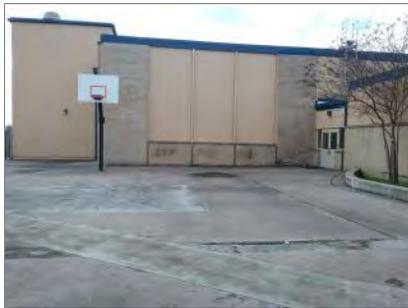
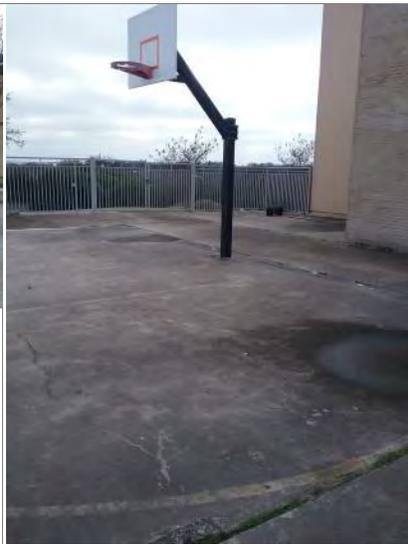
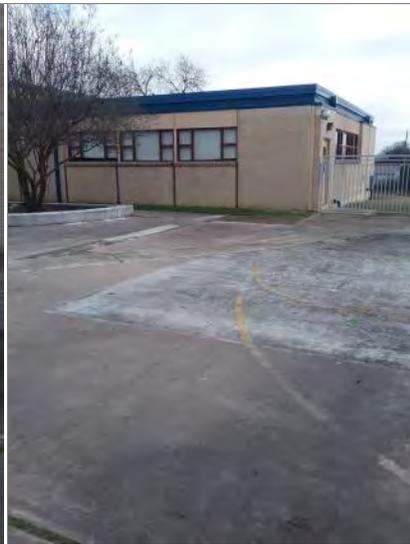
BB court with patches and cracks	Missing BB net	Repaint needed for BB court

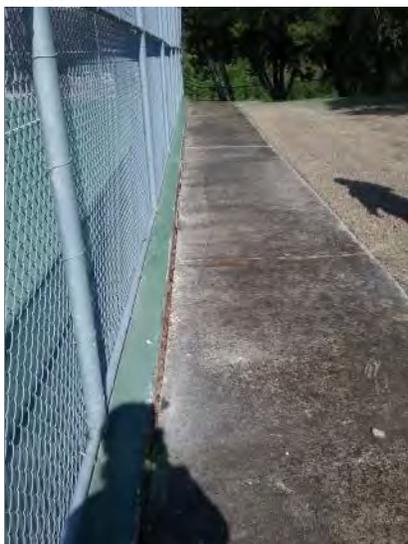
Sidewalk separation at tennis court

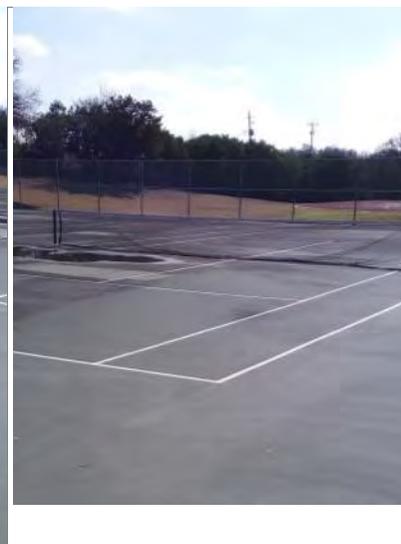
Damaged nets

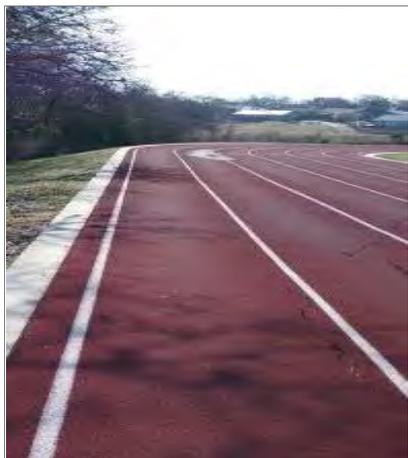
Cracking and ponding on Track

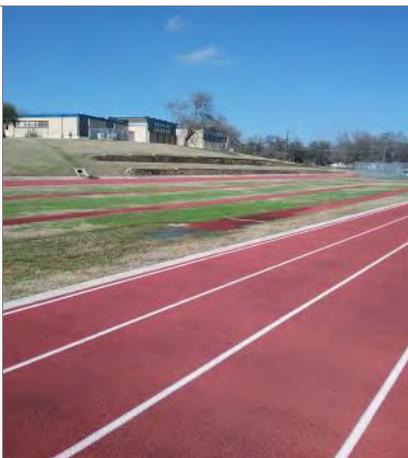
Ponding inside Track

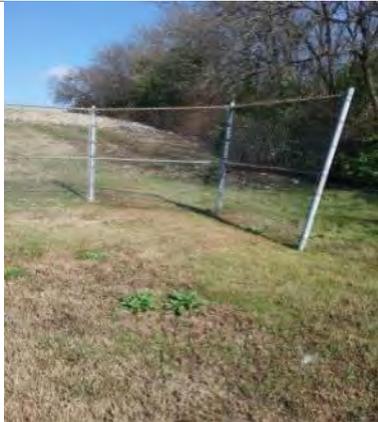
Kickball fence in need of repair

1. Drainage study required to prevent ponding on Soccer Field due to low elevation on site. High-volume area inlet in vicinity of field.
2. Re-sod and re-stripe field.
3. Replace / Repair Kickball fences.
