Mendez Middle School Site Summary

Main School Building – BLDG-058A

South Addition/Theater Building – BLDG-058B

West Addition Building – BLDG-058C

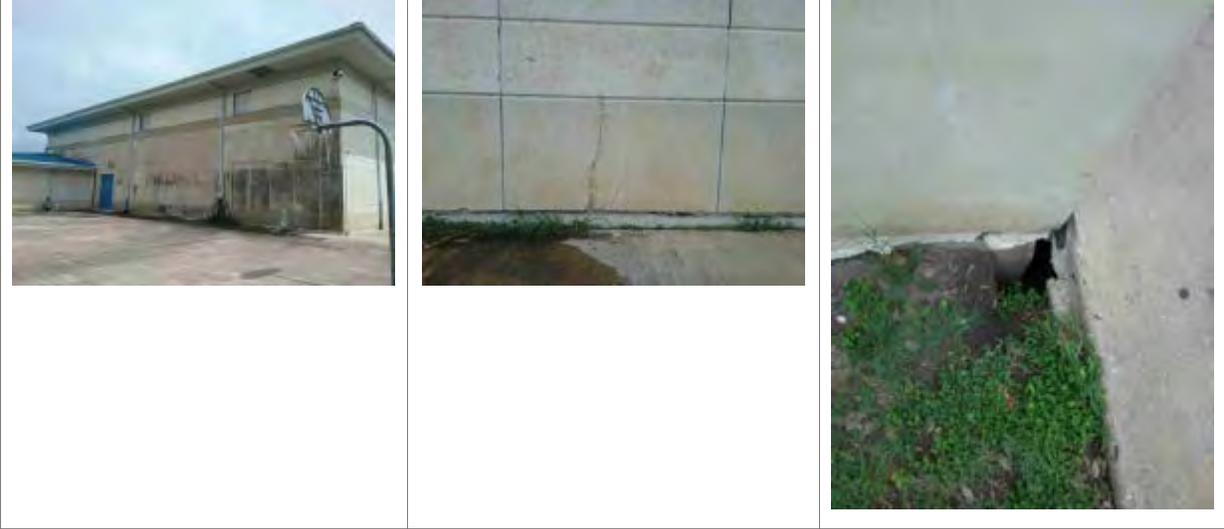
System	Subsystem	Condition and Deficiency Overview	System Condition Rating
Exterior	Exterior Walls	The exterior consists of limestone panels. The exterior construction is original and in average condition for the age of the building. The limestone panels appear to be cracked, chipped, and soiled in various locations while the joints between the limestone panels are dried, deteriorated, and missing in areas. The soil at grade around the building perimeter is eroded in some areas. A void space or hole at the joint of the building foundation and exterior concrete slab at northeast corner of building was observed at the time of survey.	Average
	Exterior Windows	The exterior windows are metal framed with single pane glazing. The windows appear to be in average condition with reported water infiltration around the window frames on the second floor of the west end of the building.	Average
	Exterior Doors	The exterior doors are metal with metal frames. There is one secure main public entryway located at the south side of the building. The entry doors and remaining service doors around the facility are metal. The doors appear to be in average condition.	Average

1. Replace cracked and chipped precast concrete panels with new panels that match the existing façade. Clean soiled panels free of dirt and moss growth. Replace joint material between precast concrete panels; typical on entire façade.
2. Clean and recaulk precast wall and bench construction at main entry as joints are deteriorated.
3. Backfill hole at the northeast corner of building with gravel and appropriate fill material. Monitor area for continued erosion problems.
4. Repair/reseal windows presenting leak issues.

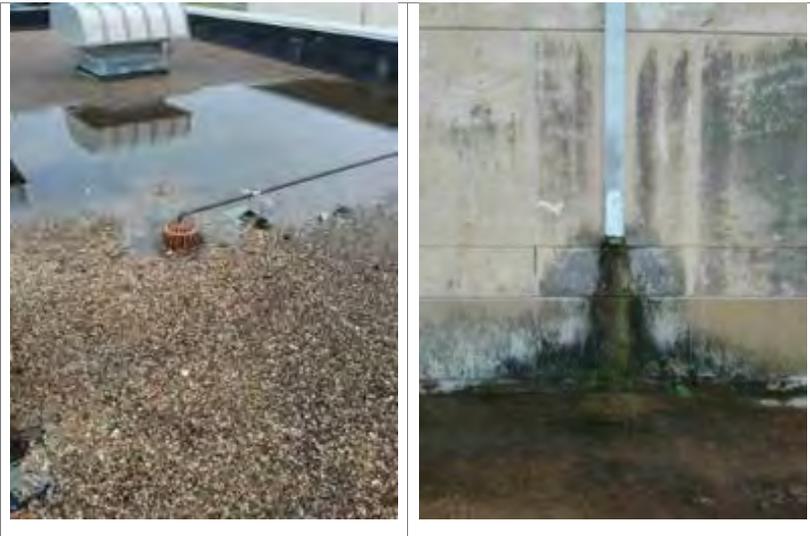
Roofing Deficiency Examples

Roofing	The roof is constructed of standing seam metal. It is in poor condition. There were multiple active leaks observed at the time of survey. Corrosion was observed on the coping edge, and minor soffit damage was observed in several areas. Water draining from the roof via the downspout system was observed to be draining directly onto the walking surface at grade or ponding along the perimeter building foundation causing a safety hazard and soil erosion.		Poor

1. Replace standing seam metal roof system complete with a new roof system.
2. Ensure downspouts drain away from building perimeter and foundation walls to prevent soil erosion.

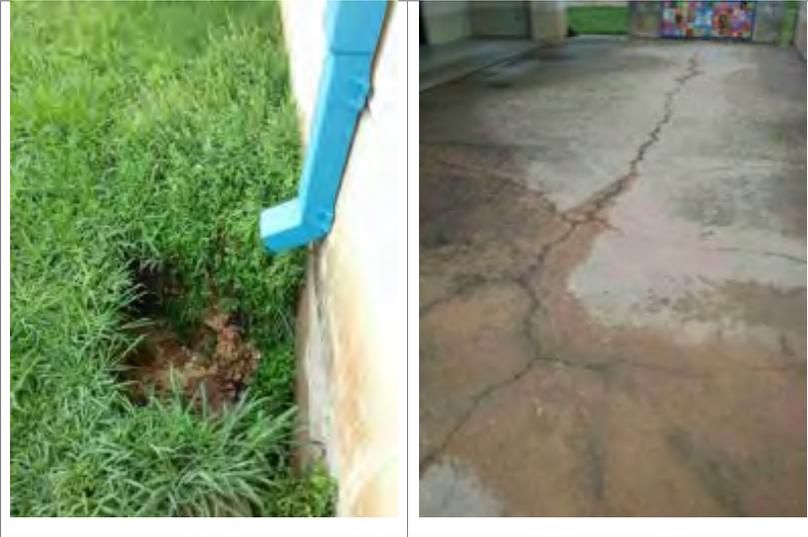
System	Subsystem	Condition and Deficiency Overview	System Condition Rating
Exterior	Exterior Walls	The exterior consists of limestone panels. The limestone panels appear to be soiled in various locations while the joints between the limestone panels are dried, deteriorated, and missing in areas. A large hole was observed at grade along the exterior foundation wall of the south façade of the building, possibly caused by soil erosion and poor water drainage. The exterior concrete patio slab located at the east façade of the building was observed to be cracked. The joint between the patio slab and building slab was observed to be deteriorated.	Average
	Exterior Windows	The windows are metal framed with single pane glazing. The windows are in average condition. The glazing was scratched and cloudy in some areas obscuring view to the exterior. Some glazing units have BB gun damage/holes.	Average

1. Clean soiled precast panels free of dirt and moss growth. Replace joint material between precast concrete panels; typical on entire façade.
2. Repaint exterior service doors ([PM Florence Rice reported this is in Summer 2016](#)).
3. Replace the exterior sliding patio doors on the east elevation with new sliding or swinging metal doors.
4. Backfill large hole observed along exterior foundation wall. Slope grade away from exterior wall.
5. Patch and repair the cracks in the exterior concrete patio slab. Replace joint between the patio slab and the building slab as it is deteriorated.
6. Replace glazing of exterior windows were scratched/cloudy or containing holes.

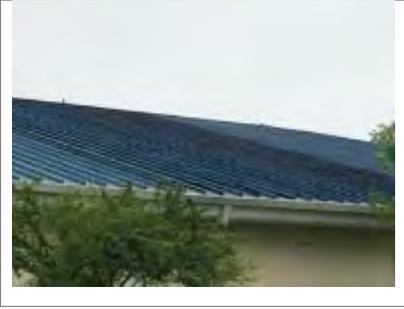
Roofing Deficiency Examples

System	Subsystem	Condition and Deficiency Overview	System Condition Rating
Roofing		The roof is constructed of standing seam metal. The roof is in poor condition. Numerous active leaks were observed in interior spaces such as the auditorium at the time of survey. The downspouts were observed to be draining directly to grade adjacent to the building perimeter, possibly causing soil erosion in some areas.	Poor
Interior Construction	Interior Walls	The interior walls are comprised of concrete masonry unit (CMU) walls or gypsum walls. Materials were in good condition.	Good
	Interior Doors	The majority of the interior doors were wood with metal frames. Metal service doors were aged, dented, and in poor condition.	Poor
	Interior Specialties	System not present.	N/A
Stairs	Exterior Stairs	System not present.	N/A
	Interior Stairs	System not present.	N/A
Interior Finishes	Interior Wall Finishes	Acoustical wall panels are utilized in the band rooms. The restroom walls consist of tile, which is aged and in average condition. AISD staff reported that the restrooms will be renovated in the near future under a funded design project. The walls in the theater were affected by water damage in some areas.	Average

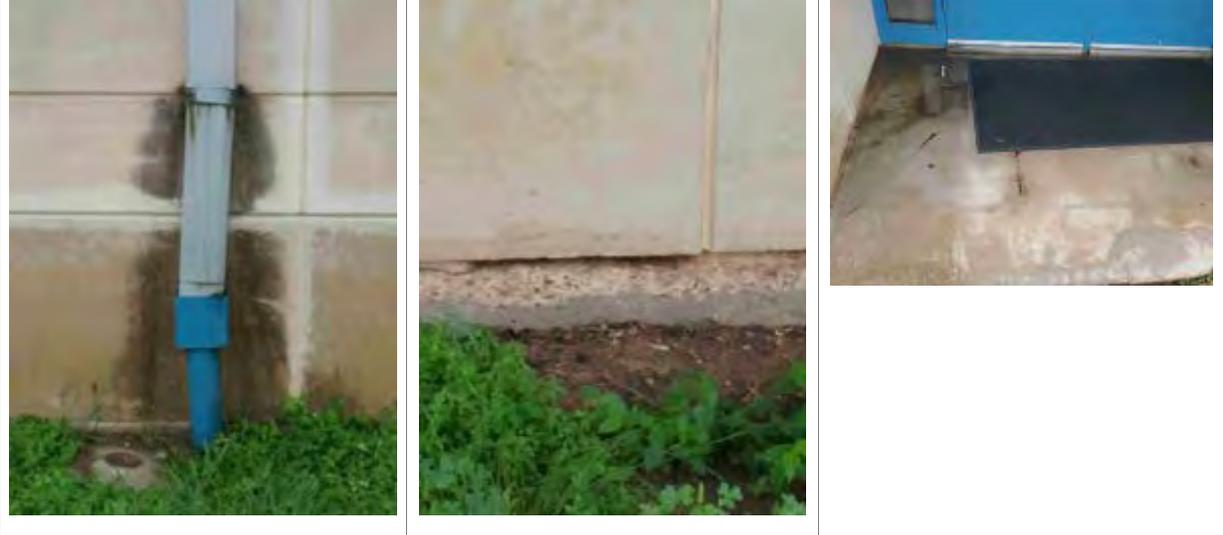
System	Subsystem	Condition and Deficiency Overview	System Condition Rating
Exterior	Exterior Walls	The exterior consists of limestone panels. The exterior construction is original. The exterior walls appear to be in good condition with minor deficiencies noted. The limestone panels are stained near the downspouts and minor, isolated chips in the panels were observed. The joint between the limestone panels and slab on grade is deteriorated or missing. Rebar is exposed in the concrete entryway slab at the north facade.	Good
	Exterior Windows	The exterior windows are metal framed with single pane glazing. The metal framed windows are in average condition, showing signs of age and cracked glazing.	Average
	Exterior Doors	The doors are metal with metal frames. There is a secure main entry located along the south elevation. The entry doors and remaining service doors around the facility are metal. There are two manually operated fiberglass roll-up doors located on the east facade of the building. The fiberglass roll-up doors appear to be in average condition showing signs of age and use.	Average

1. Patch and replace the horizontal joint between the precast panels and the slab on grade. The joint is deteriorated or missing in areas.
2. Patch repair or refinish the concrete entryway slab to cover the exposed rebar.
3. Replace glazing that is cracked or deteriorated beyond repair.
4. Clean and repaint exterior roll-up doors.

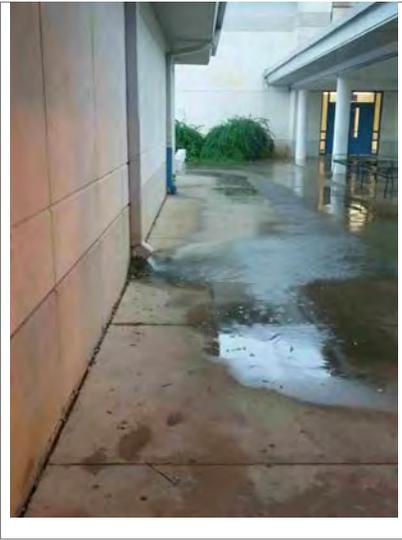
Roofing Deficiency Examples

Roofing	The roof is constructed of standing seam metal. The roof is in poor condition. Active leaks and stained ceiling tiles were observed throughout building. Water draining from the roof via the downspout system was observed to be draining directly onto the walking surface at grade or ponding along the perimeter building foundation causing a safety hazard and soil erosion.		Poor
Interior Construction	Interior Walls	The walls are comprised of CMU block or gypsum board.	Average

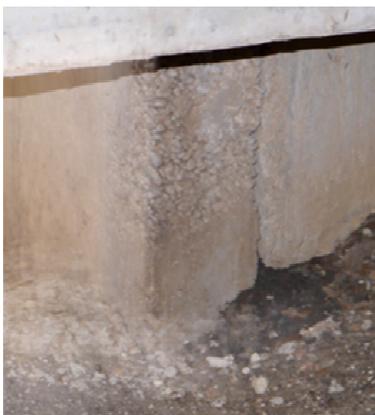
Exposed Structure

Honeycombing in areaway wall

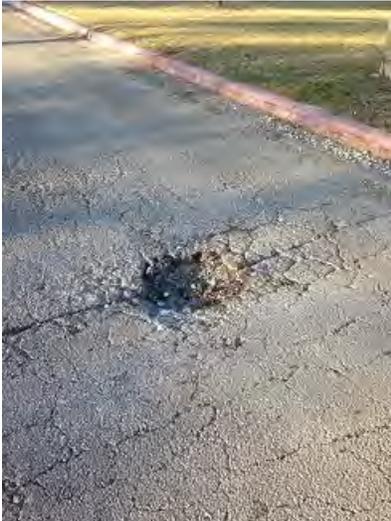
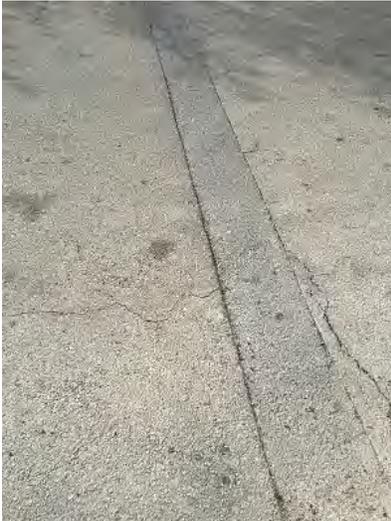
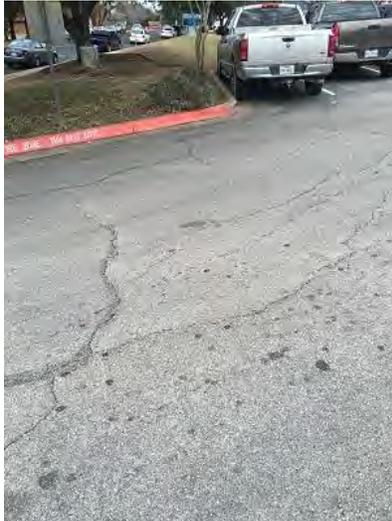
Roadways

Pothole w/ alligator cracking	Roadway patches in pavement	Cracking, surface wear

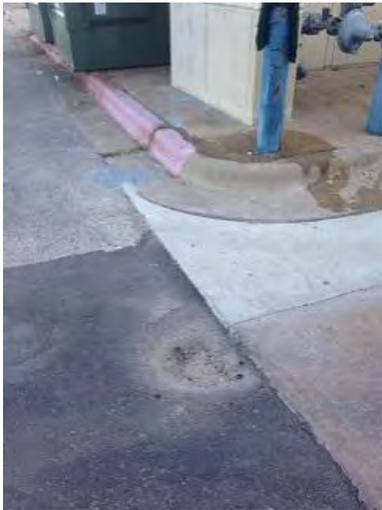
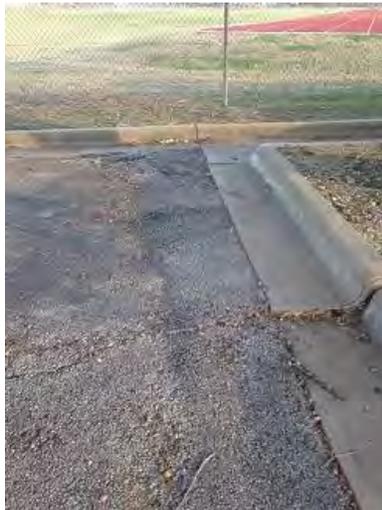
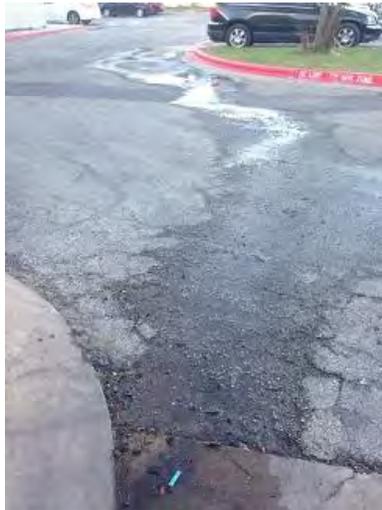
Parking Lots

Pot hole and patch	Cracking, distortion and raveling	Signs of ponding, raveling and cracking

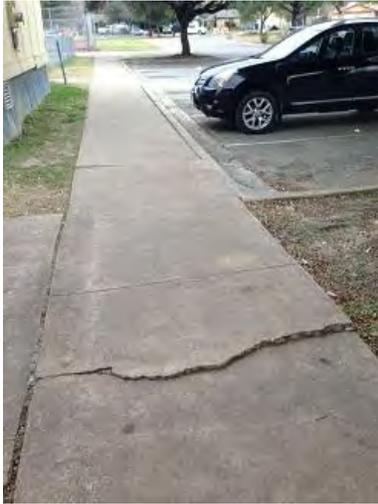
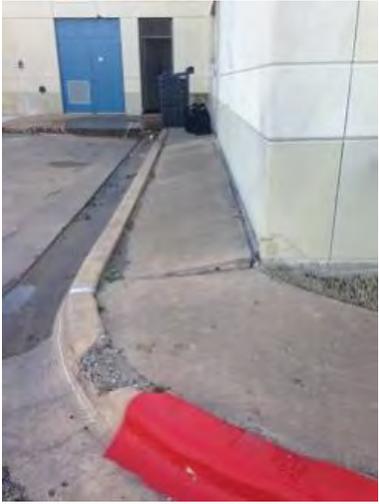
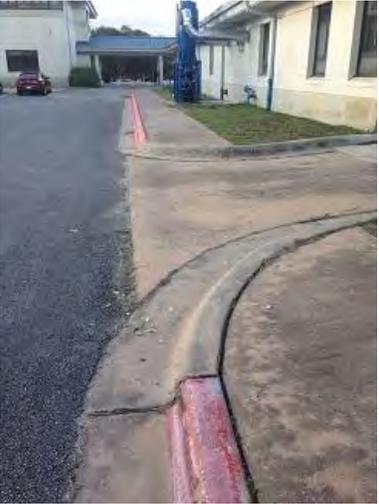
Pedestrian Paving

<p>Sidewalk cracking</p>	<p>Sidewalk sinking and heaving</p>	<p>Sidewalk needing Curb cuts</p>

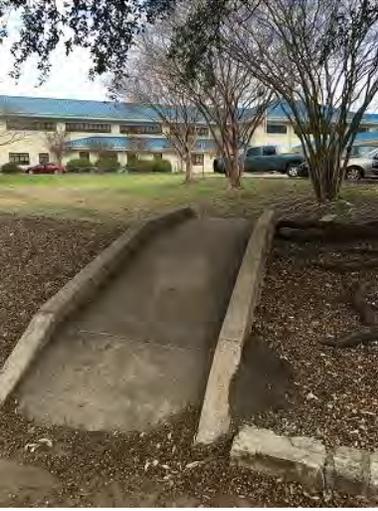
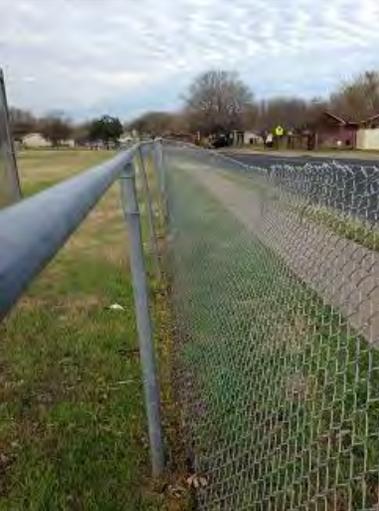
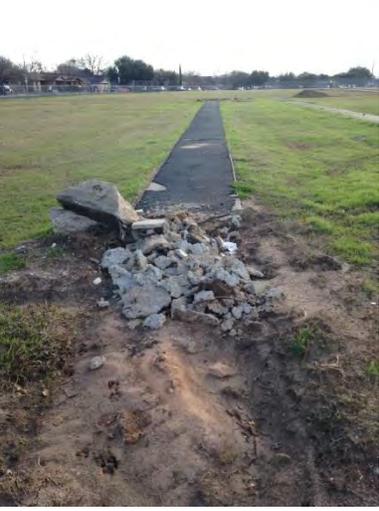
Site Development

<p>Concrete no longer needed</p>	<p>Loose fencing</p>	<p>Area of concrete/debris needs to be removed</p>

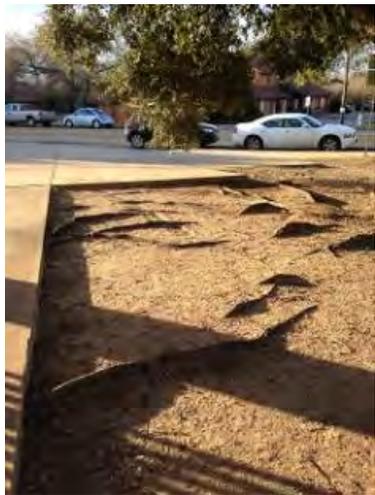
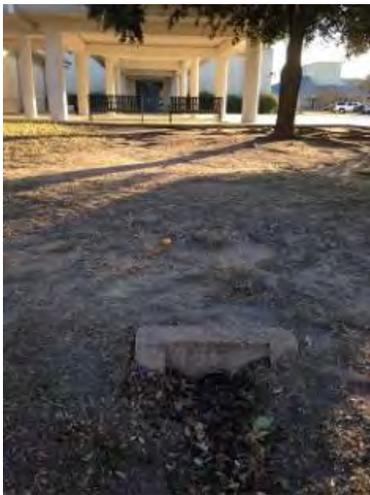
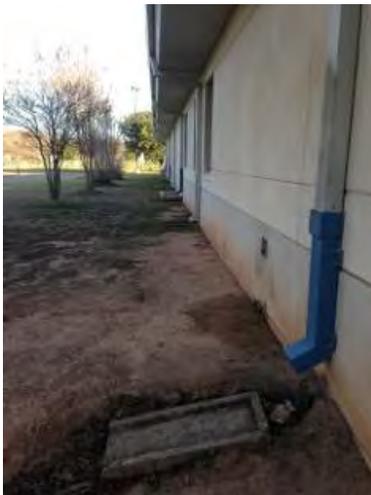
Landscaping

<p>Area with no landscaping</p>	<p>General landscaping</p>	<p>Erosion and lack of grass</p>

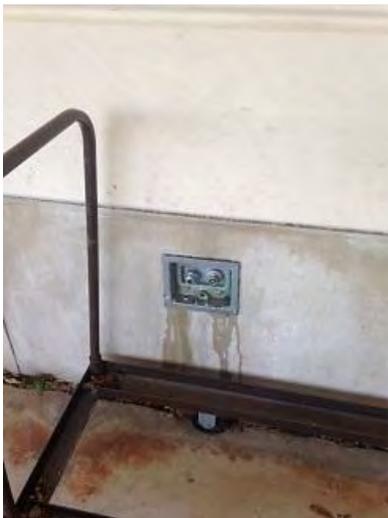
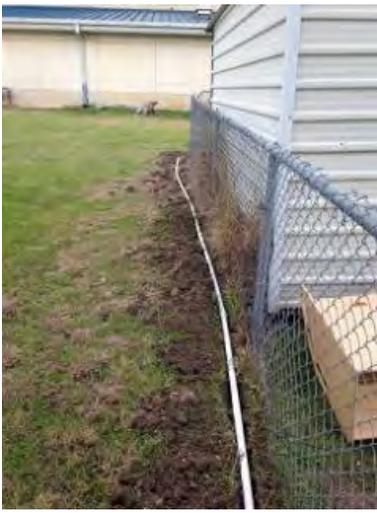
Water Supply

<p>Water leaking</p>	<p>Uncovered irrigation pipe</p>

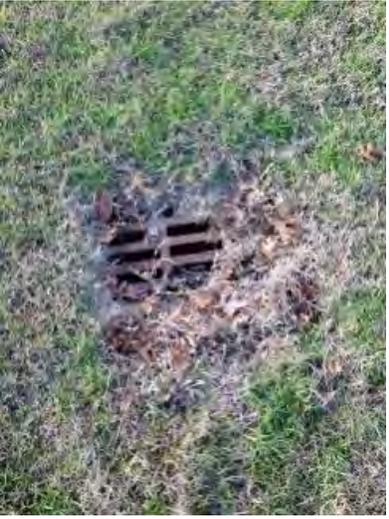
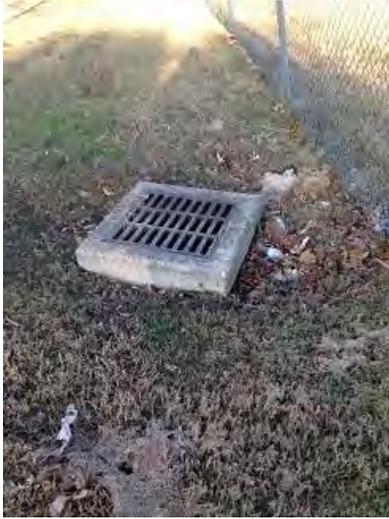
Storm Sewer

<p>Grown over inlet</p>	<p>Grade inlet to drain</p>

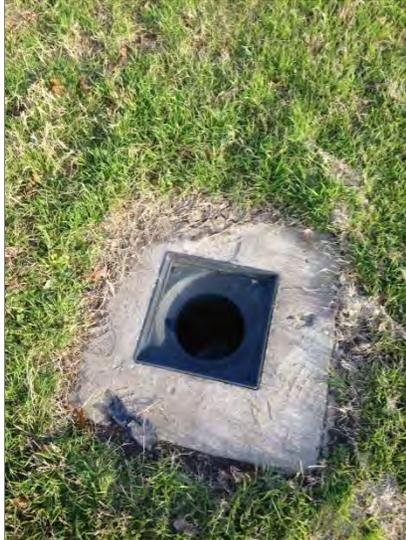
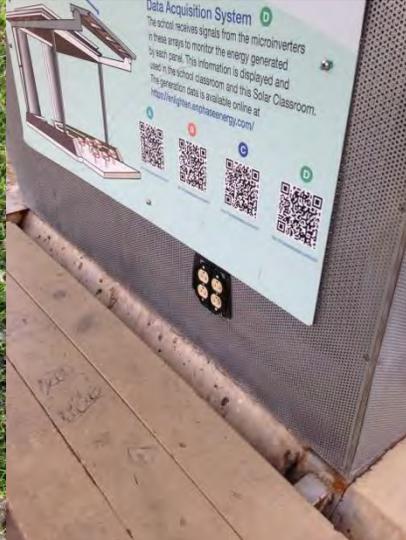
Other Site Mechanical Utilities

<p>Missing utility cover</p>	<p>Missing outlet cover</p>

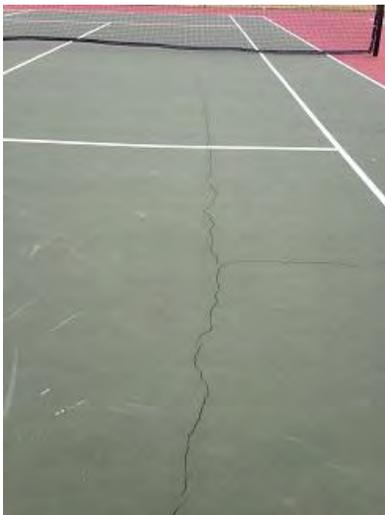
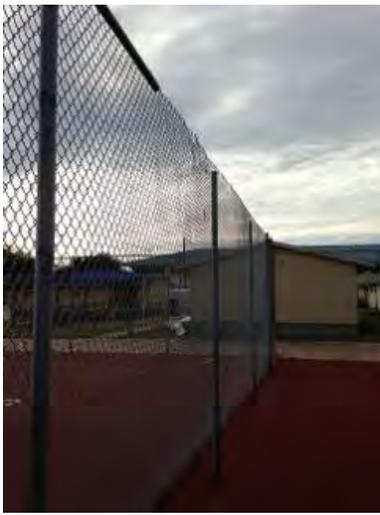
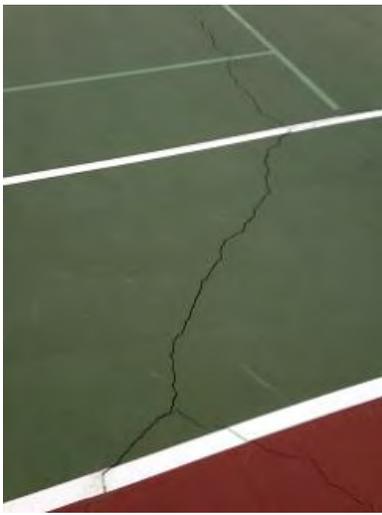
Tennis Court

Cracks in tennis court	Broken fence	Cracks in tennis court

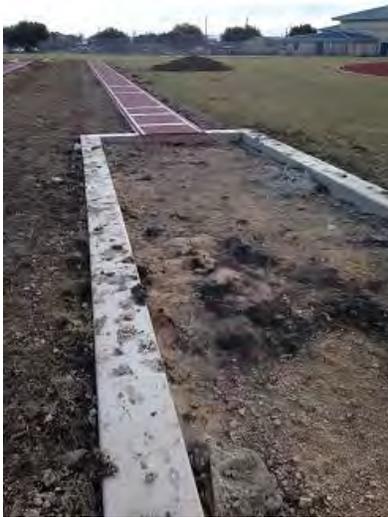
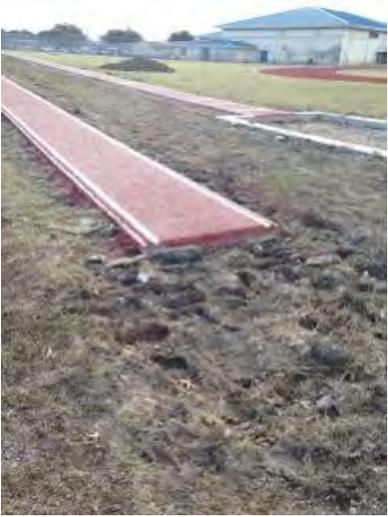
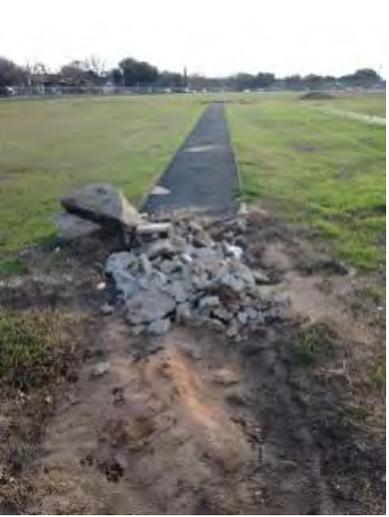
Track

Lack of sand in long jump (under construction)	Landscaping / sod around new tracks	Remove old track and debris

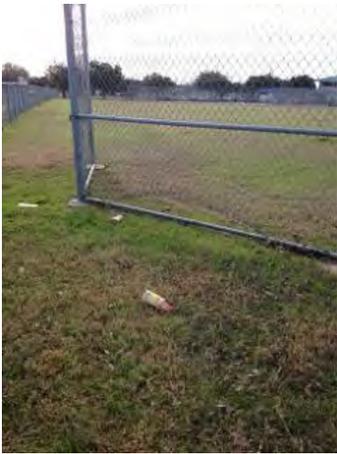
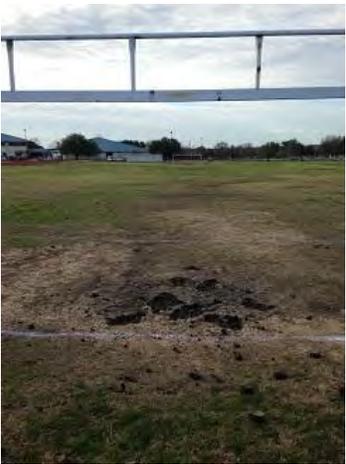
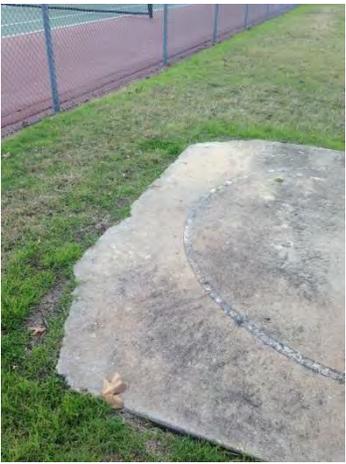
Baseball/ Soccer/ Shotput

Damaged baseball fence	Damaged soccer field	Broken shotput pad

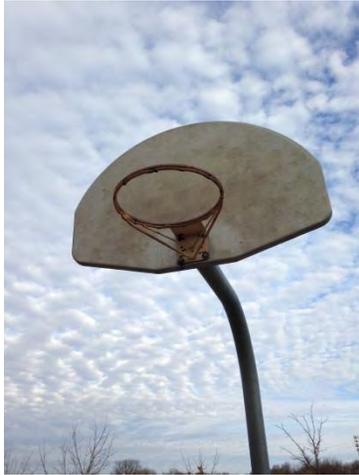
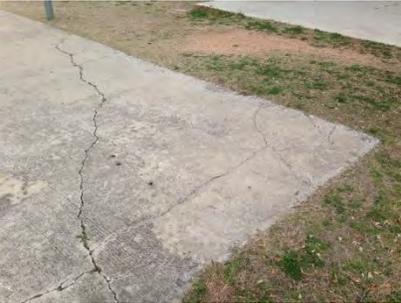
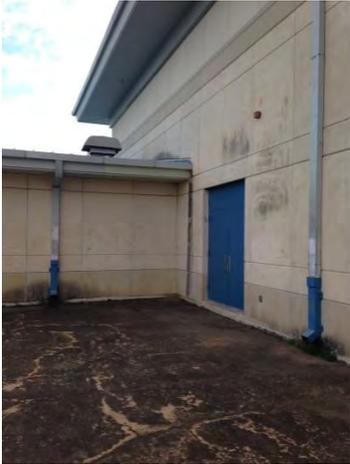
Basketball Courts

<p>Deteriorating BB hoop</p>	<p>Cracking BB court</p>	<p>Worn and mildew BB court</p>

1. Repair cracks in concrete.
2. Install new backboards, rims and nets.
