Murchison Middle School Site Summary

Introduction

Main School Building – BLDG-052A

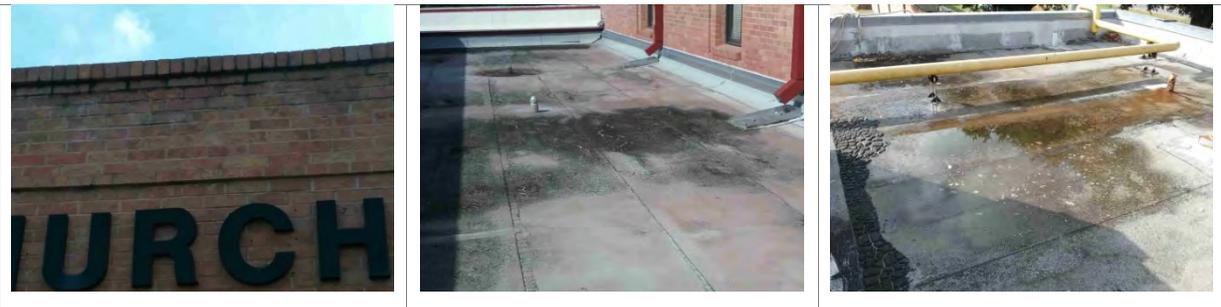
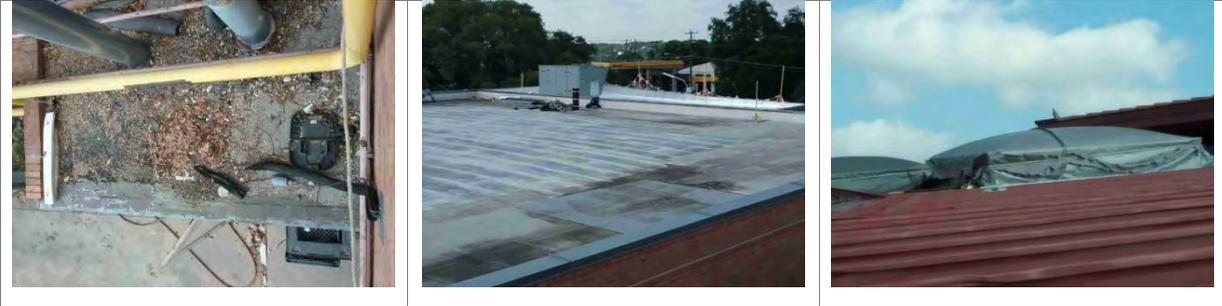
Roofing Deficiency Examples

Roofing	<p>There are 14 different roof areas for this building: More than half of the roofs are single-ply membrane, while others were standing seam metal. Of the single-ply type, only the areas over the small gymnasium, locker rooms, and band/art wing were in average condition. The remainder of the roofs (over the cafeteria, kitchen, and covered halls) appeared to need replacement. The roof over the water heater closet (A-20) adjacent to the kitchen was in very poor condition. The roof-covered entry sidewalk on the cafeteria side (A-25) lacks a metal cap over the brick parapet, and signs of deterioration were evident. The roof over the kitchen (A-27) was in very poor condition, and water was ponding from an AC unit. The roof over the cafeteria showed signs of ponding, and staff have reported leaks. It was reported that the skylights leak in both the small and large gymnasiums. Teacher James Wood reported the following: evidence of ponding was observed at all roof locations, insufficient slope and too few drains at all locations, no parapet cap or deteriorated caps at all locations, and flashing was improperly installed or missing.</p> <p>The large standing seam metal roof covering the second floor classroom area appeared to be in average condition from above; however, classrooms under these roofs have significant leak stains on the ceiling of each classroom. Principal Rebekah Van Ryn reported that a metal cap is not sufficient to prevent storm water infiltration.</p>		Poor

1. Replace roof sections experiencing extreme deterioration.
2. Investigate standing seam metal roofs possible leaks over classrooms.
3. Investigate skylights that were reported by staff to leak.

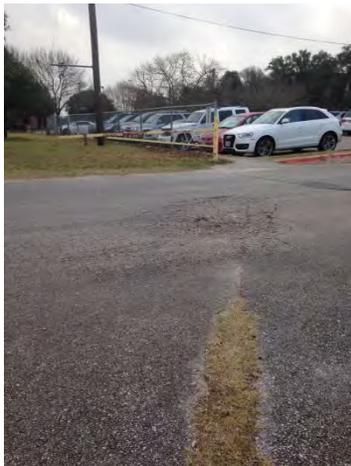
Pothole with alligator cracking in drive	Roadway patches in pavement	Cracking and surface wear

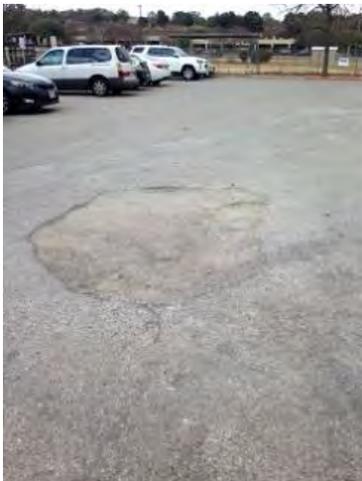
Pot hole and surface wear	Cracking in maintenance / loading dock	Signs of ponding / sediment in wheel chair ramp area

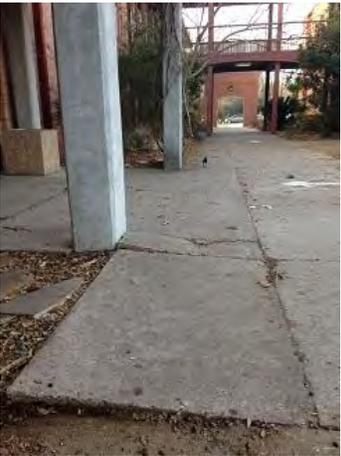
<p>Sidewalk cracking & poor drainage</p>	<p>Sidewalk sinking below curb</p>	<p>Sidewalks cracking / sinking</p>

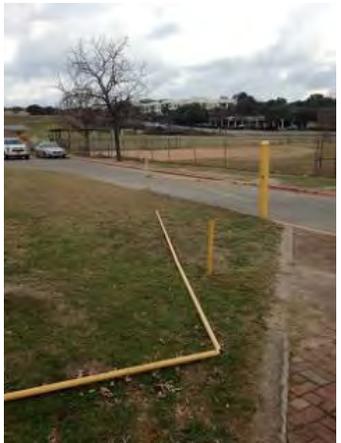
<p>Broken barrier rail along driveway</p>	<p>Hole in fencing</p>	<p>Areas of trash on site, mold</p>

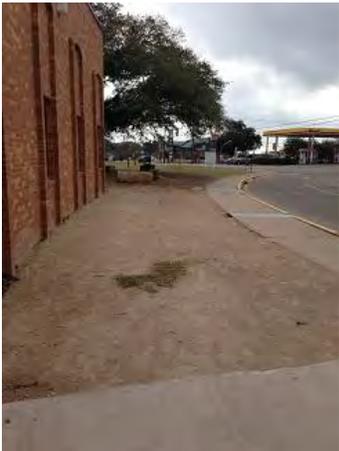
<p>Area at front with no landscaping</p>	<p>Damaged planter fencing</p>	<p>Broken irrigation spout</p>

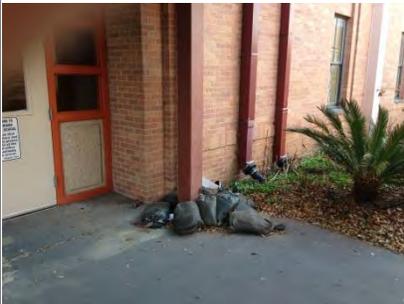
<p>Sand bags to prevent flooding</p>	<p>Gutter drains do not tie to underground</p>	<p>Condensate pipes do not tie to underground</p>

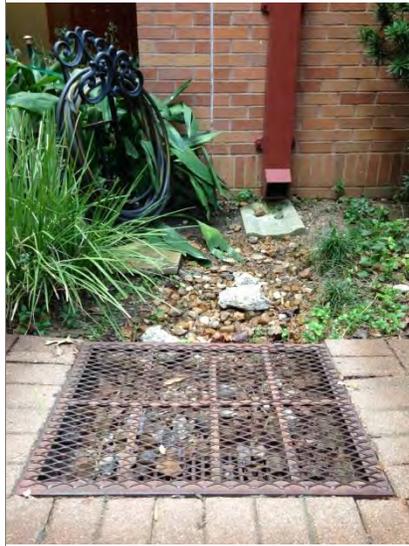
<p>Maintenance needed for dissipation rocks</p>	<p>Heaving/ distorted brick pavers</p>	<p>Water leakage into school from courtyard</p>

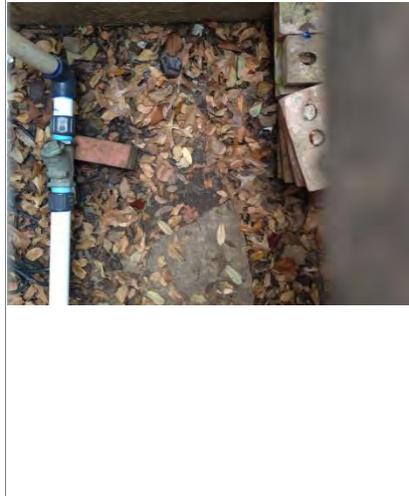
<p>Unsecured piping in crawl space</p>	<p>Uncovered utilities</p>	<p>Lack of grading around utilities</p>

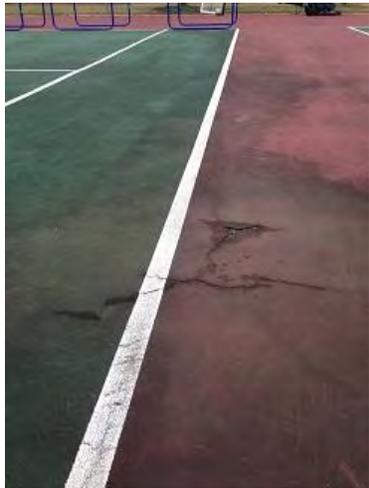
Cracks and hole in tennis court	Broken fence posts at concrete	Ponding on court

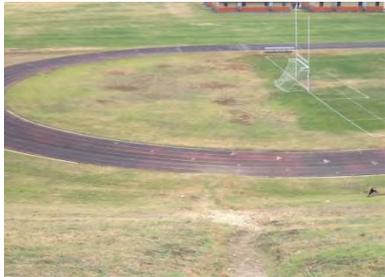
Worn grass behind goal post	Damaged field drain inlet

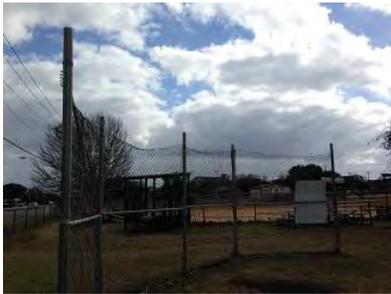
<p>Damaged fence/ lack of fence</p>	<p>Pavers around portions of the field</p>	<p>Exposed wiring on tower in center of fields</p>

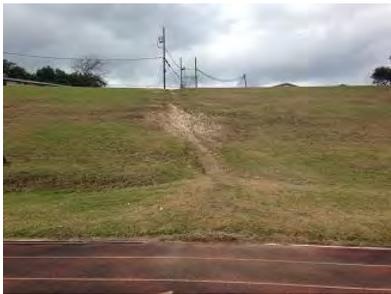
<p>Erosion occurring on hill coming onto track</p>	<p>Erosion control fence covered up</p>	<p>Edge cracks and curling / surface wear</p>
