## O. Henry Middle School Site Summary

## Main School Building – BLDG-047A

### System Deficiency Overview

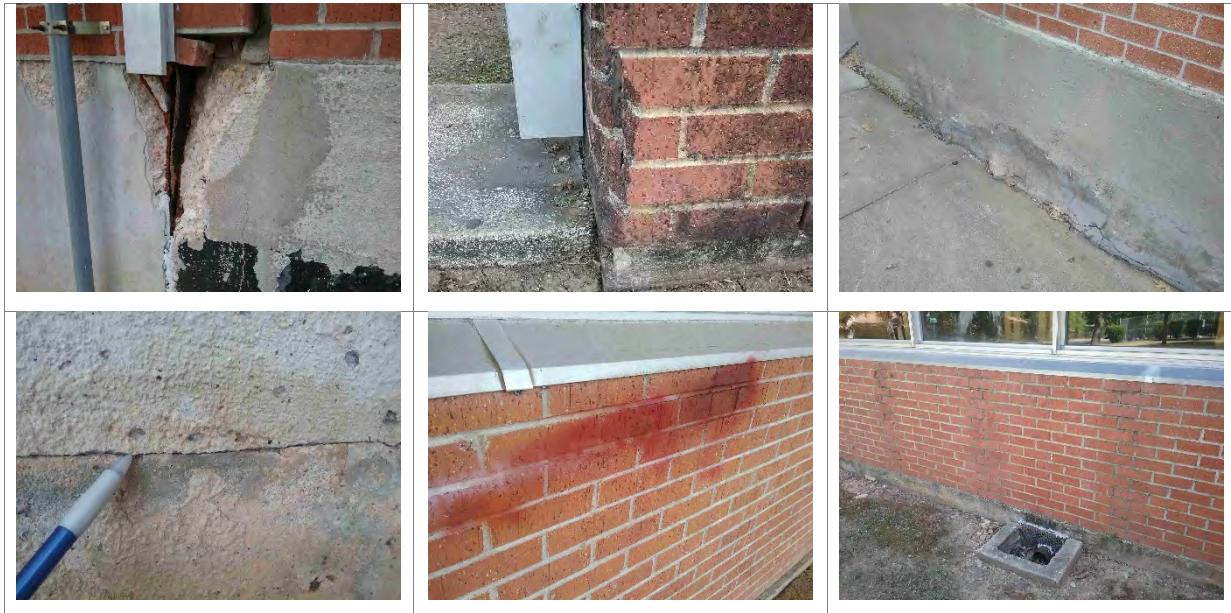
#### Exterior Walls

| System | Subsystem | Condition and Deficiency Overview | System Condition Rating |
|---|---|---|---|
| <b>Exterior</b> | Exterior Walls | <p>The exterior walls of O. Henry Middle School are faced with brick in a running bond with accents of soldier coursing. The double-height portion of the building is clad with flat metal wall panels.</p> <p>The exterior walls were observed to be in average condition with a few areas of damaged materials and discoloration. A portion of the exterior wall was damaged, exposing the waterproofing membrane beneath the surface on the north east side. A few broken corners of brick were observed throughout the building. The foundation wall near the exterior doors of corridor 3 was deformed. There was also a long hairline crack in the foundation wall running the length of the 700-wing. Spray painting on walls was observed outside the 600-wing. Discoloration was observed at the weep holes beneath windows on the north side of the 500-wing. It was reported that the administration offices, which was constructed at a different time than the rest of the facility, may have a foundation problem due to settling at a different rate than the main facility. Roaches and rats were reported throughout the facility, and an excessive quantity of roaches were observed during the assessment.</p> | Average |

1. Repair or patch areas of broken concrete and brick. Investigate for damage caused by waterproofing exposure.

2. Investigate cause of deformed foundation wall and determine structural integrity.
3. Remove spray paint and clean discolored walls.
4. Clean all window frames and panes.

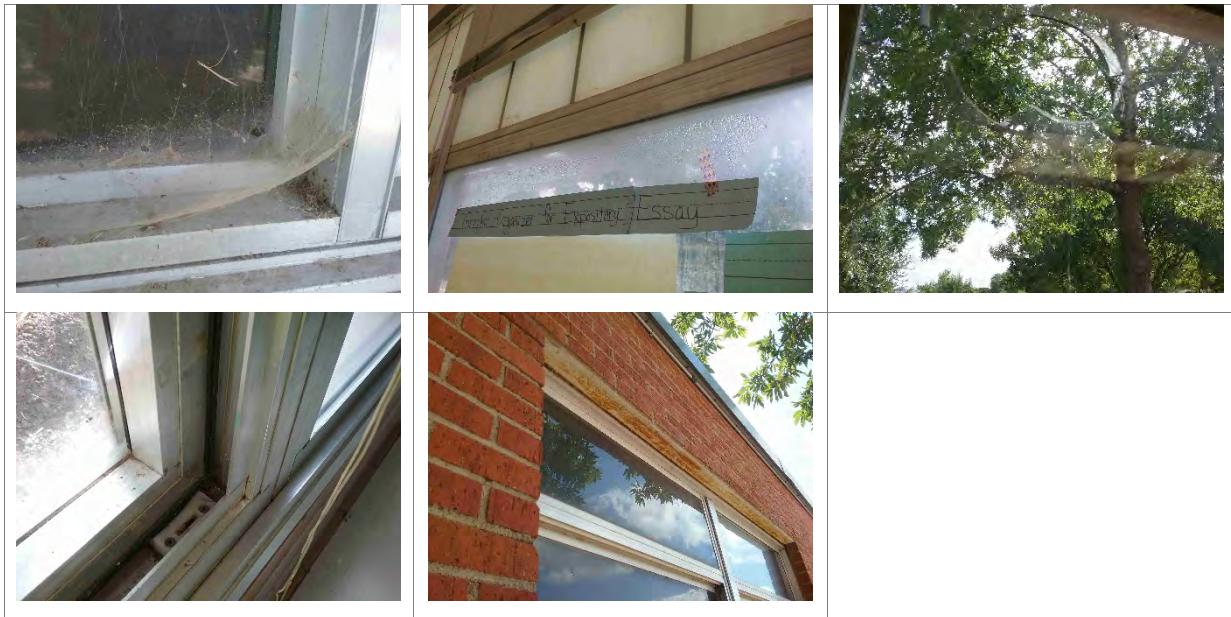
#### Exterior Windows

| System | Subsystem | Condition and Deficiency Overview | System Condition Rating |
|---|---|---|---|
| | Exterior Windows | The majority of the exterior windows are a system of aluminum-framed, double-pane windows oriented in horizontal bands. There are also some fixed translucent kalwall windows in aluminum frames. | Average |

| System | Subsystem | Condition and Deficiency Overview | System Condition Rating |
|---|---|--|---|
| | | <p>The window frames were in average condition, but no water damage was observed. It was reported that the windows along the south east side of the cafeteria and COR7 facing the courtyard suffer water intrusion during rain events. Many of the window frames were dirty. Condensation and fog were observed in some of the double pane windows, especially in the 100-wing in the south side classrooms. Many cracked or broken window panes were observed throughout the school. The construction manager on site reported that repairs to all broken panes are planned. An operable window in room 102 would not shut. It was reported that there are also window operations issues in the 100-wing facing the street, 500-wing facing the courtyard, and 600-wing facing the north side of the facility. The lintels outside the male locker room were rusting.</p> | |

5. Replace window panes with condensation and ensure proper seal.
6. Replace broken or cracked window panes.
7. **Repair windows that do not close or leak.**

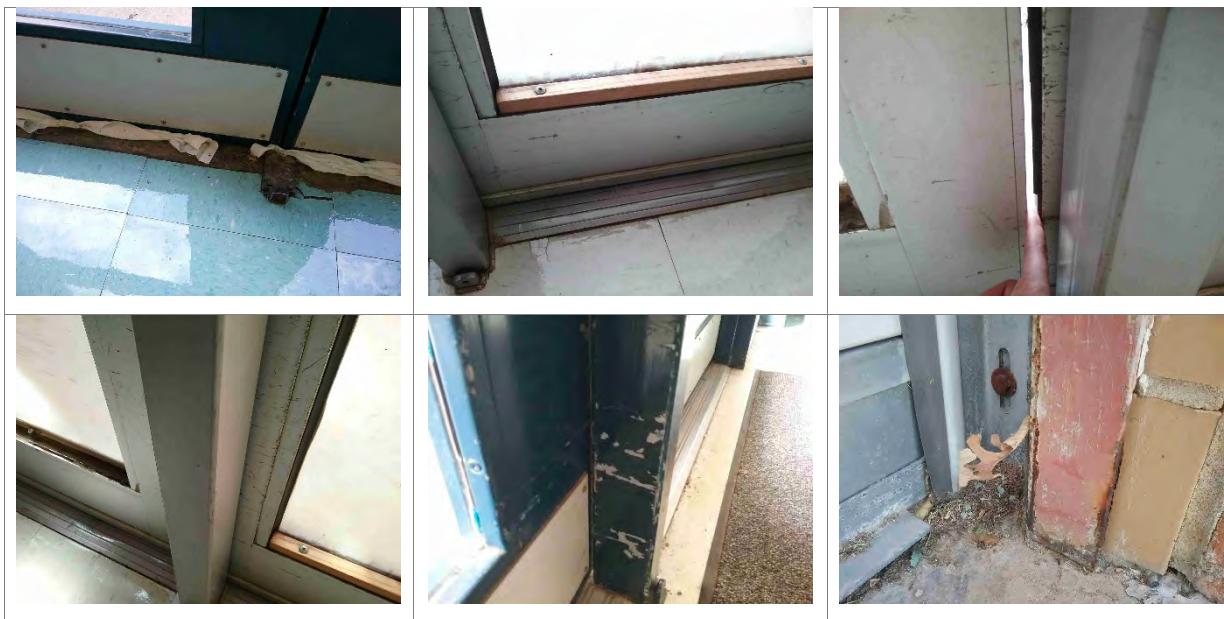
**Exterior Doors**

| System | Subsystem | Condition and Deficiency Overview | System Condition Rating |
|---|---|--|---|
| | Exterior Doors | <p>There is one main public entryway located at the northeast side of the building. These doors are glazed metal doors inserted into a metal storefront system. The remaining exterior doors are constructed similarly. There are a total of three metal overhead doors in the building, one interior to the kitchen, and two exterior doors.</p> <p>The exterior doors were observed to be in average condition. It was reported that the three exterior doors on the north side of the facility and adjacent to the main gymnasium and custodial office stick at times. Sticking was not observed during the assessment. In the 400-wing, a door had fabric stuffed between the door and the threshold. The exterior doors adjacent to room 601 were in poor condition as follows: the frame for the door glazing was damaged; the frame of one leaf had been replaced with a strip of wood; a centimeter-wide gap was observed between the doors when closed; the frame and glazing were scratched; and the single-pane glazing was fogged. Other doors throughout the school were scratched or slightly dented. The overhead rolling doors appeared to be in good operating condition, though the frame and lintel of the overhead rolling door is rusting on the north end of the 600-wing.</p> | Average |

8. Investigate rusting lintels for structural integrity. Replace if necessary. Repaint as required.
9. Investigate the operation of the three exterior doors on the north side of the facility and adjacent to the main gymnasium and custodial office. Repair or replace if necessary.

10. Install weatherstrip under door in 400-wing where fabric is currently present.
11. Replace exterior door system adjacent to room 601.
12. Repaint all scratched doors.

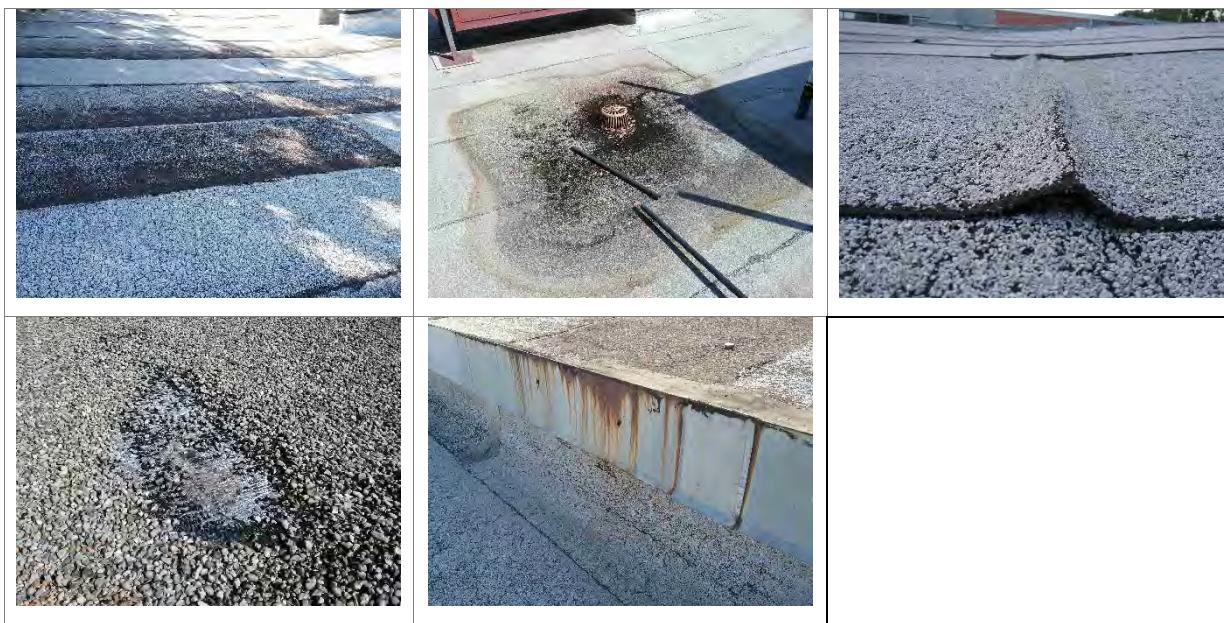
**Roofing Deficiency Examples**

| System | Subsystem | Condition and Deficiency Overview | System Condition Rating |
|---|---|---|---|
| | | The roof conditions ranged from good to failing. The modified bitumen roof was very aged, showing much of the black beneath the cracking top layer. Many areas of the roof were discolored, possibly from standing water, and the area around a couple of roof drains appeared to be improperly sloped. Many bubbles and folds were observed on the roof, which appeared to have resulted in gapping at sheet overlaps. The coatings at the top of the ridges were deteriorated. Rust stains on the edge fascia were also observed. The built-up roof was aged. Much of the tar beneath the granular topping was exposed. Roof leaks were reported over the administration offices, and the roof was extremely worn in many areas. Above the administration offices, the membrane was worn through such that the roofing insulation was clearly visible in many spots. Displaced gravel was observed in other areas as well. The built-up roof over the cafeteria was constructed in 2004 and appeared in good condition. | |

1. Repair roofing above administration offices. Inquire about roofing warranty immediately.
2. Further investigate all roof areas observed with discoloration to reslope to proper drainage points. Include areas around roof drains.
3. Refinish areas of roof with folded, bubbled, or gapping membrane.
4. Regravel built-up roof to cover areas of displaced gravel.

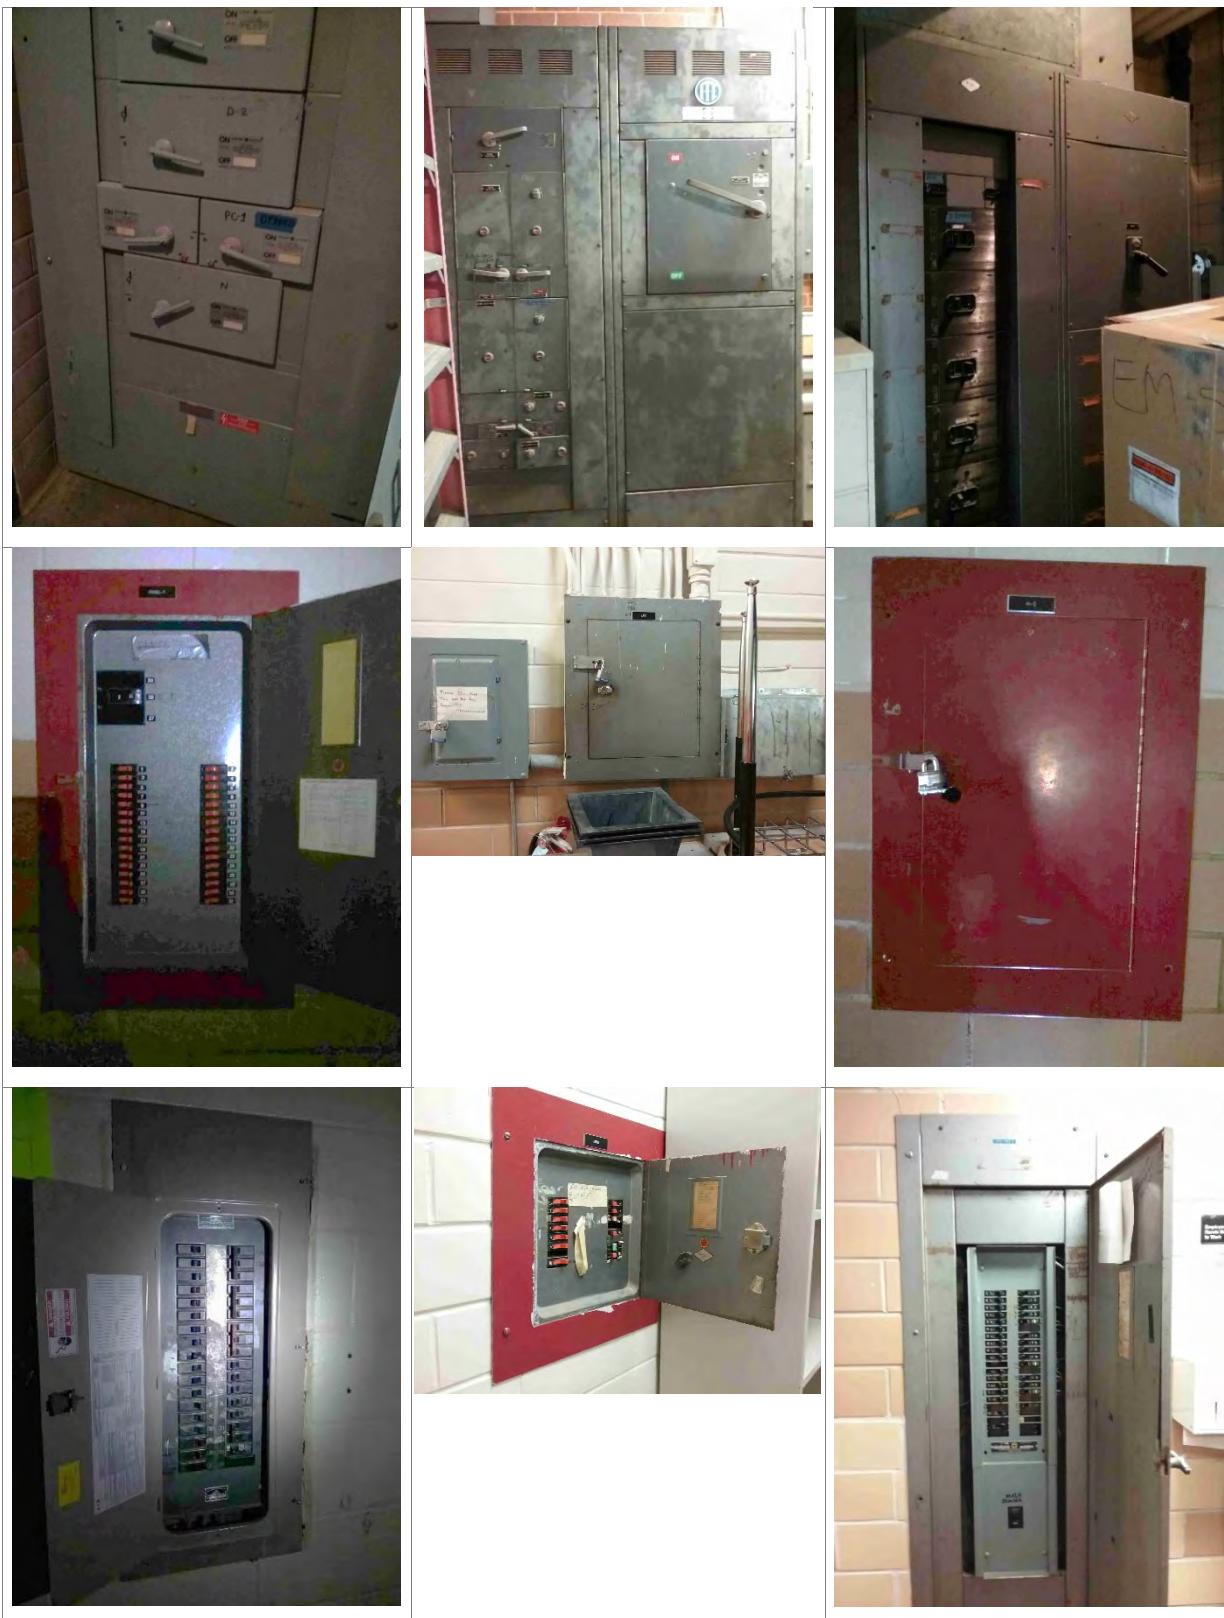
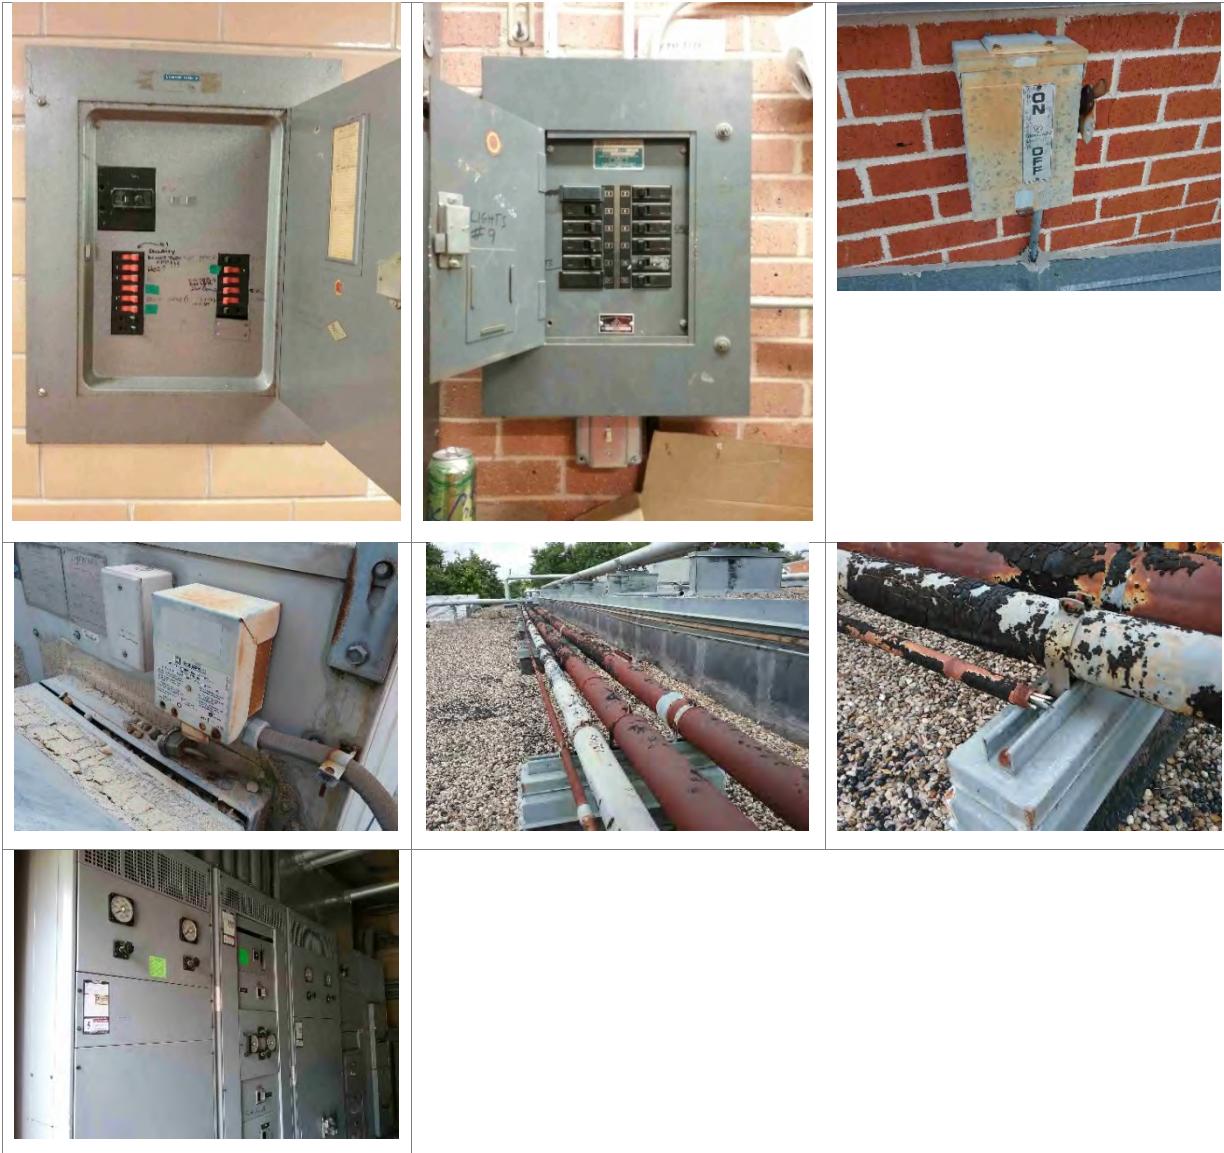
### Electrical Distribution

| System | Subsystem | Condition and Deficiency Overview | System Condition Rating |
|---|---|---|---|
| <b>Electrical</b> | Electrical Distribution | <p>The electrical service enters the building at the 208/120-volt 3000-amp main switchboard located in Electrical Room #3 via underground service from a pad-mounted utility company transformer. The main switchboard feeds all 208/120-volt equipment throughout the campus. The building does not have a lightning protection system. There is no main breaker for the main switchboard, so incoming power cannot be de-energized.</p> <p>The electrical distribution equipment was in poor condition. Electrical distribution system upgrades took place in 1985, 1999, and 2006; however, approximately 60% of the panels and switchgear appeared to be from the original construction and are still active. A majority of the original construction panels appeared to have corrosion. There were also screws missing from the housing enclosure of some of the units. Two panelboards were missing breaker covers, and the bussing was exposed behind the breaker board. This condition could be considered a life safety hazard, and breaker covers should be installed immediately. Facility staff specifically reported that two panels in the kitchen, a panel in the small gymnasium, panels in the 100- and 300-wings, and panels in the coaches' offices are outdated. However, there is no panel in Corr 300; it is actually in Corr 500. Furthermore, no panels were observed in the female coach's office.</p> | Poor |

| System | Subsystem | Condition and Deficiency Overview | System Condition Rating |
|---|---|---|---|
| | | <p>Most of the disconnect switches on the roof appeared to be severely corroded. There were also some conduits that appeared to have severe corrosion, and one conduit appeared to be cut off and had exposed conductors (life safety concern).</p> | |

1. Immediately provide missing circuit breaker cover plates for all electrical equipment that were noted, as these instances should be considered life safety hazards.

2. Repair or replace all electrical equipment affected by corrosion or rust. If the corrosion/rust is beyond the enclosure, then replacement is suggested.

1. Replace panelboard 'F' that is in COR 100 and panelboards 'H1' and 'H2' in COR 500.
2. Replace panelboard 'LP1A' that is located in the male coach's office.
3. Replace panelboard located in the small gymnasium.
4. Replace two-section panelboard 'B' located in the kitchen.
5. Replace all original construction panels and switchgear throughout the facility.
6. Replace stage lighting and stage dimming control system.
7. Replace existing 3000A MLO (main lugs only) main switchboard with a new 3000A MCB (main circuit breaker) switchboard.
8. Change lighting in both gyms to LED.

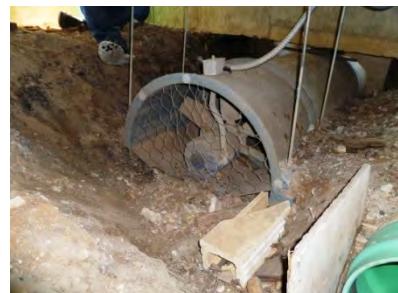
Pipe with fan leading to areaway

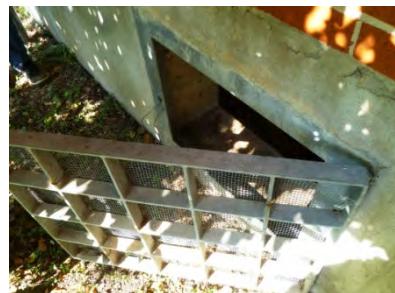
Unlocked access door

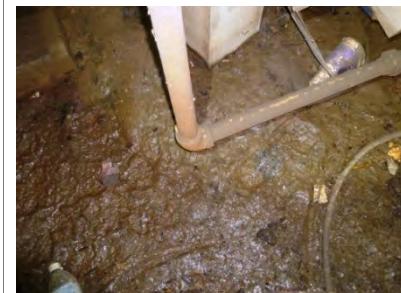
Saturated soil

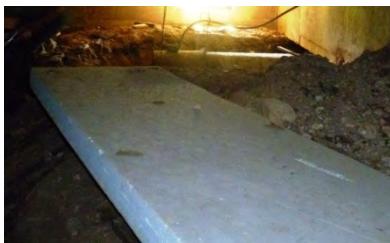
Fallen rigid insulation

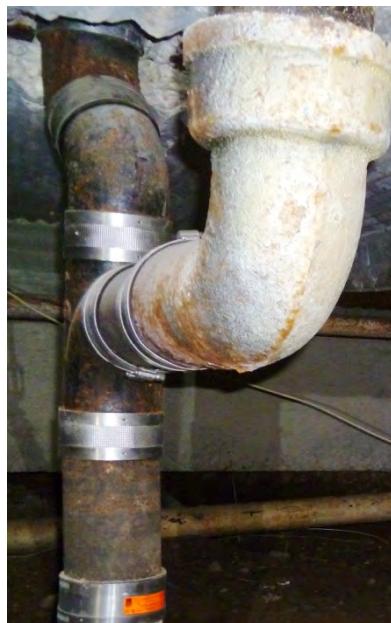
Rusted cast iron pipe

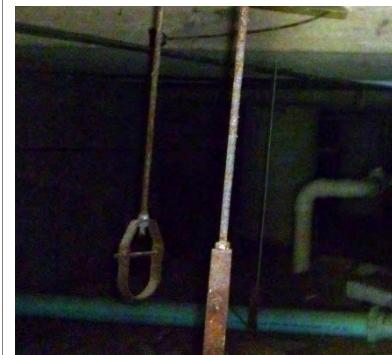
Rusted hangers

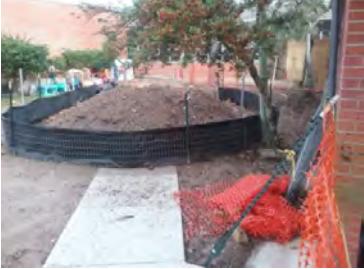
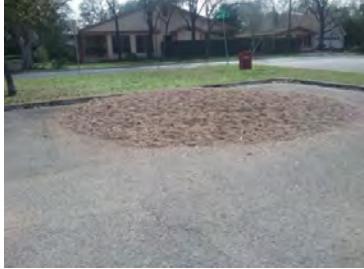
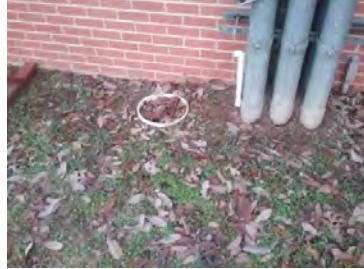
| SW of school construction material | Parking Lot 3 material to be removed | Pipes to be covered |

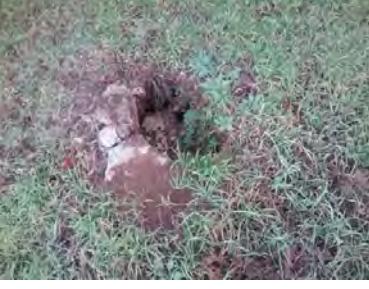
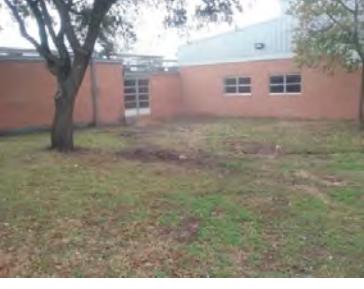
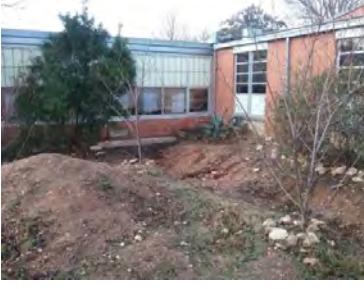
| Pest Hole Courtyard 1 | Regrading is needed to slope away from building | Erosion against the building |

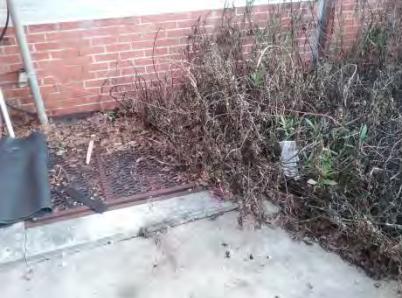
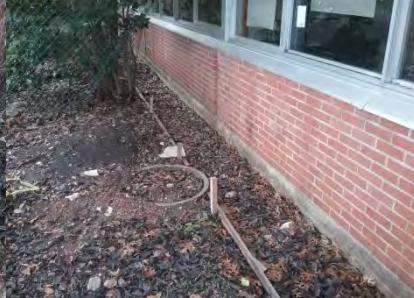
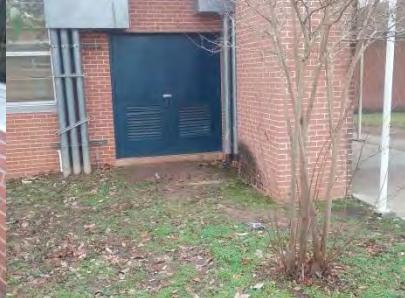
| Unserviceable Inlet | Incomplete Concrete Slab | Landing Needed |

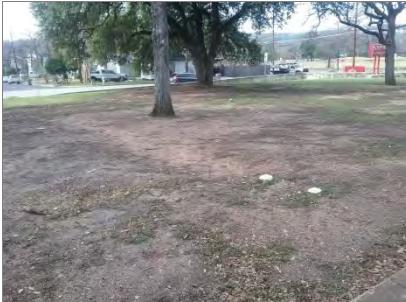
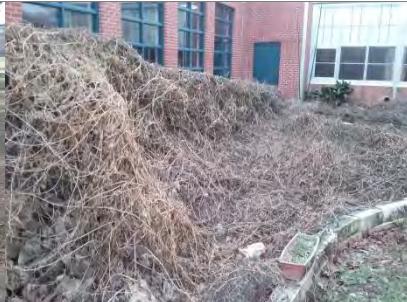
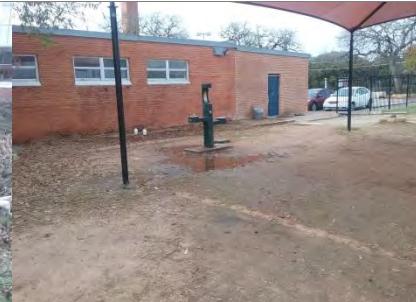
| Resodding Needed | Overgrown Landscaping | Low spots and ponding |

1. Remove unnecessary debris and concrete pads.
2. Redo riprap at drainage outlets.
3. Cover all open inlets.
4. Resod and regrade.

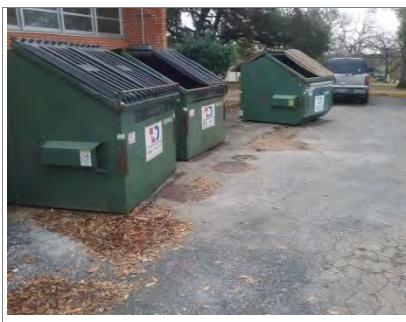
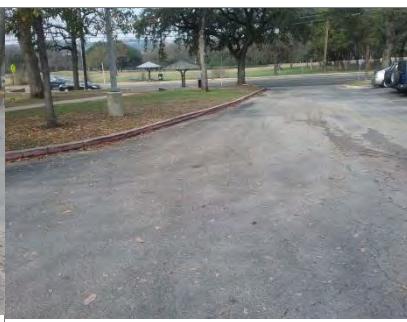
| No concrete pad under dumpster | Reported Lighting Issues |

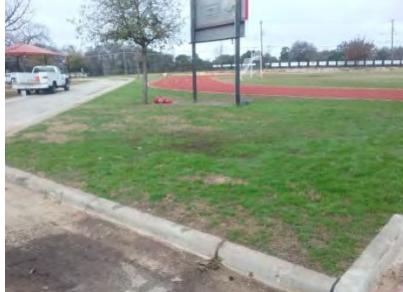
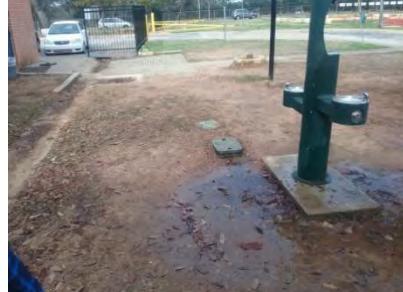
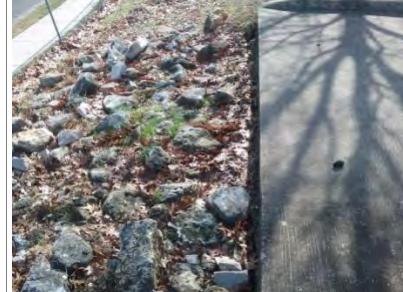
| Track and Low Spot | Playfield with low spots and erosion | Outlet in need of new riprap |

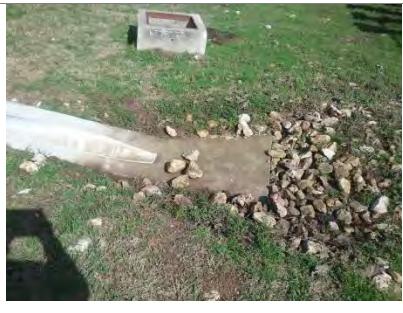
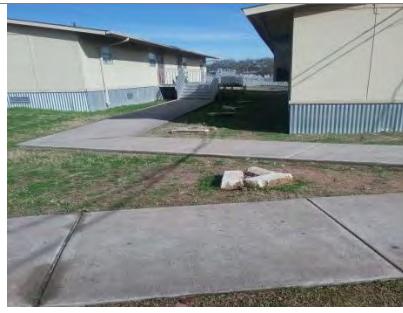
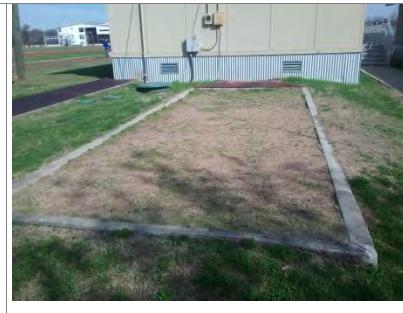
| Open Inlet and Eroded Outlet | Material to be removed | Material to be removed or resodded |
