## Webb Middle School Site Summary

<b>Address</b>	601 E St. Johns Avenue Austin, TX 78752
<b>Number of Permanent Campus Facilities</b>	2
<b>Original Year of Construction</b>	1961
<b>Total Campus Building Area (combined)</b>	120,985 SF

## Main School Building – BLDG-053A

## Site/Civil Assessment

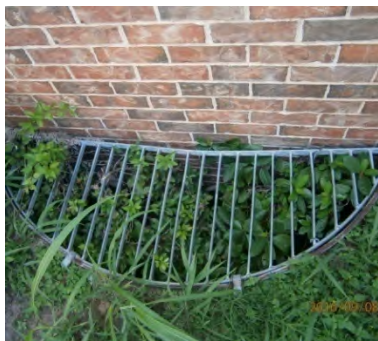
Areaway clogged with vegetation

1. Investigate methods to improve site drainage so water runs away from building instead of into the crawl space
2. Clear blocked areaways
3. Investigate need for improved ventilation
4. Restore access to crawl space (keep storage off hatches)
5. Clean rusted hatch frame and protect from further corrosion

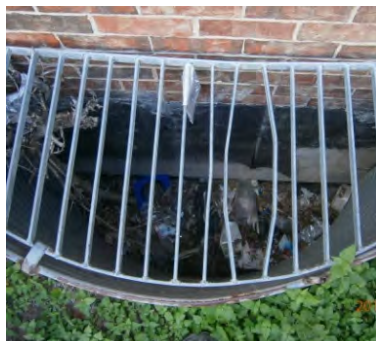
Bottom of areaway clogged with soil and debris

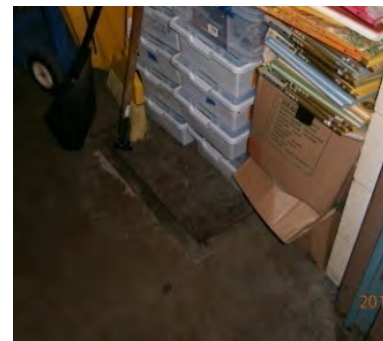
Storage on floor hatch prevents access to crawl space

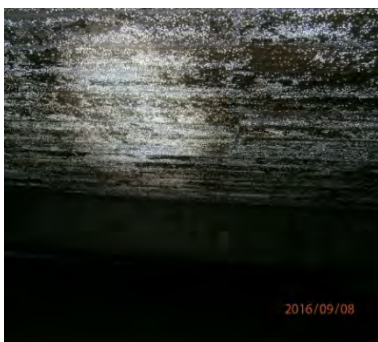
Condensation on slab underside

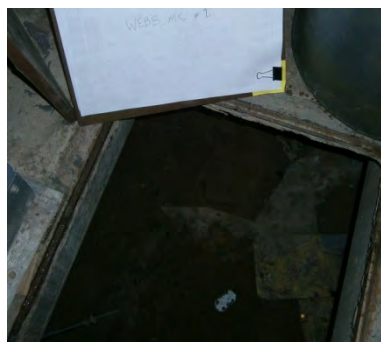
Rusted hatch frame

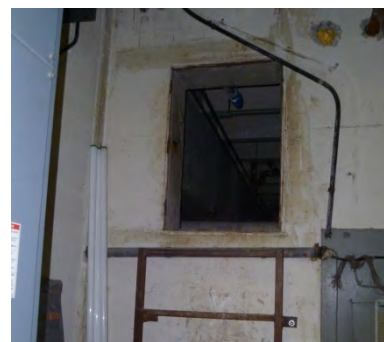
Missing hatch door

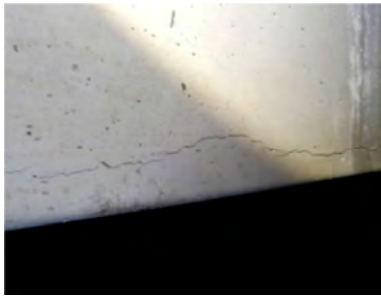
<p>Longitudinal cracks along bottom of channel joist</p>

1. Replace or strengthen severely corroded slab channels
2. Repair badly spalled/cracked concrete elements
3. Clean exposed/rusted reinforcement and protect from further corrosion

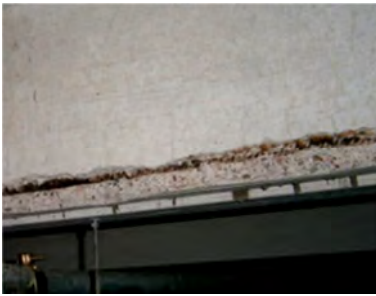
<p>Severe longitudinal spalling along bottom of channel joist, exposed/corroded rebar</p>

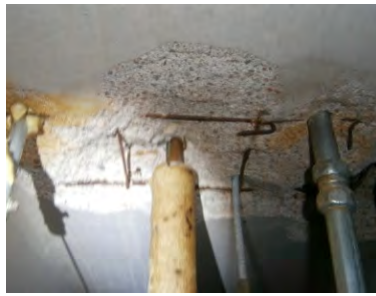
<p>Spalling &amp; exposed/corroded reinforcement at slab pipe penetration</p>

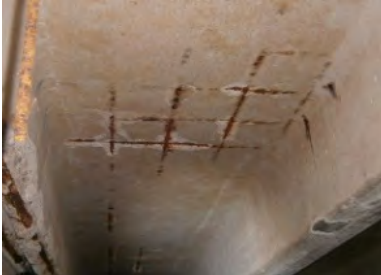
<p>Exposed/corroded reinforcement at underside of channel slab, spalling &amp; corrosion in bottom of channel joist</p>

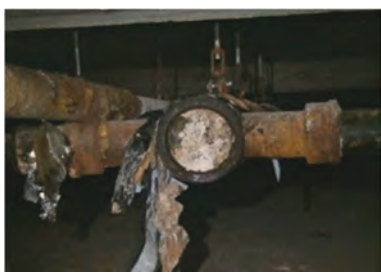
<p>Degraded pipe insulation</p>

1. Repair corroded cast iron pipes & protect from further corrosion or replace
2. Replace heavily corroded hangers/supports
3. Replace degraded/moldy pipe insulation

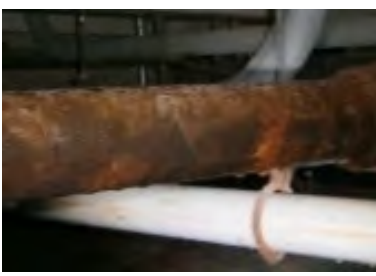
<p>Rusted cast iron pipe</p>

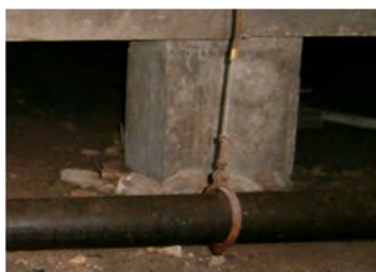
<p>Rusted pipe hanger</p>

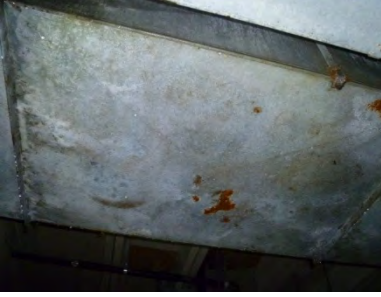
<p>Corrosion on ductwork</p>

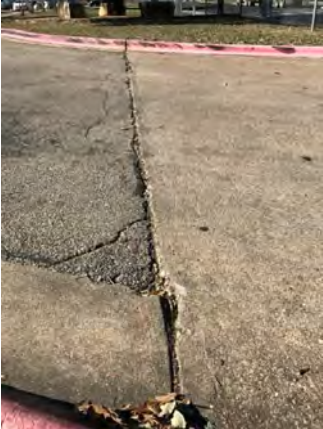
R1 alligator cracks and broken pavement	R1 Transverse cracks and busted C&G	R2 alligator cracks

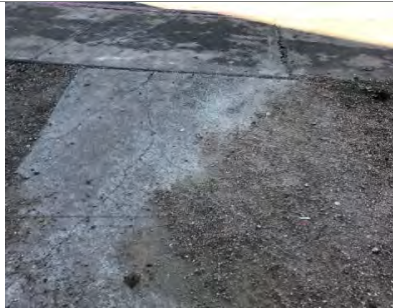
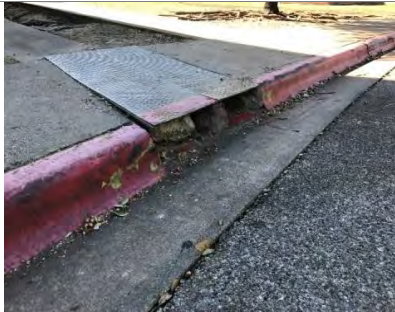
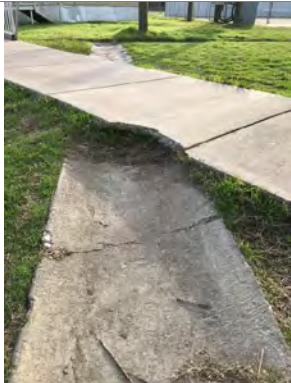
Decomposed granite on sidewalk	Metal plate section not flush	Gutter flume clogged
