NELSON BUS TERMINAL

2016 Facility Condition Assessment as of August 2016

7105 Berkman Dr.
Austin, TX 78752

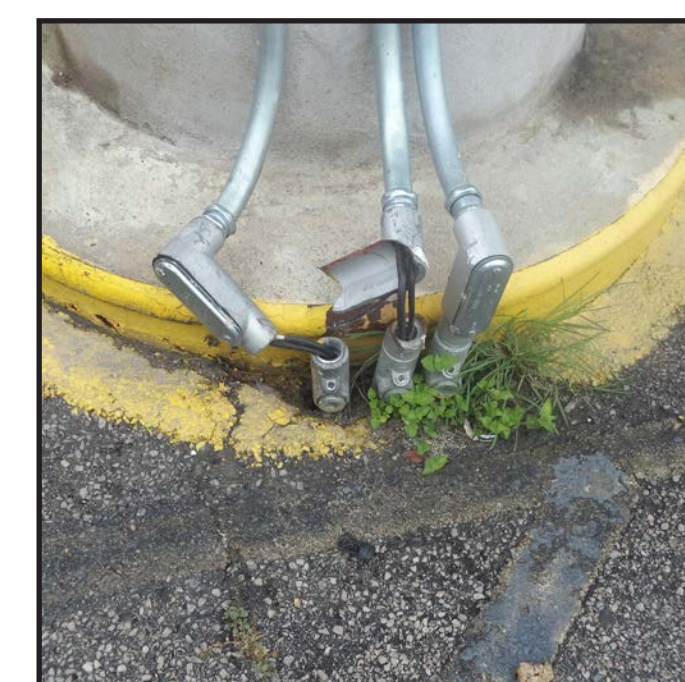
Electrical Distribution
Outdoor Wires Exposed to Elements

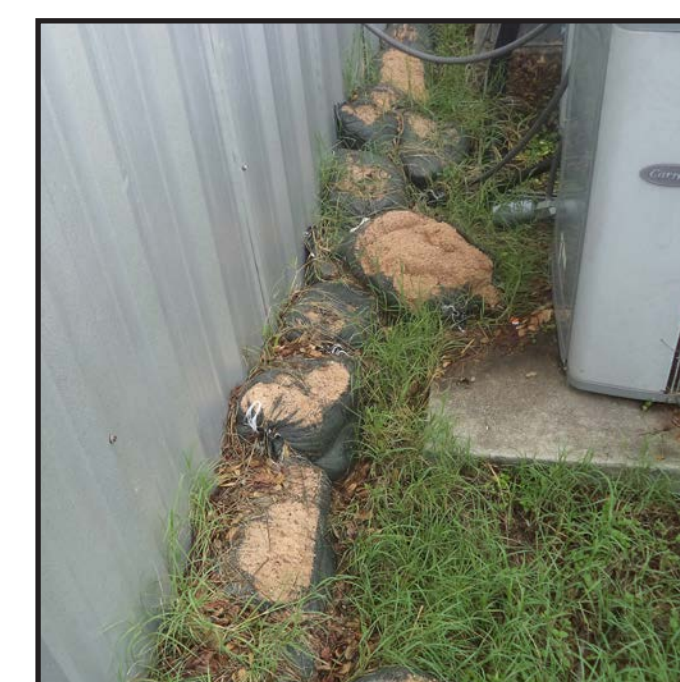
Exterior Walls
Water Leakage; Ineffective Sandbags

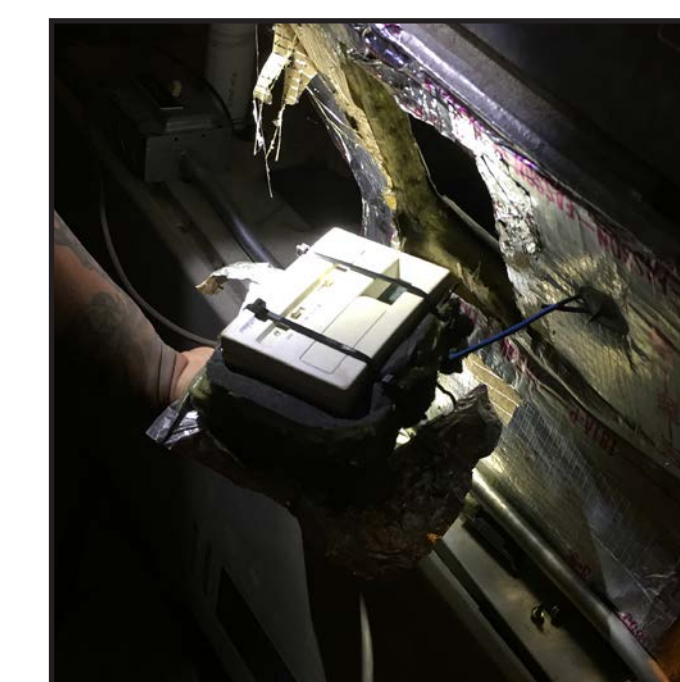
Mechanical / HVAC
Damaged Insulation

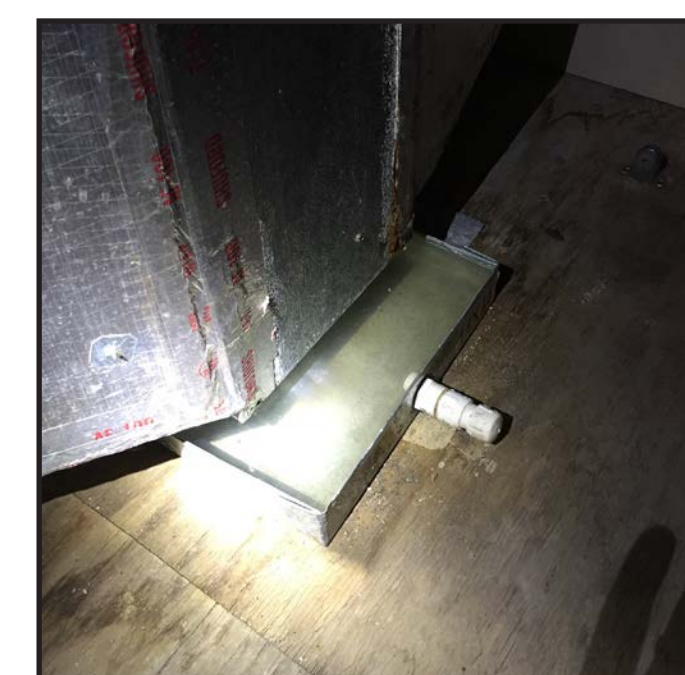
Mechanical / HVAC
Drip Pans Overflowing
Causing Ceiling Damage

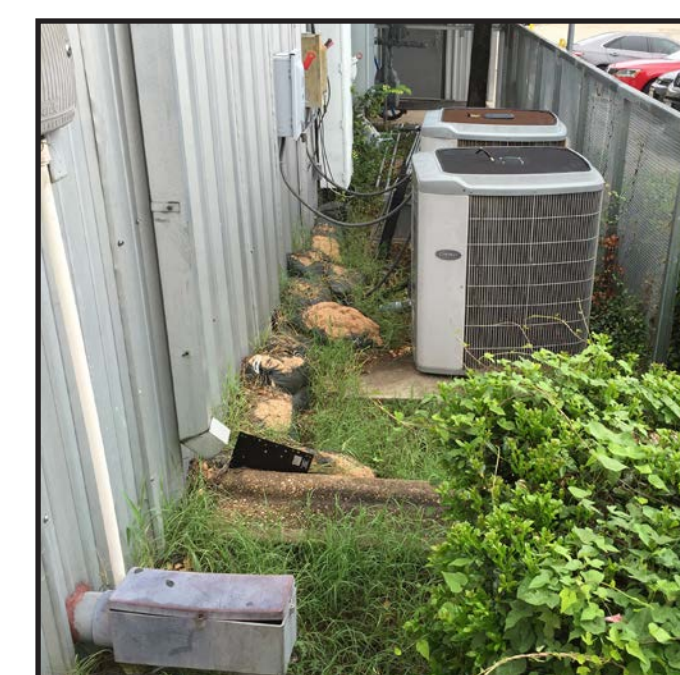
Mechanical / HVAC
Rusted System

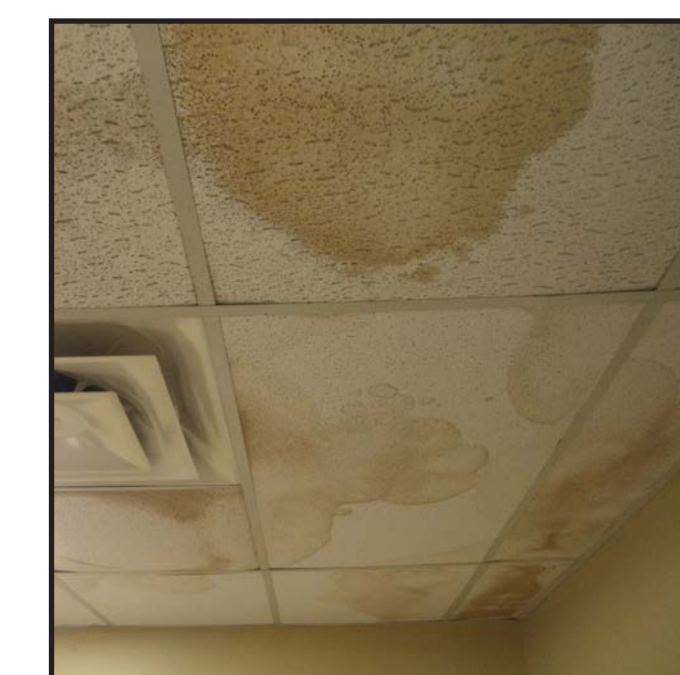
Interior Ceiling Finishes
Ceiling Tiles with Water Damage

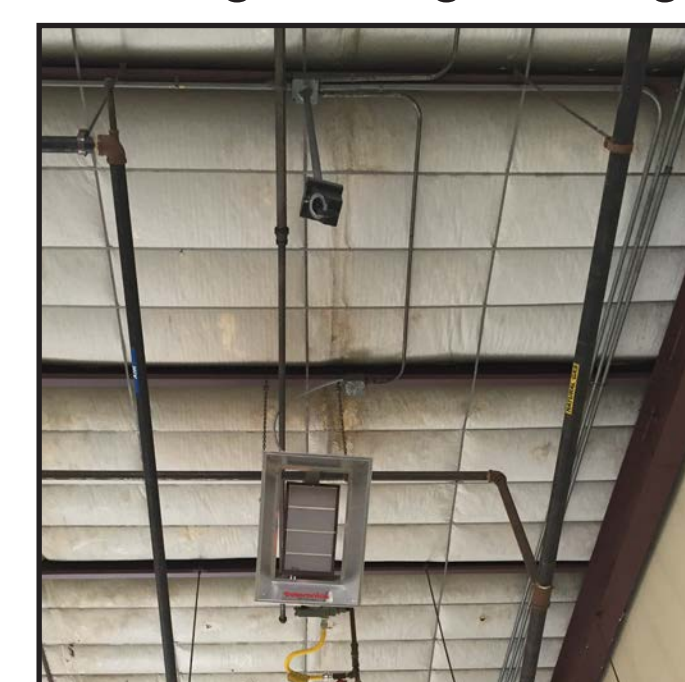
Interior Ceiling Finishes
Wear & Tear

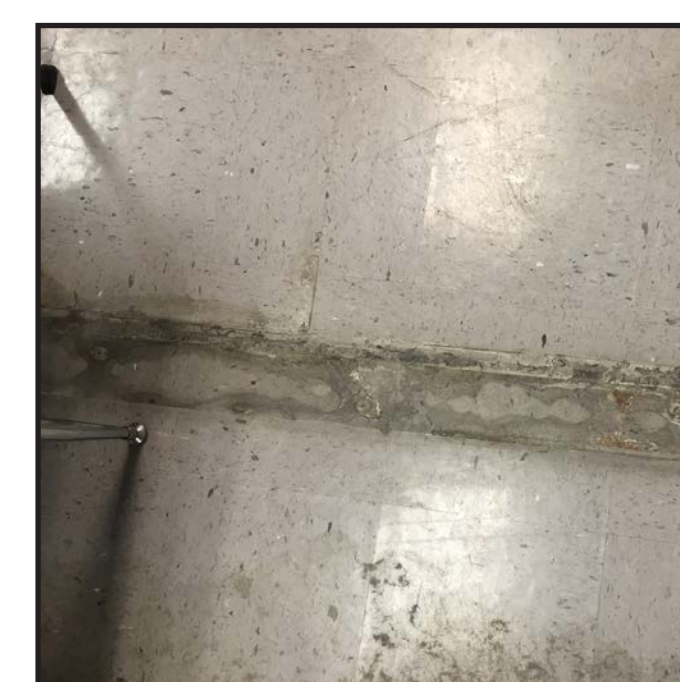
Interior Floor Finishes
Excessive Wear & Tear

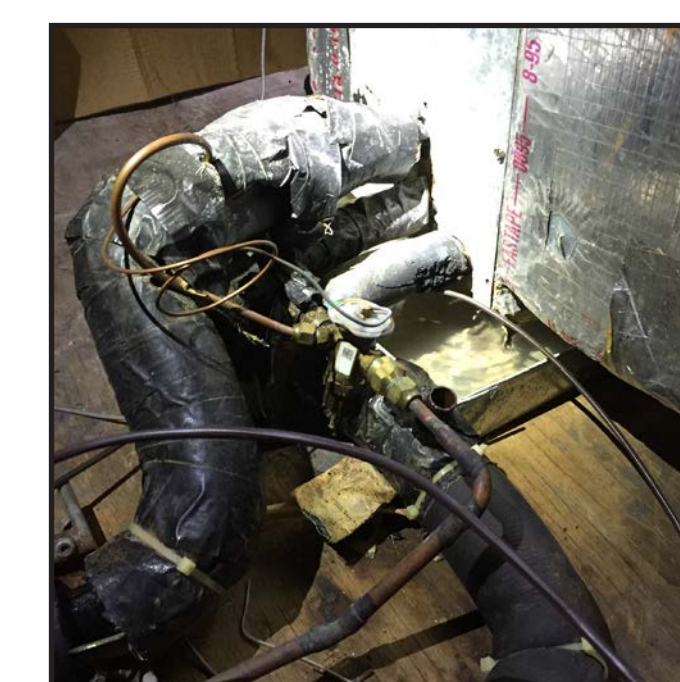
Plumbing
Wear & Tear
