# FACILITY CONDITION ASSESSMENT

*Andrews ES* | February 2022

Andrews ES is located at 6801 Northeast Dr in Austin, Texas. The oldest building is 58 years old (at time of 2020 assessment). It comprises 61,659 gross square feet.

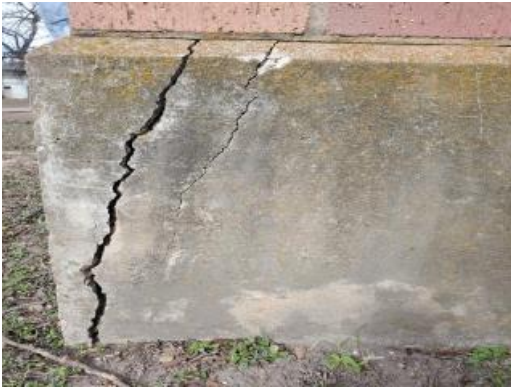
Cracked foundation

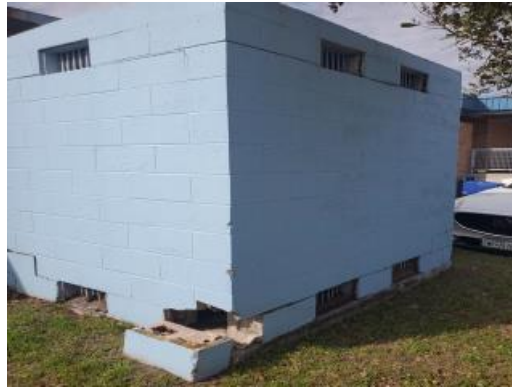
Damaged building exterior

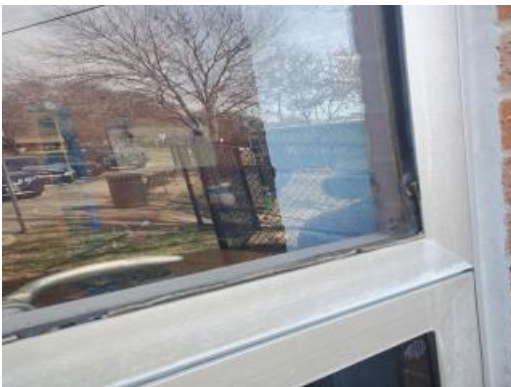
Damaged window

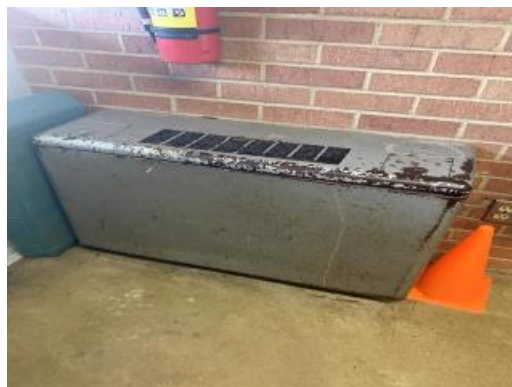
Ventilation unit at end of life

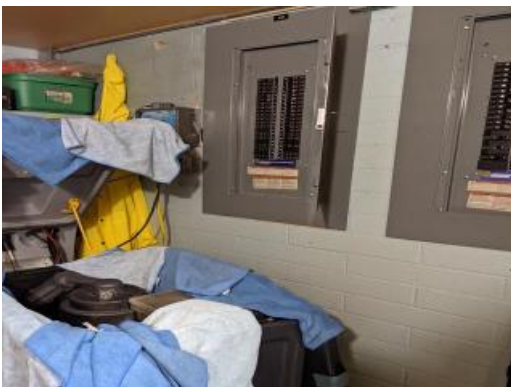
Obstructed electrical panel

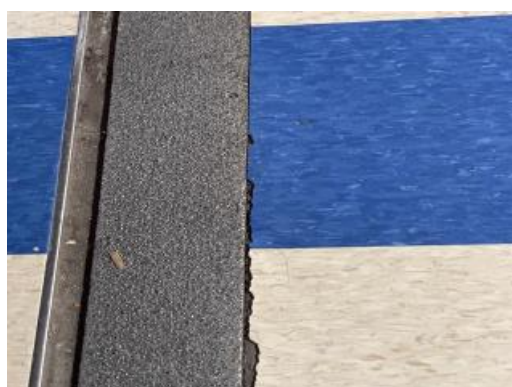
Chipped and worn ceramic tile flooring.

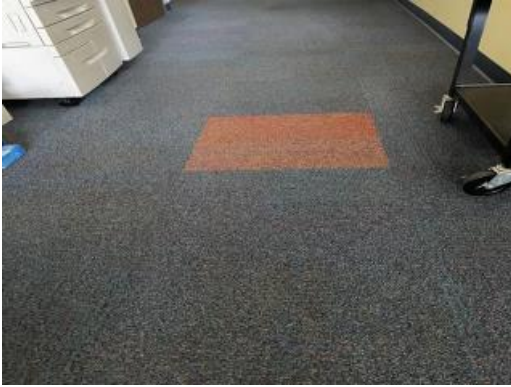
Non-uniformity of carpet flooring.

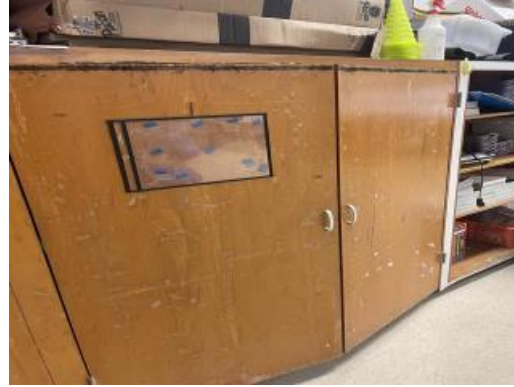
Scratched and worn classroom cabinetry.

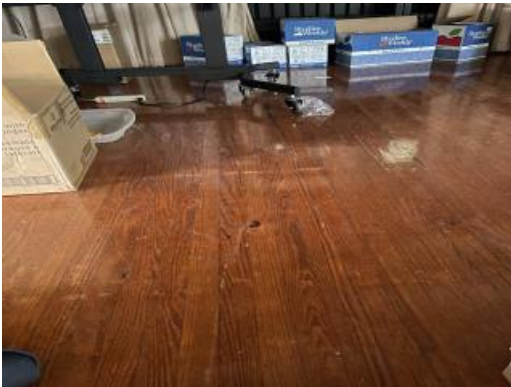
Scratched and worn wood floor panels.
