# FACILITY CONDITION ASSESSMENT

*Austin HS* | February 2022

Austin HS is located at 1715 W. Cesar Chavez St. in Austin, Texas. The oldest building is 45 years old (at time of 2020 assessment). It comprises 340,540 gross square feet.

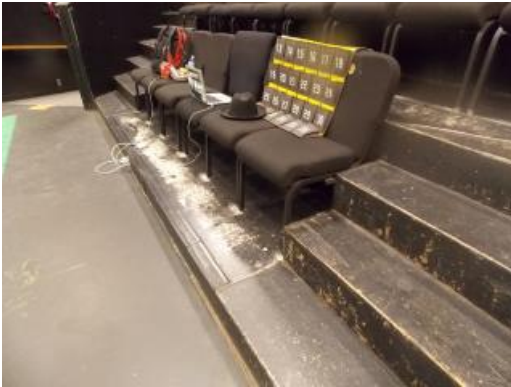
Worn theater flooring

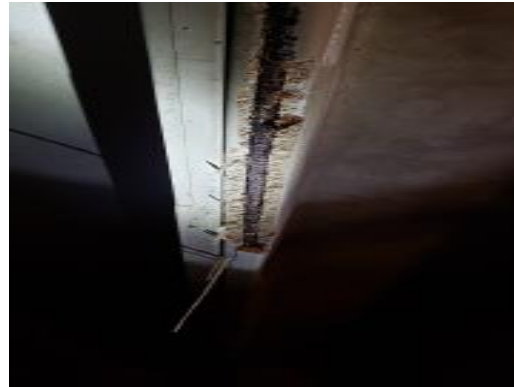
Exposed rebar in basement

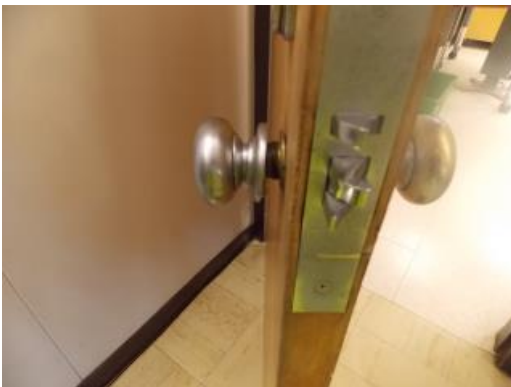
Damaged door hardware

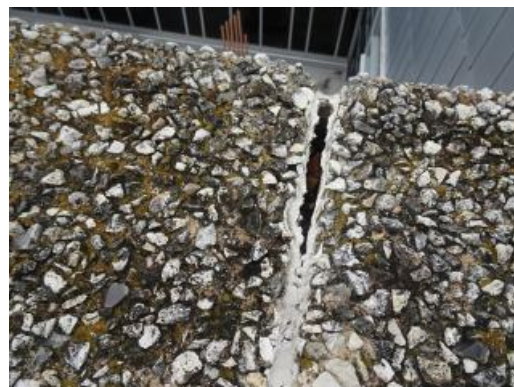
Failed sealant

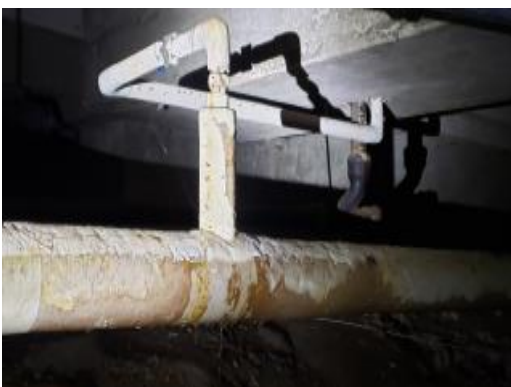
Pipes leaking in crawl space

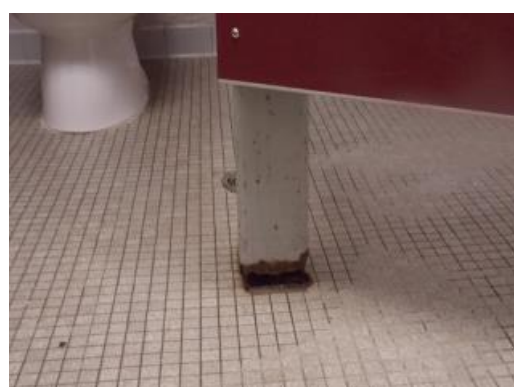
Bathroom partition damaged

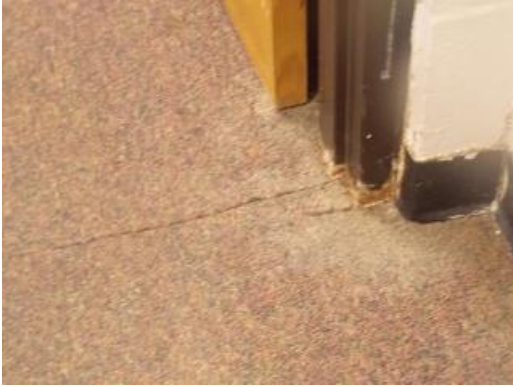
Interior doorway damage

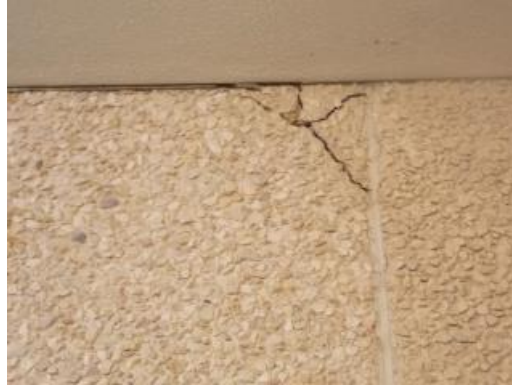
Cracked flooring

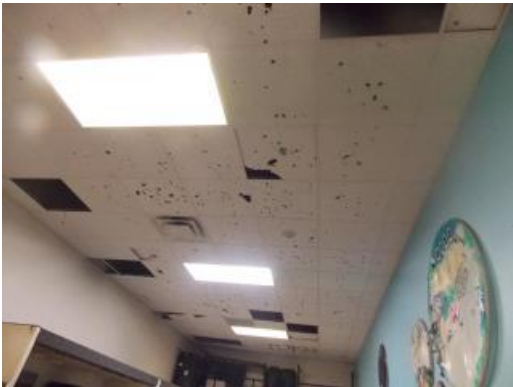
Aged ceiling tiles
