# FACILITY CONDITION ASSESSMENT

*Baranoff ES* | February 2022

Baranoff ES is located at 12009 Buckingham Gate Rd in Austin, Texas. The oldest building is 21 years old (at time of 2020 assessment). It comprises 80,087 gross square feet.

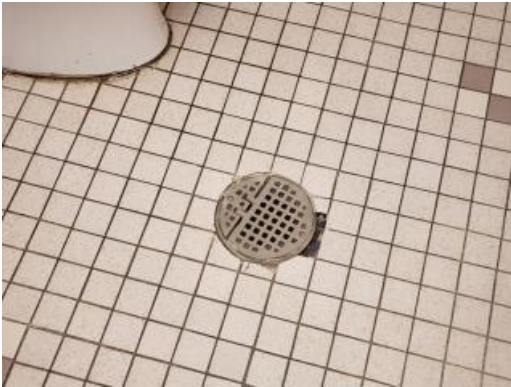
Damaged and old ceramic tile floors

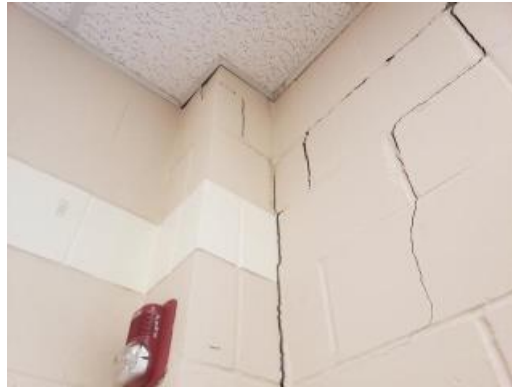
Possible foundation settlement

Deficiency	Category	Qty	UoM	Priority	Repair Cost	ID
Structural Study Recommended <b>Note:</b> Wall cracks throughout the building, foundation study recommended	Deferred Maintenance	1	Job	1	\$12,910	3767
	<b>Sub Total for System</b>	<b>1</b>	<b>items</b>		<b>\$12,910</b>

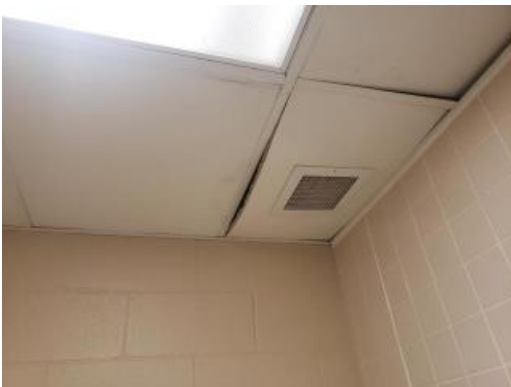
Sagging ceiling tiles

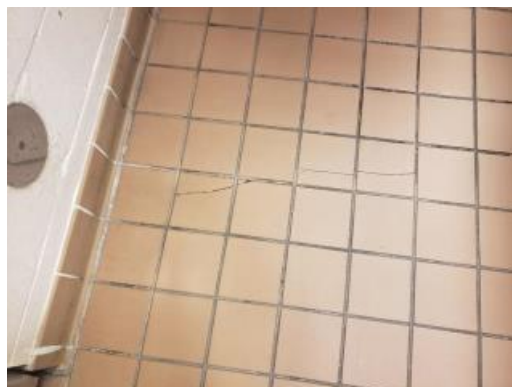
Cracked bathroom ceramic tile flooring

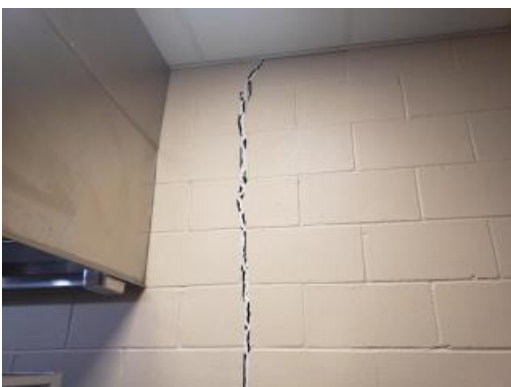
Possible foundation settlement

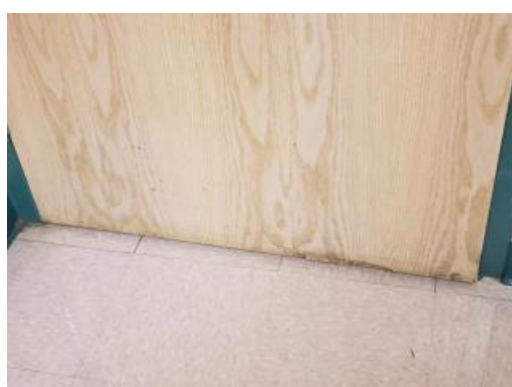
Worn interior doors

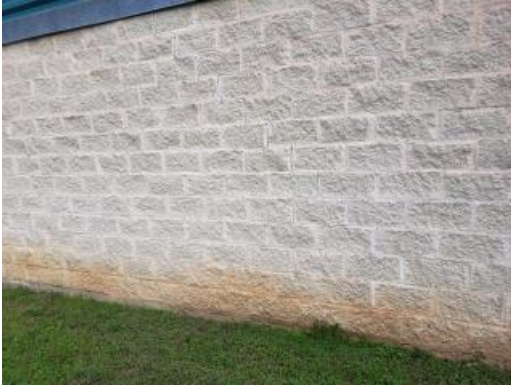
Exterior walls stained

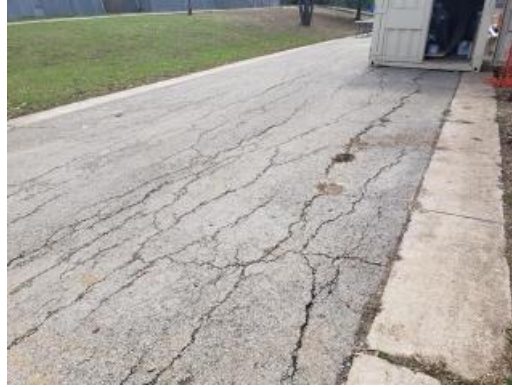
Cracked asphalt pavement

Deficiency	Category	Qty	UoM	Priority	Repair Cost	ID
Asphalt Driveway Replacement <b>Note:</b> Cracks, settling and potholes throughout.	Capital Renewal	20,000	SF	3	\$128,609	2551
Asphalt Paving Replacement	Capital Renewal	100	CAR	4	\$145,080	3768
Exterior Basketball Goal Replacement <b>Note:</b> Missing backboard	Capital Renewal	1	Ea.	4	\$6,653	2550
Motorized Gate Replacement <b>Note:</b> Sagging and scrapes the ground. <b>Location:</b> Near east playground	Capital Renewal	12	LF	4	\$9,946	2549
PROGRAM DEFICIENCIES	ADA Compliance	81,866	EACH	5	\$140,562	3770
PUBLIC DEFICIENCIES	ADA Compliance	59,465	EACH	5	\$102,100	3769
TAS ACCESSIBILITY DEFICIENCIES	ADA Compliance	81,678	EACH	5	\$140,240	3771
	<b>Sub Total for System</b>	<b>7</b>	<b>items</b>		<b>\$673,190</b>	
	<b>Sub Total for School and Site Level</b>	<b>7</b>	<b>items</b>		<b>\$673,190</b>

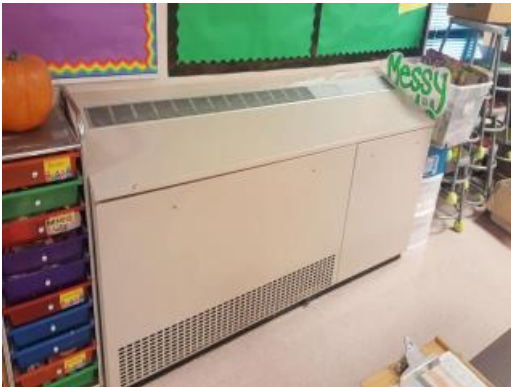
Outdated unit ventilator in classrooms

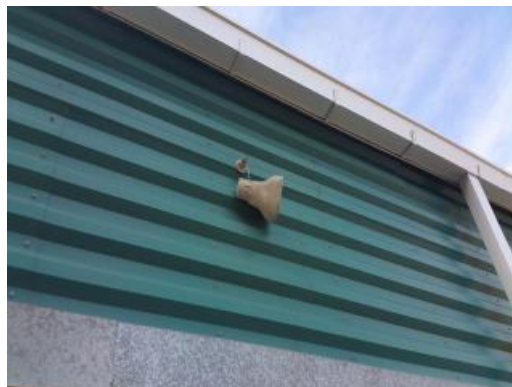
Broken exterior lighting
